Appendix F – Existing Building CCTV Drainage Survey

Project Name: 67C Camlet Way, Barnet, EN4 0NL
Project Description: Pre-build
Project Date: 02/11/2022

Survey Comments & Recommendations

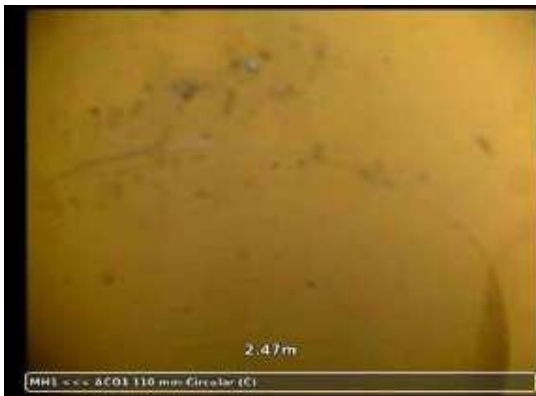
ACO1X_0a4b3754-92b0-40fb-acc1-091df3d48932_20221103_
 101148_421.jpg, 00:00:14, 2.47 m
 Line deviates down

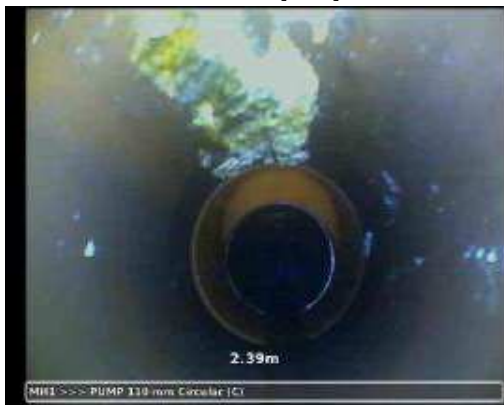
20221102-083441-snap0001.jpg, 00:00:17, 2.39 m
Junction at 12 o'clock, diameter: 110mm, CWG1

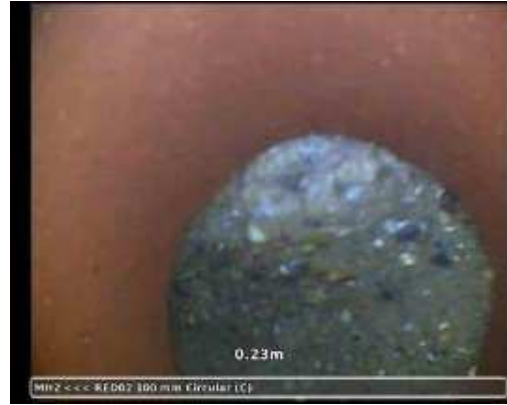
Town or Village:	Barnet	Inspection Direction:	Upstream	Upstream Node:	RED02
Road:	67C Camlet Way	Inspected Length:	0.23 m	Upstream Pipe Depth:	0.000 m
Location:	Other (state in comments)	Total Length:	0.23 m	Downstream Node:	MH2
Surface Type:		Joint Length:		Downstream Pipe Depth:	0.550 m
Use:	Other	Pipe Shape:	Circular		
Type of Pipe:	Gravity drain/sewer	Dia/Height:	100 mm		
Flow Control:	No flow control	Pipe Material:	Vitrified clay pipe (i.e. all clayware)		
Year Constructed:	Not Specified	Lining Type:	No Lining		
Inspection Purpose:	Sample survey to determine asset condition	Lining Material:	No Lining		
Comments:	Redundant pipe				
Recommendations:	Cap at manhole entry point

20221102-091350-snap0001.jpg, 00:00:09, 0.23 m
 Finish node, major connection without manhole, reference: RED02

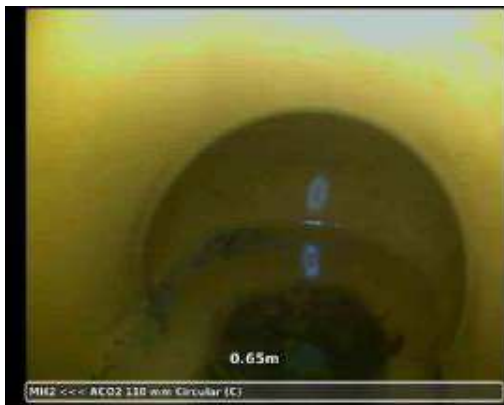
20221102-091807-snap0003.jpg, 00:00:17, 0.65 m
 Finish node, gully, reference: ACO2

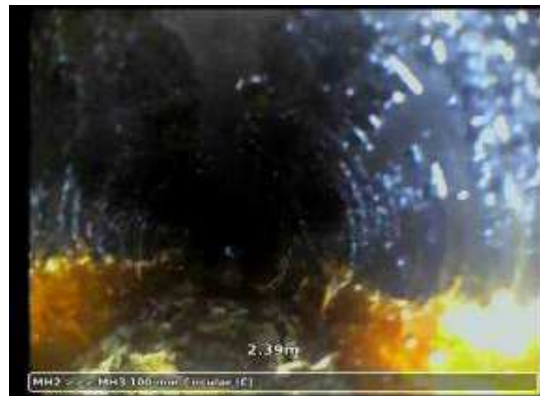
MH2X_0c38dde7-d8bb-4f88-8d2b-98dfbd033046_20221103_102754_779.jpg, 00:00:32, 2.39 m
 General photograph taken at this point
