Pavilion Gardens

Condition Survey Report

for Allen Scott Ltd

Condition Survey Report 2022

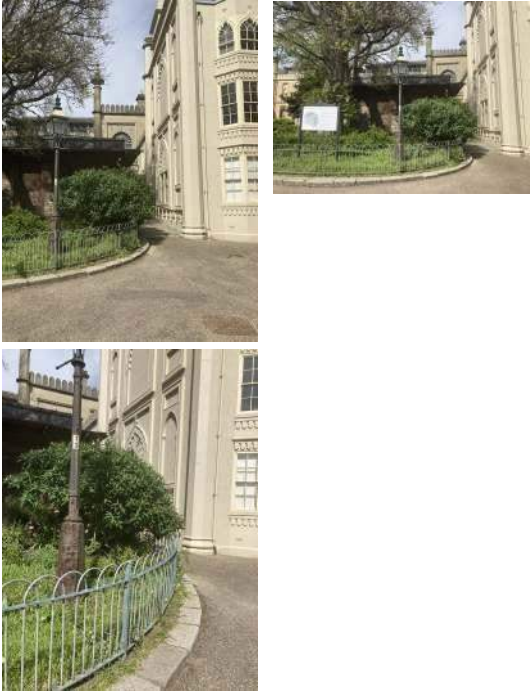
Item	Element & Description	Condition and Recommendation	Repair Category	Photograph
	EXTERNALLY			
3.1	NORTH EAST LAWN			
3.1.1	Lamp post 13			
	<p>Cast iron lamp post. This lamp post is not identified within the CBA conservation plan as being listed. Reeded square base with William IV's insignia. Different paint colours to shaft and base to the lamp.</p>	<p>a Significant corrosion to reeded base.</p>	<p>A</p>

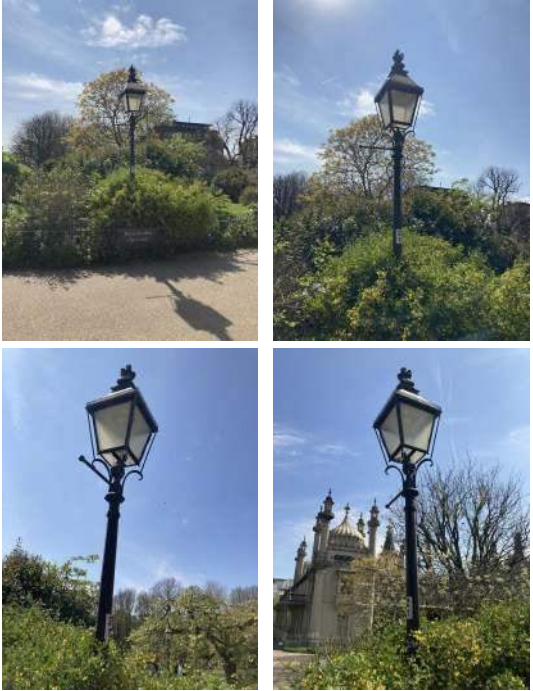
Item	Element & Description	Condition and Recommendation	Repair Category	Photograph
3.2	THE KINGS LAWN			
3.2.1	Lamp post 21			
	<p>Cast iron lamp post. Not included within CBA as listed. Reeded square base with William IV's insignia. Glass is slightly opaque and appears marked internally. Partially opaque glass.</p>	<p>a Good but base obscured by planting.</p>	<p>B</p>

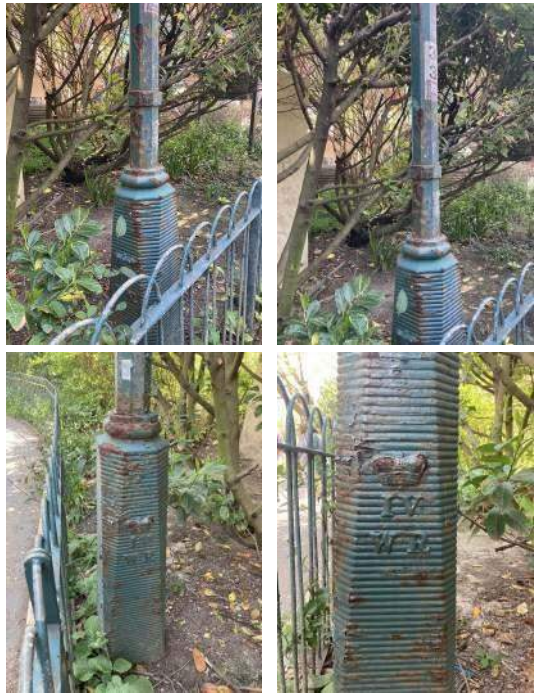
Item	Element & Description	Condition and Recommendation	Repair Category	Photograph
3.3	WESTERN LAWN			
3.3.1	Lamp post 33			
	<p>Cast iron lamp post. Grade II listed. Original gas fittings removed circa late C19 or C20 and now has LED bulb. Reeded square base with William IV's insignia.</p>	<p>a Significant corrosion to reeded base and octagonal post. Light green paint scheme.</p>	<p>A</p>

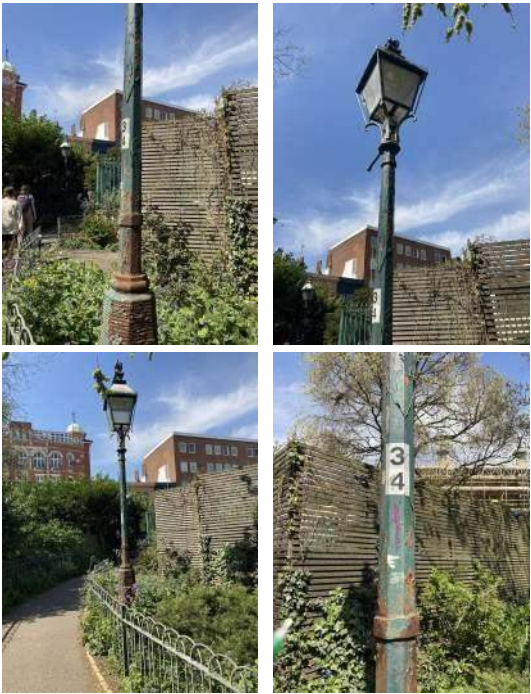
Item	Element & Description	Condition and Recommendation	Repair Category	Photograph
3.3.2	Lamp post 34			
	<p>Cast iron lamp post. Not noted within CBA conservation plan as listed. Reeded square base with William IV's insignia.</p>	<p>a Very poor with significant corrosion to reeded base and octagonal column.</p>	<p>A</p>

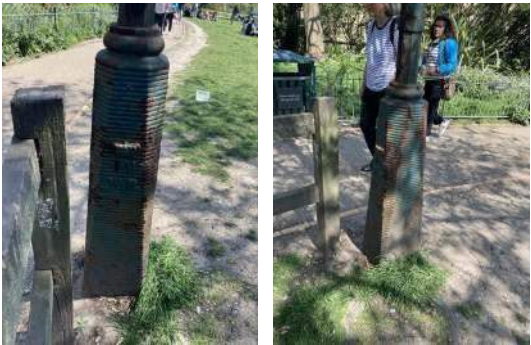
Item	Element & Description	Condition and Recommendation	Repair Category	Photograph
3.3.3	Lamp post 35			
	<p>Cast iron lamp post. Grade II listed. Original gas fittings removed circa late C19 or C20 and now has LED bulb. Reeded square base with William IV's insignia. Clear glass.</p>	<p>a Very poor with significant corrosion to reeded base and octagonal column.</p>	<p>A</p>

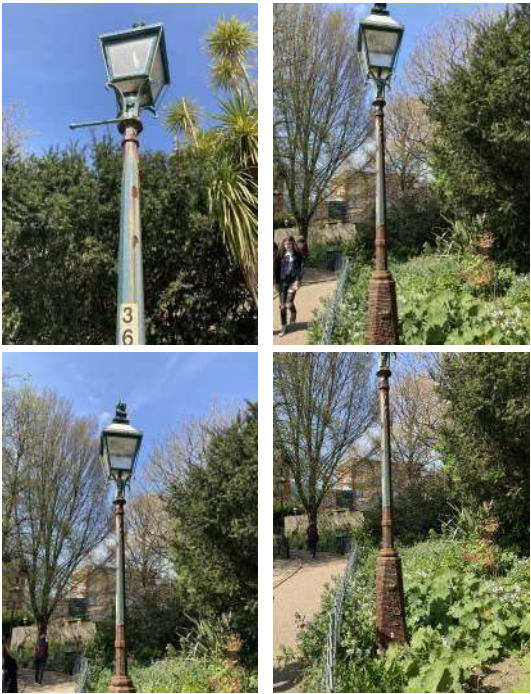
Item	Element & Description	Condition and Recommendation	Repair Category	Photograph
3.3.4	Lamp post 36			
	<p>Cast iron lamp post. Not included in the CBA plan as listed. Reeded square base with William IV's insignia. Light green painting scheme.</p>	<p>a Very poor with significant corrosion to reeded base and octagonal column.</p>	<p>A</p>

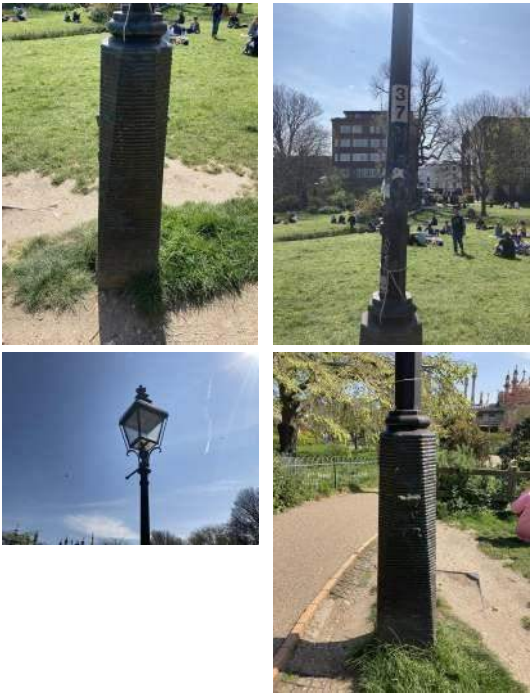
Item	Element & Description	Condition and Recommendation	Repair Category	Photograph
3.3.5	Lamp post 37			
	<p>Cast iron lamp post. Not included in the CBA conservation plan as listed. Reeded square base with William IV's insignia. Evidence of 2 paint schemes, lighter green covered by a darker green.</p>	<p>a Good. Lichen and moss to reeded base.</p>	<p>B</p>

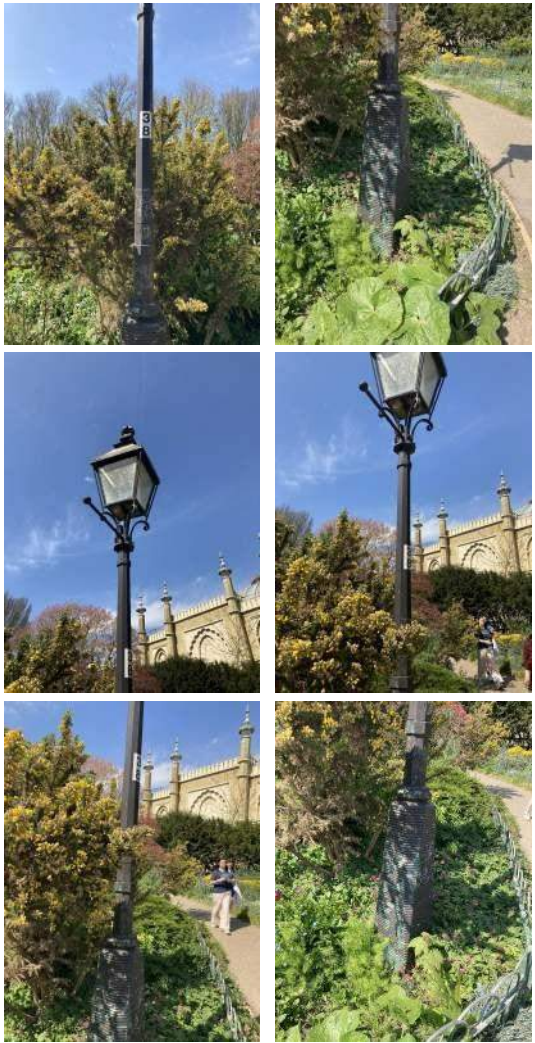
Item	Element & Description	Condition and Recommendation	Repair Category	Photograph
3.3.6	Lamp post 38			
	<p>Cast iron lamp post. Grade II listed. Original gas fittings removed circa late C19 or C20 and now has LED bulb. Reeded square base with William IV's insignia. Evidence of at least 2 paint schemes, lighter green with darker green on top.</p>	<p>a Support of lamp connection to be investigated when high level access available as appears to be sitting out of vertical.</p>	<p>B</p>

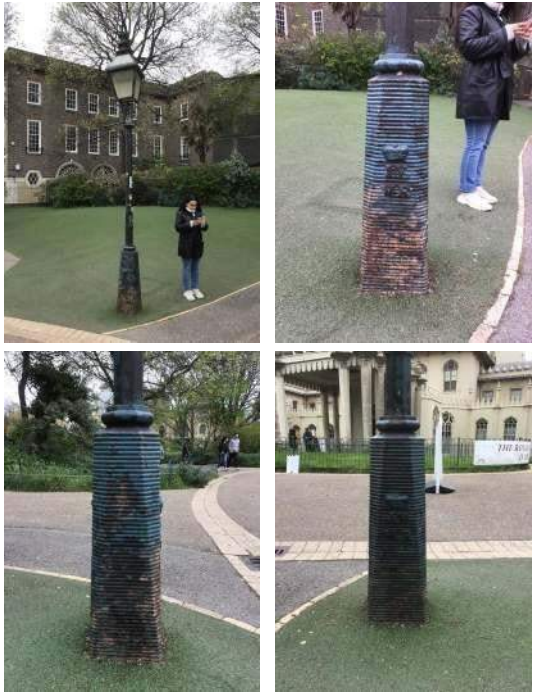
Item	Element & Description	Condition and Recommendation	Repair Category	Photograph
3.3.7	Lamp post 24			
	<p>Cast iron lamp post. Grade II listed. Original gas fittings removed circa late C19 or C20 and now has LED bulb. Reeded square base with William IV's insignia.</p>	<p>a Corrosion at base. Set within astro turf area.</p>	<p>A</p>

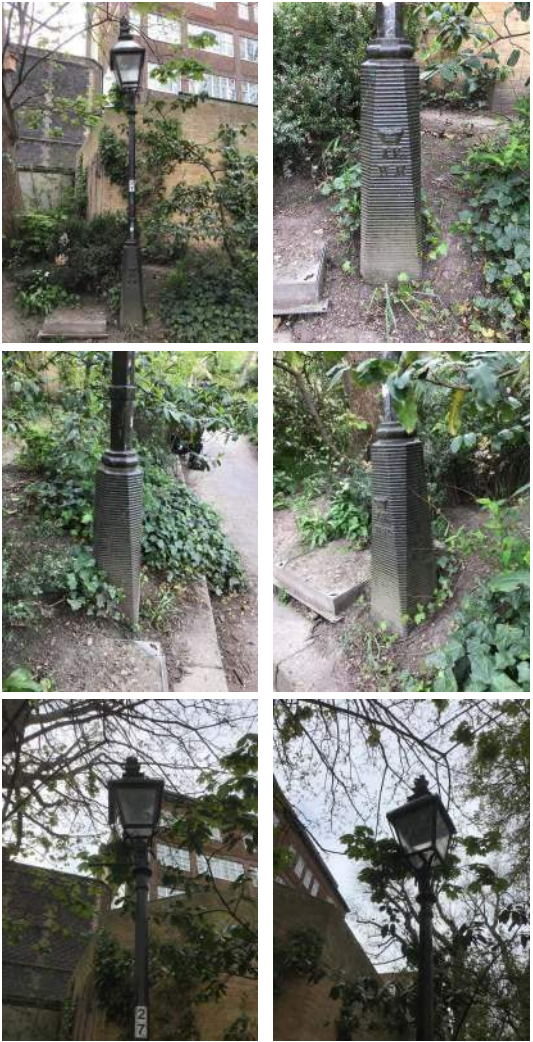
Item	Element & Description	Condition and Recommendation	Repair Category	Photograph
3.3.8	Lamp post 27			
	<p>Cast iron lamp post. Grade II listed. Original gas fittings removed circa late C19 or C20 and now has LED bulb. Reeded square base with William IV's insignia. Evidence of previous light green and darker green on top paint schemes.</p>	<p>a Good.</p>	<p>B</p>

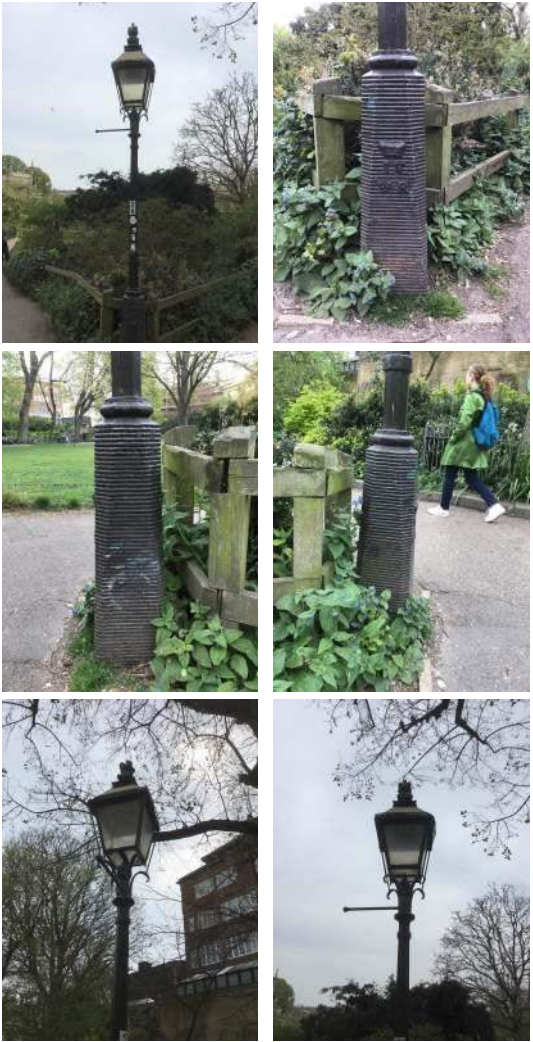
Item	Element & Description	Condition and Recommendation	Repair Category	Photograph
3.3.9	Lamp post 28			
	<p>Cast iron lamp post. Grade II listed. Original gas fittings removed circa late C19 or C20 and now has LED bulb. Reeded square base with William IV's insignia.</p>	<p>a Corrosion at base.</p>	<p>B</p>

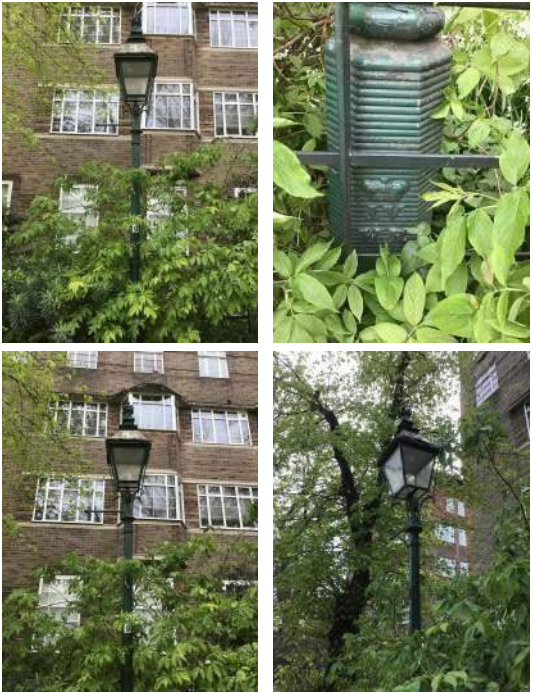
Item	Element & Description	Condition and Recommendation	Repair Category	Photograph
3.3.10	Lamp post 29			
	<p>Cast iron lamp post. Grade II listed. Original gas fittings removed circa late C19 or C20 and now has LED bulb. Reeded square base with William IV's insignia.</p>	<p>a Paint flaking and base obscured by planting.</p>

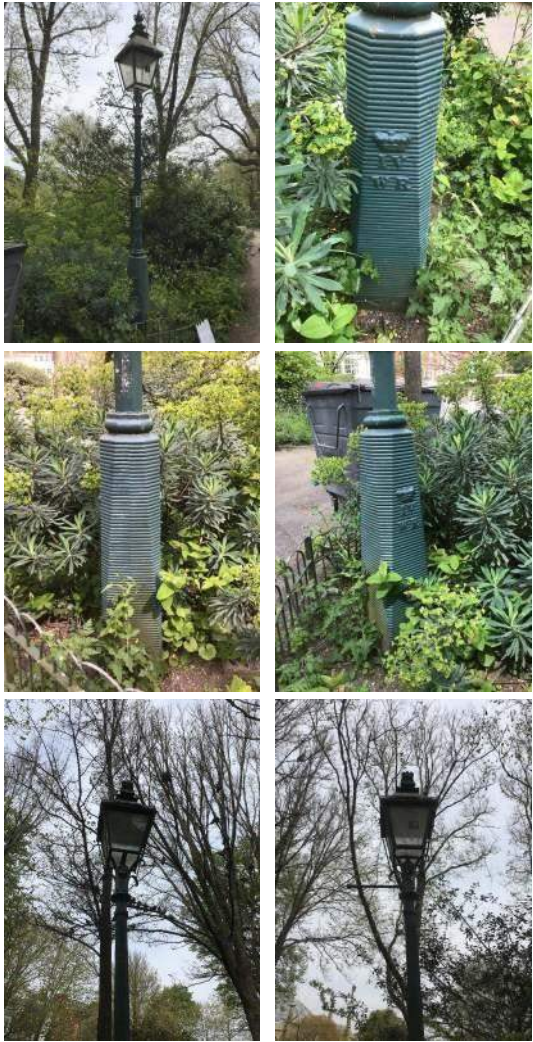
Item	Element & Description	Condition and Recommendation	Repair Category	Photograph
3.3.11	Lamp post 30			
	<p>Cast iron lamp post. Grade II listed. Original gas fittings removed circa late C19 or C20 and now has LED bulb. Reeded square base with William IV's insignia.</p>	<p>a Good.</p>	<p>B</p>

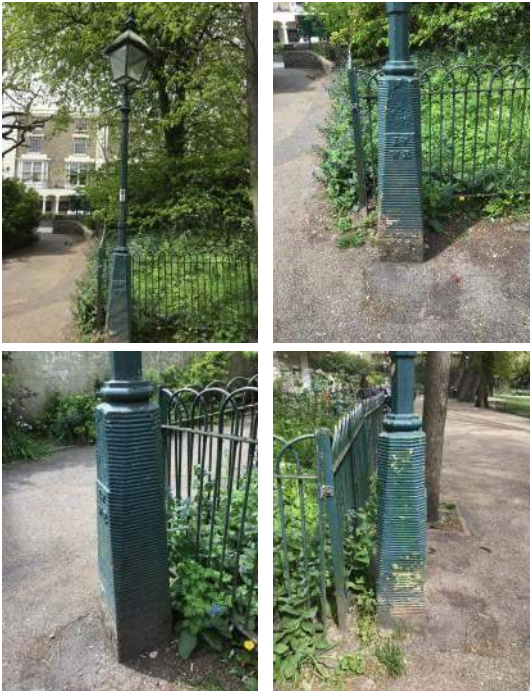
Item	Element & Description	Condition and Recommendation	Repair Category	Photograph
3.3.12	Lamp post 31			
	<p>Cast iron lamp post. Grade II listed. Original gas fittings removed circa late C19 or C20 and now has LED bulb. Reeded square base with William IV's insignia. Clear glass. Evidence of previous paint schemes with yellow (primer?) light green and dark green.</p>	<p>a Corrosion at base and paint flaking.</p>	<p>A</p>

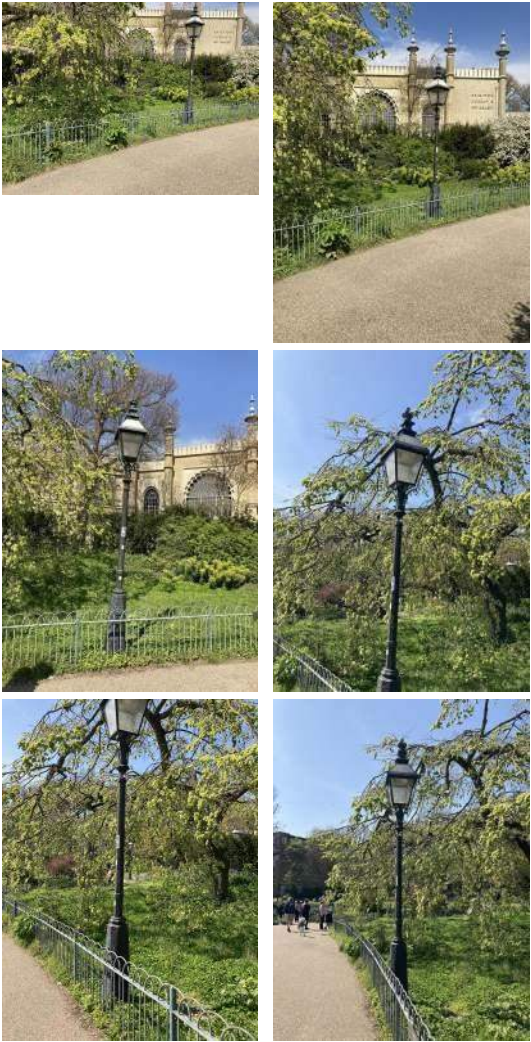
Item	Element & Description	Condition and Recommendation	Repair Category	Photograph
3.4	WESTERN LAWNS			
3.4.1	Lamp post 39			
	<p>Cast iron lamp post. Grade II listed. Original gas fittings removed circa late C19 or C20 and now has LED bulb. Reeded square base with William IV's insignia. Clear glass. 2 paint schemes evident.</p>	<p>a Good. Pain flaking to base and lamp supports. Graffiti evident on glass.</p>	<p>B</p>

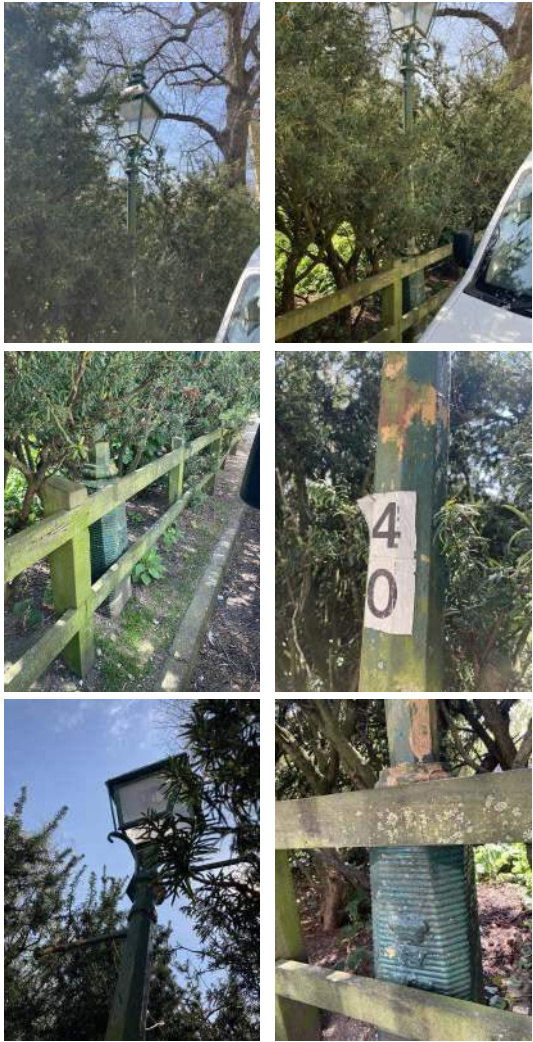
Item	Element & Description	Condition and Recommendation	Repair Category	Photograph
3.4.2	Lamp post 40			
	<p>Cast iron lamp post. Grade II listed. Original gas fittings removed circa late C19 or C20 and now has LED bulb. Reeded square base with William IV's insignia. Double maintenance arm and clear tinted glass.</p>	<p>a Good condition. Paint flaking and some corrosion at base.</p>	<p>B</p>

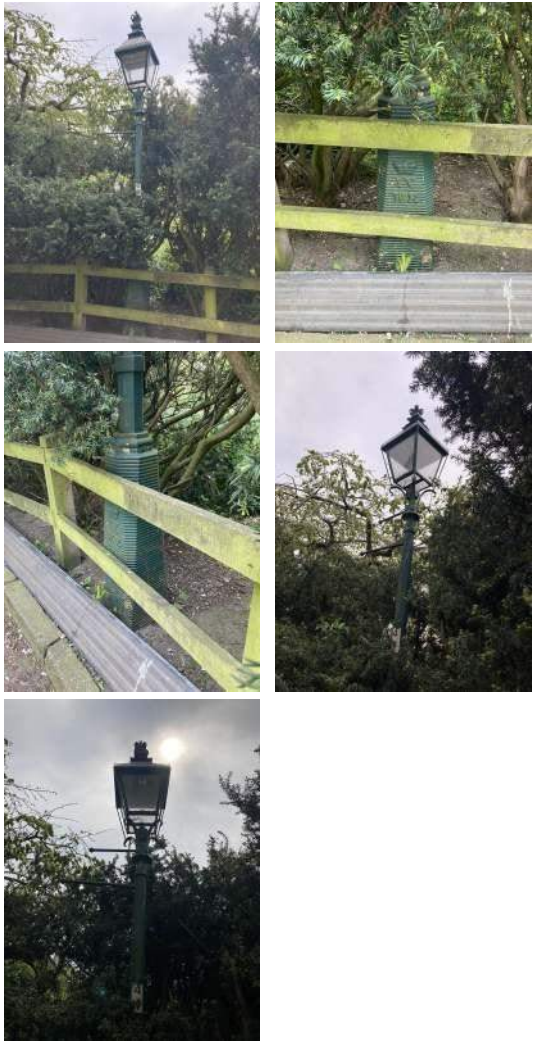
Item	Element & Description	Condition and Recommendation	Repair Category	Photograph
3.4.3	Lamp post 41			
	<p>Cast iron lamp post. Grade II listed. Original gas fittings removed circa late C19 or C20 and now has LED bulb. Reeded square base with William IV's insignia. Clear glass. Double maintenance arm. Light green paint scheme.</p>	<p>a Some corrosion at base and yellow (primer?) paint can be seen.</p>

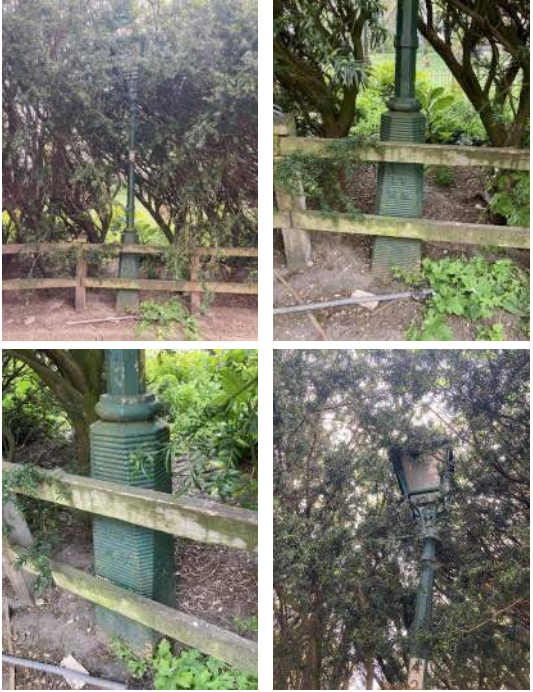
Item	Element & Description	Condition and Recommendation	Repair Category	Photograph
3.4.4	Lamp post 42			
	Cast iron lamp post. Grade II listed. Original gas fittings removed circa late C19 or C20 and now has LED bulb. Reeded square base with William IV's insignia. Clear tinted glass. Light green painting scheme with yellow (primer?) patches evident.	a Some corrosion evident at base. Lamp itself appears damaged and not sitting vertical to octagonal post.	A

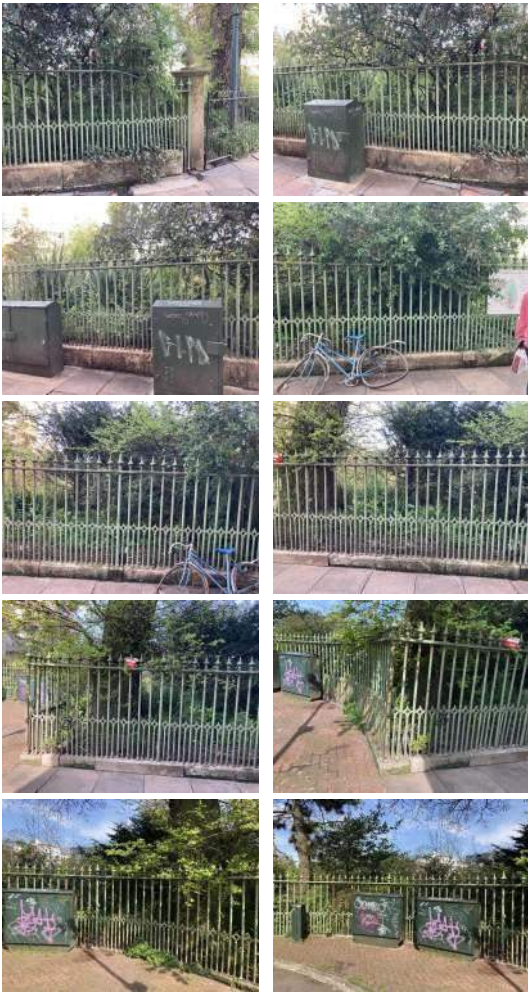
3.6	SOUTHERN AND EASTERN BOUNDARY			
3.6.1	Cast Iron Railings			
	<p>Existing cast iron railings set into stone plinth at base. Painted in a light green finish. Post cap design of a domed spike. Serpentine style supports to the main upright balusters projecting into the garden. It may be beneficial to carry out paint analysis prior to any redecoration and repair scheme. A test for lead paint may also be beneficial. Unusual not to have a base rail and uprights are at very tight centres.</p>	<p>a Generally poor with sections of significant rust and corrosion expansion of the railings. Top rail is failing in some locations. Balusters in many areas need to be re-caulked at base. Stone has eroded to the base leaving lead caulking exposed and in some areas the caulking is missing entirely.</p>	A

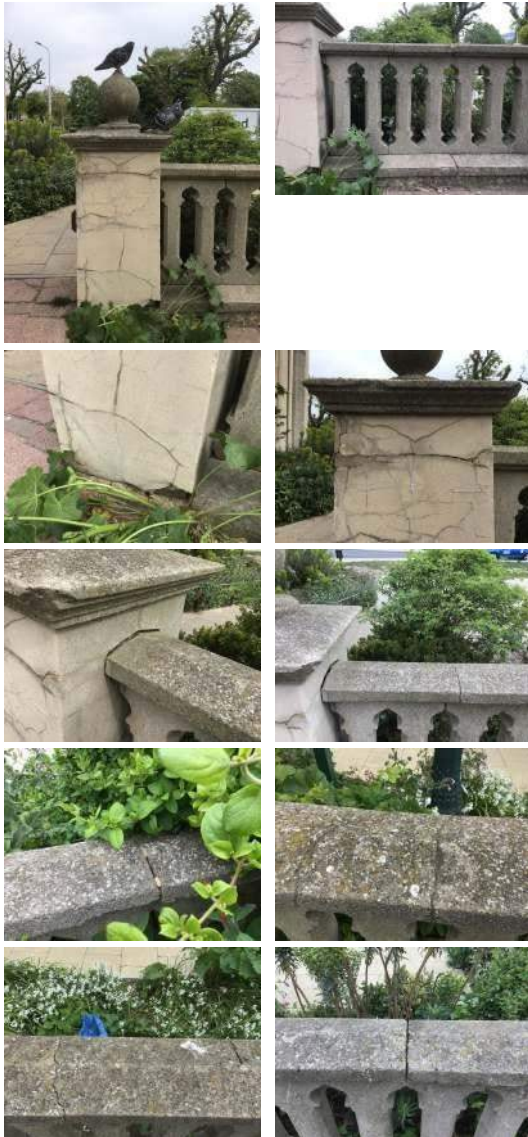
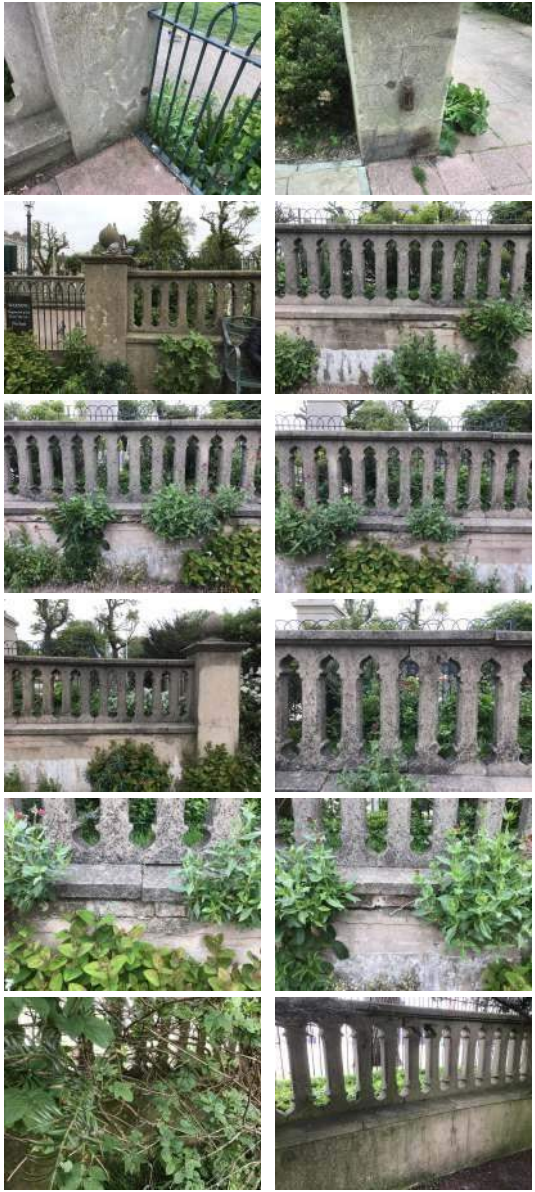
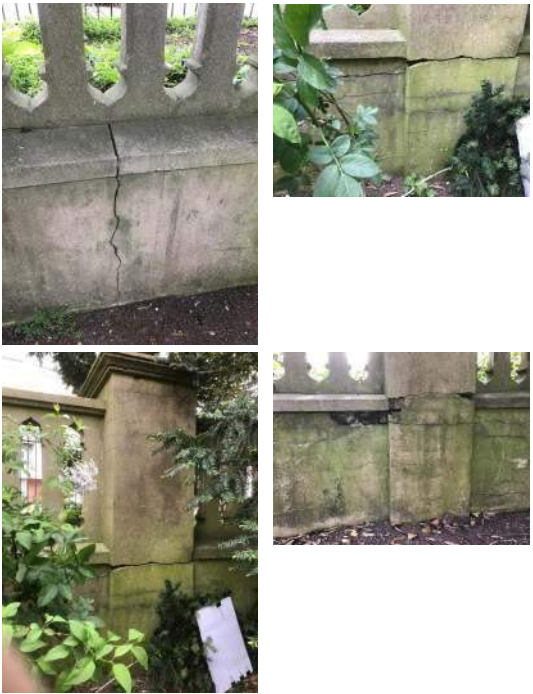
Item	Element & Description	Condition and Recommendation	Repair Category	Photograph
3.7	EASTERN AND NORTHERN BOUNDARY			
3.7.1	Cast stone wall with rendered brickwork plinth			
	<p>Cast stone finials, top rail and paired Indian style balusters on plinth cap and rendered common brickwork below. Height varies.</p>	<p>a Varies. In some locations, the wall is covered with plant growth preventing full survey access and defects may be concealed. Previous crack repairs can be seen and section adjacent original gate access to the east of North Gate is loose and actively moving. Section to north boundary where ground level is high, render has significant lime leeching through render and large horizontal cracks. Plinth cap has moved in locations and coping also disrupted. Considerable plant growth growing through the open cracked joints. Locations of defects are indicated on the relevant site plan and reference made to the photos. Some cracks in copings and open coping joints. Pillars can be seen to have evidence of previous gate installation. Moss growth evidenced to plinth.</p> <p>Note: damaged section adjacent north gate. Taken off site, to be repaired and re-instated.</p>	A

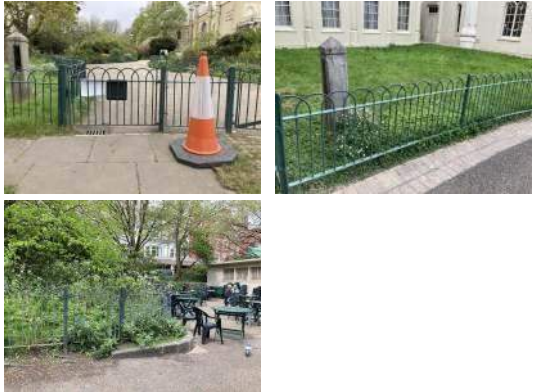
3.8	BRIGHTON BOWTOP RAILINGS FORMING BOUNDARY TO PARK ON EASTERN AND NORTHERN SIDE ADJACENT THE CHURCH STREET TO THE NORTH AND THE OLD STEIN TO THE EAST. THESE ARE A MODERN ADDITION TO THE PARK AND FORM THE PUBLIC BOUNDARY BETWEEN THE PATH AND PARK.			
3.8.1	Brighton Bowtop railings.			
	Brighton Bowtop galvanised steel painted dark green railings. This is the main security boundary between the Old Stein and the park and was installed during the 1980s?	a Good. Paint flaking from some.	C

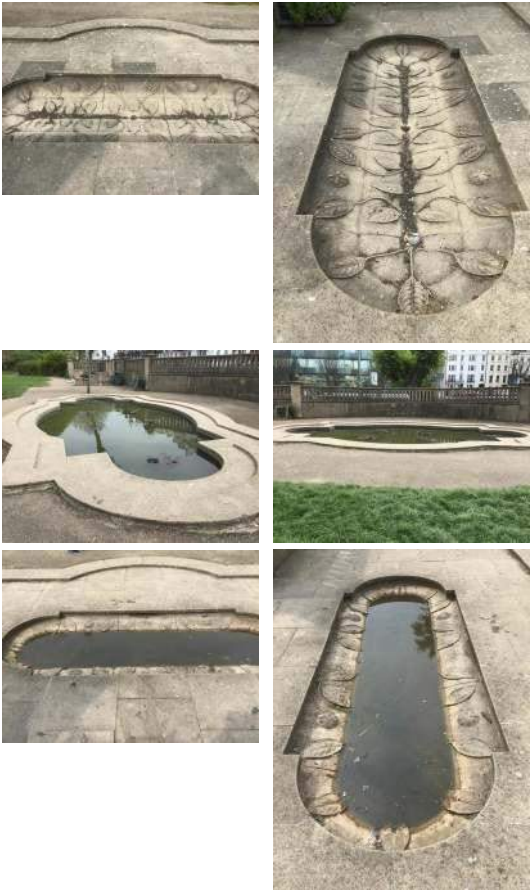
Item	Element & Description	Condition and Recommendation	Repair Category	Photograph
3.9	EAST LAWN			
3.9.1	East Lawn water features and steps			
	<p>Cast stone pond and 2 number sunken waterfeatures (?). North water feature is full of water and south water feature is dry with a single drainage point in the centre. Ornate pattern of leaves have been cast in the sections of base which fall to the centre.</p>	<p>a Unable to fully inspect north water feature. Where profile of leaves are visible, appear in sound condition. To south water feature, leaves and 4 no. boss profiles in good condition.</p>	<p>C</p>

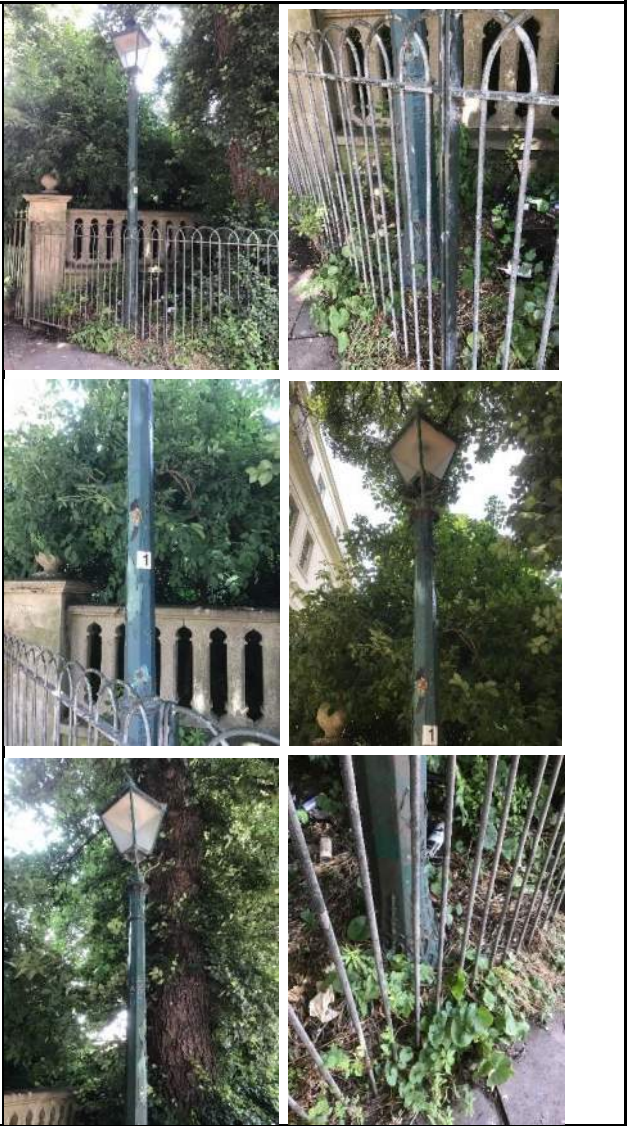
Item	Element & Description	Condition and Recommendation	Repair Category	Photograph
3.9.2	Lamp post 1			
	Cast iron lamp post.	Suitable preparation to remove all corrosion at base (extend preparation below ground level), prime and redecorate with suitable paint finish to provide weather protection.	A

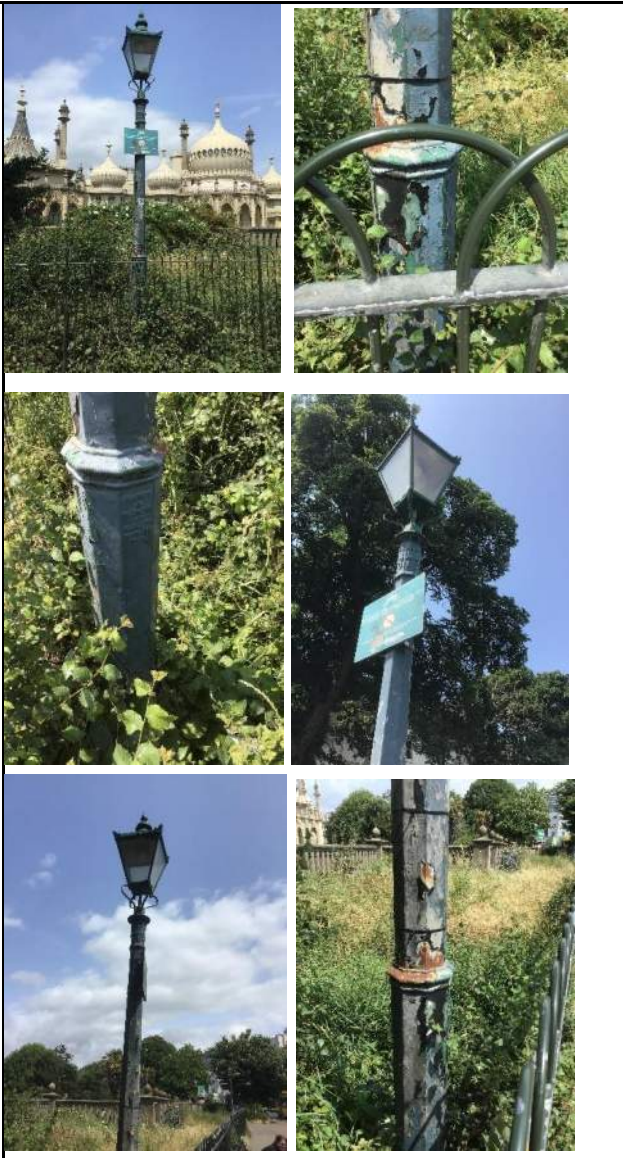
Item	Element & Description	Condition and Recommendation	Repair Category	Photograph
3.9.3	Lamp post 2			
	Cast iron lamp post.	Suitable preparation to remove all corrosion at base (extend preparation below ground level), prime and redecorate with suitable paint finish to provide weather protection.	A

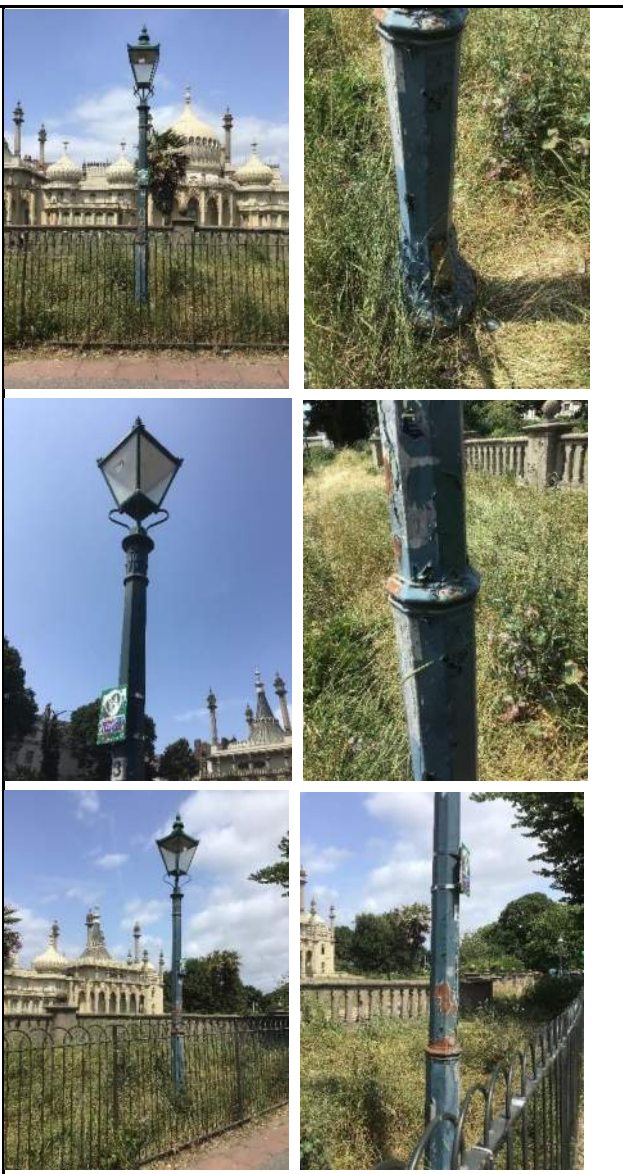
Item	Element & Description	Condition and Recommendation	Repair Category	Photograph
3.9.4	Lamp post 3			
	Cast iron lamp post.	Suitable preparation to remove all corrosion at base (extend preparation below ground level), prime and redecorate with suitable paint finish to provide weather protection.	A

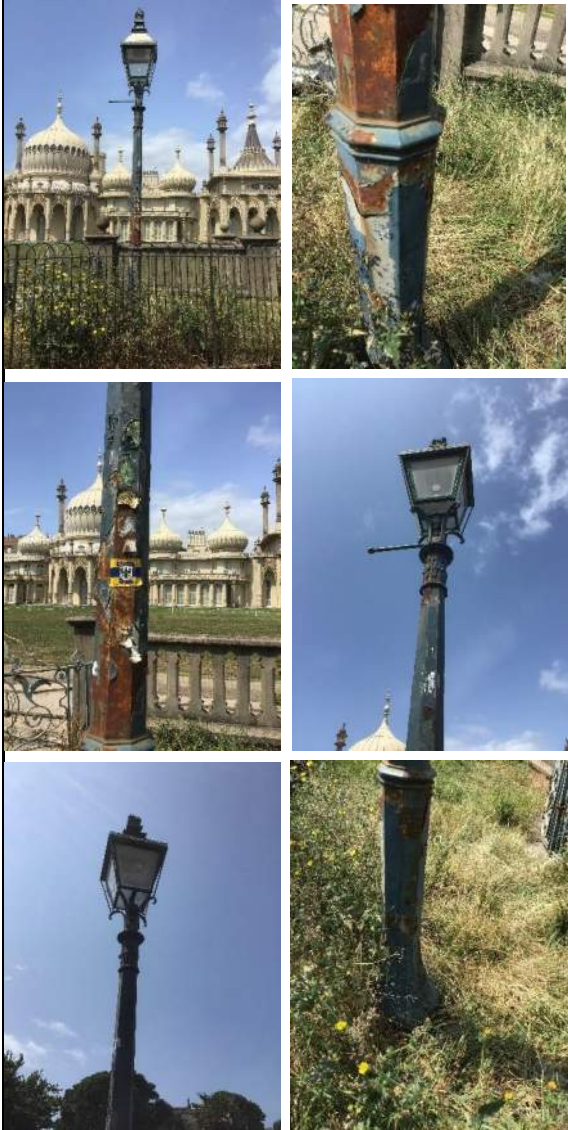
Item	Element & Description	Condition and Recommendation	Repair Category	Photograph
3.9.5	Lamp post 4			
	Cast iron lamp post.	Suitable preparation to remove all corrosion at base (extend preparation below ground level), prime and redecorate with suitable paint finish to provide weather protection.	A

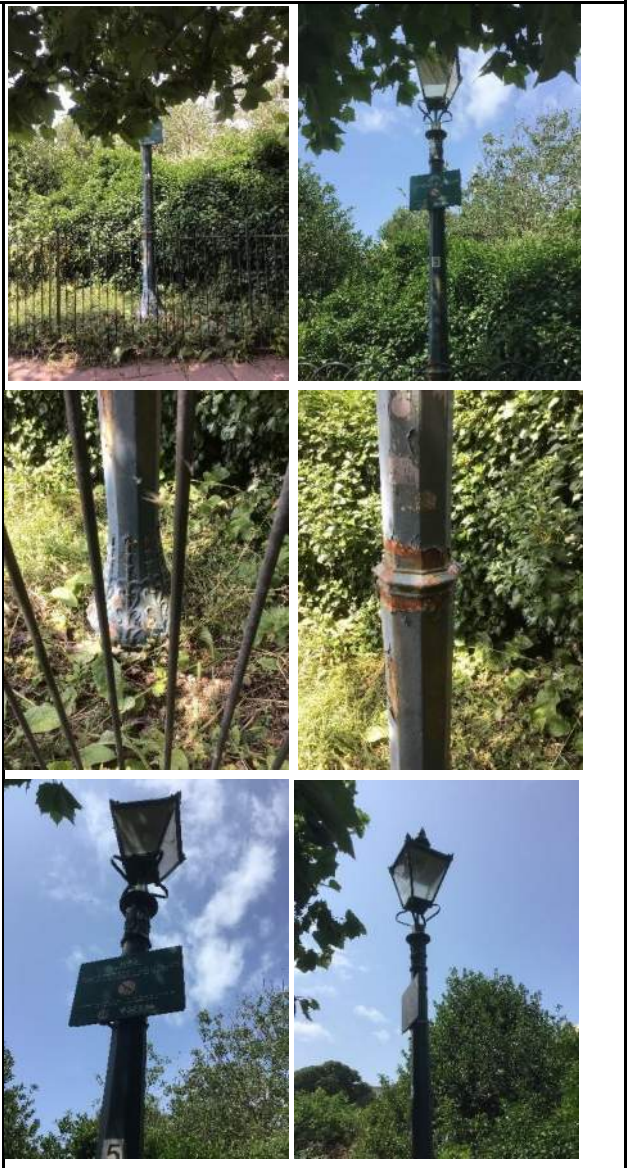
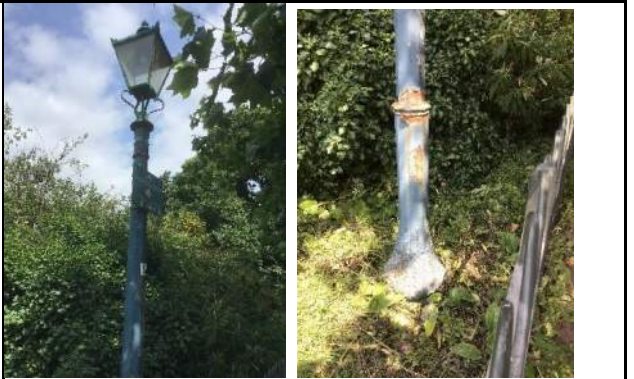
Item	Element & Description	Condition and Recommendation	Repair Category	Photograph
3.9.6	Lamp post 5			
	Cast iron lamp post.	Suitable preparation to remove all corrosion at base (extend preparation below ground level), prime and redecorate with suitable paint finish to provide weather protection.	A

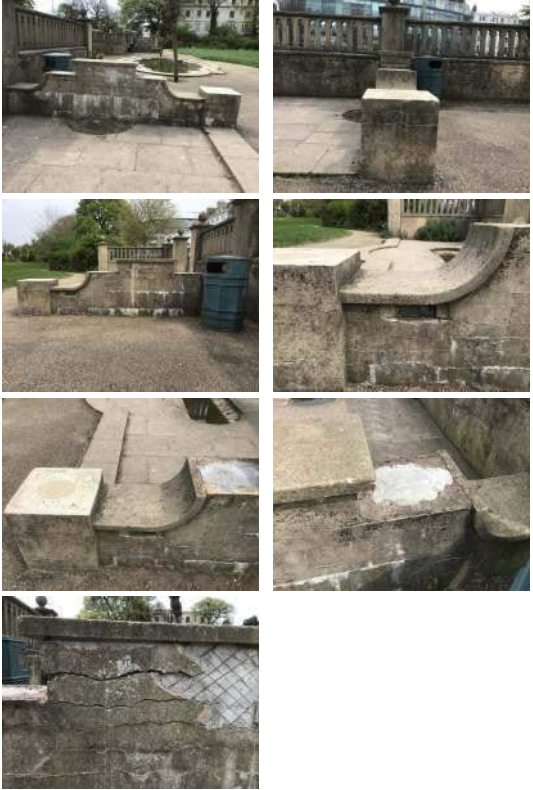
Item	Element & Description	Condition and Recommendation	Repair Category	Photograph
3.10	EASTERN LAWN			
3.10.1	Rendered wall to south of pond			
	<p>Varying height rendered brickwork wall with curved and straight cast stone coping stones. Forms divide between pond and water feature. Small semi circular planting bed to north side.</p>	<p>a Poor. 3 no. coping stone missing. Regular horizontal cracking evident to all sections of wall. Previous cement render repairs evident. Leeching lime evident to base of wall. May be evidence of finial on end pillar</p>	A

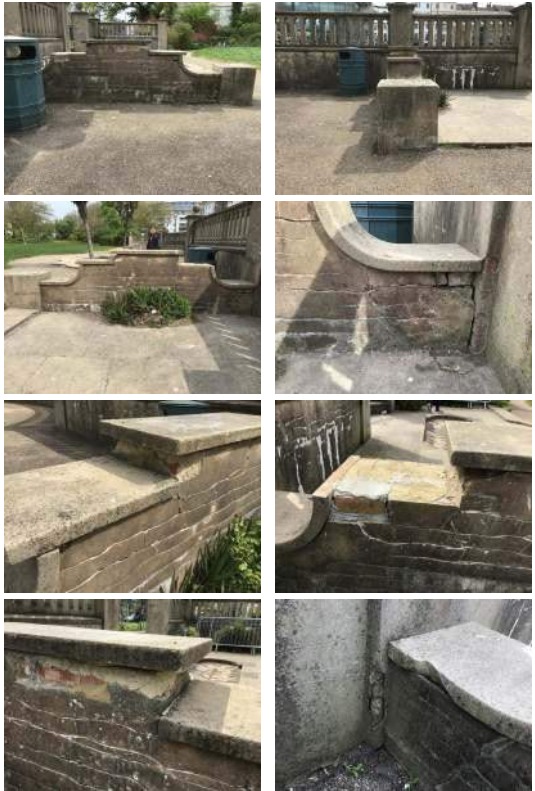
Item	Element & Description	Condition and Recommendation	Repair Category	Photograph
3.10.2	Rendered wall to north of pond			
	<p>Varying height rendered brickwork wall with curved and straight cast stone coping stones. Forms divide between pond and water feature. Small semi circular planting bed to north side.</p>	<p>a Poor. 2 no. missing coping stones. Previous poor repairs evident in hard cement mortar to large horizontal coping stone and brick repair with very hard cement mortar adjacent boundary wall. Regular horizontal cracking evident to both sides to render. Semi circular planting bed to south side. Curved coping stone damaged.</p>	A

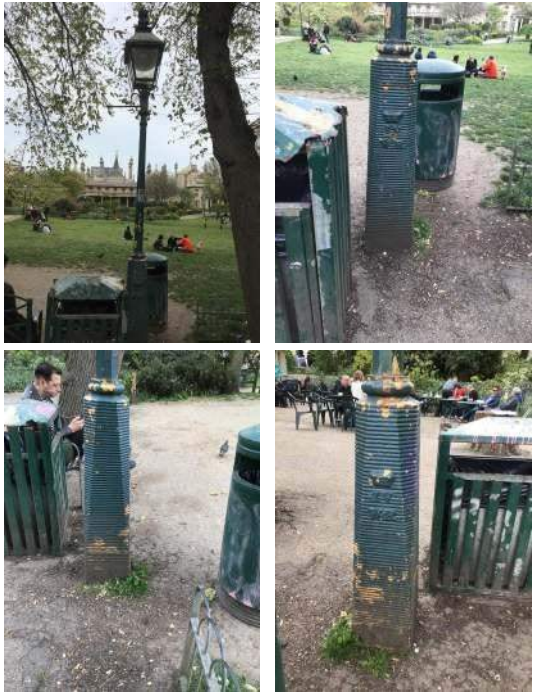
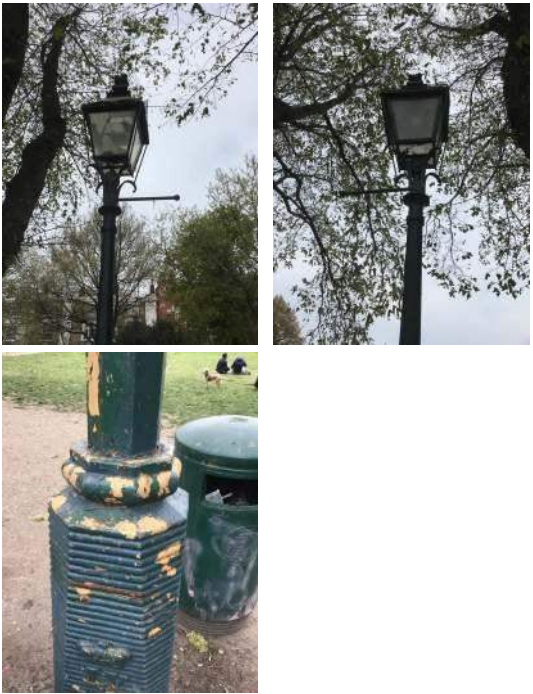
Item	Element & Description	Condition and Recommendation	Repair Category	Photograph
3.11	THE KING'S LAWN			
3.11.1	Lamp post 32			
	<p>Cast iron lamp post. Does not appear on the CBA conservation plan as listed. Reeded square base with William IV's insignia. Evident of previous paint schemes of yellow (primer?), light green and dark green.</p>	<p>a Cast iron components appear sound but bulb damaged. Paint flaking and corrosion at base.</p>	<p>A</p>

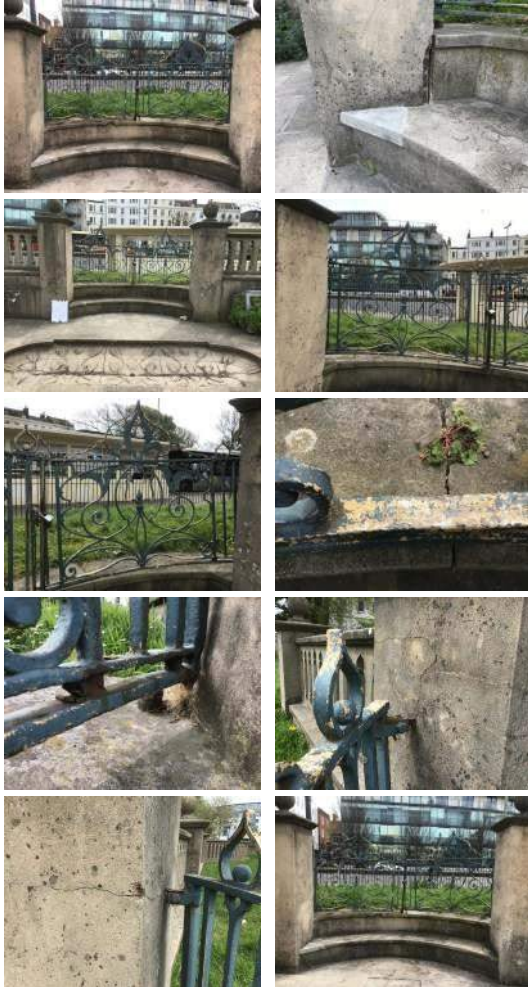
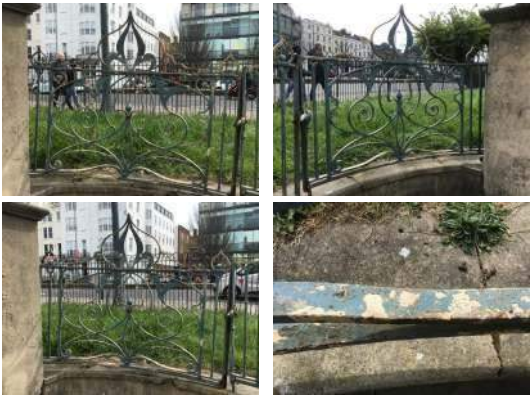
Item	Element & Description	Condition and Recommendation	Repair Category	Photograph
	EXTERNAL			
3.12	EASTERN BOUNDARY			
3.12.1	Cast iron gates			
	<p>Cast iron ornate curved gates supported on the cast stone pillars (some corrosion appears layered suggestive of wrought iron may be a hybrid of cast and wrought iron gates).. Part of the original boundary treatment to the park and designed to be viewed in conjunction with the Palace behind. These gates would have provided the public access to the eastern lawn and set between the pond and water features. Due to the installation of the modern high Brighton bowtop fencing to the path adjacent the Old Stein road.</p>	<p>a Poor, gates have dropped and appear not to be in active use.</p>	<p>A</p>

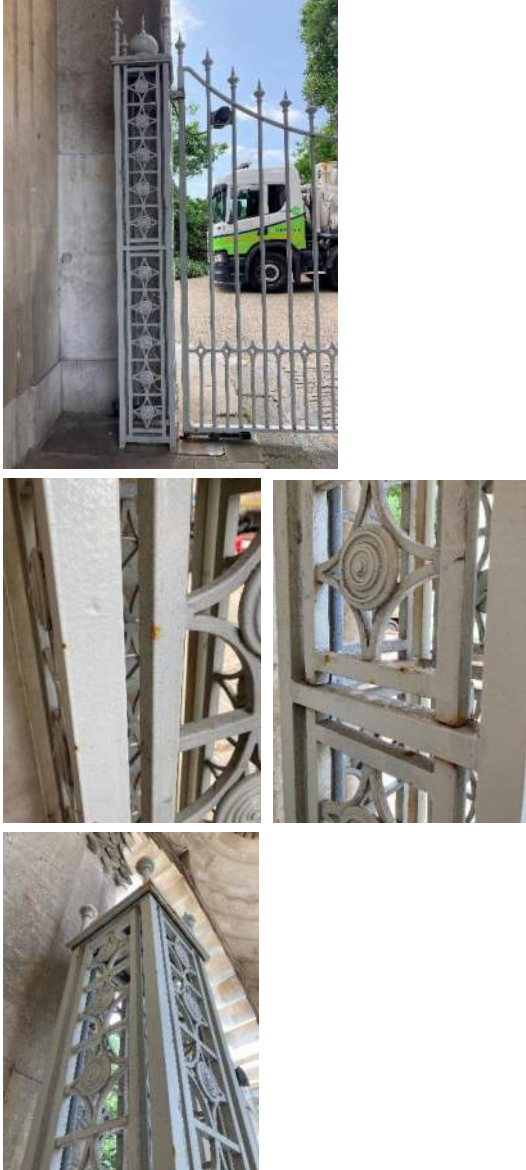
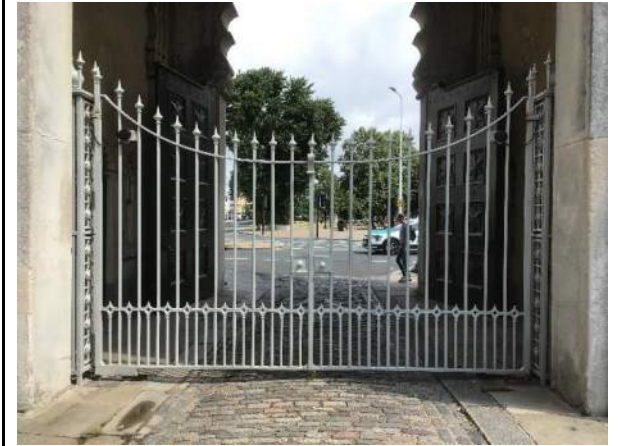
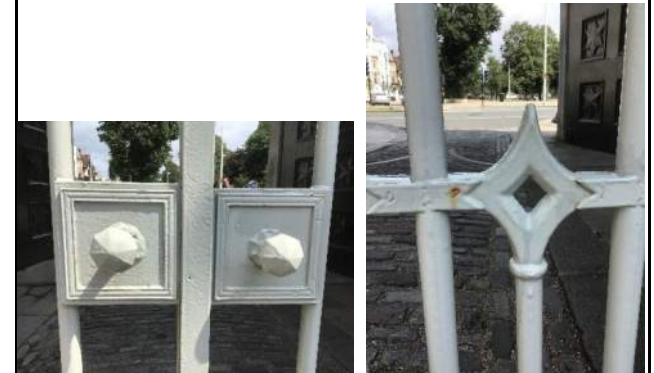
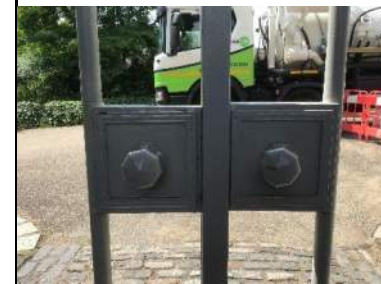
Item	Element & Description	Condition and Recommendation	Repair Category	Photograph
3.13	NORTH EAST LAWNS			
3.13.1	Automatic Vehicle Gate to North Gate			
	Existing modern painted galvanised steel automatic vehicle gates and 2 no. piers.	<p>Generally good condition with small areas of corrosion evident.</p> <p>Suitable preparation to remove all corrosion prime and redecorate with suitable paint finish to provide weather protection.</p>	B
