Pavilion Gardens

Condition Survey Report

for Allen Scott Ltd

Condition Survey Report 2022

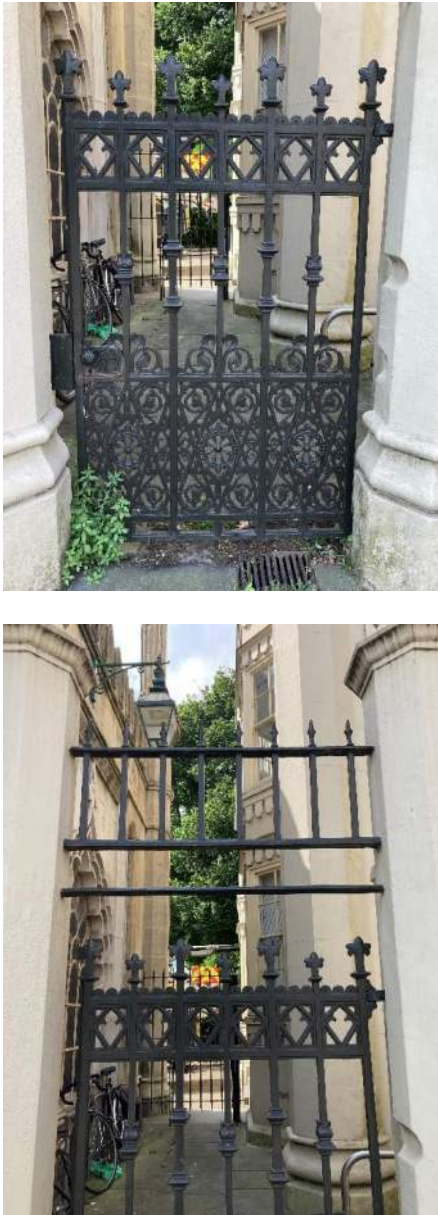
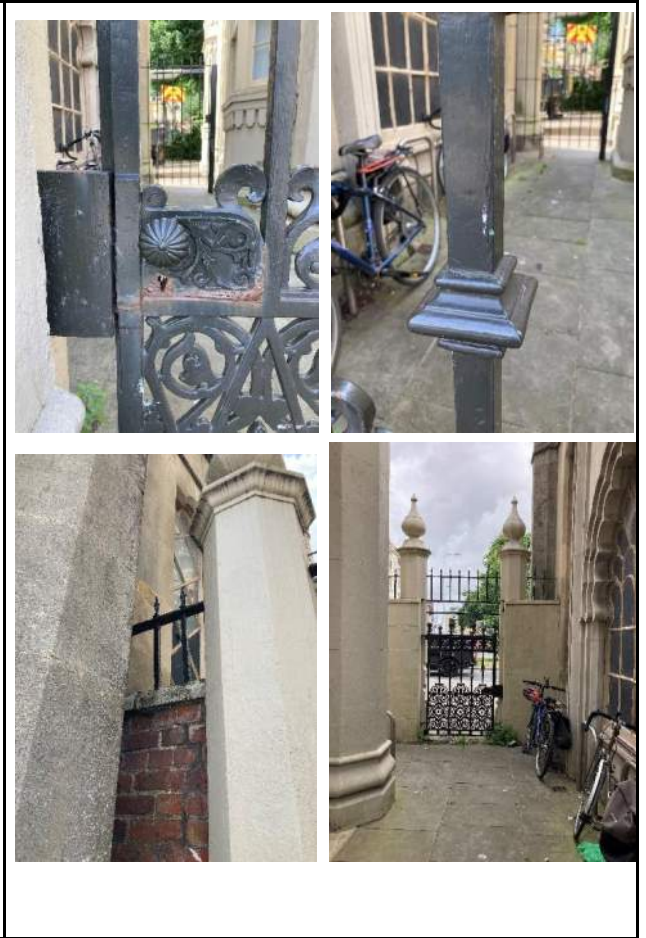
3.13.2	Ornate Gate to North Gate			
	Cast iron ornate Gate on the boundary of the garden.	Suitable preparation to remove all corrosion, prime and redecorate with suitable paint finish to provide weather protection. Overhaul, ease and adjust lock.	B

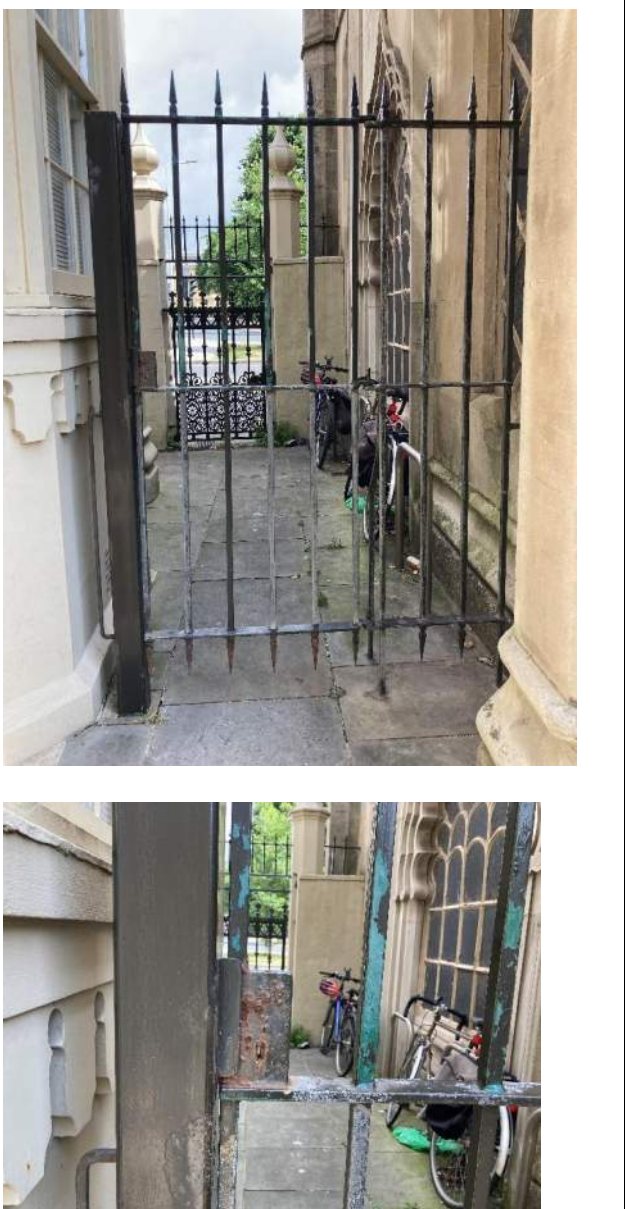
3.13.3	Modern Gate to North Gate	Painted galvanised steel modern gate within boundary of the Garden. Suitable preparation to remove all corrosion, prime and redecorate with suitable paint finish to provide weather protection. Overhaul, ease and adjust lock.	B

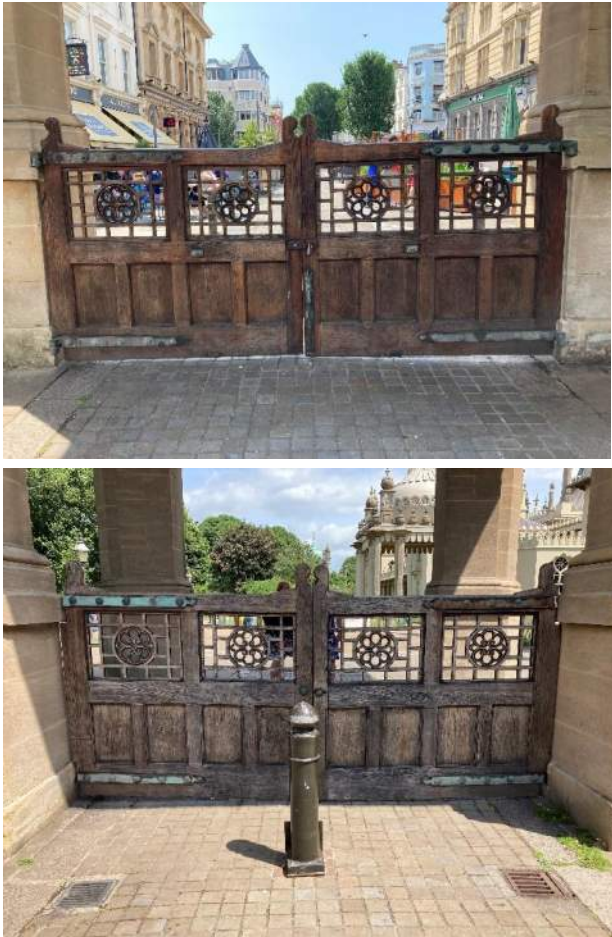
3.13.4	Timber Gates (3 No) to South Gate	<p>Existing timber gates likely to have been installed at the same time at the Gate (known as India Gate – plaque reads <i>This gateway is the gift of India in commemoration of her sons who – stricken in the great war – were tended in the Pavilion in 1914 and 1915. Dedicated to the use of the inhabitants of Bright by H.H the Maharaja of Patiala on October the 26th 1921 B. N/ Southall, Mayor</i>).</p> <p>Unable to inspect pedestrian gate covered by plywood.</p>	<p>Timber gates in generally good condition. Evidence of previous scarf repair. Missing section of timber to be replaced in matching timber and stain. Allow to replicate existing boss and replace missing bosses (2 no. missing to pair of gates).</p> <p>Hinges showing signs of corrosion to pair of gates. Treat.</p> <p>Check integrity of pintol hinges, stone cracked around fixings. Anti-corrosion treated needed.</p>	<p>B</p>

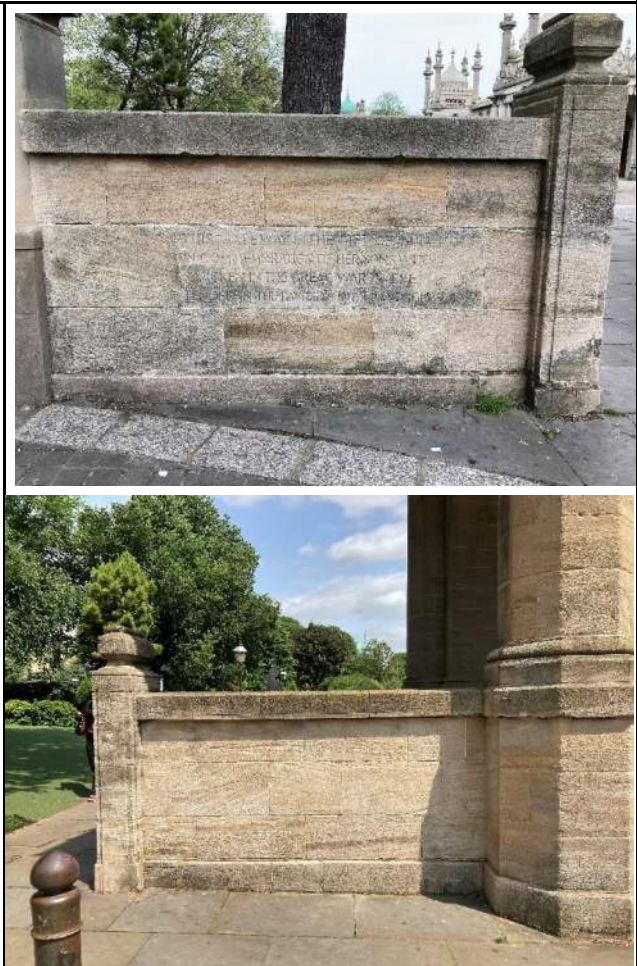
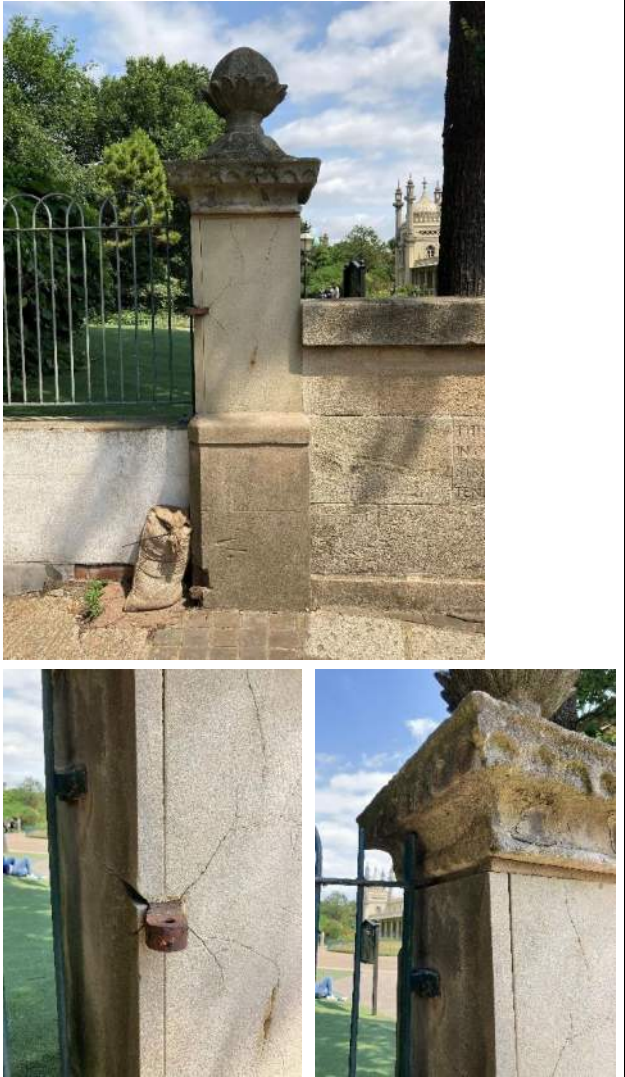
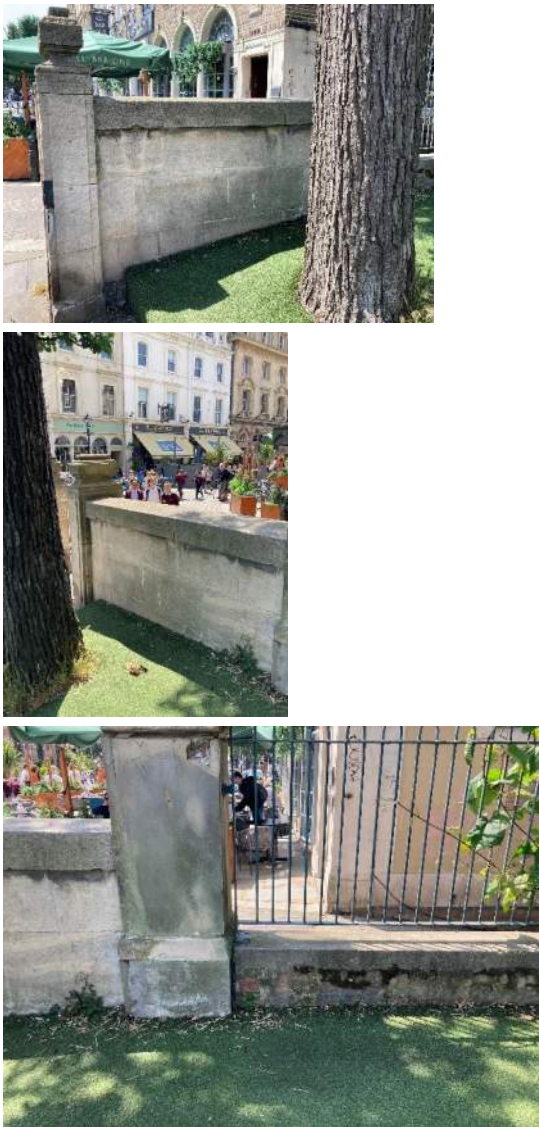
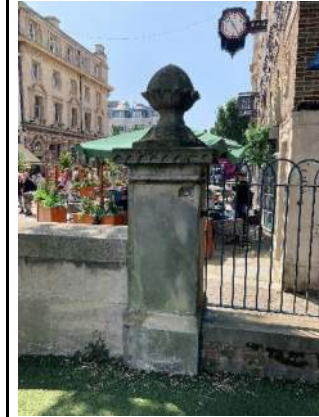
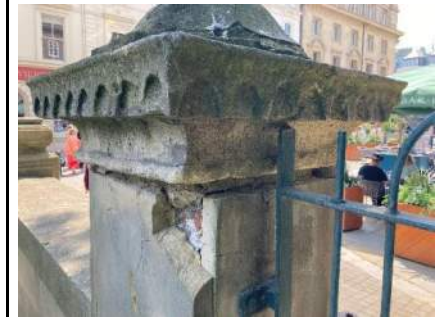
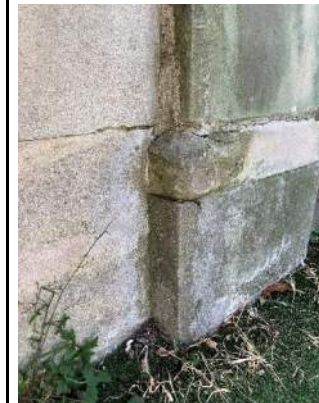
3.15	South Gate Boundary Wall		B	
	<p>Stone boundary wall installed at same time as South Gate (known as India Gate – stone inscription reads <i>This gateway is the gift of India in commemoration of her sons who – stricken in the great war – were tended in the Pavilion in 1914 and 1915</i>)</p> <p>Unable to inspect section of wall covered by plywood.</p>	<p>Generally good condition. Investigate extent of damage to stonework from pintol hinges from timber gates.</p> <p>Stone clad brickwork pier adjacent bow top railings in poor condition. Previous poor cementitious repair at base of pier. Stone cracking from rusting pintol hinges from removed gate and section of stone missing exposing brickwork core with slate DPC. If gate is not to be reinstated, remove pintols and carry out matching stone indent repairs.</p> <p>Capstone has shaling stonework, consolidate and repair.</p>
