Project
Reawakening Brighton Royal Estate
Phase 2

Drawing
McLaren Boundary Wall Details

Job Ref	Dwg No	Revision	
P1154-RHP-ZZ-00-DR-A-5013 P1			
Scale(s)	Size	Drawn	Checkd
Varies	A1	TP	PN

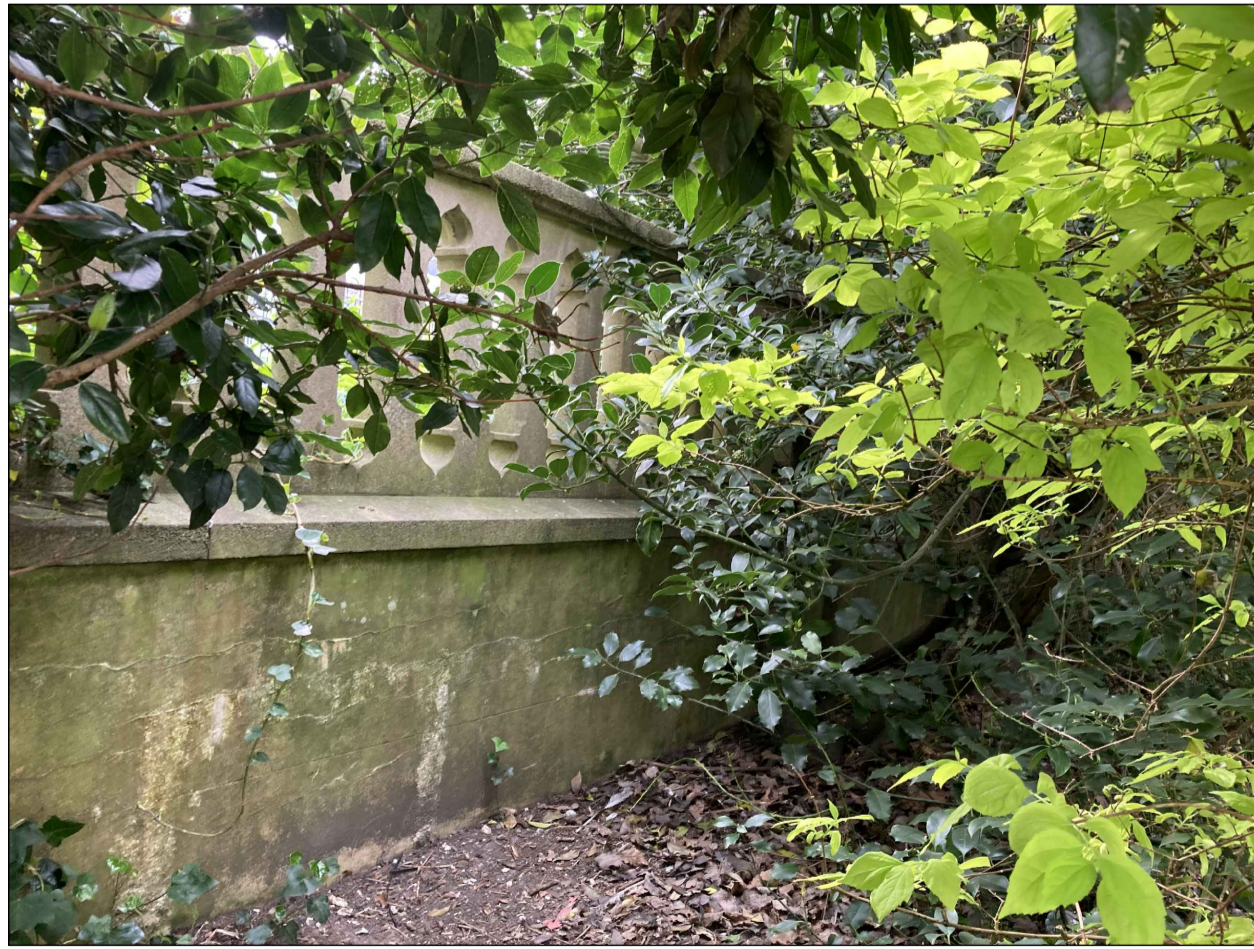
9 Part Elevation of McLaren Wall
5013 NTS

Crack - refer to SE for any remedial works.

Provisionally allow for careful dismantling and rebuilding with stainless steel slip tie to make good crack in conjunction with pier works. Refer to SE details.

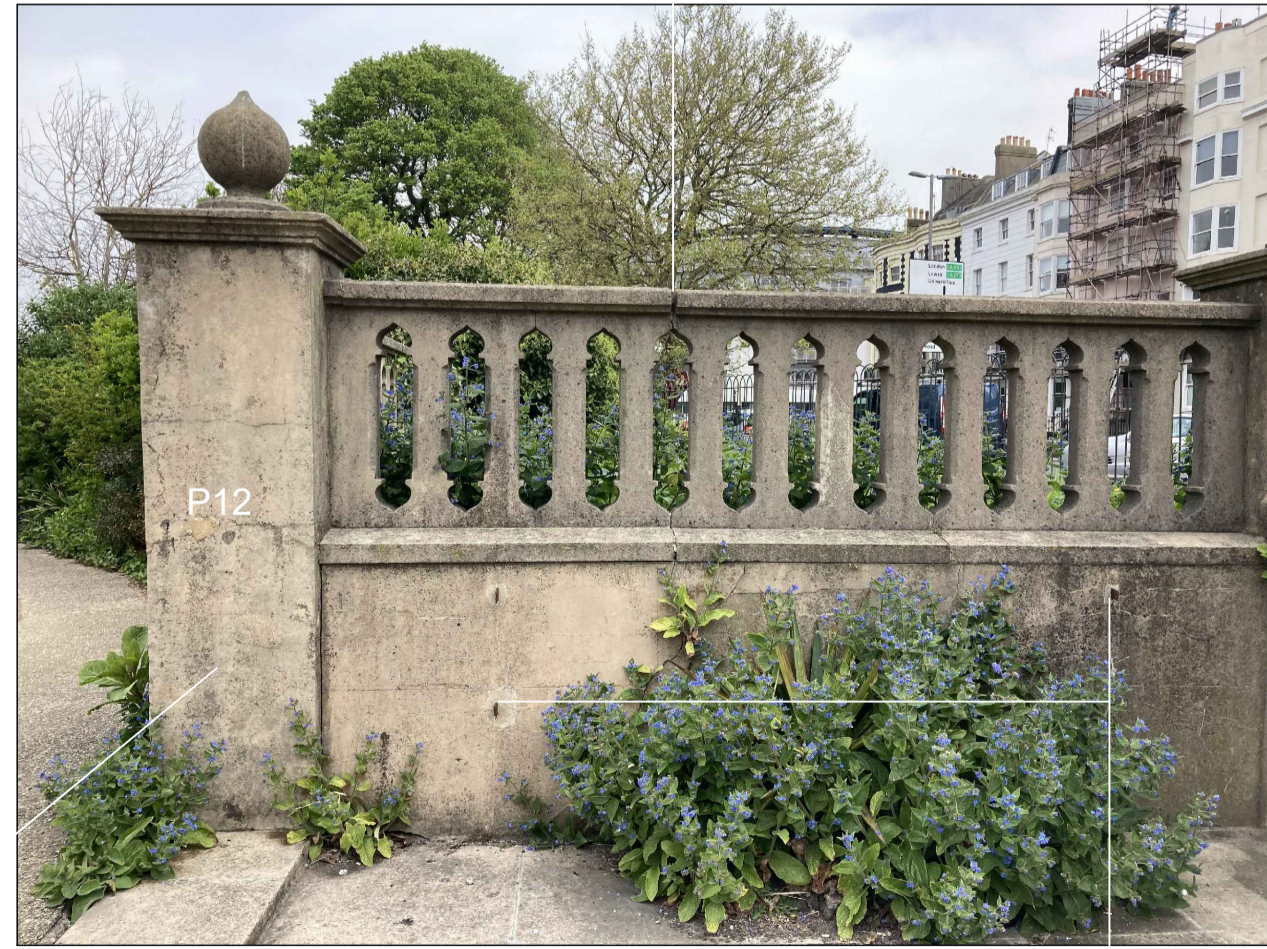
11 Part Elevation of McLaren Wall
5013 NTS

Pier appears to have moved and caused crack to wall adjacent and to investigate foundations and provisionally allow for careful dismantling and rebuilding to same dimensions re-using capstone and new lime render
