3. Original condition survey carried out in April 2022.
4. To be read in conjunction with RHP P1154-RHP-ZZ-SC-A-8200 Brighton Pavilion Gardens Schedule of works.

Project  
**Reawakening Brighton Royal Estate Phase 2**

Drawing  
**Palace Place Railings Details**

P1154-RHP-ZZ-00-DR-A-5050 P1

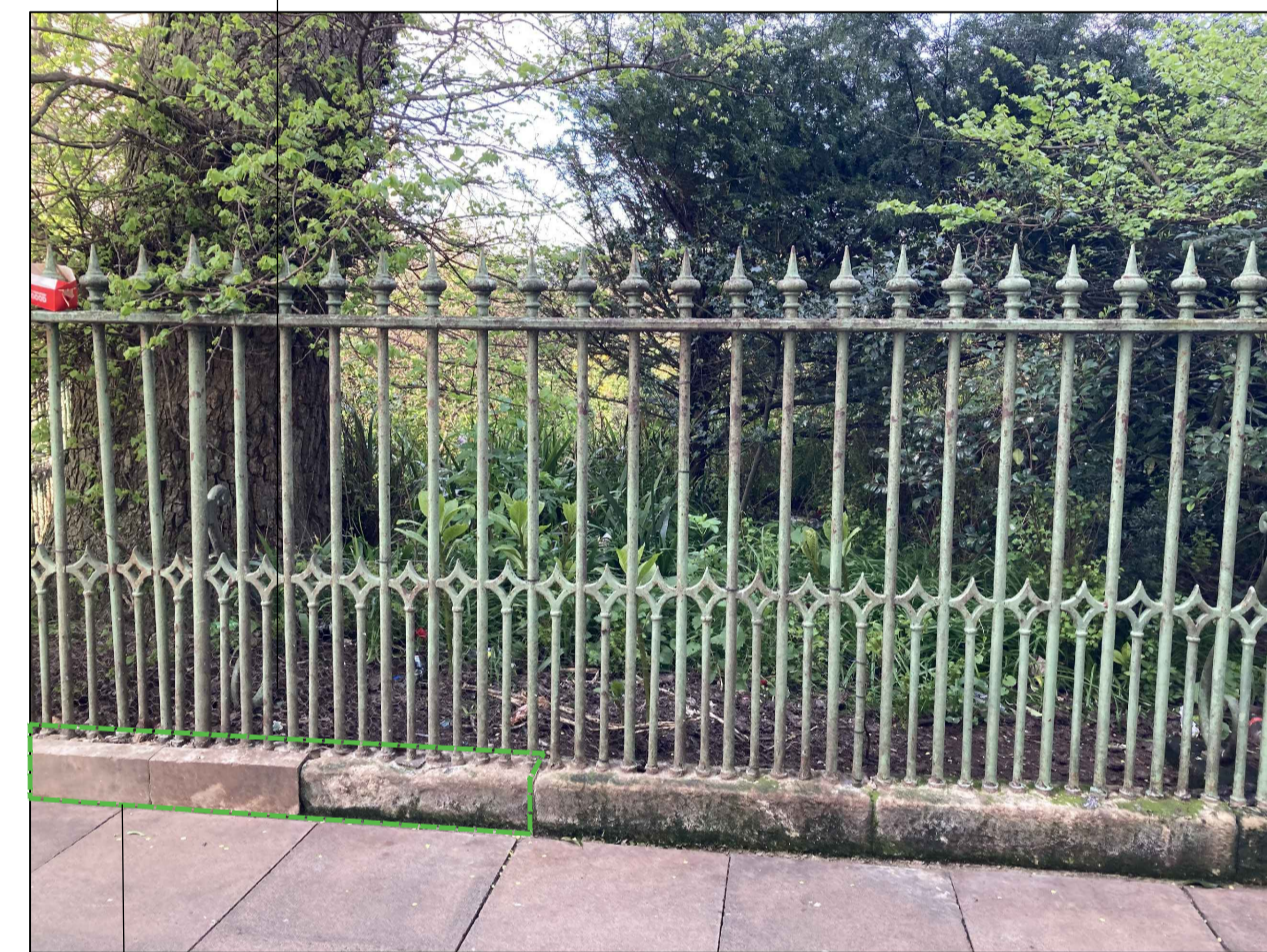
7 Elevation of Type F1 railing  
5050 NTS

Poor face repair carried out. Option of replacement stone by removal and reinstating panels with new lead caulking to be priced.

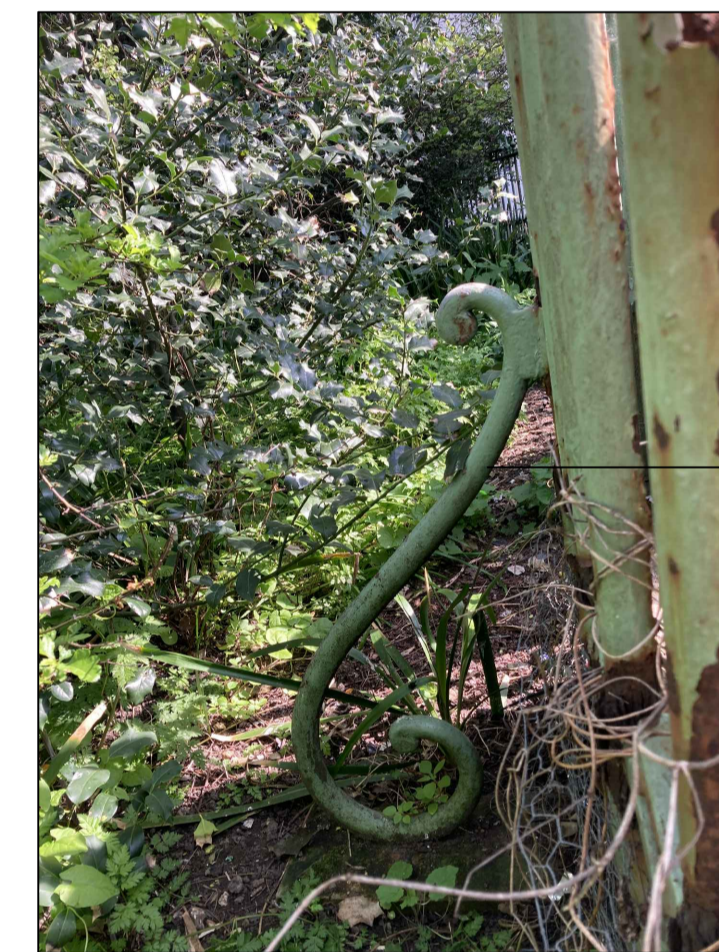
Typical brace on stone plinth
