Sycamore Lodge - Workshops & Garage Hickling Pastures

Structural Inspection Report

Prepared by: Anita Hession MSc BEng
Reviewed by: Becky Rabjohns MEng
Job Number: 30123
Document Reference: Report 2

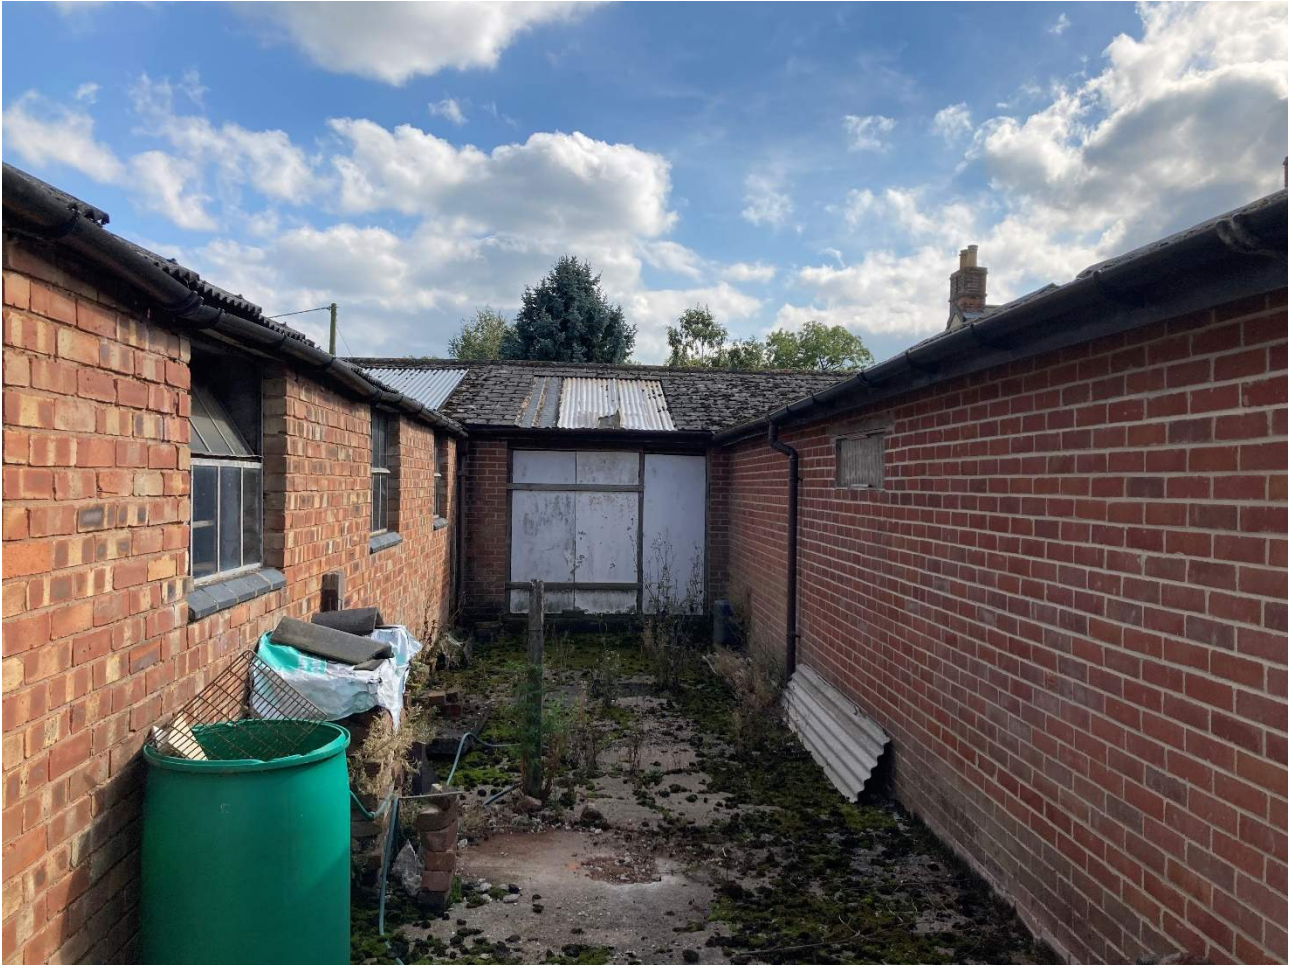
The courtyard is an external area between the other outbuildings. The floor is a concrete slab.

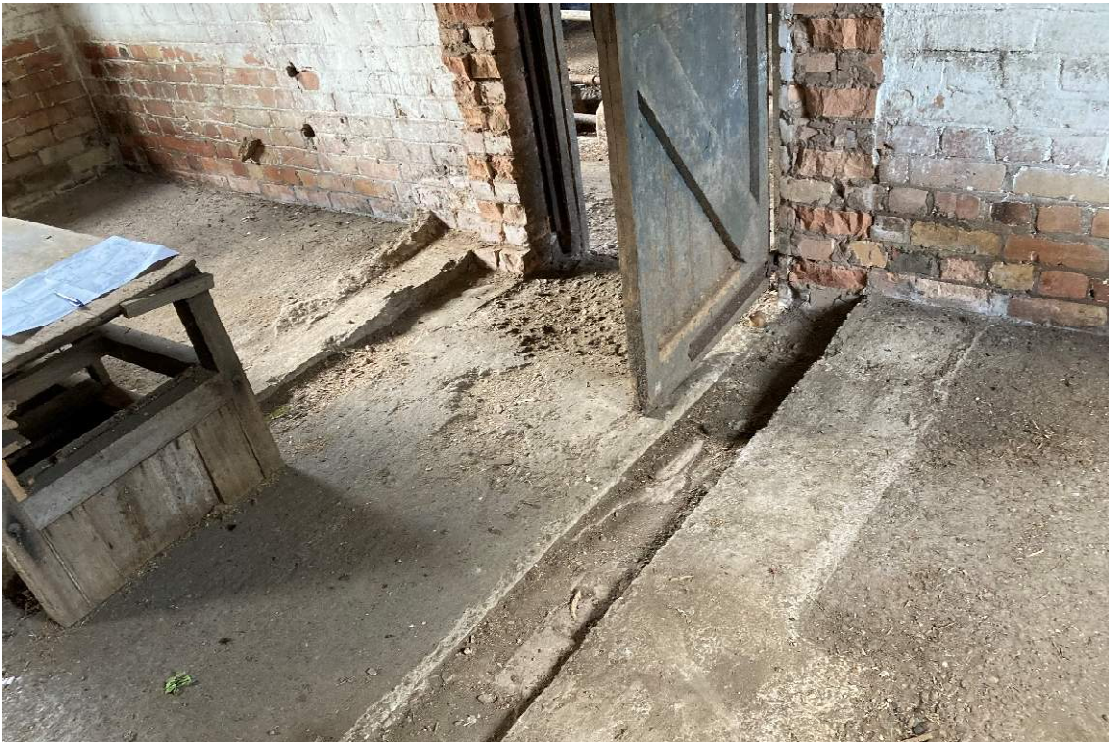
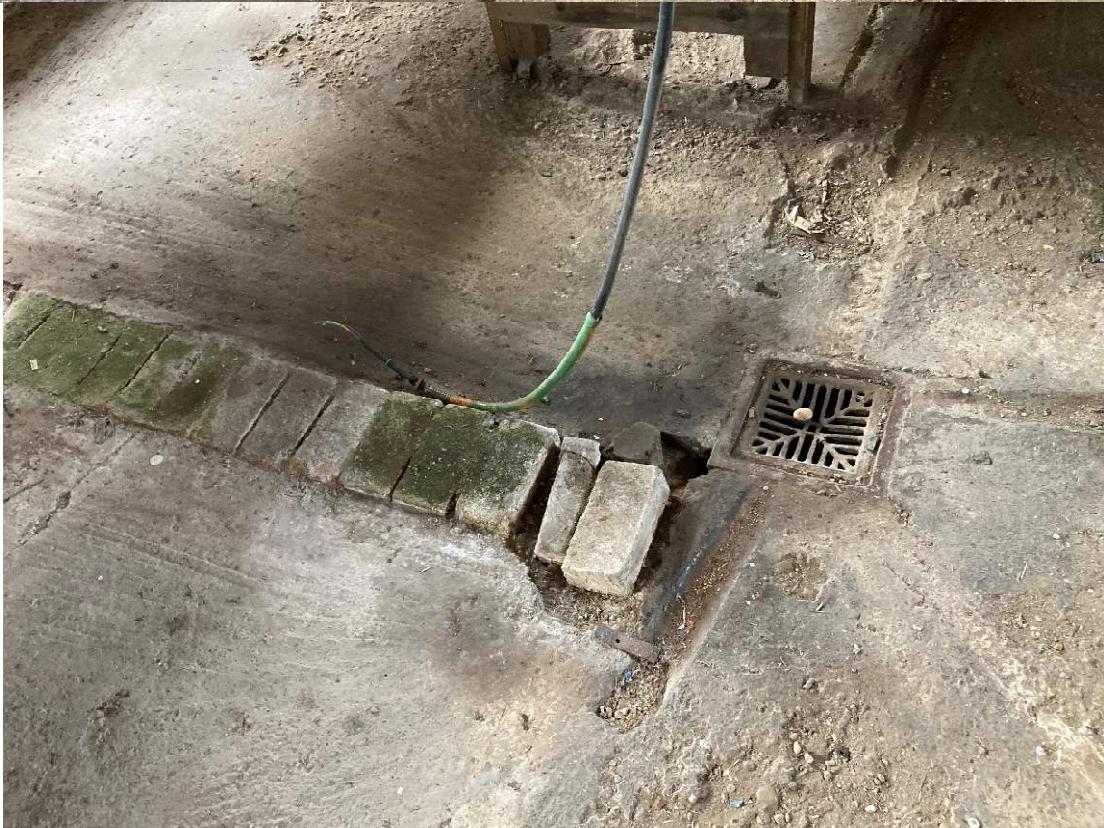
The concrete slab was 100mm thick on white polythene on 125mm crushed brick fill. The slab was in poor condition due to its previous use with level changes, steps and chases where it appears that brick piers have been removed in the past.

None of the ground slabs have any reinforcement or insulation. The slabs to the courtyard and workshops are not suitable for reuse due to the cracking and haphazard steps in Workshop 2. The ground slabs to the store and garage are more suited for reuse subject to architect's specification for insulation and levels. The hairline cracking of the garage slabs has occurred at expected locations due to drying shrinkage of the concrete after construction and no reinforcement to control the cracking.

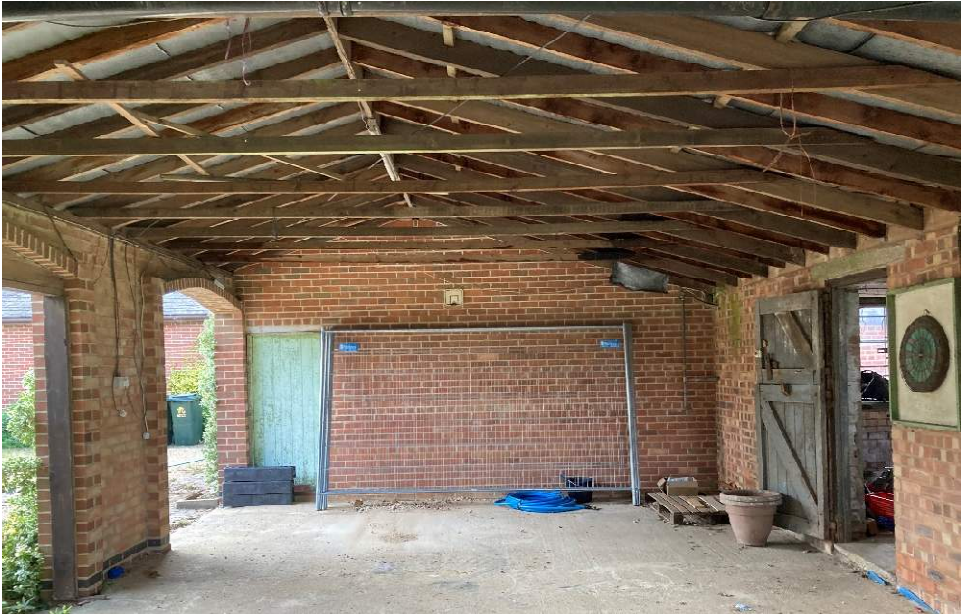
Garage 1 is an area formed between Workshop 2, Garage 2 and the pole barn, it has open sides to the pole barn and the door openings to the house courtyard are also open. The brickwork facing the house courtyard is 215mm thick brick with 327mm masonry piers with 327mm thick brickwork flat arches over the openings.

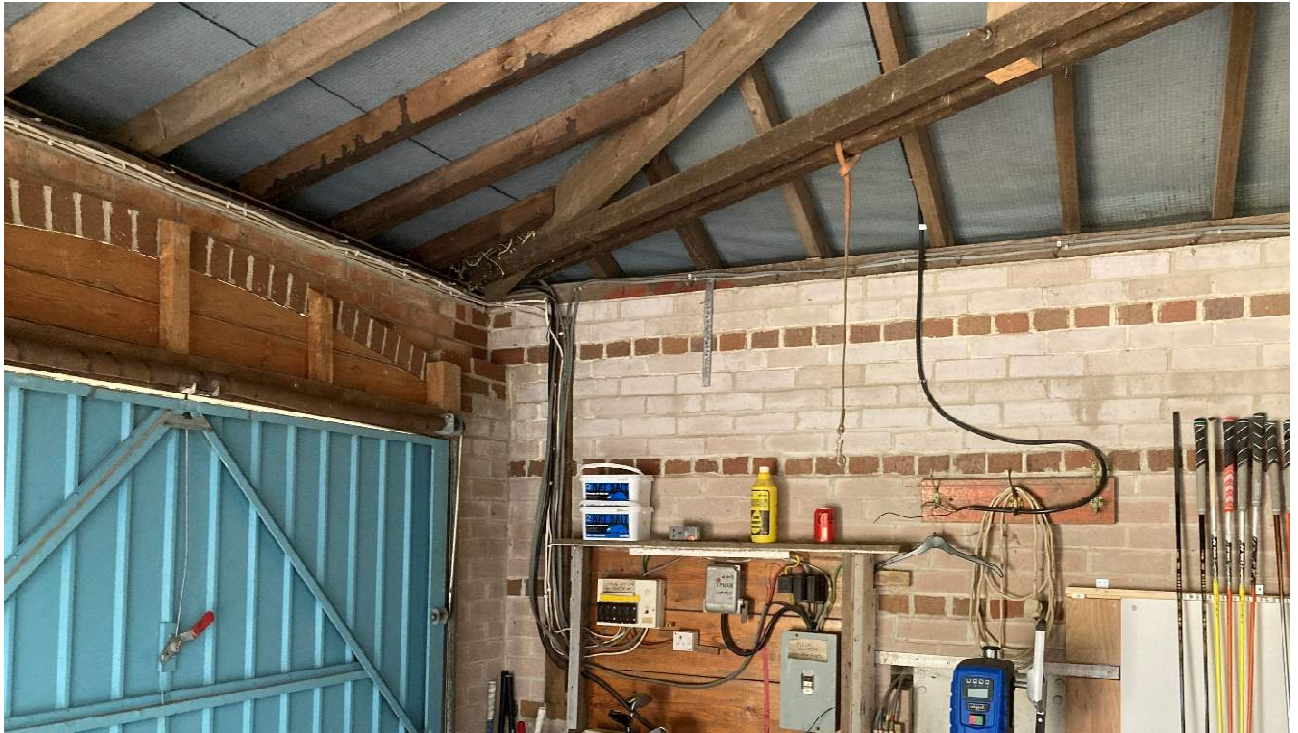
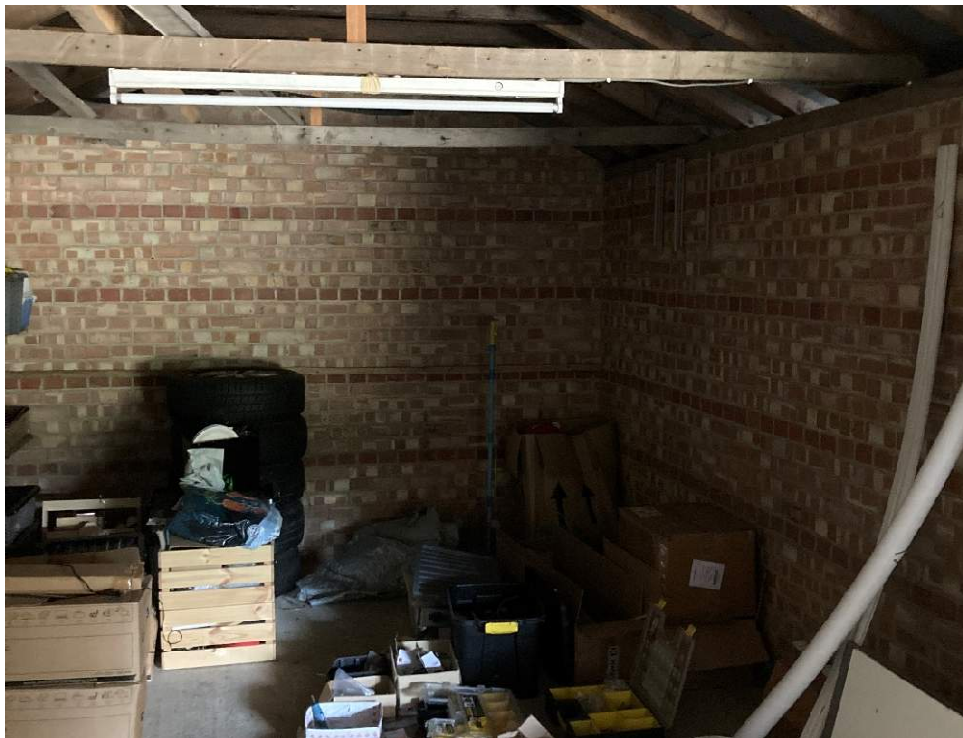
Garage 2 is formed with walls of different construction. The wall with garage doors and wall between the garages is 215mm thick brick with 327mm masonry piers and 327mm thick brickwork flat arches over the openings. The wall facing the house is 215mm thick and the common bonding header bricks at 6 course centres with light colour bricks to the interior and 215mm piers. The remaining walls are the same common bonded construction but with the same bricks as the exterior on the interior.
