Sycamore Lodge Outbuildings Hickling Pastures

Structural Inspection Report

Job Number: 30123
Document Reference: Report

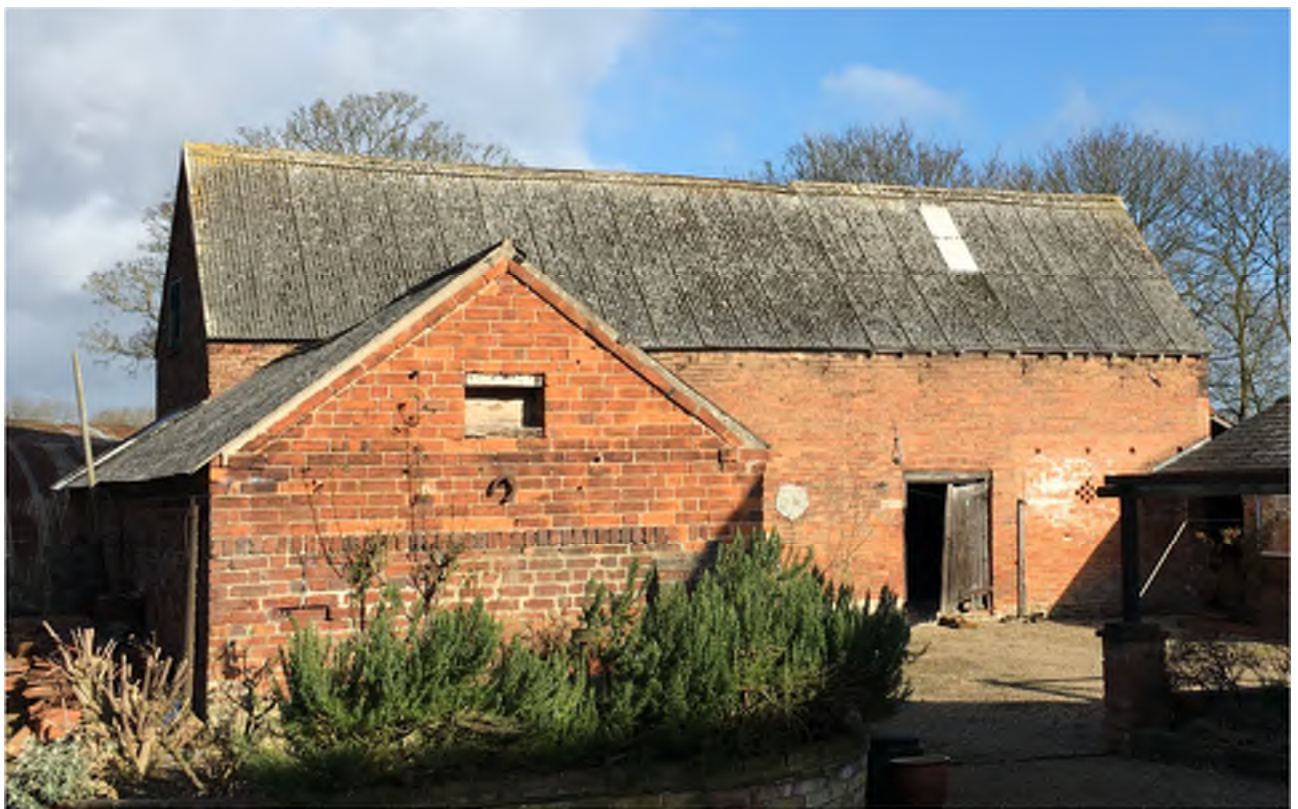
Stables in foreground, Threshing Barn beyond

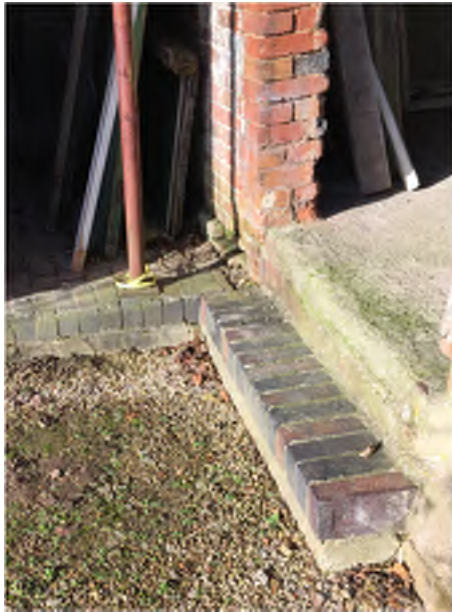
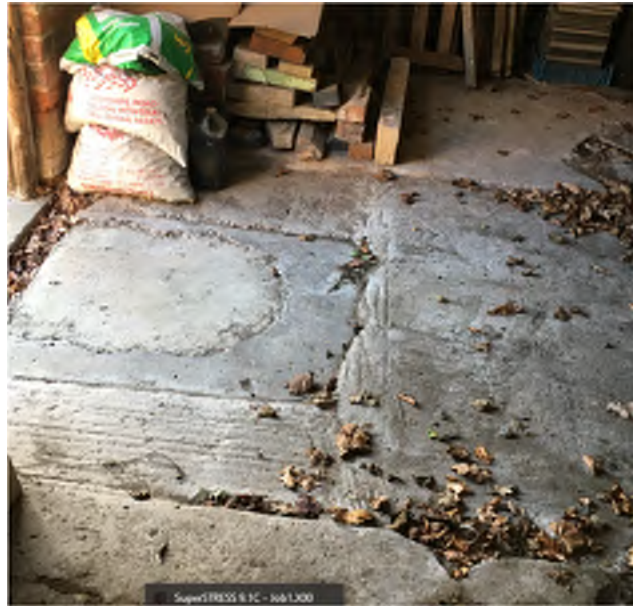
The ground floor in the left hand room sits above the level of the internal courtyard by a couple of steps, the floor under the first floor is concrete, with feeding stalls against the rear wall.

The floor in the main Barn is brick-paved except for at the right hand end where there is a shallow timber plinth.

- Wholesale replacement, repairs and strengthening to the roof. There are areas of substantial decay, the rafters and purlins are inadequate.
- Replacement of the first floor and mezzanine
- Removal of the brick-paved ground floor to allow a new insulated slab to be installed. This would probably undercut the existing shallow foundations, necessitating underpinning to carry it out
- Repairs to external walls including crack repair and corner bonding.
- Excavation of trial holes to check existing foundation details. It is likely that the walls sit on shallow spread foundations, and the observed movements indicate that settlement has occurred, so underpinning would probably be required.
- All other non-structural works to bring the shell up to modern insulation requirements.

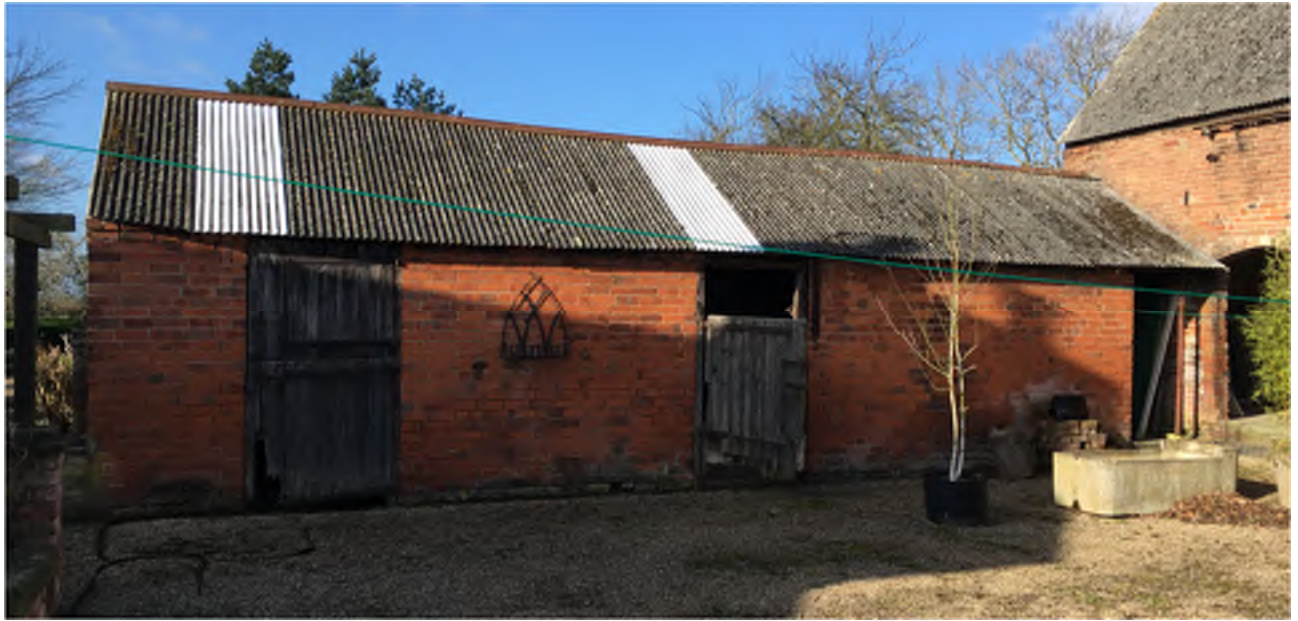
The roof is cementitious corrugated sheets supported by timber rafters and a timber ridge beam. One of the wallplates has been Acrow-propped where the Stable meets the Barn

The roof members are adequate for a cementitious roof but are unlikely to be justifiable for any heavier replacement roof covering.

- Demolition of the rear wall, and therefore the roof, to allow the walls to be rebuilt on new foundations.
- Removal of the brick-paved ground floor to allow a new insulated slab to be installed. This would probably undercut the existing shallow foundations, necessitating underpinning to carry it out
- All other non-structural works to bring the shell up to modern insulation requirements.
