LOWER WOODHOUSE FARM  
FERNHILL  
ALMONDSBURY  
BRISTOL  
BS32 4LU

KYTEX LTD.  
2023067  
[info@kytex.co.uk](mailto:info@kytex.co.uk)

# 1. Introduction

### 3. Structural Description and Observations – Barn A

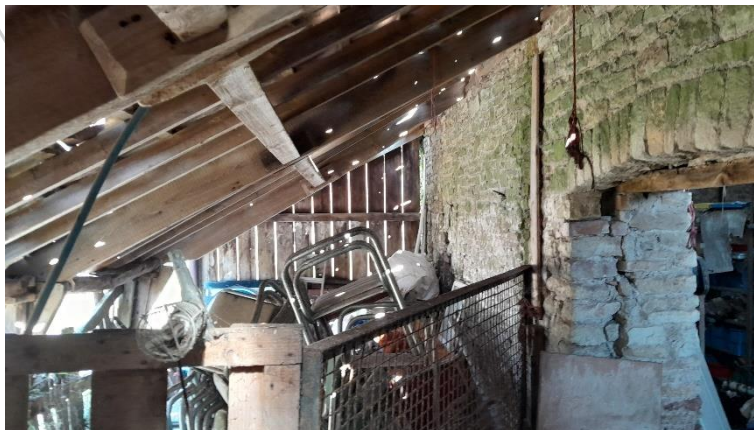
3.2.7 The southwest lean-to roof consists of timber battens and pan tiles.

3.2.8 75mm x 50mm timber rafters at 400mm centres span over a central row of purlins.

3.2.9 120mm x 100mm timber purlins span between large primary lean-to rafters.

3.2.10 6 large 220mm x 65mm primary rafters span between a stone wall and the low eaves wall plate.

*Photo 5: Southwest lean-to internal roof*

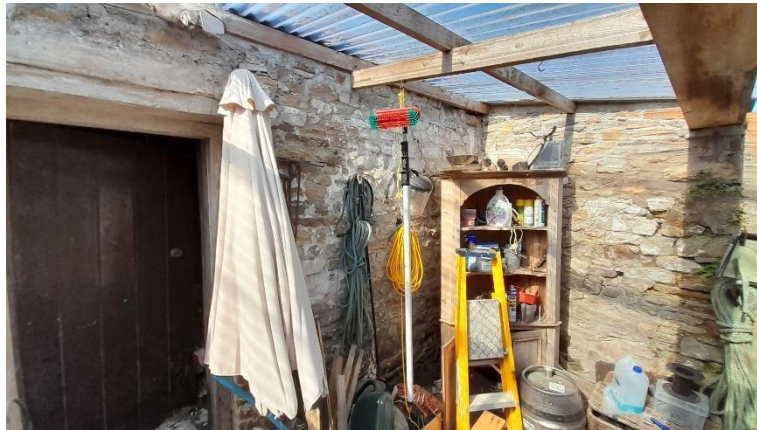
3.2.11 The northeast lean-to consists of battens and pan tiles with small area of clear perspex roof.

3.2.12 75mm x 50mm timber rafters span between the wall and over a timber purlin of approx. 225mm x 75mm.

*Photo 6: Northeast lean-to internal roof*

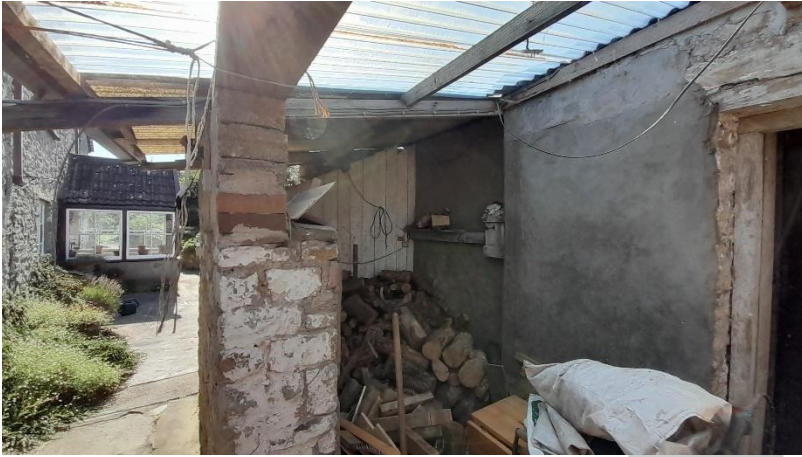
- 3.3.8 There is a single cast iron (assumed) 120mm diameter column supporting the roof on the west corner of the timber lean-to.
- 3.3.9 The northeast lean-to consists of stone walls. The floor level of this lean to is approximately 1100mm lower than the duopitch and is therefore assumed to be retaining.

*Photo 10: Stone lean-to*

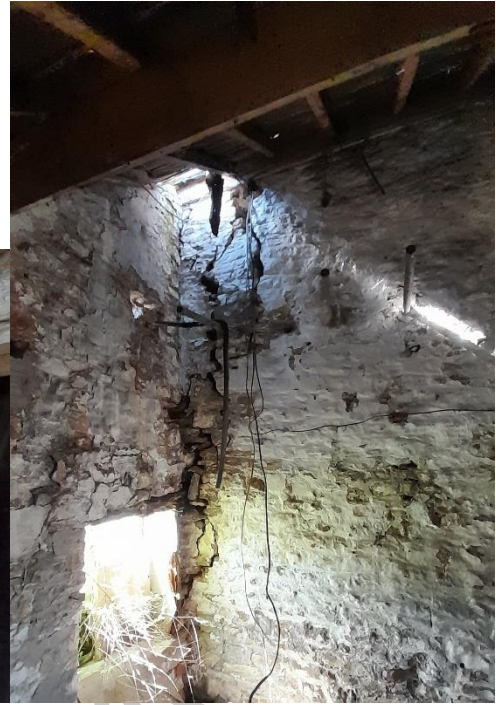
*Photo 11: Stone lean-to interior*

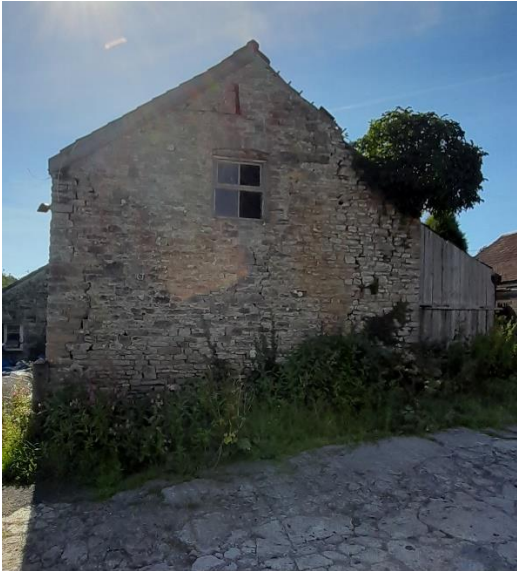
3.3.3 The northwest gable also has multiple cracks present. A large vertical crack runs to the left-hand side of the window opening.

*Photo 12: Northwest elevation*

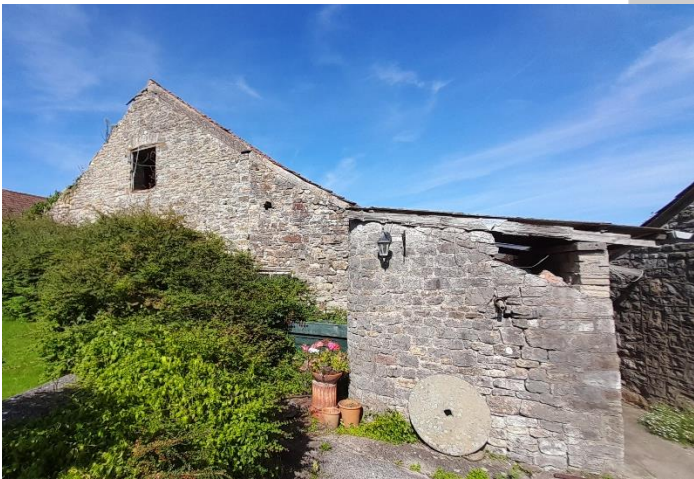
3.3.2 The southeast gable wall is noted to have pulled away from the return walls with significant cracking present on the south and east corners. The purlins have likely lost their bearings through decay and water ingress which has destabilised the wall.

*Photo 14: Southeast elevation*

6.5.2 Large cracks will require a combination of specialist stitch bars and partial rebuilding to ensure the walls are sufficiently bonded into the return buttressing walls.

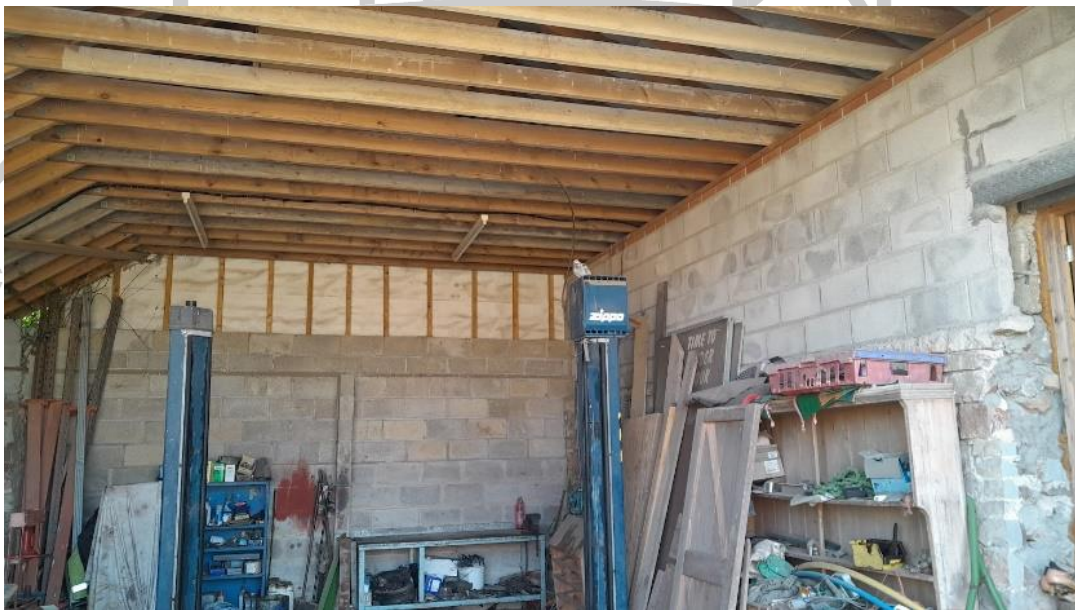
4.3.3 The rear of the frame (southeast) appears to be constructed from an internal blockwork wall and an external timber frame. Externally this is clad with 150mm horizontal featherboard with a 25mm lap.

*Photo 16: Internal view of blockwork wall and timber frame.*

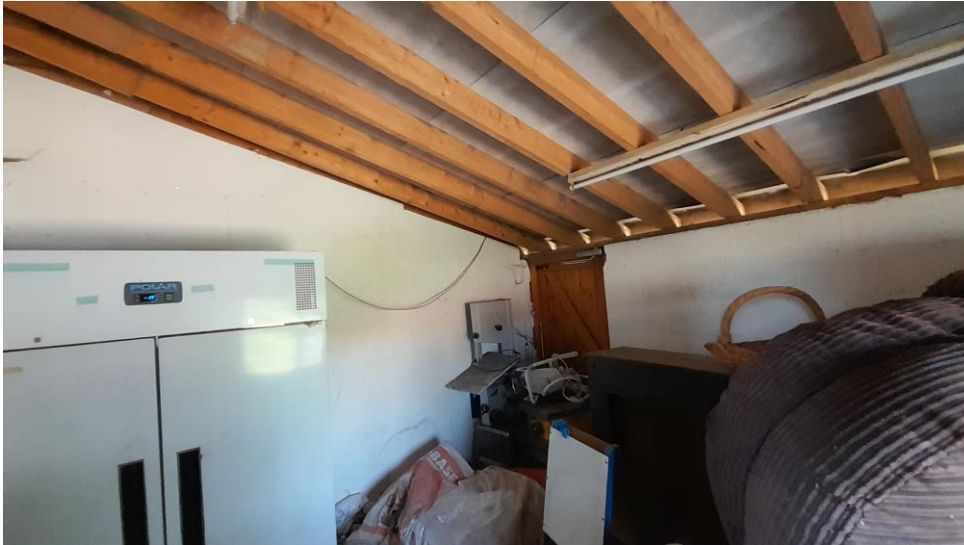
- 4.3.4 The northeast lean-to is constructed in blockwork with timber clad door to the front (northwest).
- 4.3.5 The southwest lean-to is constructed of blockwork, finished with an external render and a large door opening on the southeast elevation, clad with featherboard timbers. There is a step up of circa 660mm into the southwest lean-to from the central duopitched area.

*Photo 17: Internal view of southwest lean-to*
