Arboricultural Consultancy for Lloyds Bank

Insured	Mr Trevor Williams	Address	8 Taylors Cottages , Potters Bar, EN6 3LL		
Client	Subsidence Management Services	Contact	Ian Domigan	Claim No.	IFS-LBG-SUB-22-0104199
ES Ref	SA-253088	Consultant	Keith Burgess	Contact No.	0330 380 1036
Report Date	09/06/2023

Ridge 8 Taylers Cottages, Potters Bar, EN6 3LL

Risk Address: Ridge 8 Taylors Cottage, Potters Bar EN6 3LL

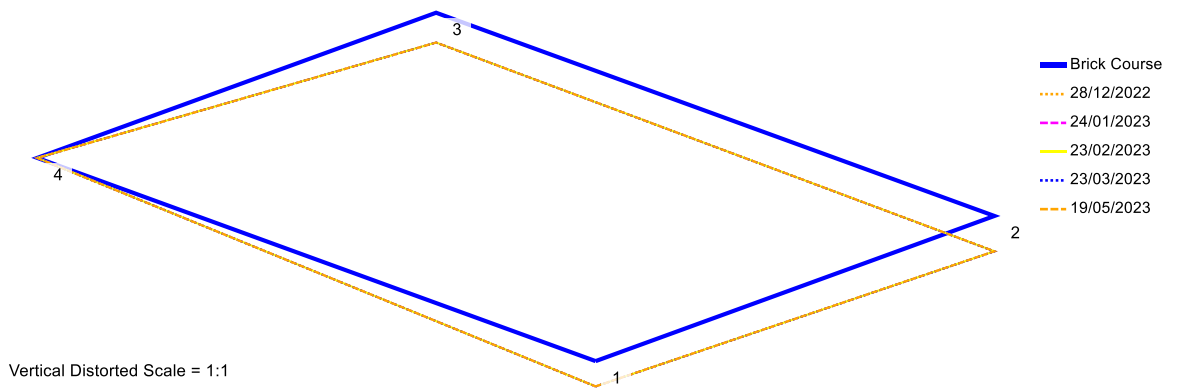
Level Monitoring Displacement Map

The following image shows an isometric representation of the movement of the property, based on the Level Monitoring Stations that were installed.
