Ballantruan Farmhouse

Ballindalloch, Moray

Analytical assessment

January 2023

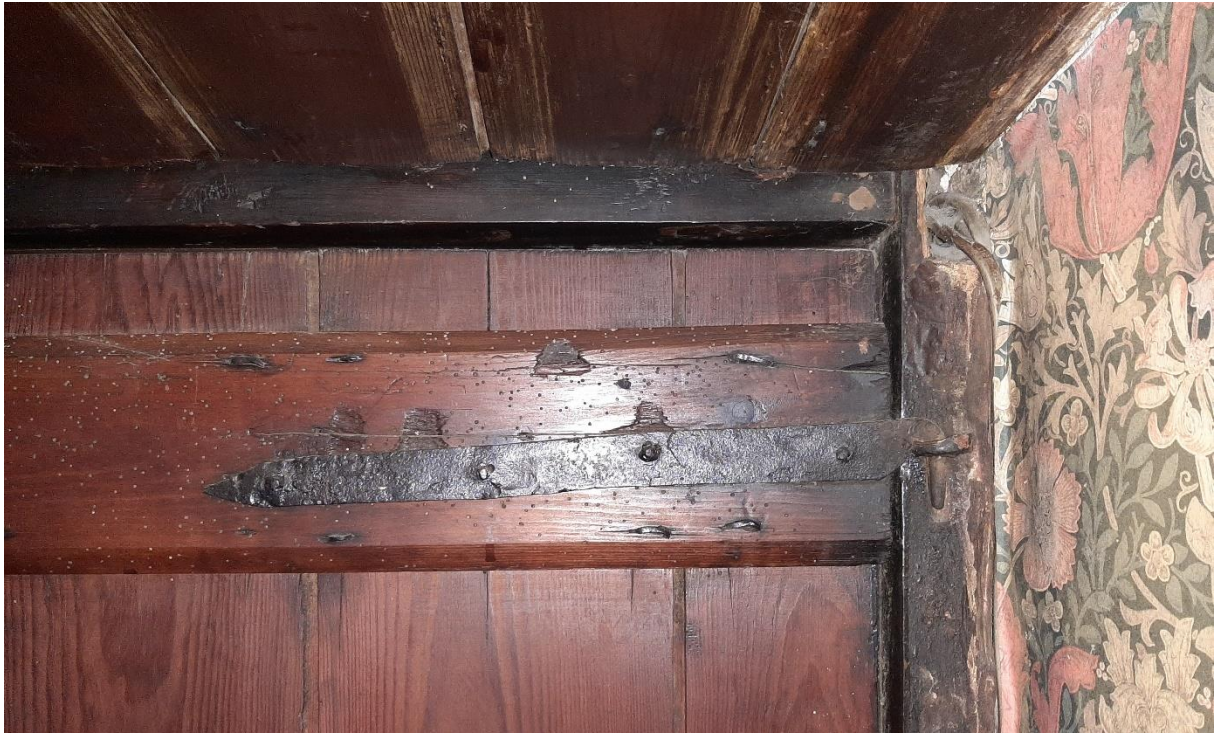
The existing entrance at the east end of the north wall, now leading into the present kitchen range, may have been an original external entrance. However, the thick external wall and the finish of the doorway, including the discrepancy in height between the internal and external openings is not in keeping with the joineray and structural work elsewhere in the first phase of the building. The door within is relatively early, of plank-and-batten construction that features wrought iron fittings - band hinges with pointed termini suspended from loops, a latch (re-set), etc.

Detail of door to kitchen range

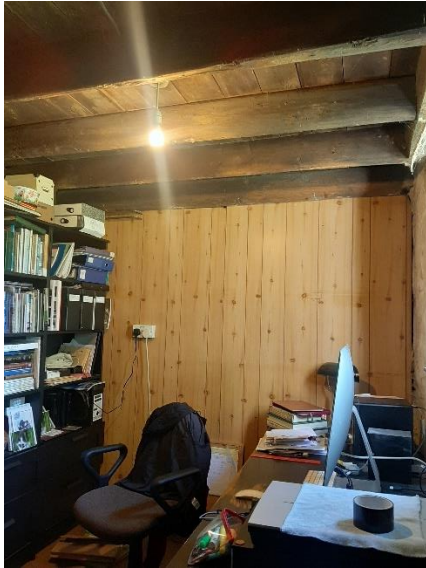
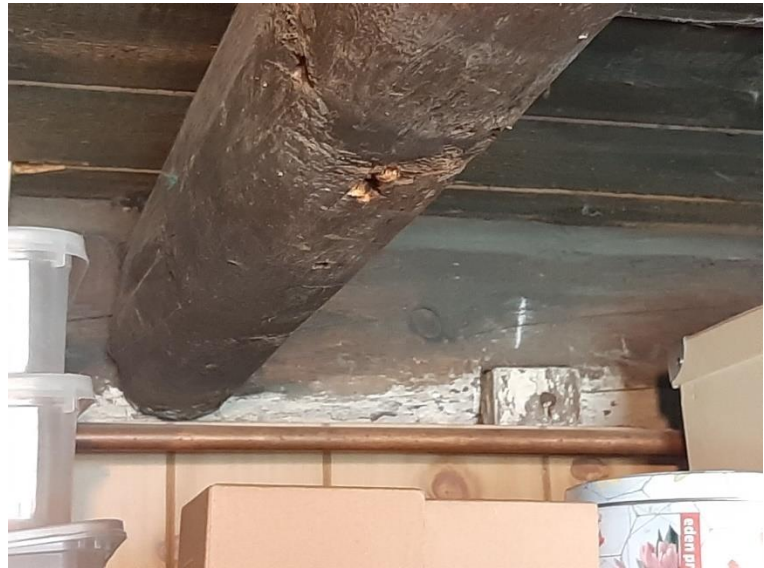
The modern room interior is mostly lined out with the exception of the open ceiling structure. Towards the wall-tops parts of the framing behind are visible, revealing roughly dressed vertical studs affixed to the joists above with wrought nails, lath and plaster to the outer side, all limewashed. This chamber may originally functioned as a larder off the kitchen.

Interior of inner room; right – detail of wall top showing early partitioning construction – top of a stud, whitewashed

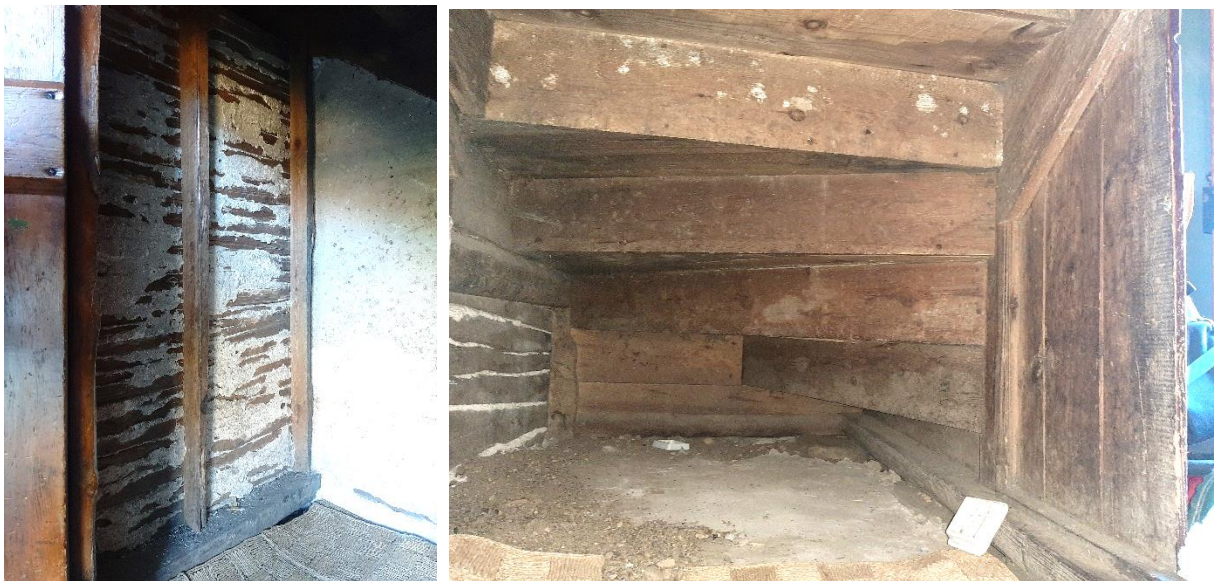
The under-stair space revealed details of the construction of both the stair sub-structure itself and of the adjacent partition walls. Localised investigation during the site visit demonstrated that the partitioning had been footed upon flat stones apparently laid on to the underlying sub-soil.

Under-stair area : left – rear wall of box-bed to south; right – stair construction

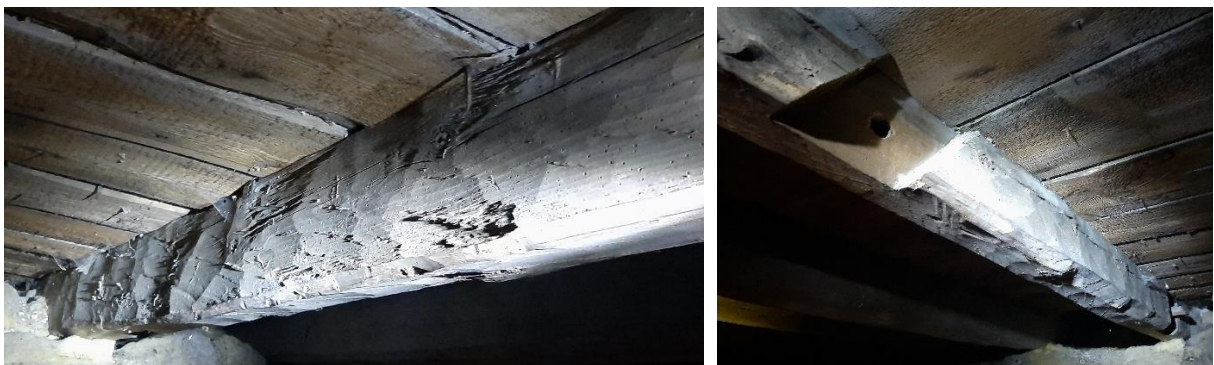
The roof structure is accessible by means of a hatch at the head of the stair. With the rafter feet and lower rafter extents obscured by the first floor coombing, only the upper parts of the structure are presently accessible. The roof is a notable survival of common rafter construction comprising multiple coupes of A-frame configuration with a single collar that corresponds to the ceiling flat above the coombing at first floor level⁹. All timbers are roughly adze-hewn conifer cabers that are squared or still partly in-the-round. As noted the rafter foot assembly was not accessible. The existing configuration comprises a single relatively low collar that is of half-lapped half-dove-tail detail, affixed with single wrought spikes. At the apex the rafters are lapped and similarly spiked.

Detail showing adze-dressing to roof timbers

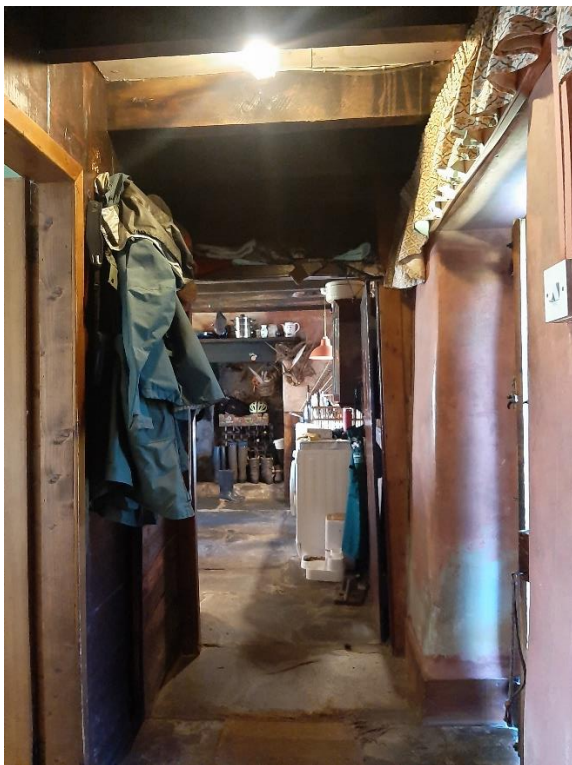
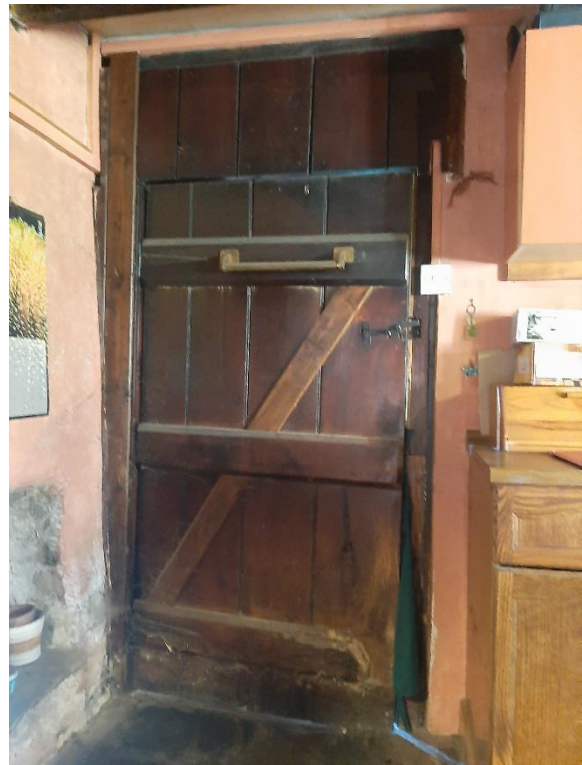
Left - vestibule to kitchen, looking north; right – rear of kitchen door

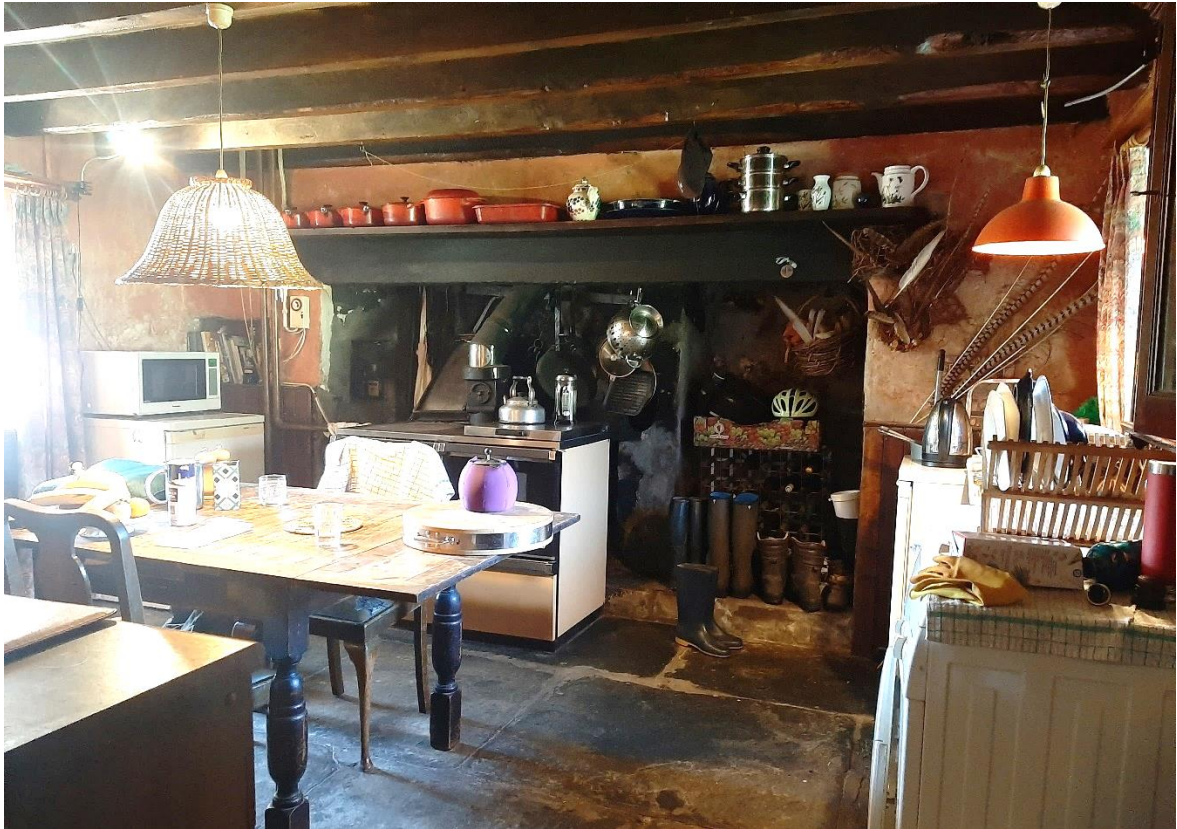
The kitchen interior is dominated by the froad fireplace opening to the north wall. Though visually impacted by the insertion of the existing boiler, c.1985, this still retains an early wrought-iron *swey*, chains etc, the ash pit and grate remain, and other internal features such as a salt box recess to the west jamb and a further recess to the east. Elsewhere within the kitchen interior there are further mural recesses to the west end of the north wall, the south end of the east wall, and possibly one, now blocked, within the west wall to the south side of the existing window.

Kitchen interior showing broad fireplace opening to north wall

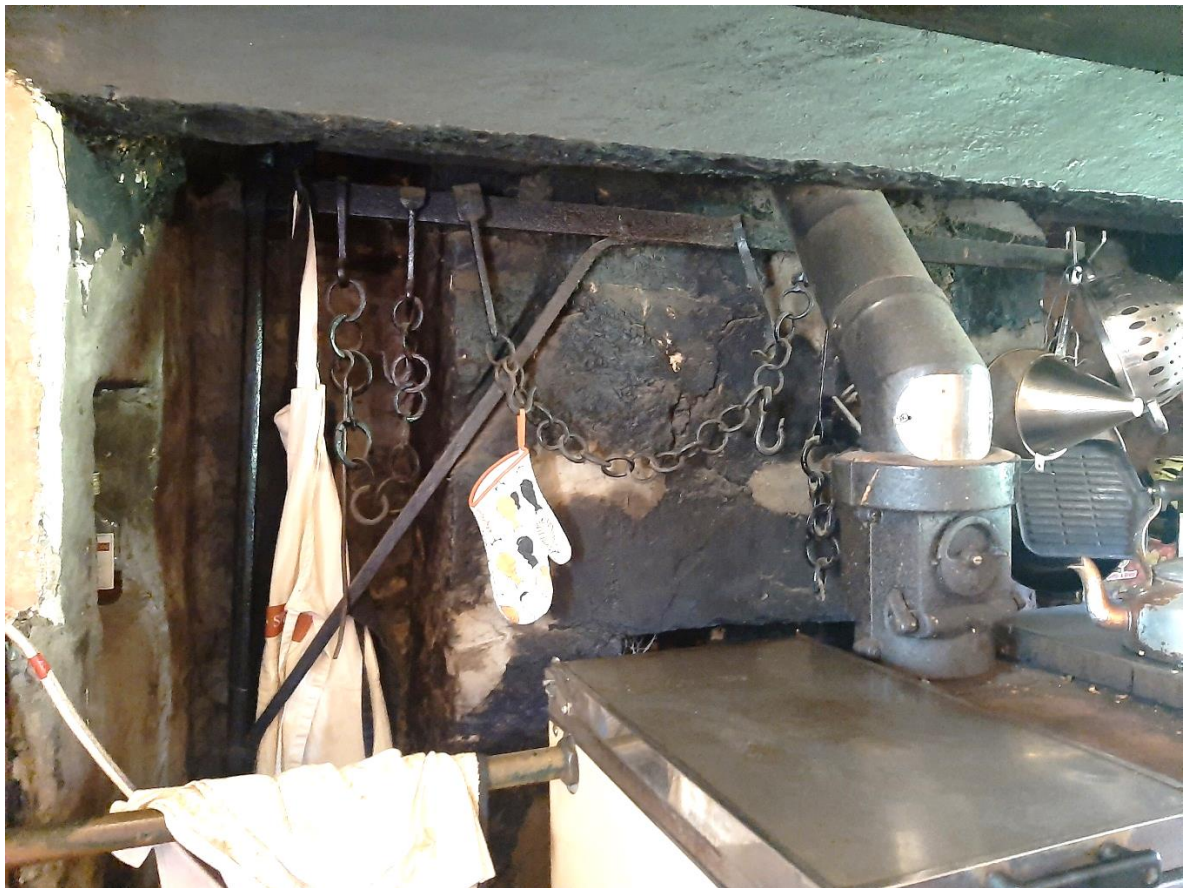
Kitchen fireplace interior – detail of swey

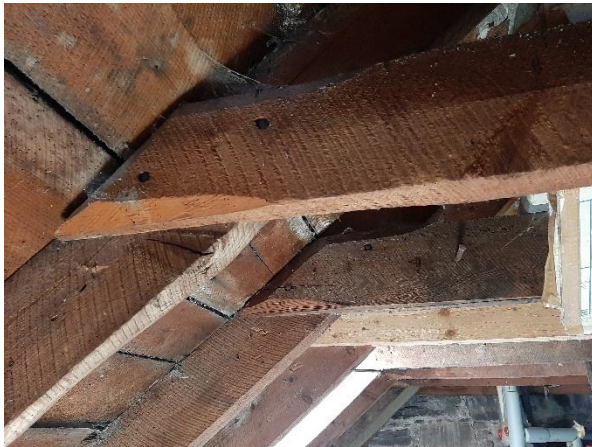
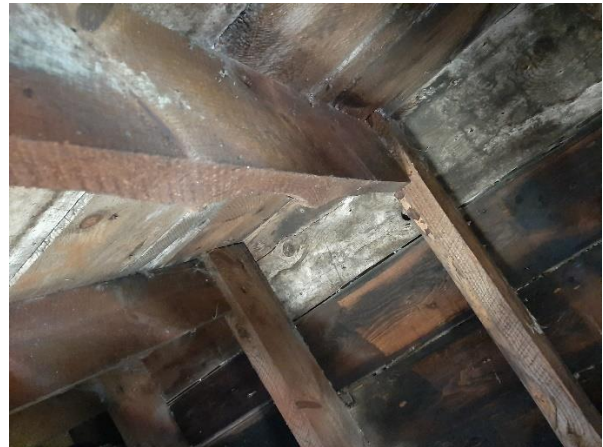
Left – detail of collar joint; right – detail of apex jointing
