# Bradford College Future Technology Centre Flood Risk Assessment

Curtins Ref: 079306-CUR-00-XX-RP-C-002

Issue Date: 06 September 2023

Client Name: Bradford College

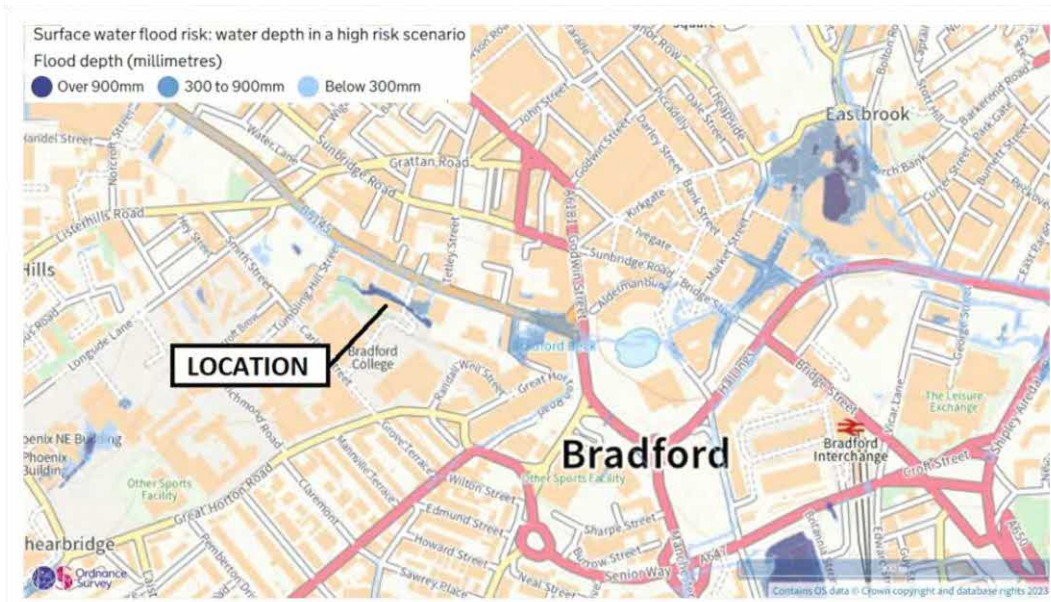
Figure 5-1 – Environment Agency Flood Risk from Surface Water – High Risk (1 in 30 Year)

Figure 5-1 shows the high risk 1 in 30-year chance of flooding i.e. generally more regular flash summer storms. The deepest (>900 mm) surface water flood depth is contained to the beck channel with some shallow (<300 mm) depth flooding on Thornton Road. This is contained within Thornton Road and no flooding can be seen within the building footprint.

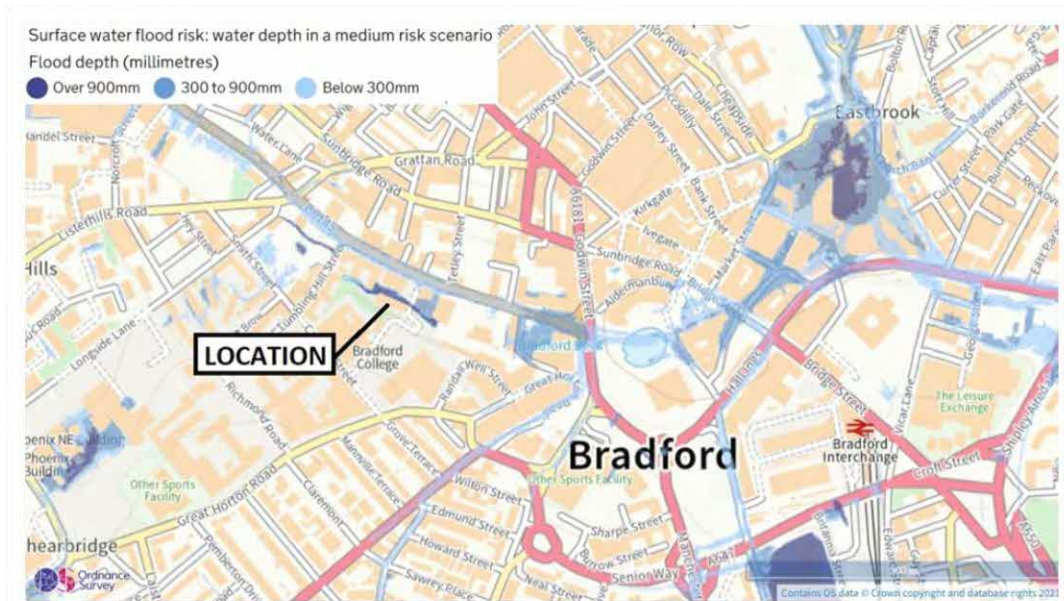
Figure 5-2 – Environment Agency Flood Risk from Surface Water – Medium Risk (1 in 100 Year)

Figure 5-2 shows the medium risk 1 in 100-year chance of flooding i.e. the typical design event for surface water flood risk. The depths and extent are very similar to the high-risk scenario (1 in 30 year).

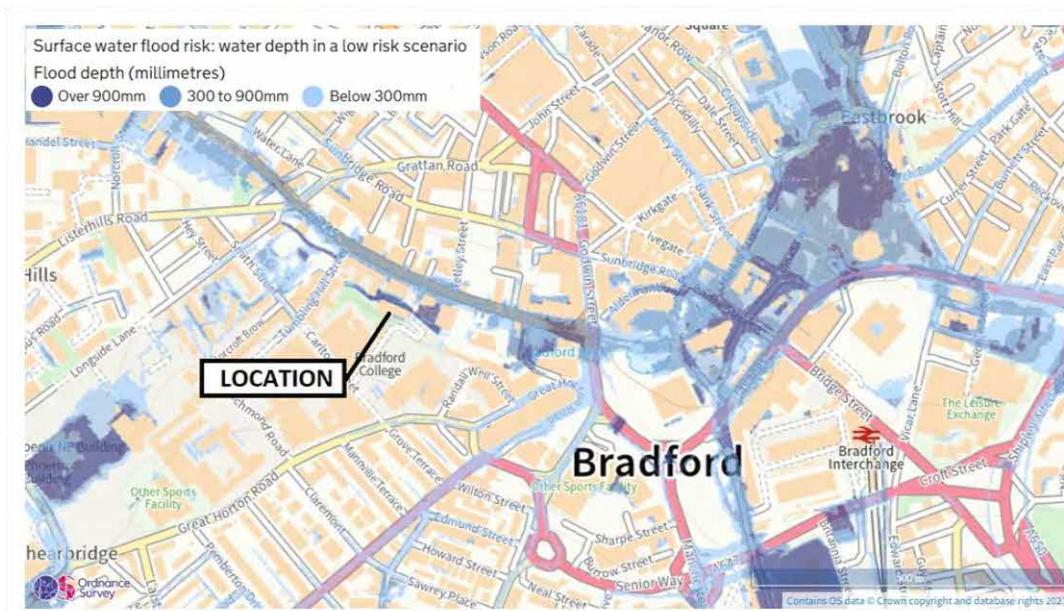
Figure 5-3 – Environment Agency Flood Risk from Surface Water Low Risk (1 in 1,000 year)

Figure 5-3 shows the low risk 1 in 1,000-year chance of flooding i.e. the most extreme surface water flood risk event. As with the high and medium risk maps, the extent and depth of flooding to the beck remains relatively constant. However, a greater depth (300 -900 mm) and extent now arise on Thornton Road with the carriageway routing flows eastward into the city centre.

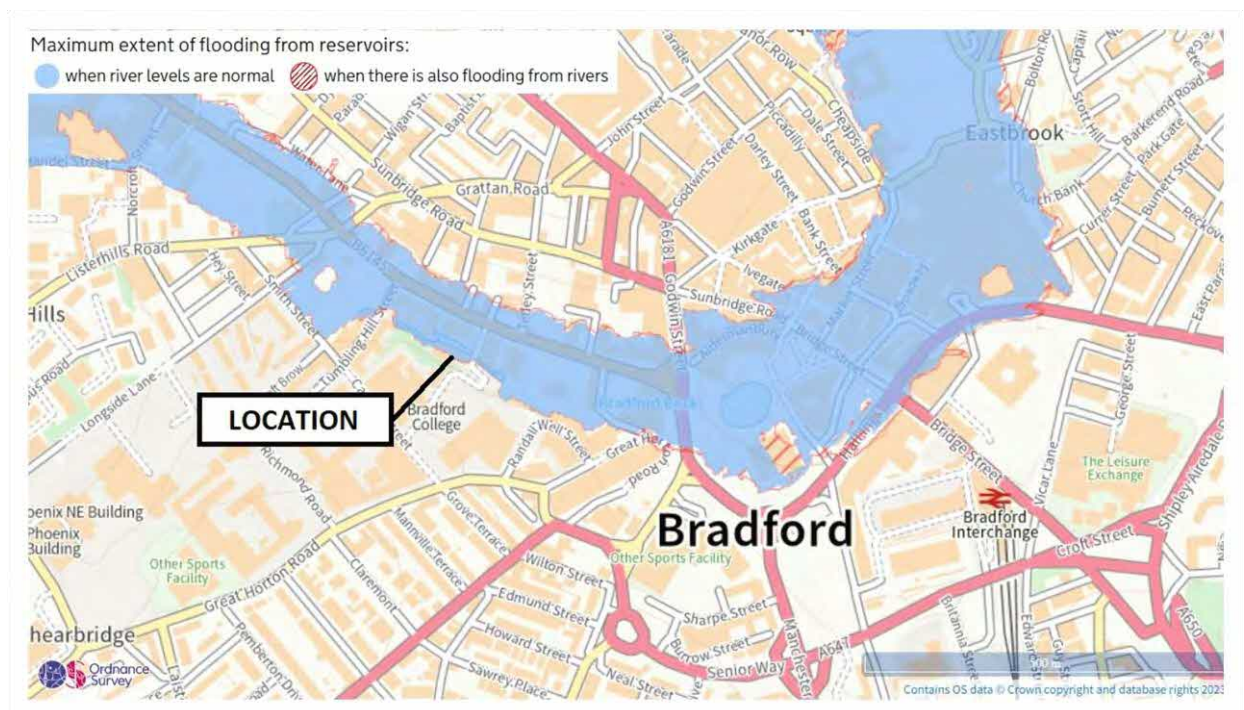
Figure 5-4 – Environment Agency Flood Risk from Reservoirs

The risk extents can be seen to roughly mimic that of the Flood Zone 2 extents so risk could be assessed as high. However, the Environment Agency mapping advises that the risk is associated with Challow Heights East and West Reservoirs owned by Yorkshire Water, and Lower and Upper Chellow Reservoirs owned by Bradford Council. The constant maintenance and close scrutiny reservoirs have from the 'Authorities' (Yorkshire Water and Bradford Council in this case), means the risk associated with catastrophic failure and increase in risk as a result of climate change is actually considered low.

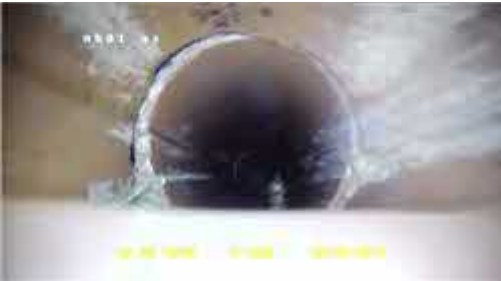
| Pos | Video Ref | Code | Cont. | Description | Image |
|---|---|---|---|--|---|
| 00.1m | 0:00:07 | RF | | Roots fine at joint - Severity 1 | Image Provided - Ref: 0_2<br> |

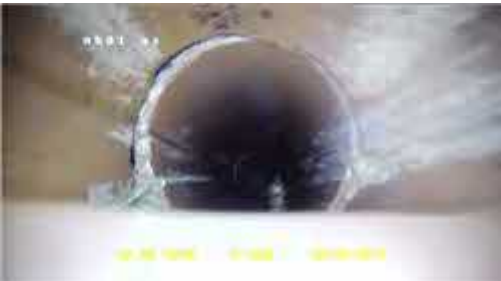
| Pos | Video Ref | Code | Cont. | Description | Image |
|---|---|---|---|--|---|
| 00.2m | 0:00:07 | OJM | | Open joint medium - Severity 2 | Image Provided - Ref: 0_3<br> |

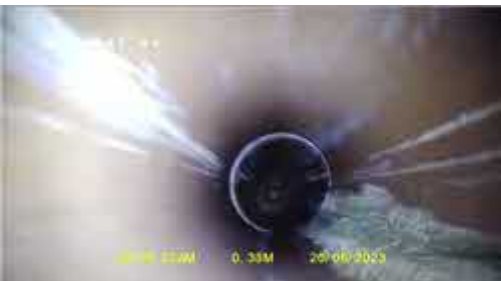
| Pos | Video Ref | Code | Cont. | Description | Image |
|---|---|---|---|--|---|
| 00.4m | 0:00:12 | DES | | Settled deposits fine: 5% cross-sectional area loss - Severity 2 | Image Provided - Ref: 0_4<br> |

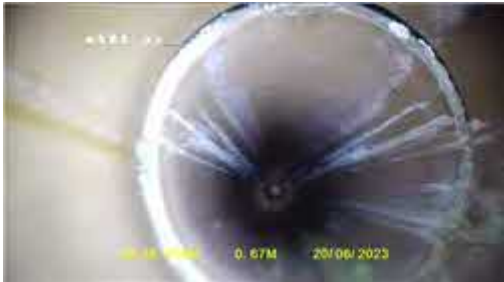
| Pos | Video Ref | Code | Cont. | Description | Image |
|---|---|---|---|--|--|
| 00.7m | 0:00:14 | OJM | | Open joint medium - Severity 2 | Image Provided - Ref: 0_5<br> |

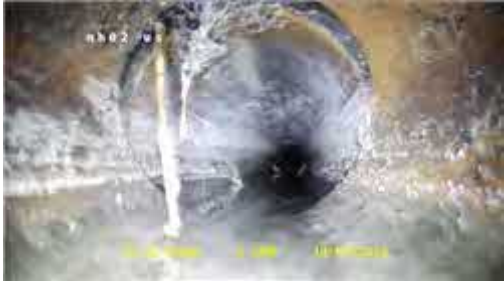
| Pos | Video Ref | Code | Cont. | Description | Image |
|---|---|---|---|---|---|
| 00.5m | 0:00:00 | JDM | | Joint displaced medium - Severity 2 | Image Provided - Ref: 2_1<br> |

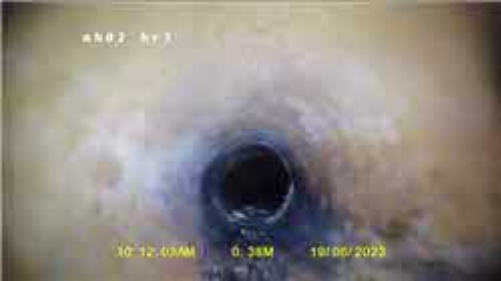
| Pos | Video Ref | Code | Cont. | Description | Image |
|---|---|---|---|--|---|
| 00.4m | 0:00:00 | DES | | Settled deposits fine: 5% cross-sectional area loss - Severity 2 | Image Provided - Ref: 4_1<br> |

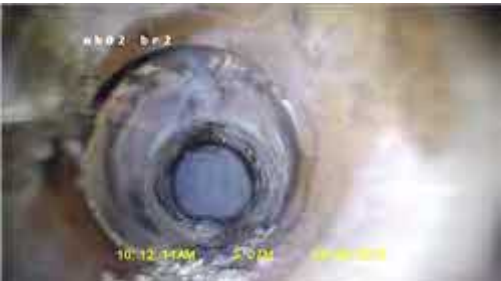
| Pos | Video Ref | Code | Cont. | Description | Image |
|---|---|---|---|--|---|
| 03.1m | 0:00:14 | OJM | | Open joint medium - Severity 2 | Image Provided - Ref: 4_3<br> |

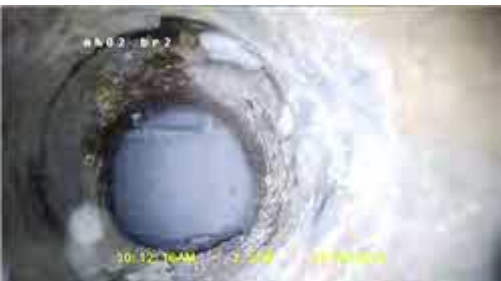
| Position | Code | Description | CD | Pic | Video Ref |
|---|---|---|---|---|---|
| 03.4 | H | Hole in drain/sewer 12-01 | | 4_4 | 0:00:15 |

| Pos | Video Ref | Code | Cont. | Description | Image |
|---|---|---|---|--|---|
| 03.4m | 0:00:15 | H | | Hole in drain/sewer from 12 o'clock to 01 o'clock - Severity 3 | Image Provided - Ref: 4_4<br> |

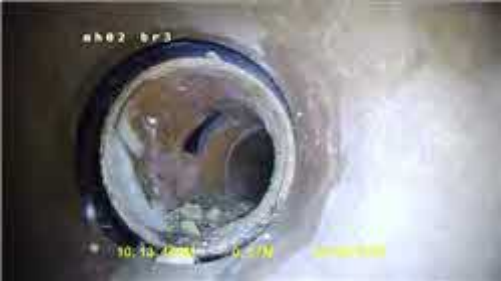
| Position | Code | Description | CD | Pic | Video Ref | |
|---|---|---|---|---|---|--|
| 00.7 | OJL | Open joint large | | 5_1 | 0:00:00 | |

| Pos | Video Ref | Code | Cont. | Description | Image |
|---|---|---|---|--|---|
| 00.7m | 0:00:00 | OJL | | Open joint large - Severity 3 | Image Provided - Ref: 5_1<br> |

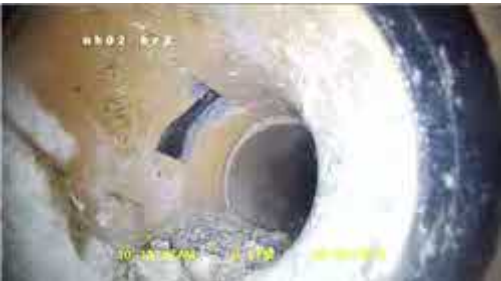
| Pos | Video Ref | Code | Cont. | Description | Image |
|---|---|---|---|--|---|
| 00.7m | 0:00:06 | DES | | Settled deposits fine: 5% cross-sectional area loss - Severity 2 | Image Provided - Ref: 5_3<br> |

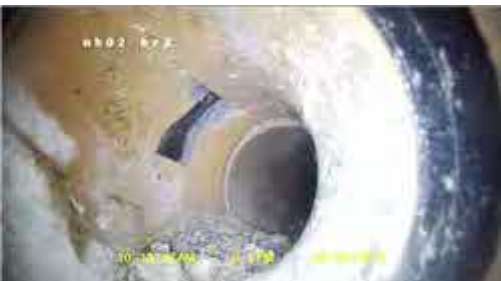
| Position | Code | Description | CD | Pic | Video Ref | |
|---|---|---|---|---|---|--|
| 00.8 | FM | Fracture multiple 12-12 | | 5_4 | 0:00:06 | |

| Pos | Video Ref | Code | Cont. | Description | Image |
|---|---|---|---|--|---|
| 00.8m | 0:00:06 | FM | | Fracture multiple from 12 o'clock to 12 o'clock - Severity 4 | Image Provided - Ref: 5_4<br> |

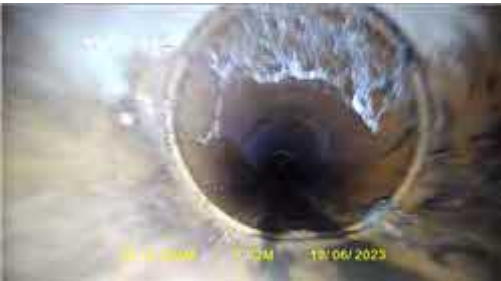
| Position | Code | Description | CD | Pic | Video Ref | |
|---|---|---|---|---|---|--|
| 01.8 | FL | Fracture longitudinal 03 | 6_3 | 0:00:11 | | |

| Pos | Video Ref | Code | Cont. | Description | Image |
|---|---|---|---|--|---|
| 01.8m | 0:00:11 | FL | | Fracture longitudinal at 03 o'clock - Severity 3 | Image Provided - Ref: 6_3<br> |

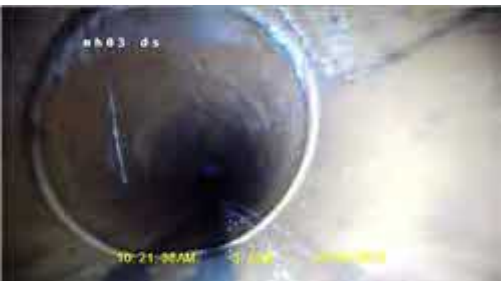
| Pos | Video Ref | Code | Cont. | Description | Image |
|---|---|---|---|--|---|
| 03.5m | 0:00:16 | OJM | | Open joint medium - Severity 2 | Image Provided - Ref: 6_4<br> |

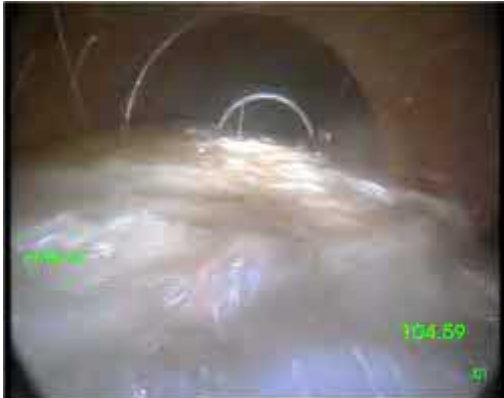
| Pos | Video Ref | Code | Cont. | Description | Image |
|---|---|---|---|---|---|
| 00.0m | 0:00:00 | WL | | Water level: 50% Height/Diameter | Image Provided - Ref: 8_1<br> |

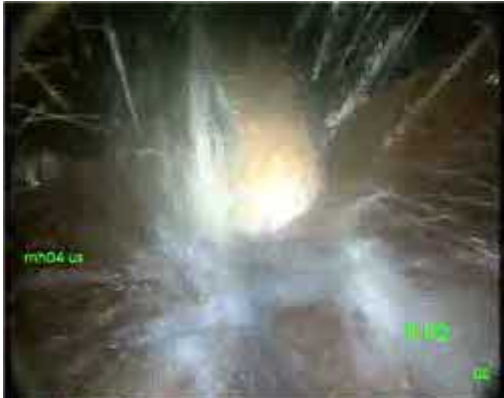
| Pos | Video Ref | Code | Cont. | Description | Image |
|---|---|---|---|---|--|
| 00.1m | 0:00:00 | REM | | General remark<br>Flow Coming From Internal<br>Backdrop - Assumed To Be<br>Surface Gully Line | Image Provided - Ref: 9_1<br> |

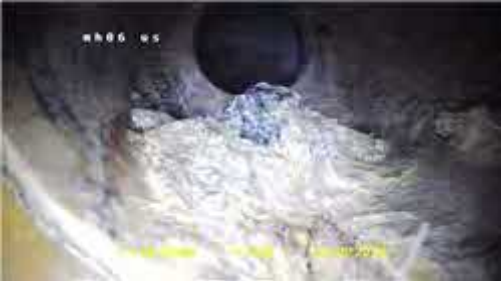
| Pos | Video Ref | Code | Cont. | Description | Image |
|---|---|---|---|---|---|
| 00.0m | 0:00:00 | DES | | Settled deposits fine: 10% cross-sectional area loss - Severity 2 | Image Provided - Ref: 11_1<br> |

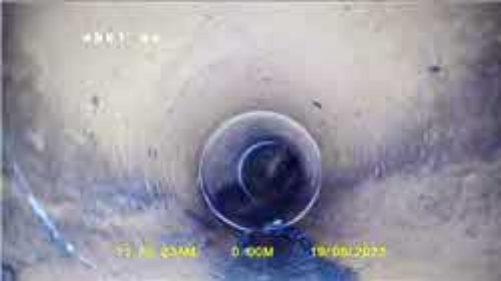
| Pos | Video Ref | Code | Cont. | Description | Image |
|---|---|---|---|---|--|
| 00.0m | 0:00:00 | FC | | Fracture circumferential from 07 o'clock to 09 o'clock - Severity 3 | Image Provided - Ref: 13_1<br> |

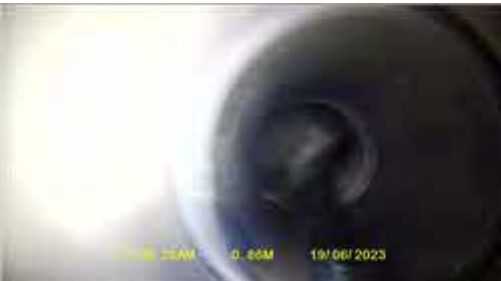
| Pos | Video Ref | Code | Cont. | Description | Image |
|---|---|---|---|---|--|
| 00.9m | 0:00:03 | OJM | | Open joint medium - Severity 2 | Image Provided - Ref: 13_3<br> |

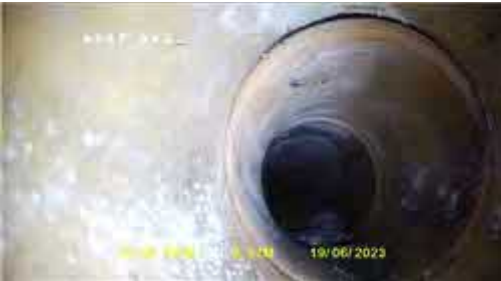
| Pos | Video Ref | Code | Cont. | Description | Image |
|---|---|---|---|--|--|
| 00.6m | 0:00:10 | OJM | | Open joint medium - Severity 2 | Image Provided - Ref: 14_2<br> |

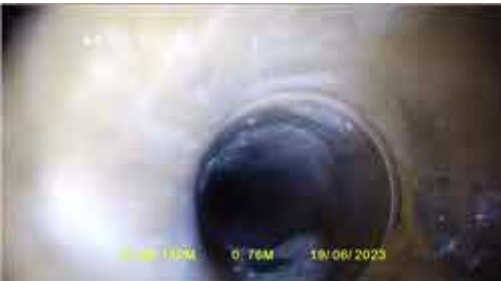
| Pos | Video Ref | Code | Cont. | Description | Image |
|---|---|---|---|--|--|
| 00.8m | 0:00:14 | DES | S1 | Settled deposits fine 0.8m - 7m: 5% cross-sectional area loss - Severity 2 | Image Provided - Ref: 14_3<br> |

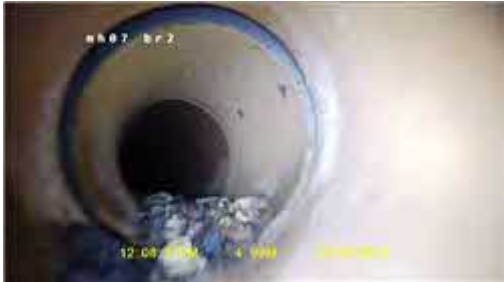
| Pos | Video Ref | Code | Cont. | Description | Image |
|---|---|---|---|---|--|
| 05.0m | 0:00:38 | OJM | | Open joint medium - Severity 2 | Image Provided - Ref: 14_6<br> |

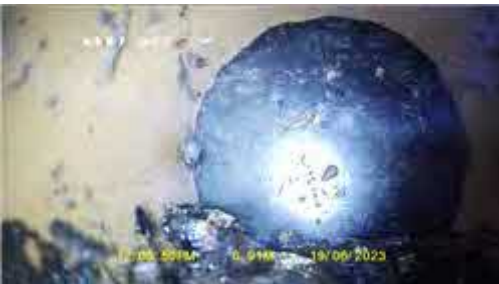
| Pos | Video Ref | Code | Cont. | Description | Image |
|---|---|---|---|---|---|
| 07.0m | | SA | | Survey abandoned<br>Capped Off | <p>Image Provided - Ref: 14_9999</p> |

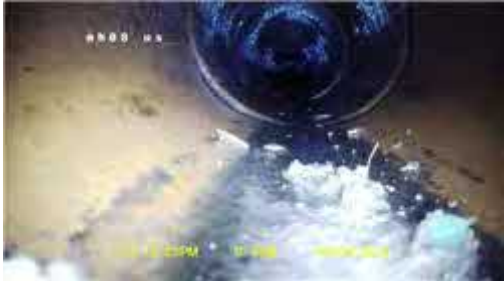
| Pos | Video Ref | Code | Cont. | Description | Image |
|---|---|---|---|--|--|
| 00.0m | 0:00:00 | DES | | Settled deposits fine: 5% cross-sectional area loss - Severity 2 | Image Provided - Ref: 15_1<br> |

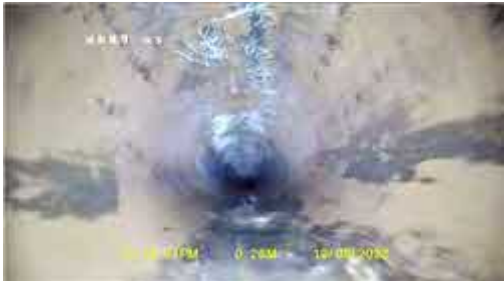
| Pos | Video Ref | Code | Cont. | Description | Image |
|---|---|---|---|---|--|
| 00.3m | 0:00:00 | DEF | S1 | Attached deposits, fouling 0.3m - 3.3m from 05 o'clock to 07 o'clock: 5% cross-sectional area loss - Severity 2 | Image Provided - Ref: 16_1<br> |

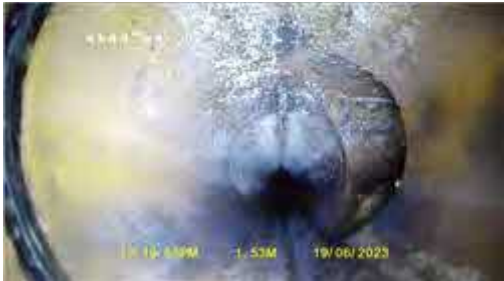
| Pos | Video Ref | Code | Cont. | Description | Image |
|---|---|---|---|---|--|
| 01.5m | 0:00:10 | OJM | | Open joint medium - Severity 2 | Image Provided - Ref: 16_3<br> |

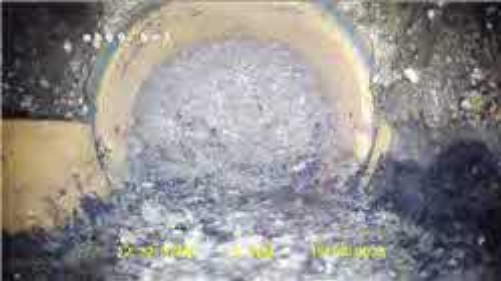
| Pos | Video Ref | Code | Cont. | Description | Image |
|---|---|---|---|--|---|
| 00.0m | 0:00:00 | DEX | | Other settled deposits: 5% cross-sectional area loss - Severity 3<br>Fouling | Image Provided - Ref: 17_1<br> |

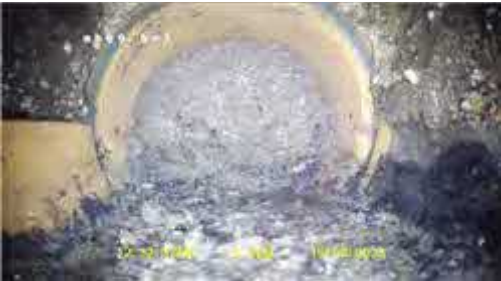
| Pos | Video Ref | Code | Cont. | Description | Image |
|---|---|---|---|--|---|
| 00.1m | 0:00:00 | DEX | | Other settled deposits: 100% cross-sectional area loss - Severity 3<br>Fouling | Image Provided - Ref: 17_2<br> |

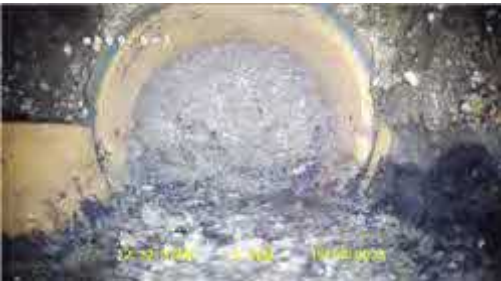
| Pos | Video Ref | Code | Cont. | Description | Image |
|---|---|---|---|--|---|
| 00.1m | | SA | | Survey abandoned<br>Survey Abandoned - Unable To Pass Fouling | Image Provided - Ref: 17_9999<br> |

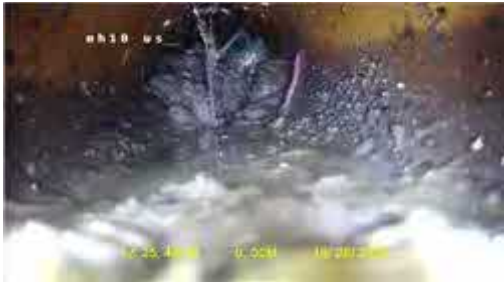
| Pos | Video Ref | Code | Cont. | Description | Image |
|---|---|---|---|--|---|
| 00.0m | 0:00:00 | DEX | | Other settled deposits: 10%<br>cross-sectional area loss -<br>Severity 3<br>Fouling | Image Provided - Ref: 18_2<br> |

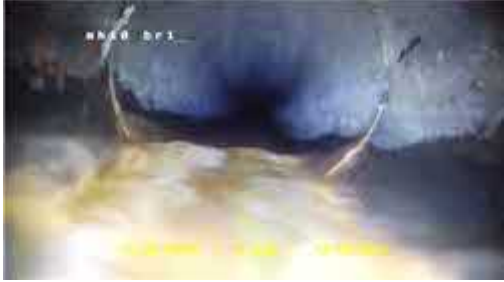
| Pos | Video Ref | Code | Cont. | Description | Image |
|---|---|---|---|--|---|
| 00.0m | 0:00:00 | MH | | Start node type, manhole, reference mh10 br1 | Image Provided - Ref: 19_0<br> |

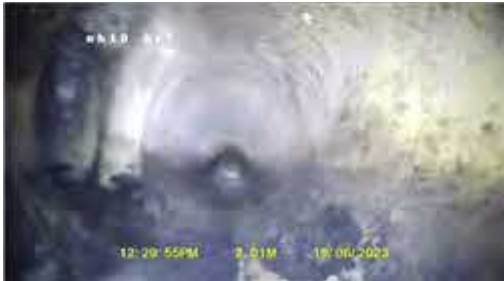
| Pos | Video Ref | Code | Cont. | Description | Image |
|---|---|---|---|--|---|
| 02.1m | 0:00:20 | JN | | Junction at 09 o'clock: 100mm Diameter | Image Provided - Ref: 19_2<br> |

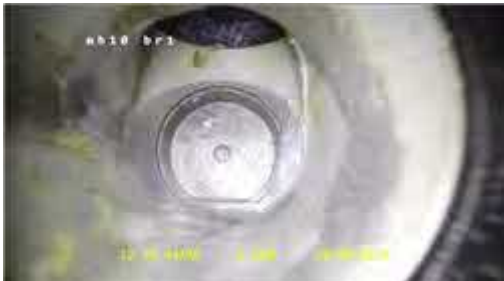
| Pos | Video Ref | Code | Cont. | Description | Image |
|---|---|---|---|--|---|
| 03.4m | 0:00:30 | JN | | Junction at 12 o'clock: 100mm Diameter | Image Provided - Ref: 19_3<br> |

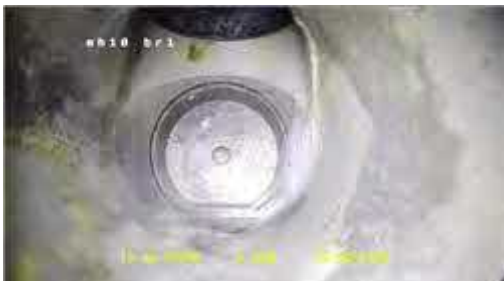
| Pos | Video Ref | Code | Cont. | Description | Image |
|---|---|---|---|--|---|
| 03.5m | | SA | | Survey abandoned Capped Off | Image Provided - Ref: 19_9999<br> |

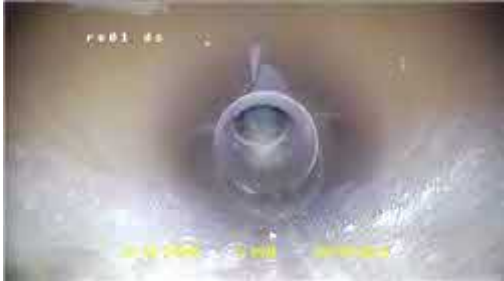
| Pos | Video Ref | Code | Cont. | Description | Image |
|---|---|---|---|---|--|
| 00.0m | 0:00:00 | LD | | Line of drain/sewer deviates down | Image Provided - Ref: 21_1<br> |

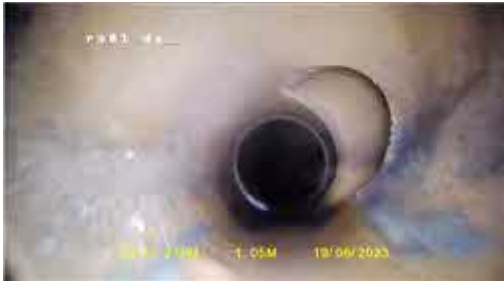
| Pos | Video Ref | Code | Cont. | Description | Image |
|---|---|---|---|---|--|
| 01.2m | 0:00:06 | JN | | Junction at 03 o'clock: 100mm Diameter | Image Provided - Ref: 21_2<br> |

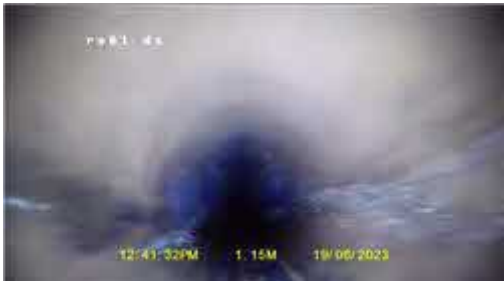
| Pos | Video Ref | Code | Cont. | Description | Image |
|---|---|---|---|---|--|
| 01.2m | 0:00:07 | WL | S1 | Water level 1.2m - 22.2m: 5% Height/Diameter | Image Provided - Ref: 21_4<br> |

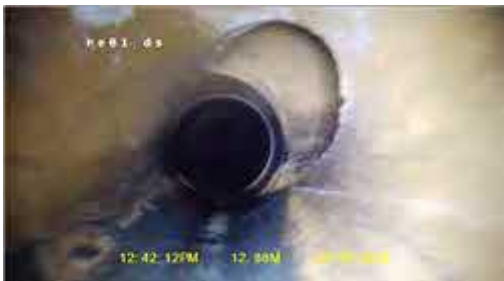
| Pos | Video Ref | Code | Cont. | Description | Image |
|---|---|---|---|---|--|
| 12.9m | 0:00:47 | JN | | Junction at 03 o'clock: 100mm Diameter | Image Provided - Ref: 21_3<br> |

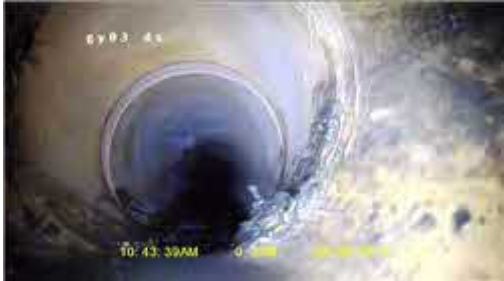
| Pos | Video Ref | Code | Cont. | Description | Image |
|---|---|---|---|--|--|
| 00.0m | 0:00:00 | WL | | Water level: 5% Height/Diameter | Image Provided - Ref: 24_1<br> |

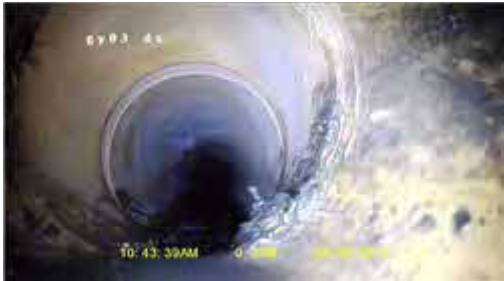
| Pos | Video Ref | Code | Cont. | Description | Image |
|---|---|---|---|--|--|
| 00.0m | 0:00:00 | DES | | Settled deposits fine: 5% cross-sectional area loss - Severity 2 | Image Provided - Ref: 24_2<br> |

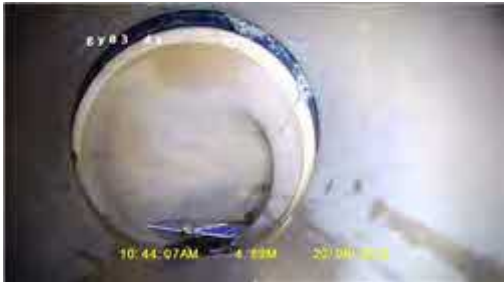
| Pos | Video Ref | Code | Cont. | Description | Image |
|---|---|---|---|---|---|
| 05.0m | 0:00:28 | DER | | Settled deposits coarse: 5% cross-sectional area loss - Severity 3 | Image Provided - Ref: 24_5<br> |

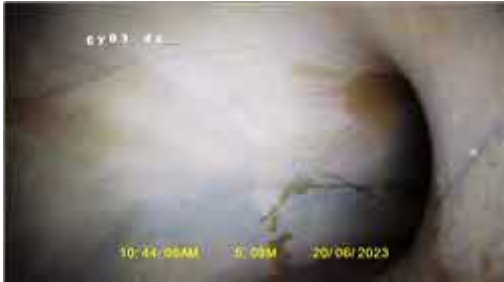
| Pos | Video Ref | Code | Cont. | Description | Image |
|---|---|---|---|---|---|
| 05.2m | 0:00:29 | LR | | Line of drain/sewer deviates right | Image Provided - Ref: 24_6<br> |

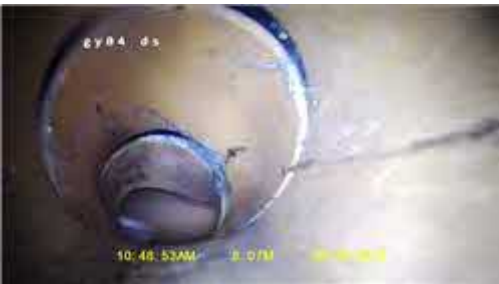
| Pos | Video Ref | Code | Cont. | Description | Image |
|---|---|---|---|---|--|
| 08.2m | 0:00:38 | LD | | Line of drain/sewer deviates down | Image Provided - Ref: 25_5<br> |
