s h e d visual structural survey
Flemings Hall barns
Beddingfield, Suffolk

As part of the proposed conversion works to the existing barns and outbuildings at Flemings Hall, Bedingfield, **s h e d** undertook a visual structural survey on the property to inform the planning submission and overall development proposals.

s h e d undertook the visual survey in July 2023. Weather conditions were fine and dry.

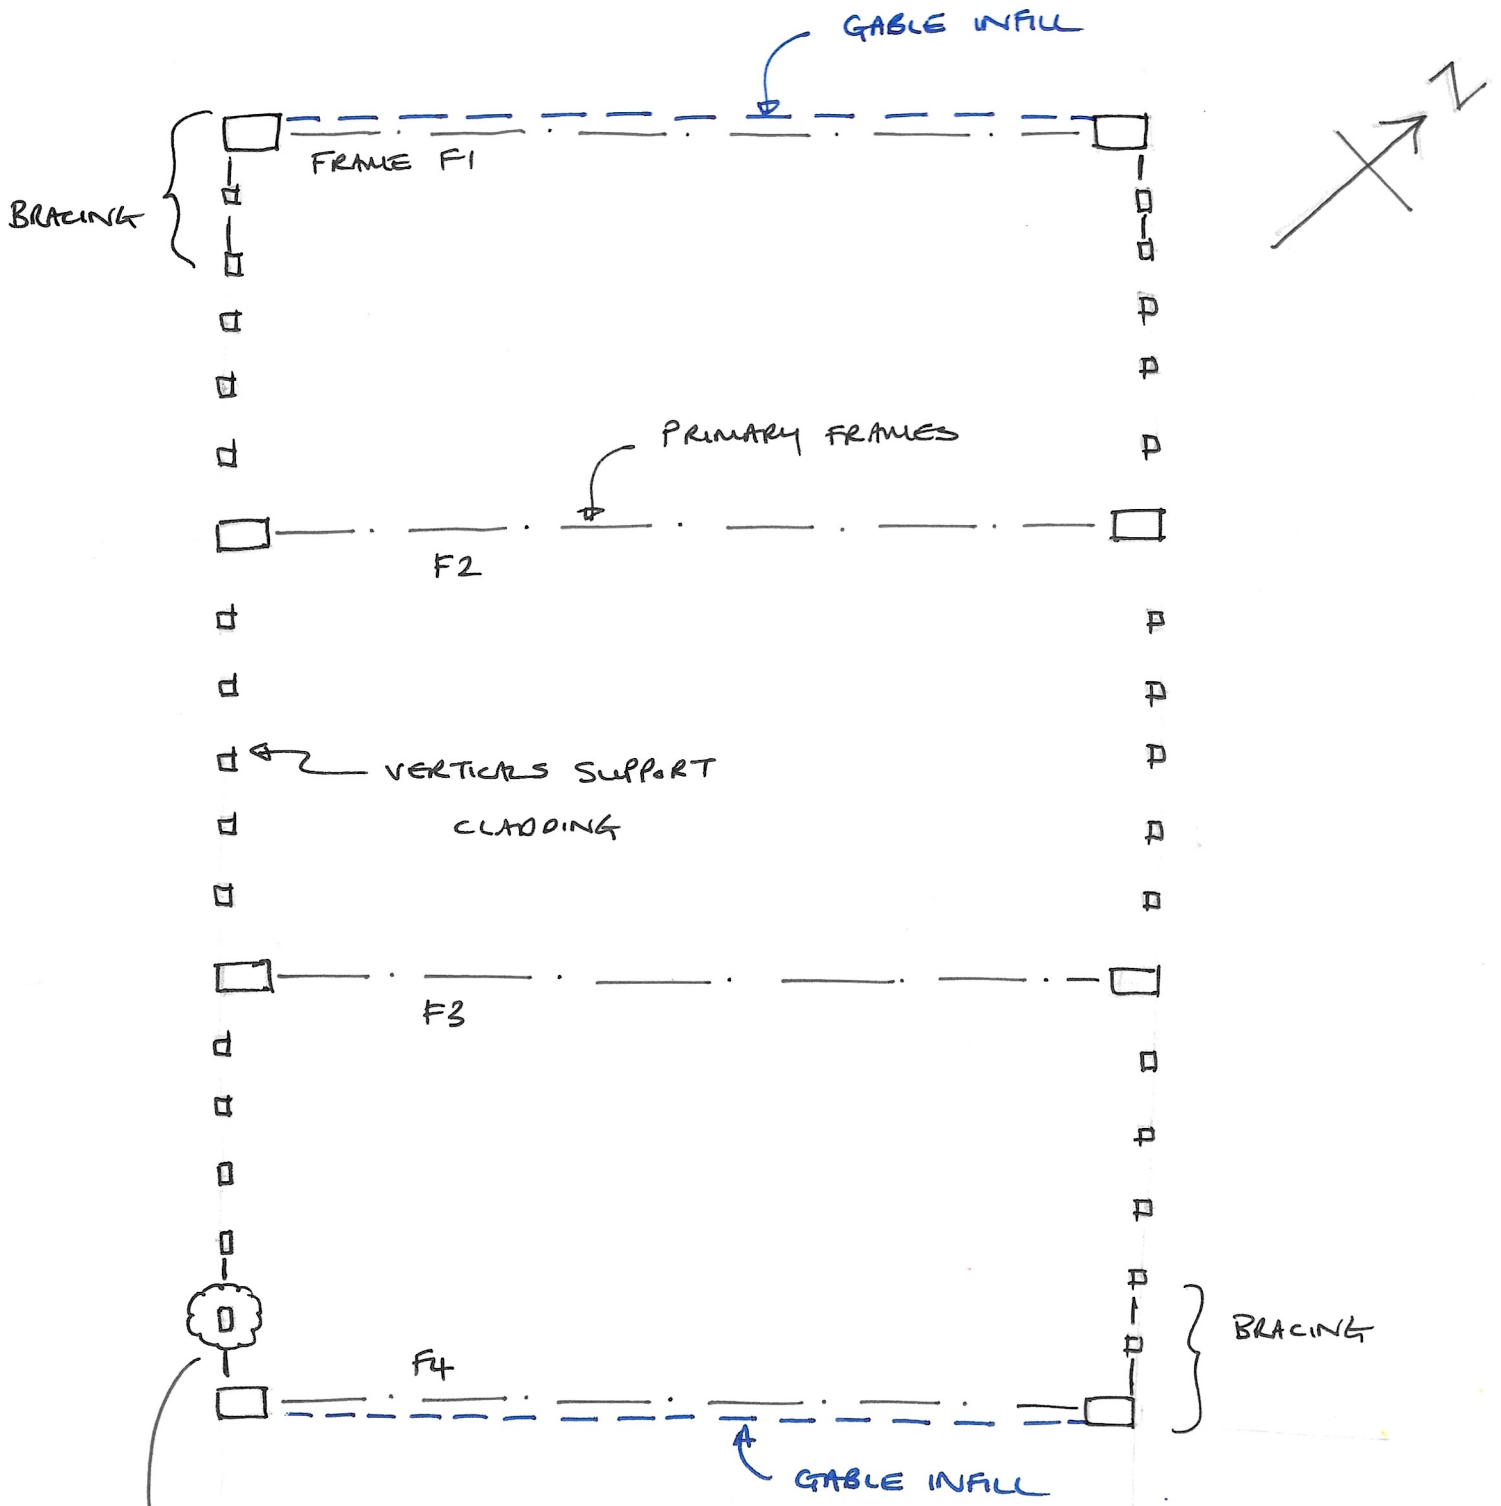
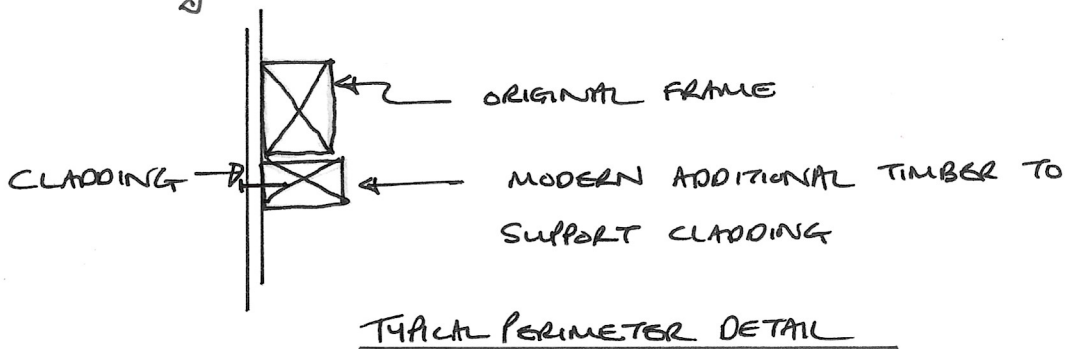
BARN STRUCTURAL FRAME (NTS)

The barn is an historic structure with timber condition consistent in parts with its age, although substantial repairs have already been undertaken sensitively to the roof. This can be feasibly continued with the principal frame and wall members repaired and replaced as required. This, along with stabilisation of the base via local underpinning will ensure long term integrity of the structure and so it can be considered suitable for conversion with the necessary repairs carried out, and any localised strengthening works undertaken.
