**STRUCTURAL INSPECTION  
OF  
THE STABLES  
AT  
PILGRIMS' FARM  
WHITE HILL ROAD  
OVERTON  
RG25 3DS**

**221224 Rev A- JUNE 2023**

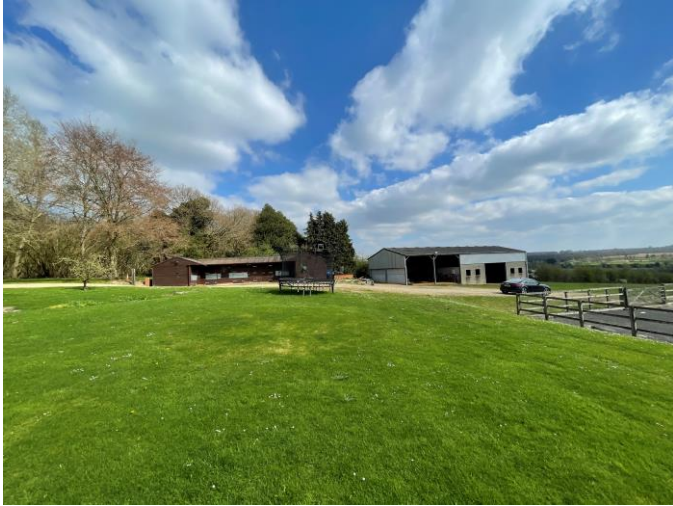
1. Stables and Fodder Barn

- 3.15 The roof had been repaired in the past, and was clad with stirling board sheets. There was extensive evidence of leaking and some of the sheets were rotten (see photograph 1).
