- 1.1.1 This arboricultural report is required by our client as part of an investigation into soil shrinkage subsidence damage at:
  - 2 Convent Avenue, South Kirby, Pontefract, West Yorkshire, WF9 3NX.

2.1.1 The site was surveyed during January 2022 by **Charles Cocking** FdSc (Arboriculture), MArborA.

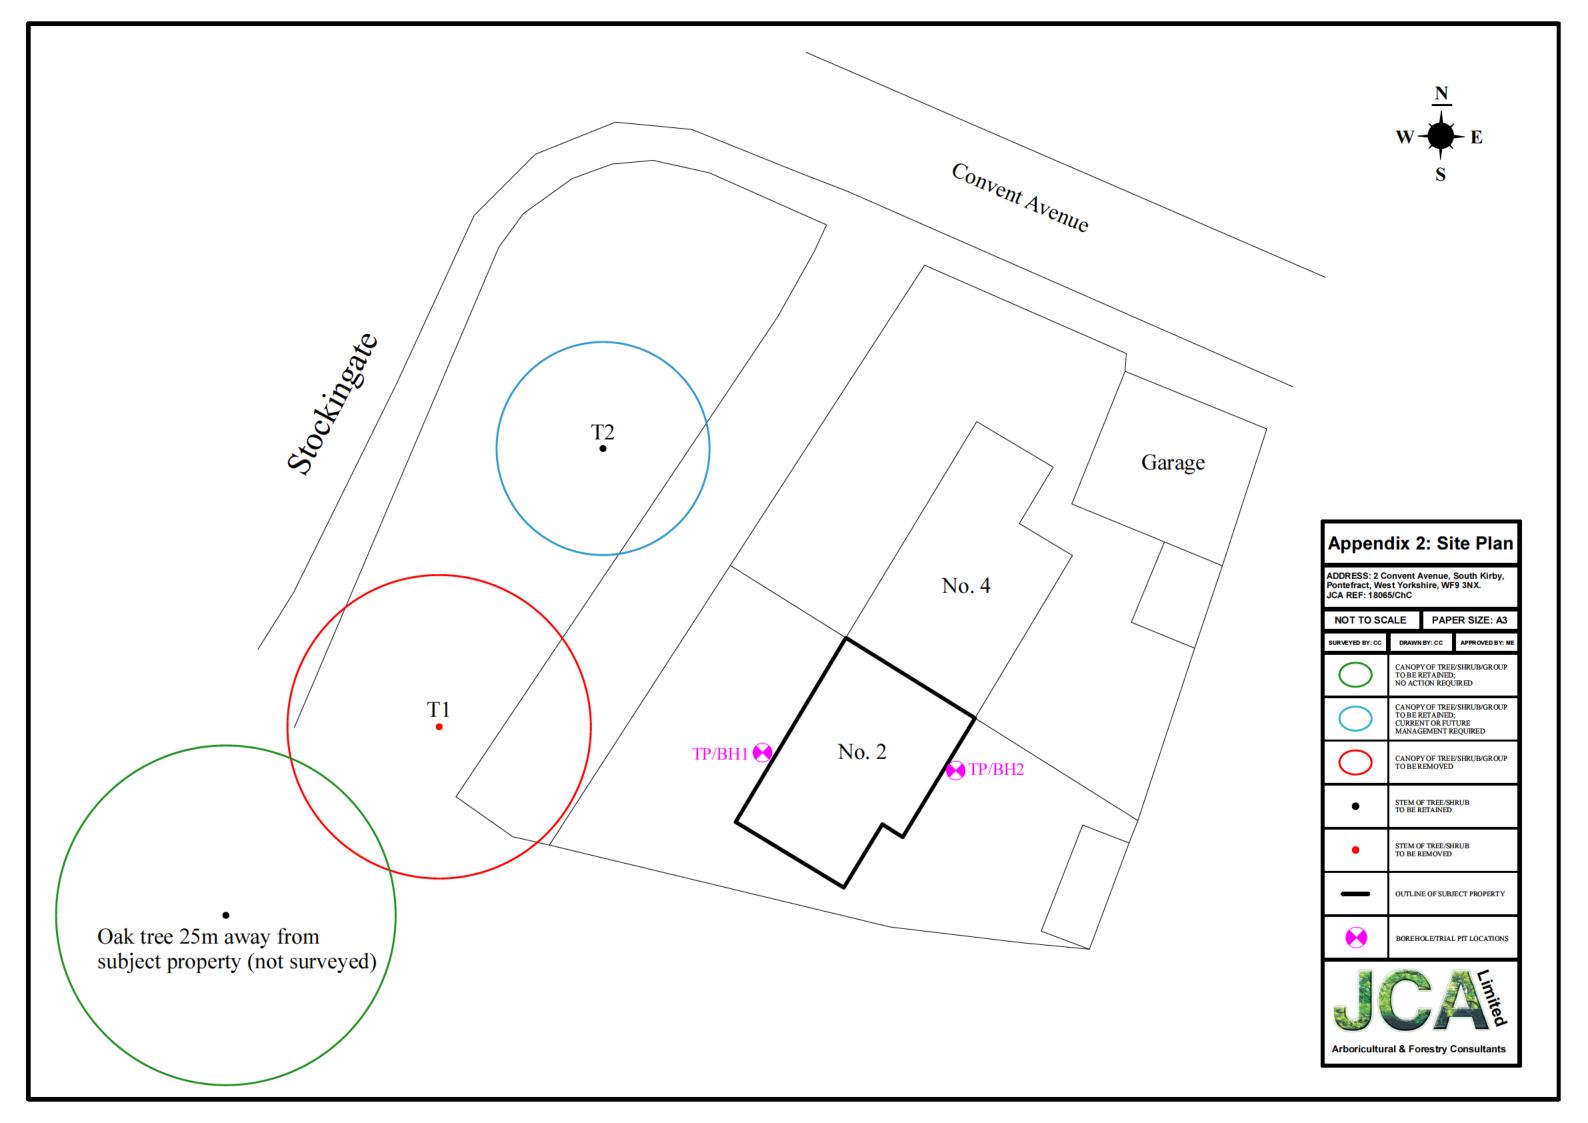
- 5.1 Descriptions of the surveyed vegetation and all recommended work are detailed in the tables at **Appendix 1**.
- 5.2 Please refer to the site plan at **Appendix 2** for the locations of the vegetation surveyed and all the relevant site features.
