**CCTV REPORT FOR: 2 CONVENT AVENUE  
SOUTH KIRKBY  
PONTEFRACT  
WEST YORKSHIRE  
WF9 3NX**

**Insured:** Miss Claire Hibbert  
**Reference:** DLG-SN-21-003542 Ins Ref: 079598843

**Site Visit:** 04-Nov-21  
**Report Date:** 24-Nov-21

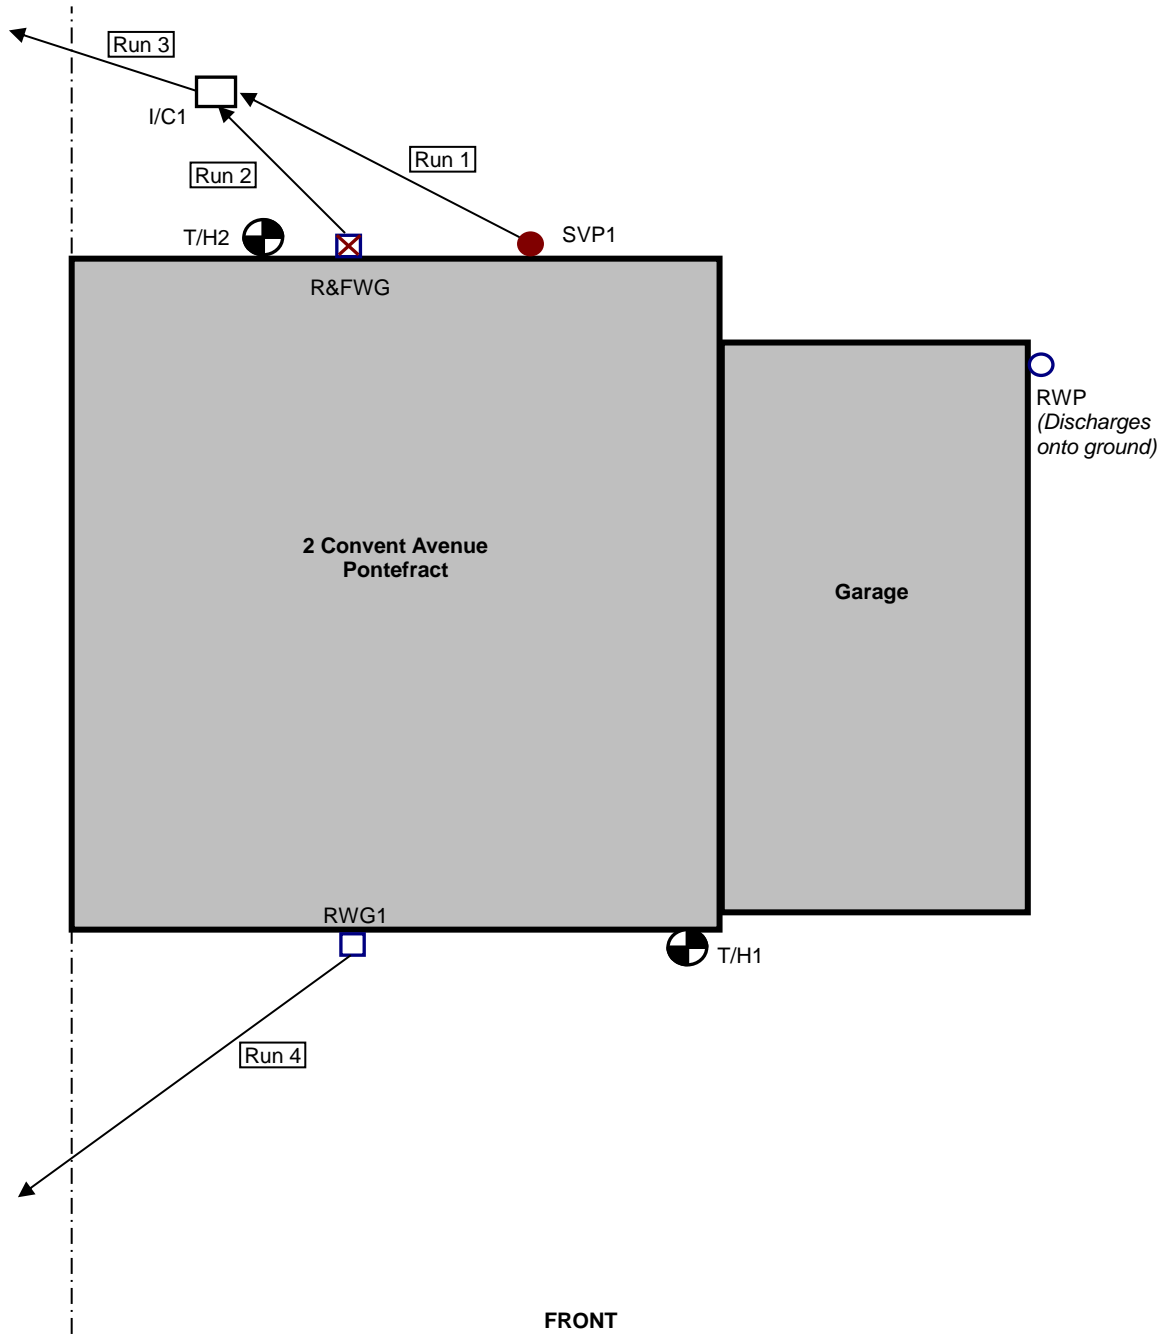
# SITE AND DRAINAGE LAYOUT

**Note: Runs shown in red have been adopted by the local water authority.**

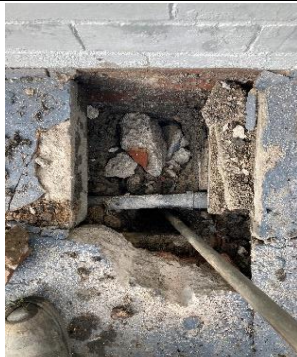
**Photograph**

Roots Depth & Diameter:
From 1.0m
Down to 2.0m
up to 3mm diameter
Water Depth Hit & Rise:
None observed on site
Reason for Termination :
Encountered obstruction
Compact sand

Depth (m)	Soil Descriptions <i>(NB: Field crew description only)</i>	Test Type	Depth (m)	
			From	To
G.L.				
1.00	Stiff brown CLAY	V(n) 72	1.000	
2.00	Stiff brown slightly sandy CLAY	V(n) 75	1.500	
3.00	End of Borehole

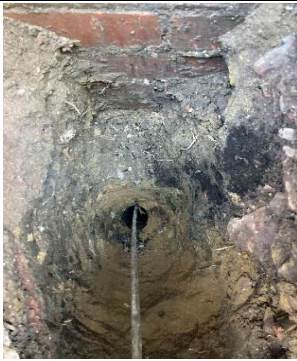
Roots Depth & Diameter:  
None observed on site

Reason for Termination :  
Encountered obstruction  
Compact sand

Depth (m)	Soil Descriptions <i>(NB: Field crew description only)</i>	Test Type	Depth (m)	
			From	To
G.L.				
1.00	Stiff brown mottled grey sandy CLAY	V(n) 47	1.000	
1.50	Stiff brown mottled grey slightly sandy CLAY	V(n) 47	1.500	
3.00	End of Borehole			
<b>Photograph</b>

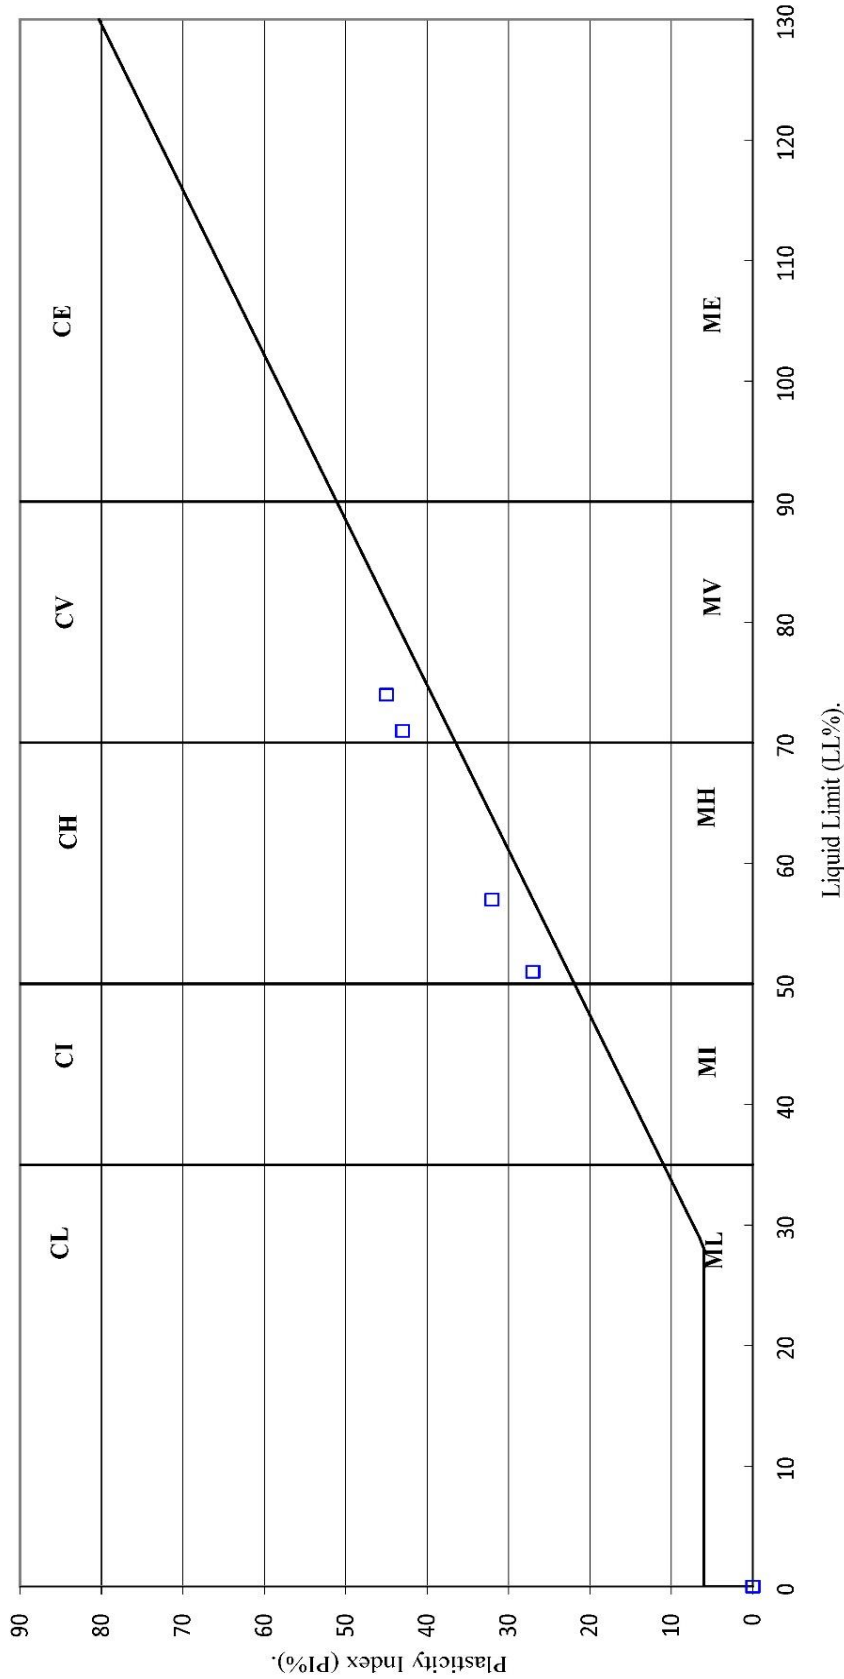
## PLASTICITY CHART FOR CASAGRANDE CLASSIFICATION.

Hole Number	Sample Number	Sample Type	Top Depth m	Base Depth m	Moisture Content % Clause 3.2	Linear Shrinkage % Clause 6.5	Particle Density Mg/m <sup>3</sup> Clause 8.2	Liquid Limit % Clause 4.3/4	Plastic Limit % Clause 5.3	Plasticity Index % Clause 5.4	Passing .425mm %	Remarks
TP/BH1			1.00	1.50	28			74	29	45	100	Very High Plasticity CV
TP/BH1			1.50	2.00	26			71	28	43	100	Very High Plasticity CV
TP/BH1			2.00	2.50	13			57	25	32	100	High Plasticity CH
TP/BH1			2.50	3.00	10			51	24	27	100	High Plasticity CH

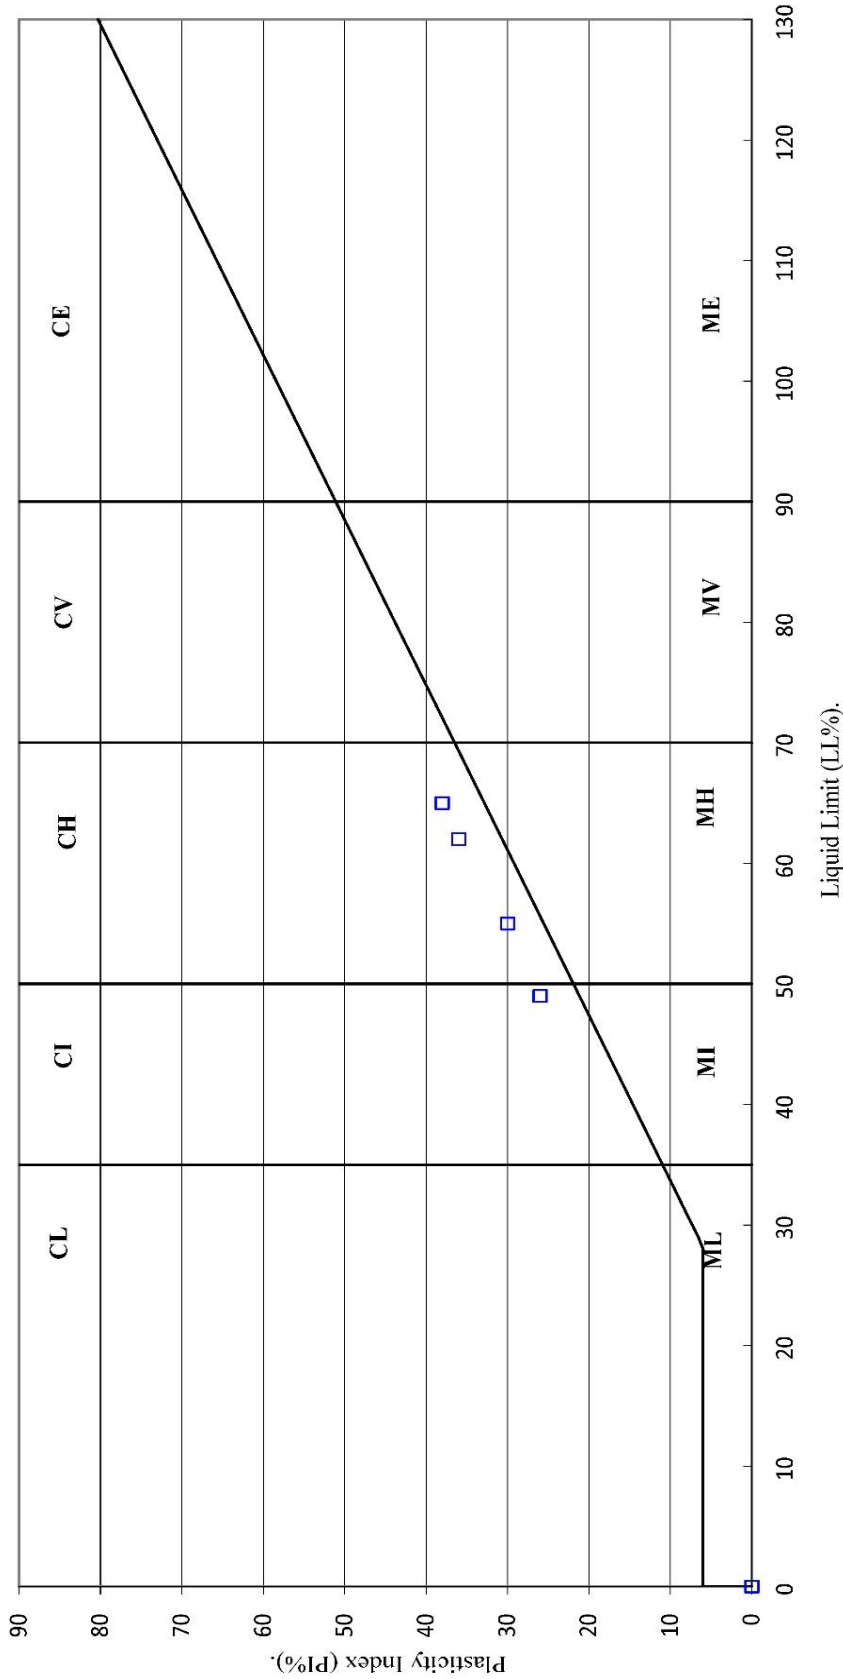
**PLASTICITY CHART FOR CASAGRANDE CLASSIFICATION.**

Hole Number	Sample Number	Sample Type	Top Depth m	Base Depth m	Moisture Content % <small>Clause 3.2</small>	Linear Shrinkage % <small>Clause 6.5</small>	Particle Density Mg/m <sup>3</sup> <small>Clause 8.2</small>	Liquid Limit % <small>Clause 4.3/4</small>	Plastic Limit % <small>Clause 5.3</small>	Plasticity Index % <small>Clause 5.4</small>	Passing .425mm %	Remarks
TP/BH2			1.00	1.50	21			49	23	26	100	Intermediate Plasticity CI
TP/BH2			1.50	2.00	22			65	27	38	100	High Plasticity CH
TP/BH2			2.00	2.50	36			62	26	36	100	High Plasticity CH
TP/BH2			2.50	3.00	23			55	25	30	100	High Plasticity CH
