**Structural Condition Survey for  
Faccenda Farms Ltd, Lower Farm,  
Hillesden, Buckingham, MK18 4BY**

Ref: 230790-CON-ZZ-ZZ-RP-S-0001

Revision: P01

Date: 26 July 2023

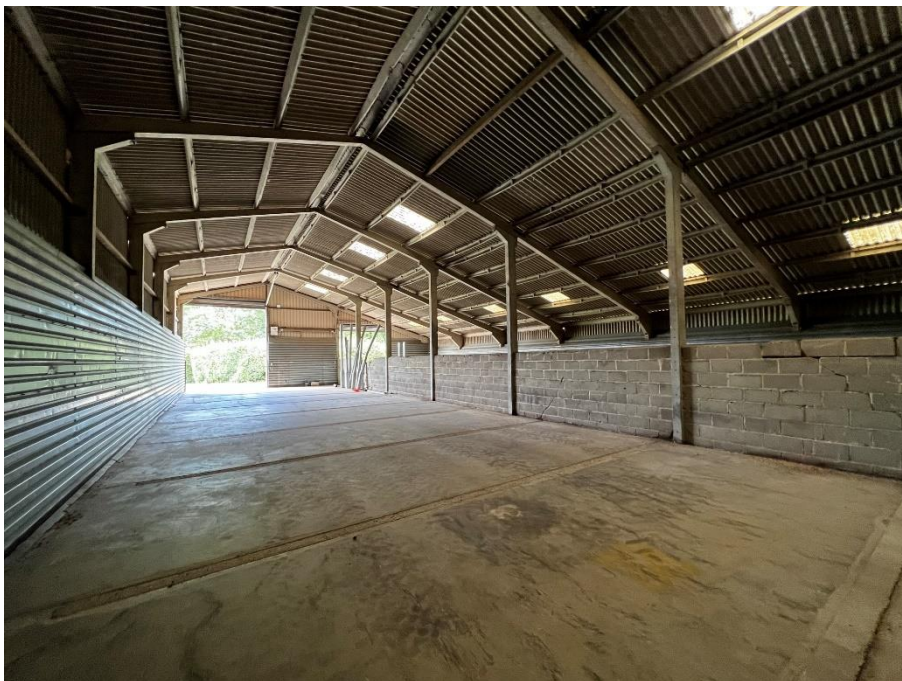
5.13 Corrugated asbestos cement roof sheeting spanning between precast concrete purlins

- 4.4 A Refurbishment & Demolition asbestos survey will be required and potential asbestos containing material removed (refer items 3.1 and 3.4). Replacement roofing materials should be no heavier than the existing, otherwise strengthening might be required of existing roof structure.
