Site Investigation Report

152939.1.1.BSI

Job Summary

Auger were commissioned by to undertake a site investigation and CCTV inspection of the underground drainage within the area of concern (AOC) at the property.

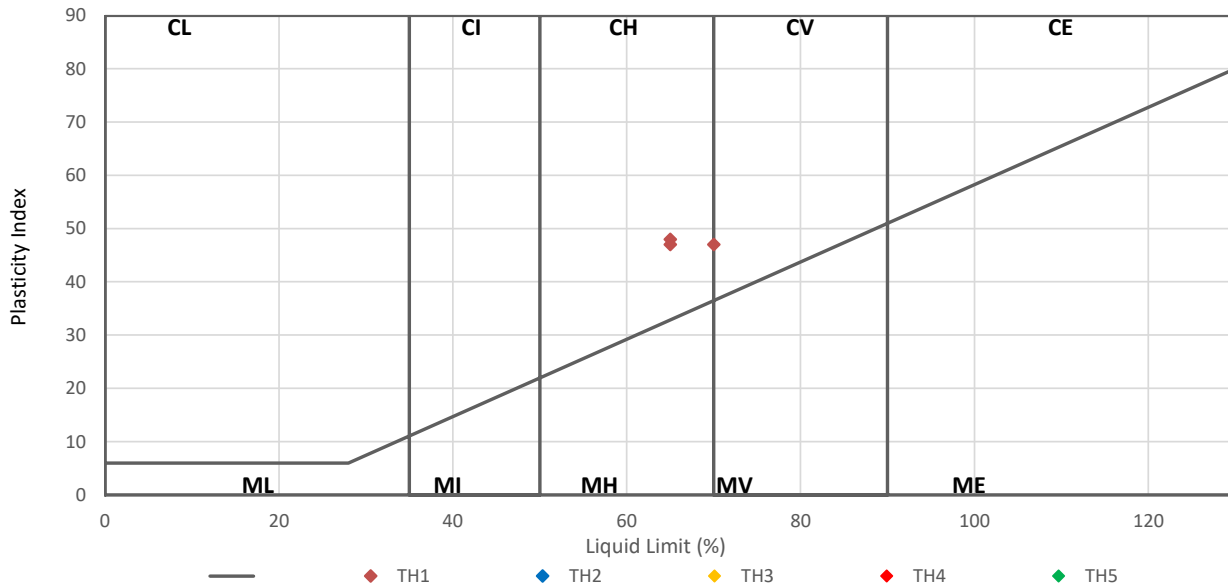
Modified Plasticity Index (PI) <10 : Non Classified
 Modified PI = 10 to <20 : Low volume change potential (LOW VCP)
 Modified PI = 20 to <40 : Medium volume change potential (Med VCP)
 Modified PI = 40 or greater : High volume change potential (HIGH VCP)
