# ARBORICULTURAL ASSESSMENT REPORT

Flat 2 Kenilworth Place, Basildon, SS15 4DQ

PRI Ref: 270358

Survey Date: 25/08/2023

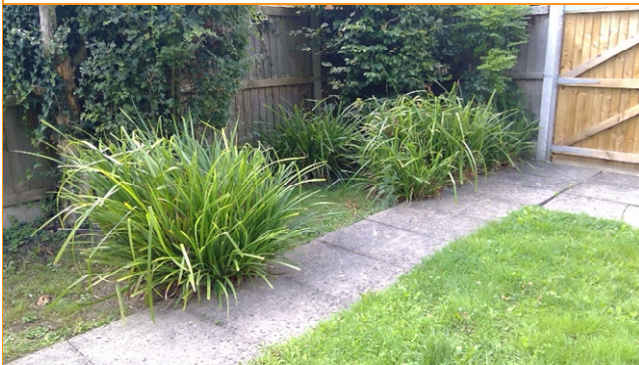
S1 - Pampass Grass

Tree No	Common Name	Age Class	Condition	Height (m)	Crown Spread (m)	Stem diam. (mm)	Dist to bldg. (m)	Roots Implicated	Pruning history	Recommendation	Tree work constraints	Notes	Owner address	Owner
S1	Pampass Grass	Mature	Fair	0.8	1.0	20	3.5	N	No significant past tree works.	No work required.			Flat 2 Kenilworth Place Basildon SS15 4DQ	PH
ST1	Unknown	N/A	DD	1.7	0	0	8.0	N	Subject to past management-felled to 1.7m.	No work required.			Flat 2 Kenilworth Place Basildon SS15 4DQ	PH
T1	Ash (Common)	Young	Fair	2.2	1.0	40	3.3	N	Subject to past management. No significant recent management.	No work required.			Flat 2 Kenilworth Place Basildon SS15 4DQ	PH
T2	Hawthorn	Early Mature	Fair	4.6	1.8	125	7.35	N	Subject to past management. No significant recent management.	No work required.			Flat 2 Kenilworth Place Basildon SS15 4DQ	PH

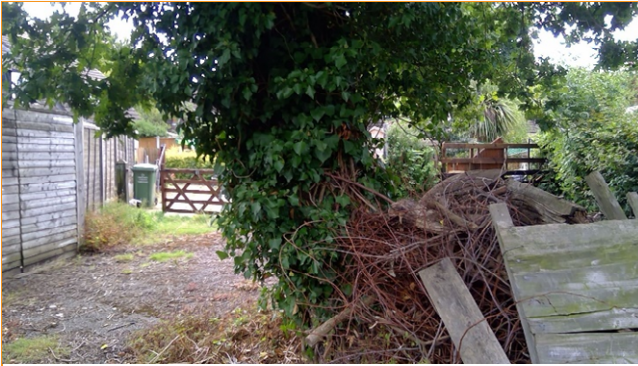
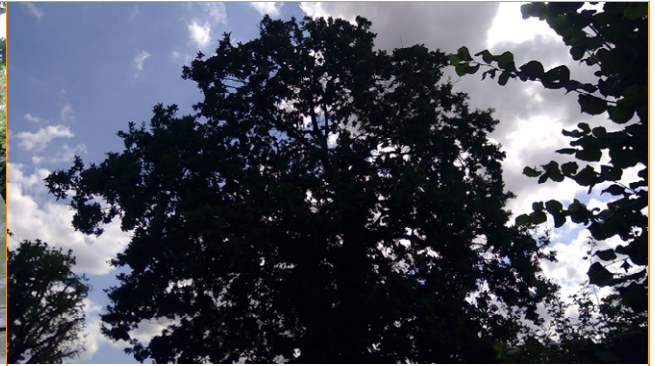
T3 - Oak (English)

Tree No	Common Name	Age Class	Condition	Height (m)	Crown Spread (m)	Stem diam. (mm)	Dist to bldg. (m)	Roots Implicated	Pruning history	Recommendation	Tree work constraints	Notes	Owner address	Owner
T3	Oak (English)	Mature	Fair	11.5	10.0	540*	18.76	N	Subject to past management. No significant recent management.	No work required.		Ivy clad stem to 8.0m.	Basildon Council	LA
T4	Oak (English)	Mature	Fair	14.0	14.2	390*	16.38	Y	No significant past tree works.	Fell and treat stump with eco plugs (broadleaved).	Access through side/rear gate. Obstructions sheds/greenhouses.		58 Kenilworth Place Basildon SS15 4DQ	P3P
T5	Oak (English)	Mature	Fair	13.5	14.0	420*	17.1	Y	Subject to past management-reduced over the rear side.	Fell and treat stump with eco plugs (broadleaved).	Access through side/rear gate. Obstructions sheds/greenhouses.		58 Kenilworth Place Basildon SS15 4DQ	P3P
T6	Oak (English)	Early Mature	Fair	11.0	8.0*	300*	17.58	Y	Subject to past management. No significant recent management.	Fell and treat stump with eco plugs (broadleaved).	Access through side/rear gate.		58 Kenilworth Place Basildon SS15 4DQ	P3P

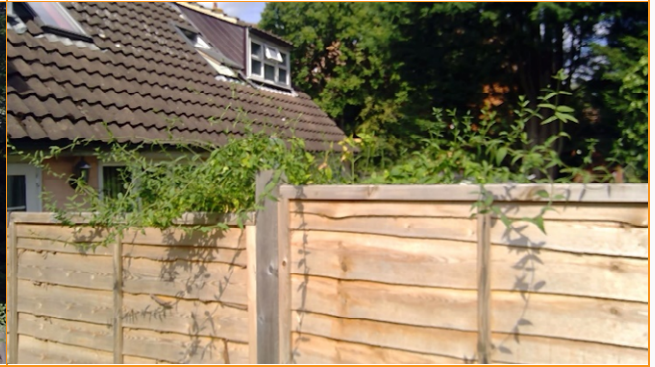
C1 - Jasmine

Tree No	Common Name	Age Class	Condition	Height (m)	Crown Spread (m)	Stem diam. (mm)	Dist to bldg. (m)	Roots Implicated	Pruning history	Recommendation	Tree work constraints	Notes	Owner address	Owner
C1	Jasmine	Early Mature	Fair	2.0	1.2	20*	4.14	N	No significant past tree works.	No work required.			58 Kenilworth Place Basildon SS15 4DQ	P3P
H1	Hornbeam	Mature	Fair	3.4	1.8	140	3.3	N	Managed as a hedge.	No work required.			Flat 2 Kenilworth Place Basildon SS15 4DQ	PH
HG1	Mixed species hedge	Mature	Fair	5.2	3.0*	85*	6.8	N	No significant past tree works.	No work required.		Includes Hazel, Hornbeam, Ash, Hawthorn and Bramble within hedge.	54 Kenilworth Place Basildon SS15 4DQ	P3P
HG2	Mixed species hedge	Mature	Fair	3.6	3.0	300	13.0	N	Subject to past management-topped to 2.2m	No work required.		Includes Hornbeam and Hawthorn within hedge.	Basildon Council	LA
