HISTORIC BUILDING IMPACT ASSESSMENT

HORSESHOE HOUSE,

WOOTTON, OXFORDSHIRE

NOVEMBER 2023

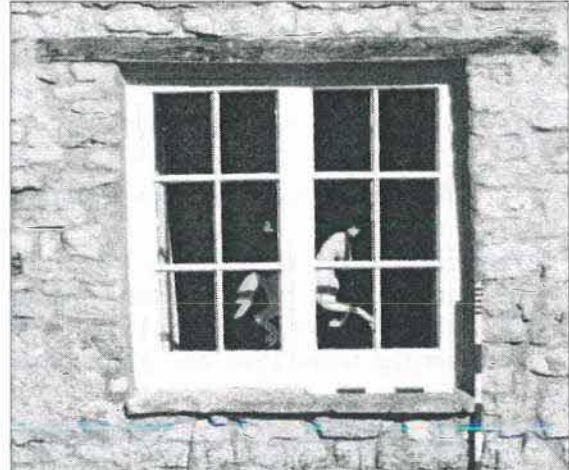
Window 2

A 20th century window. The two lights sit within an undecorated surround. Each light has ovolo and fillet moulded glazing bars c.21mm in thickness. The casement has a spiral catch and stay, both of historic design though most probably later replacements.

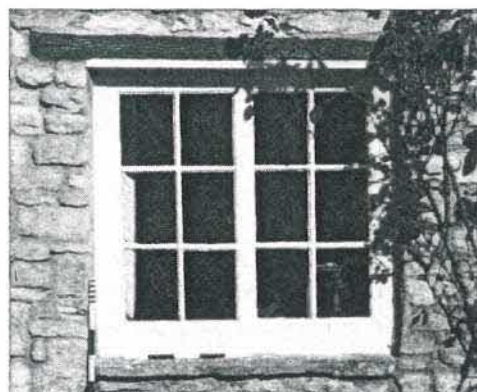
Plate 4: Window 3

A probable 19th century window. Internally the window sits within a surround that has a simple beaded moulding. The window has thin ovolo and fillet moulded glazing bars (c.18mm in thickness), and is fitted with a spiral cockspur catch, and a simple hook stay. The hook stay is of probable late 19th century date and is likely to be contemporary with the window (Hall 2005, p.91), though the latch is a later 20th century replacement.

Removal and replacement of existing window	Window 3	Moderate to High	Substantial	The window dates to the 19 th or early 20 th century and is of moderate to high historic value. Panes of historic glass remain extant and the latch is likely to be an original feature. Removal would result in substantial impact to the window, removing the significance it embodies.
Removal and replacement of existing window	Window 4	Low	Substantial	The window is a 20 th century replacement of low historic value; it does not contribute substantially to the overall significance of the building, though does demonstrate its ongoing development. Removal would result in substantial impact to the window, removing any significance it holds (which is minimal in relation to the overall significance of the building).
Removal and replacement of existing window	Window 5	Low	Substantial	The window is a 20 th century replacement of low historic value; it does not contribute substantially to the overall significance of the building, though does demonstrate its ongoing development. Removal would result in substantial impact to the window, removing any significance it holds (which is minimal in relation to the overall significance of the building).

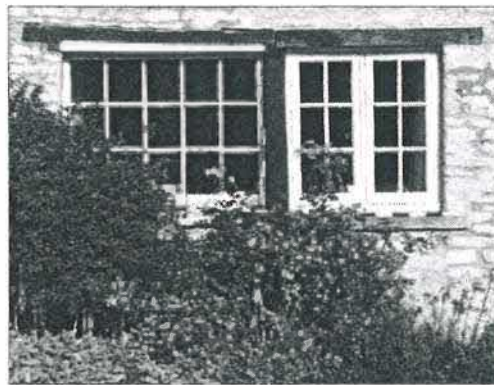
A 20th century window. Two side-hung casements that are separated by a plain wooden mullion and sit within an undecorated surround; each light has two panes over three. The right hand window (as viewed from the interior) is the same as Windows 1, 2 and 5, while the left hand is the same as Window 4; both have ovolo and fillet moulded glazing bars c.21mm in thickness. Both lights have modern: spiral catches and thumb screw casement stays.

Removal and replacement	Window 6	Low	Substantial	The window is a 20 th century replacement of low historic value; it

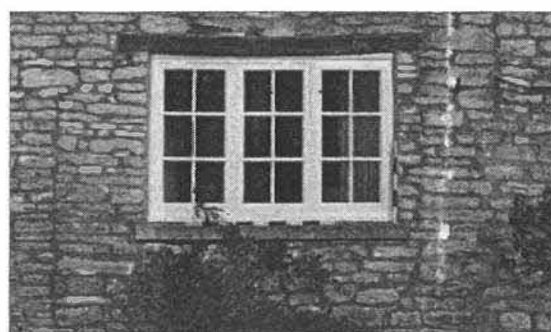
Plate 8: Window 7

A 20th century window. The window comprises three lights; a central side-hung casement of two panes over three flanked by two fixed lights of two panes over three; each light is divided by a plain wooden mullion and sits within an undecorated surround. The window has ovolo and fillet moulded glazing bars c.21mm in thickness. The casement has a modern spiral catch and a thumb screw stay.

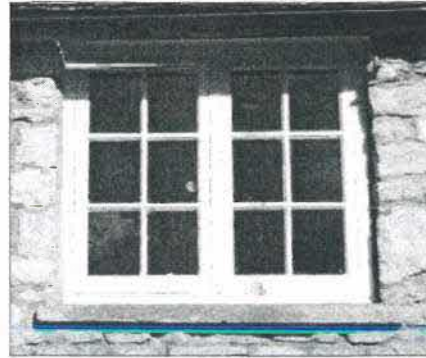
Plate 10: Window 13

A 20th century window similar in form to those seen on the ground floor. A central wooden mullion divides the window into two lights; each light sits within a plain surround. Both lights have ovolo and fillet moulded glazing bars c.21mm in thickness and the casement is fitted with a spiral cockspur catch and spiral stay.

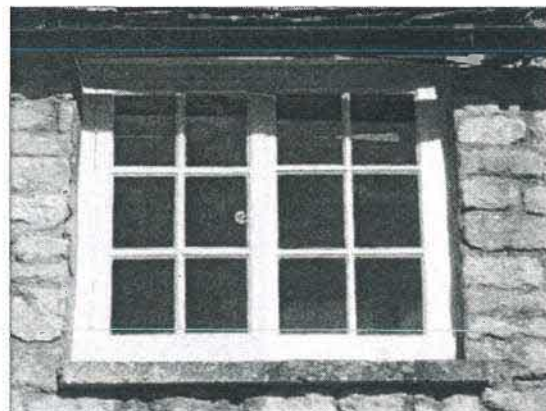
Plate 11: Window 12

This window is of two phases, though both of 20th century date. The casement has ovolo and fillet glazing bars c.20mm in thickness, with a spiral catch and stay. The fixed window has glazing bars c.19mm in thickness, also with ovolo and fillet mouldings. It is possible that the fixed window is a later replacement, as stylistically it matches ground floor windows 4 and 7. Both lights sit within a simple moulded frame.

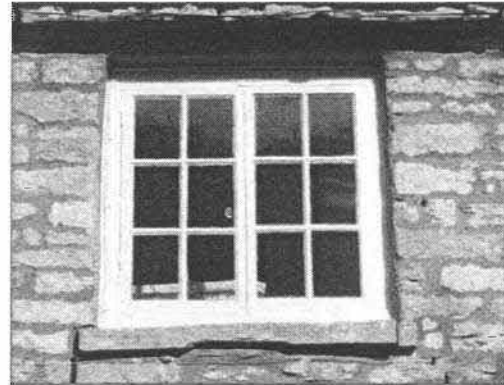
Plate 13: Window 11

Window 11 lights a bathroom. The window sits within an opening topped by a timber lintel and has a dressed stone sill. The window comprises two lights; a left-hand side-hung casement of two panes over three and a fixed light also of two panes over three. Internally the window sits within a moulded frame and is associated with wooden panel shutters of 18th or early 19th century date. The window itself is of probable 19th century date. Both lights have thin ovolo and fillet moulded glazing bars of c.17mm thickness. The fixed light has a beaded moulding on its right hand side. The casement has a modern spiral cockspur latch, and a modern thumb screw stay that matches those seen on a number of ground floor windows.

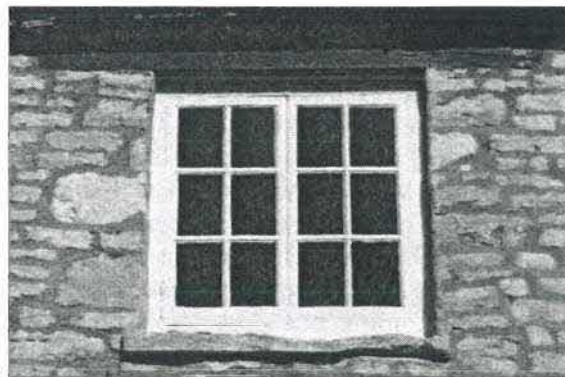
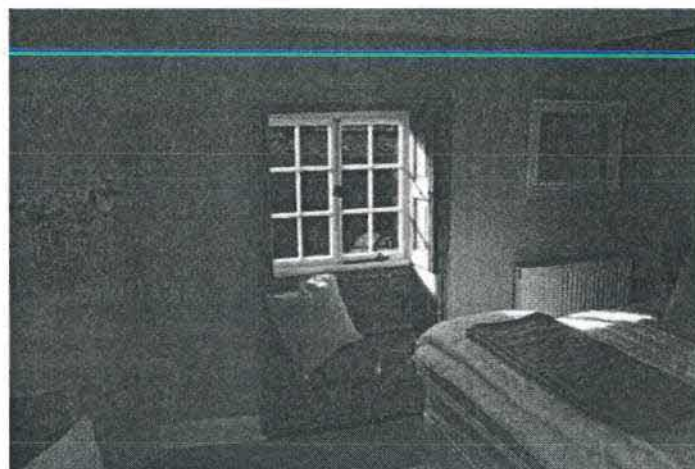
Plate 16: Window 10 within bedroom

The window itself is of probable 19th century date. Both lights have thin ovolo and fillet moulded glazing bars of c.16-17mm thickness. The mullion of the fixed light has a beaded moulding on its right hand side. The casement has a brass latch, with a replacement thumb screw stay that matches those seen on a number of ground floor windows; both are modern additions.

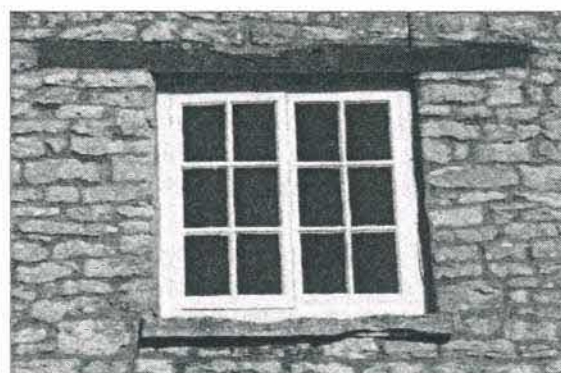
Plate 17: Window 9

Window 9 also lights a bedroom. The window sits within an opening topped by a timber lintel and has a dressed stone sill. The window comprises two lights; a left-hand side-hung casement of two panes over three and a fixed light of two panes over three. Internally the window sits within a moulded frame, over a stone window seat. The window is of probable 19th century date. Both lights have thin ovolo and fillet glazing bars of c.16-17mm thickness. The fixed light has a beaded moulding on its right hand side. The casement has a spiral latch, with a replacement thumb screw stay that matches those seen on a number of ground floor windows.

Removal and replacement of existing window	Window 9	Moderate to High	Substantial	The window dates to the 19 th century and is of moderate to high historic value. Panes of historic glass remain extant, though the fittings have probably been replaced. The similarity with windows 8, and 10 to 11 demonstrates that they are contemporary and therefore represent an identifiable phase in the development of the building. Removal would result in substantial impact to the window, removing the significance it holds
Removal and replacement of existing window	Window 10	Moderate to High	Substantial	The window dates to the 19 th century and is of moderate to high historic value. Panes of historic glass remain extant, though the fittings have probably been replaced. The similarity with windows 8, and 10 to 11 demonstrates that they are contemporary and therefore represent an identifiable phase in the development of the building. The window sits within an historic moulded surround and is associated with interior panelled shutters and a window seat, though these features are likely of an earlier phase. Removal would result in substantial impact to the window, removing the significance it

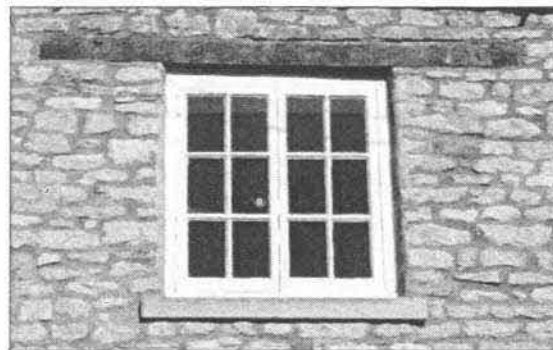
Plate 19: Window 8

Window 8 lights a bedroom. The window sits within an opening topped by a timber lintel and has a dressed stone sill. The window comprises two lights; a left-hand side-hung casement of two panes over three and a fixed light of two panes over three. Internally the window sits within a moulded frame.

This window is also of probable 19th century date, similar in form to those in Bathroom 4 and Bedrooms 3, 4 and 5. Both lights have thin ovolo and fillet moulded glazing bars of c.16-17mm thickness. The fixed light has a beaded moulding on the casement side. The casement has a spiral cockspur catch, with a replacement thumb screw stay that matches those seen on a number of other windows in the building; both are modern replacements.

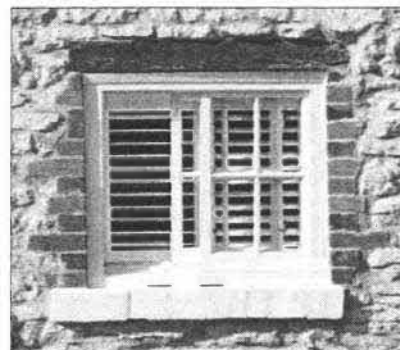
Plate 20: Window 14

Window 14 lights a utility room. The window sits within an opening topped by a timber lintel and has a dressed and painted stone sill; the sides of the aperture are brick. The window is a horizontally sliding sash of two lights, both two panes over two. The ovolo and fillet moulded glazing bars measure c.21mm in thickness and the window has two modern sash fasteners. The window is a mid to late 20th century replacement that sits within a plain frame.

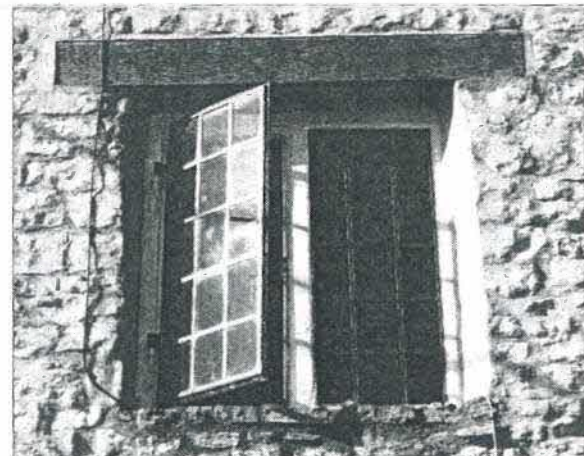
Plate 22: Window 16

Window 16 lights a home office. The window sits within an opening topped by a timber lintel and has a dressed stone sill. Internally the jambs and mullion are moulded. The window has cast iron glazing bars; the casement has horizontal saddle bars, to which the leaded light is hung. The casement is hung on decorative iron pintles and has a turnbuckle catch; analogous examples are dated to the mid-19th century (Hall 2005, p.90). The leaded panes contain plate or crown glass.

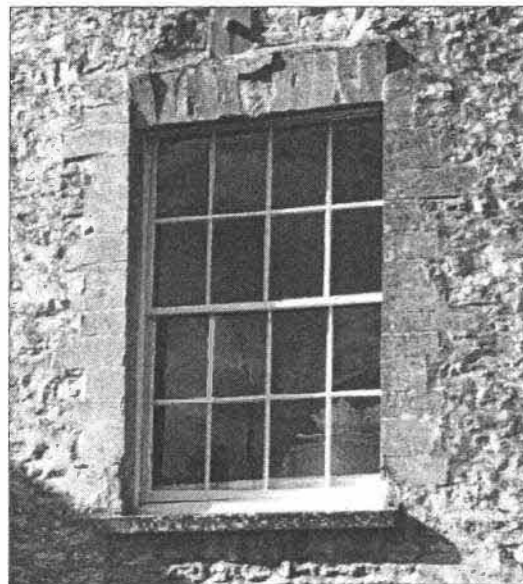
Plate 23: Window 17

Window 17 lights a store room. The window sits within an ashlar-edged opening, topped with a soldier arch, also in ashlar, and has a stone sill. The window is a double hung 19th century sash, most probably contemporary with the extension in which the window is located. The window has a moulded surround with associated shutters, likely contemporary to the window. Each light has thin ovolo and fillet moulded glazing bars c.16/17mm in thickness, with plate glass panes present.

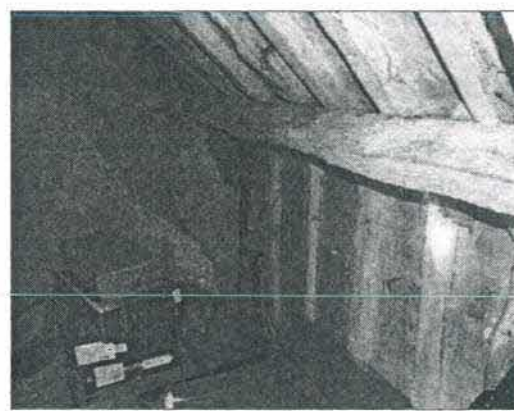
Plate 25: Roof structure in eastern end of the main range

The roof structure of the main range was accessed; this part of the roof comprises three bays formed from two principal rafter trusses, with tenoned purlins; no evidence for collars or tie beams is present. The rafters meet at a ridge plank. Historic timber studwork finished with a lath and plaster finish is present under the eaves; the skelting is also finished in lath and plaster in places, and the stonework of the east and west walls is plastered; both the timbers and plaster is whitewashed. The level of finish in the loft indicates that the room must have been occupied to some extent. In places the plaster has been removed and battens have been added in order to secure modern insulation.

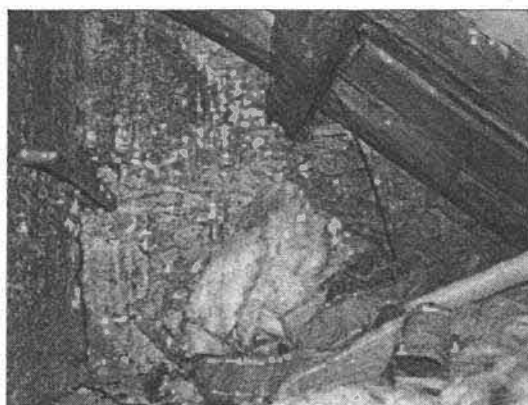
Plate 26: Roof structure of the outshut extension

The roof structure of the single storey extension comprises three bays, formed by a single principal truss with tie beam and raking struts and a stone wall that divides the hallway and western extension. Three rows of tenoned purlins support common rafters. The roof is exposed in the hallway, which is partly open to the roof; the upper part of the roof is obscured though accessible through a hatch. The western wall of the roof space is formed by the 19th century rear extension, which in this location clearly butts against the main range; this appears to be the case at the western end too, though the evidence is less definitive. The roof structure displays a range of re-used and modern timber, suggesting extensive rebuilding or repair.
