CONDITION SURVEY AND DESIGN STATEMENT

ALTERATIONS & EXTENSION TO B LISTED HOUSE

23 Market Street,
St Andrews KY16 9NS

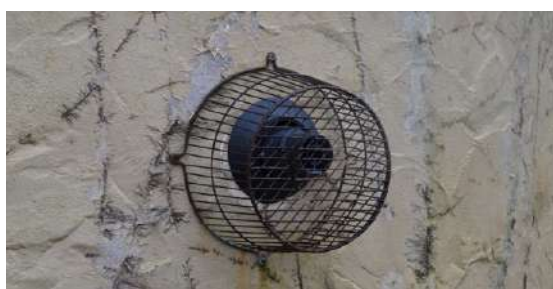
Flue installed as part of the approved application 02/02660/EFULL in 2002.

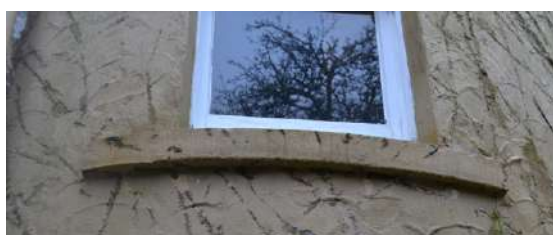
The thickness of the wall denotes a brick cavity construction which is a clear indicator of a later date of erection than the rest of the house, most likely in the 1980s. The turret extension is roofed in slates, following the original pitch of the tiled roof. The extension has been painted in the same colour as the rear extension and the paint has been textured to mimic stone materiality.

Concrete cill on turret extension indicating later construction

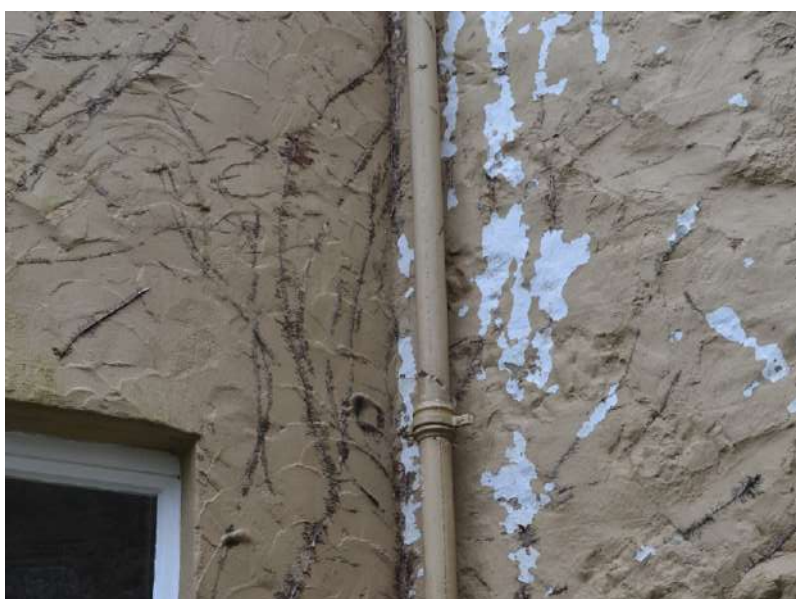
10. Turret Details

Texture difference between painted stone and painted brick of the extension

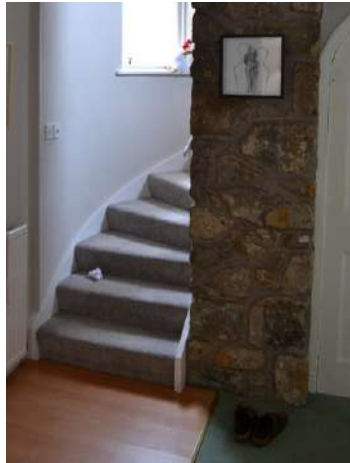
16. Opening in original stone wall to create stairs

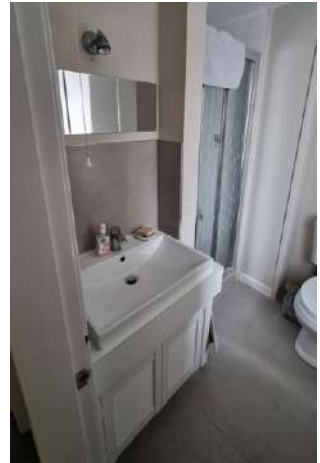
17. Modern alterations to fit shower room

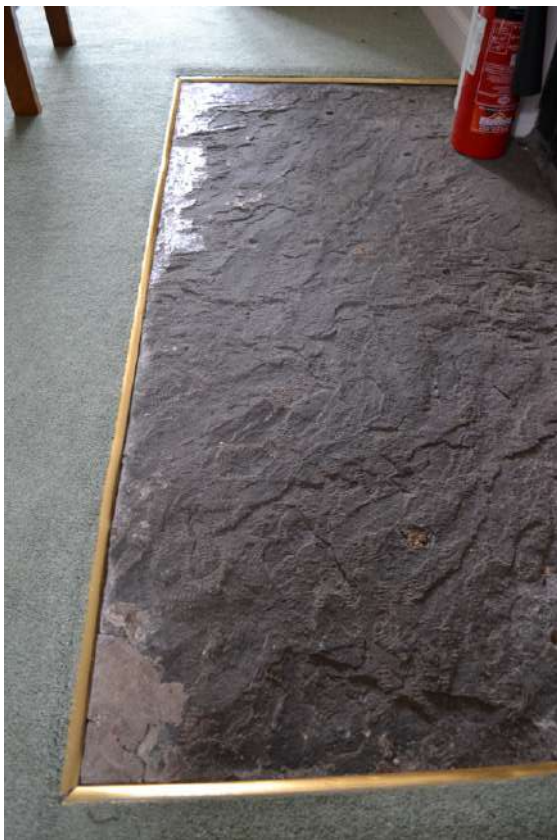
The dining room fireplace is a traditional "Art Nouveau" style cast iron fireplace with tiles on both sides. The surround is a traditional looking painted timber one. The origin and age of the fireplace, tiles and mantel are difficult to ascertain and although in keeping with the character of the house they are not original.

18. Dining Room Fireplace, surround & hearth

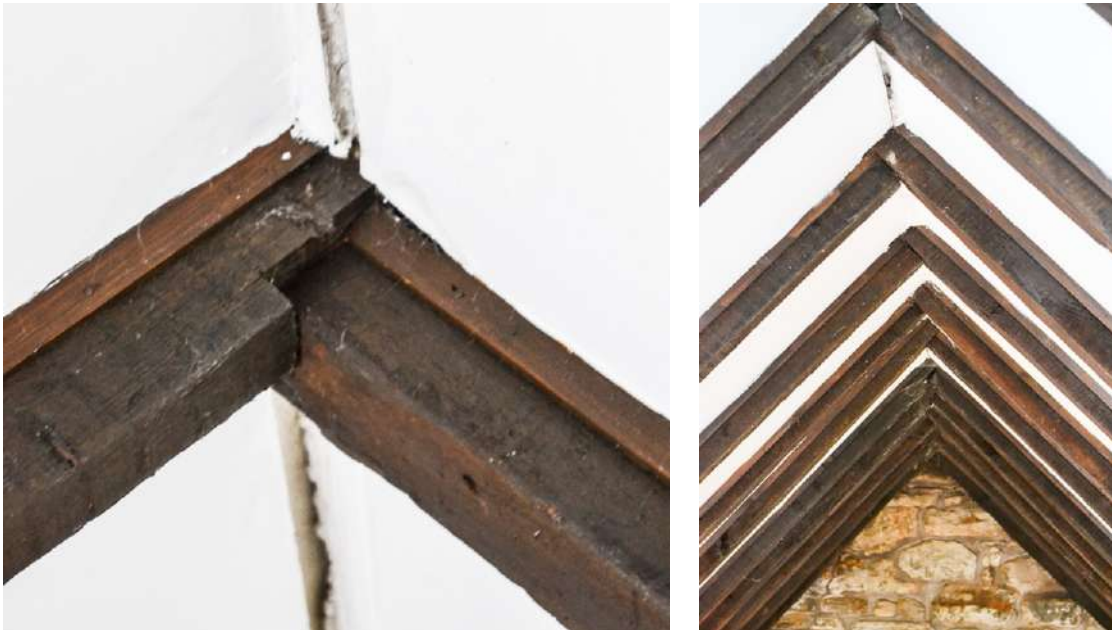
The roof structure are traditional 45° timber rafters with a half lap joint at the ridge level at about 600mm centres. Parts of the rafters are still exposed giving a clear reading of the roof's structure.

26. Timber Framework & Junction Detail

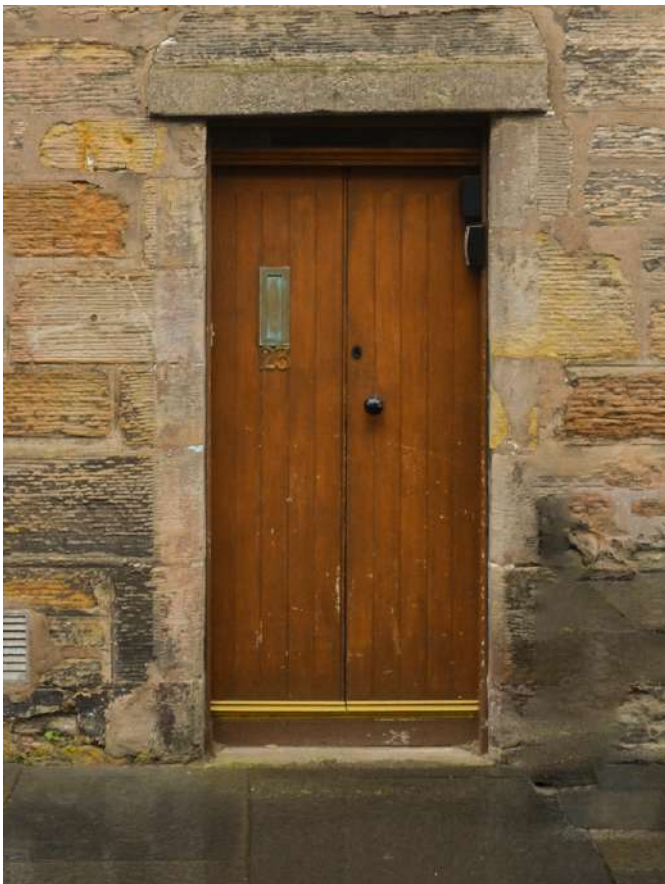
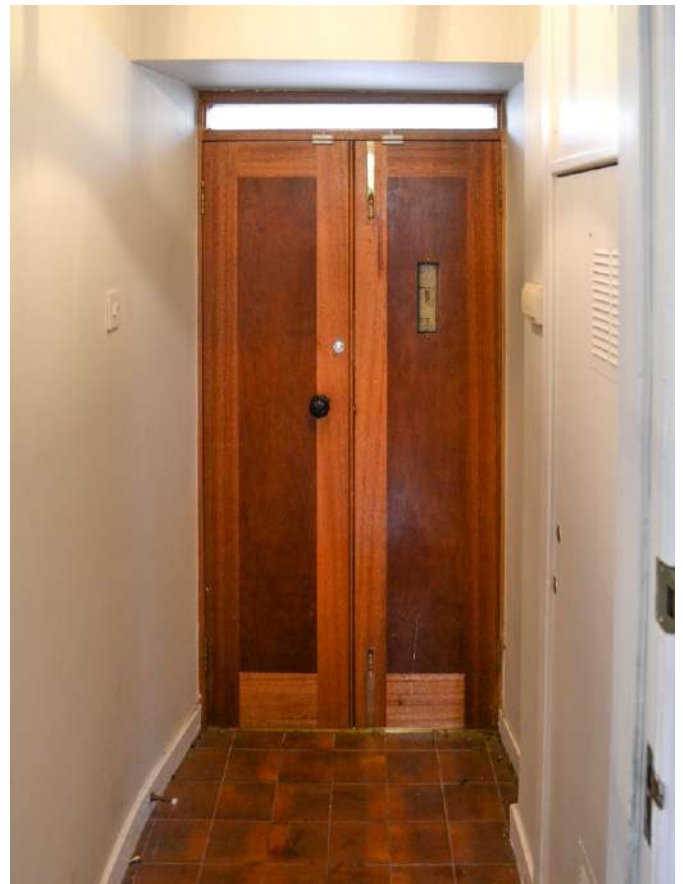
33. Entrance Door - Exterior & Interior

The proposal is to extend the vestibule space, currently narrow and impractical, and does not present any features original to the house. The existing door is to be retained to preserve the external appearance of the property.

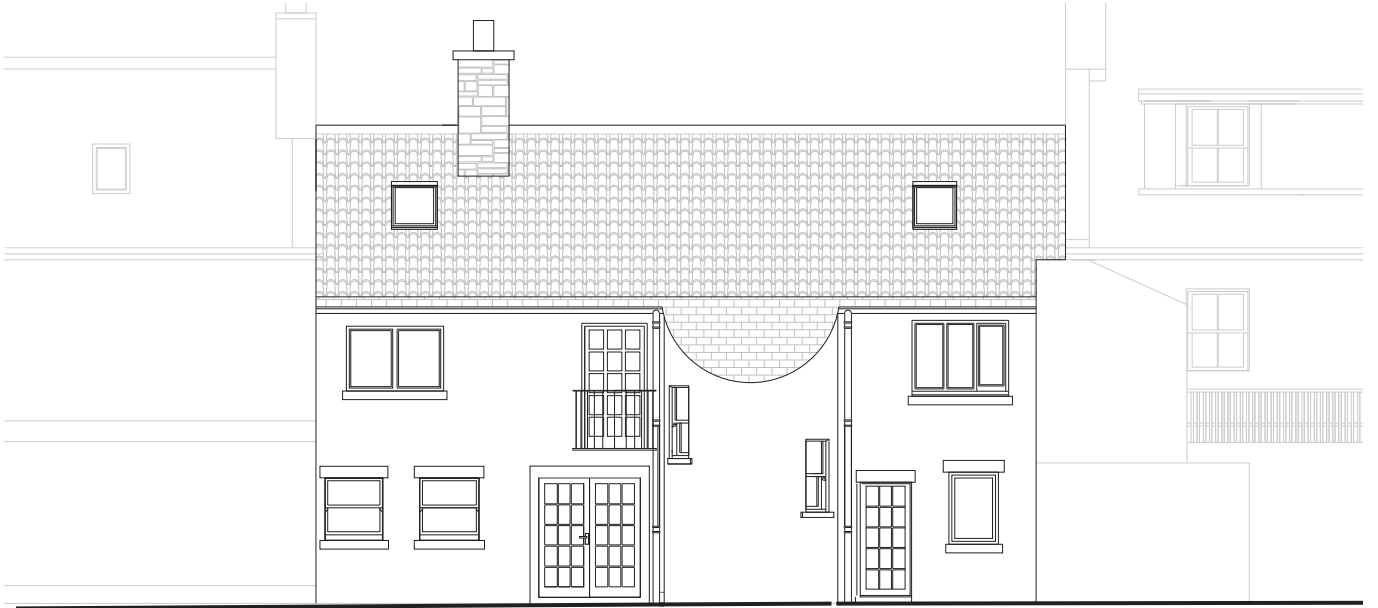
60. Existing Rear Elevation Presenting a wide variety of openings in styles, proportions and detailing. The proportions and styles are at odd with the character and date of construction of the house. There is no consideration for traditional elevation lay-out and geometry

To the north elevation, the non original opening and modern windows of the bedroom are proposed to be replaced with more traditionally proportioned ones to restore the elevation to a more original appearance. The current openings are modern alterations with concrete lintels and jambs, and poor quality brick infill in the stone work. Introducing traditional windows will enhance the north elevation's authenticity and aesthetic appeal by replacing modern, unsightly features with historically fitting elements.

The lounge space is to be retained as existing, including the fireplace and hearth. All the windows to the South elevation on the street are also to be retained. The windows to the rear elevation are proposed to be replaced with more traditionally proportioned and detailed windows to replace the existing modern ones. Those modern additions to the rear elevation are detrimental to the historical aspect of the house, mixing styles and proportions. The proposal will harmonise the existing elevation and restore its historical character.
