Tree Inspection Report

Site: Elm Court, Truro

4 March, 2018

Colin Hawke, BSc, MICFor, FArborA

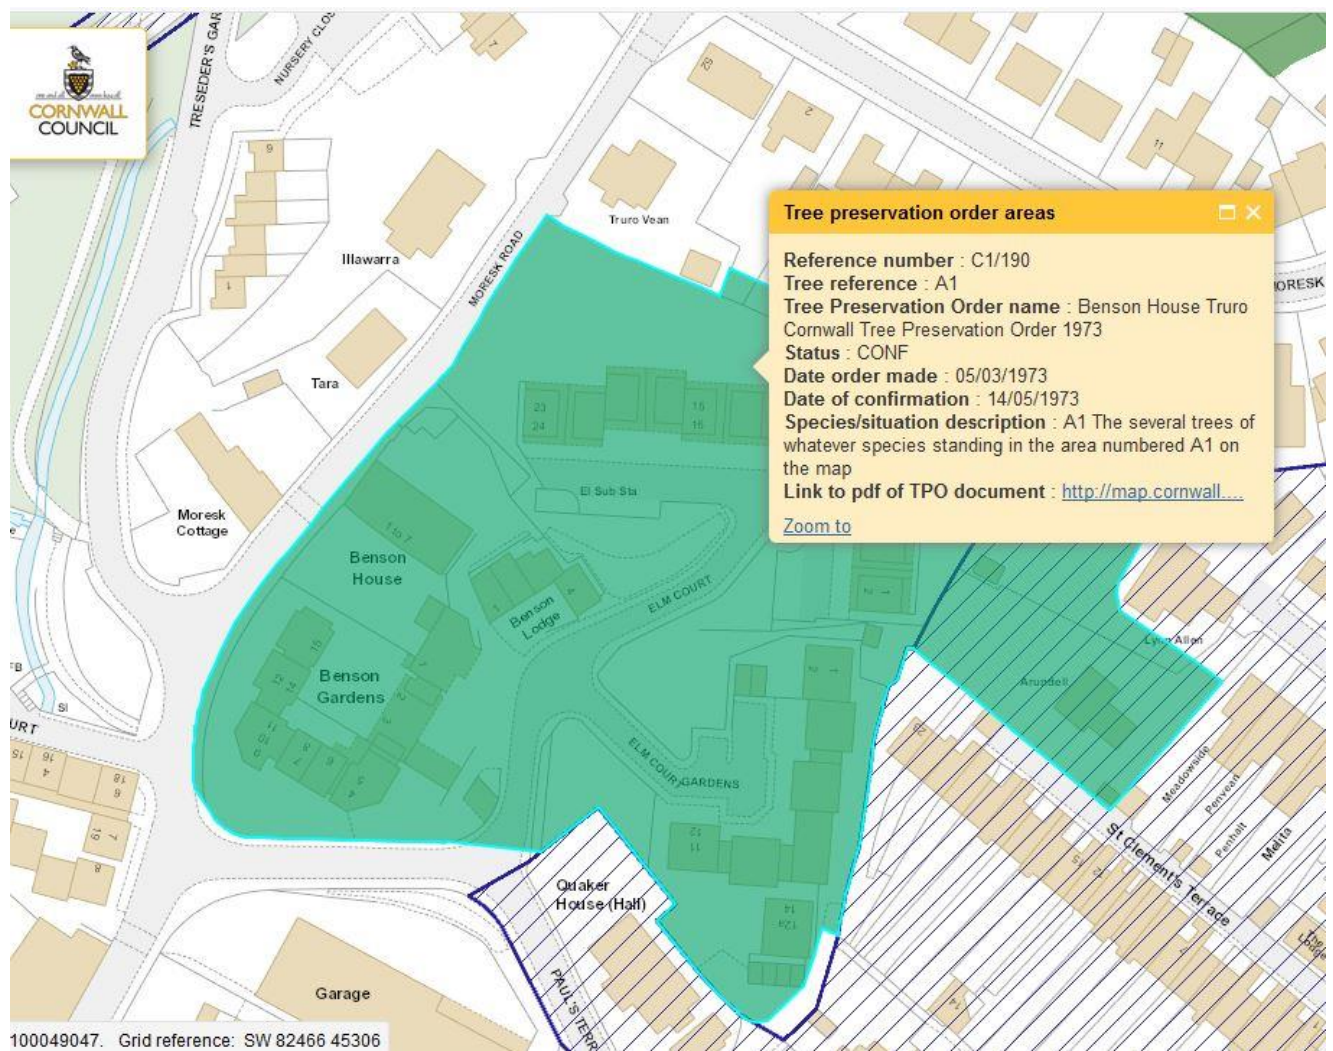
The following extract from the Cornwall Council Interactive Mapping site shows the site is covered by A1 of the Benson House Truro Cornwall Tree Preservation Order 1973. This Order protects all those trees that were growing within this area at the time the Order was made. Thus only those trees over 55 years of age are protected. Ageing trees is not easy and as time goes on it can become increasingly difficult to determine which trees are protected. The onus is on the local authority to demonstrate that any particular tree is protected.

In addition the eastern boundary of the site abuts the Truro Conservation Area which provides additional protection to trees not covered by the Order.

I would suggest that the following trees are covered by the tree preservation order (these are shown in red on the inspection schedule – Appendix 3. See also the site plan):

T1	Copper Beech
T4	Cedar
T7	Sycamore
G9	Sycamore x2
