**Project:** Save The Children Refit, Lymington  
**Prepared By:** JB  
**Present:** JB

**Project No:** 03134  
**Date:** 17<sup>th</sup> March 2023  
**Weather:** Sunny and dry

1. Inspection of first floor joists during refit works due to concern raised about their poor condition.

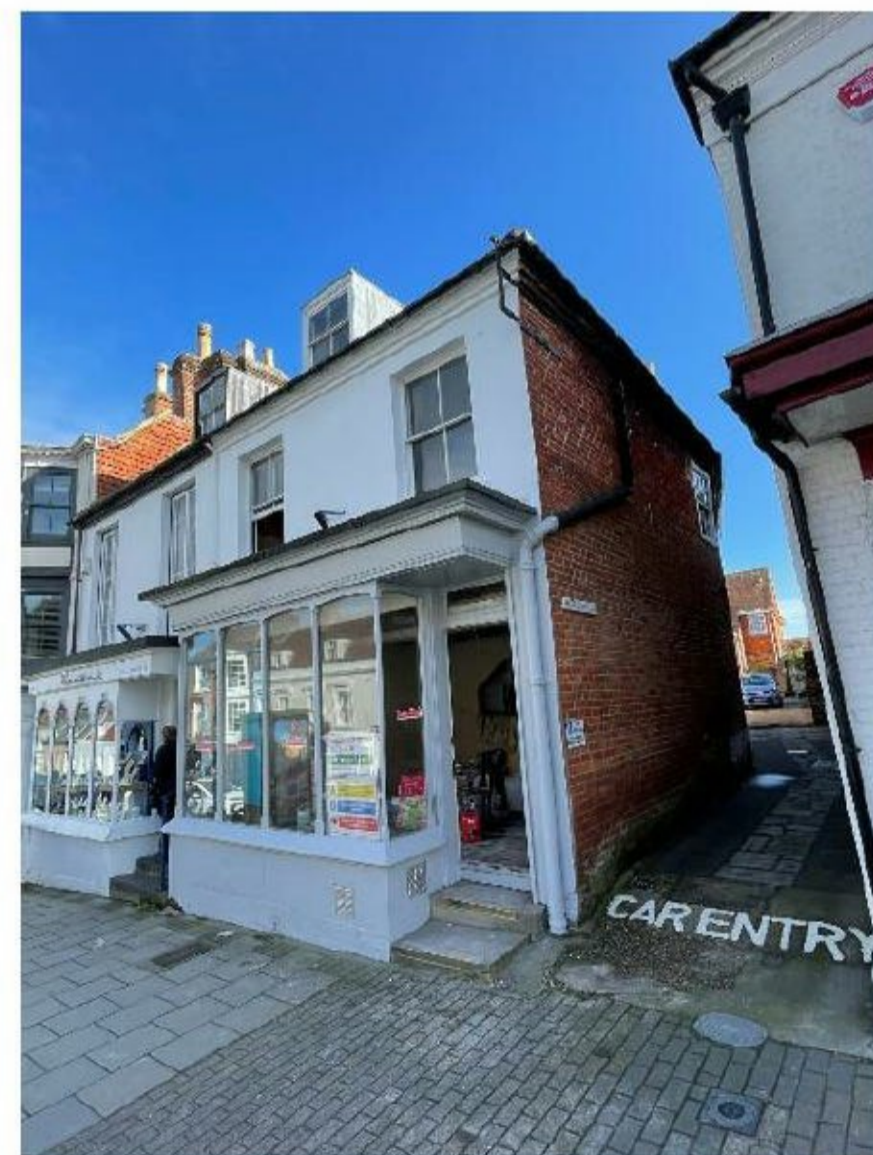
Figure 2 - Street view of 18 High Street

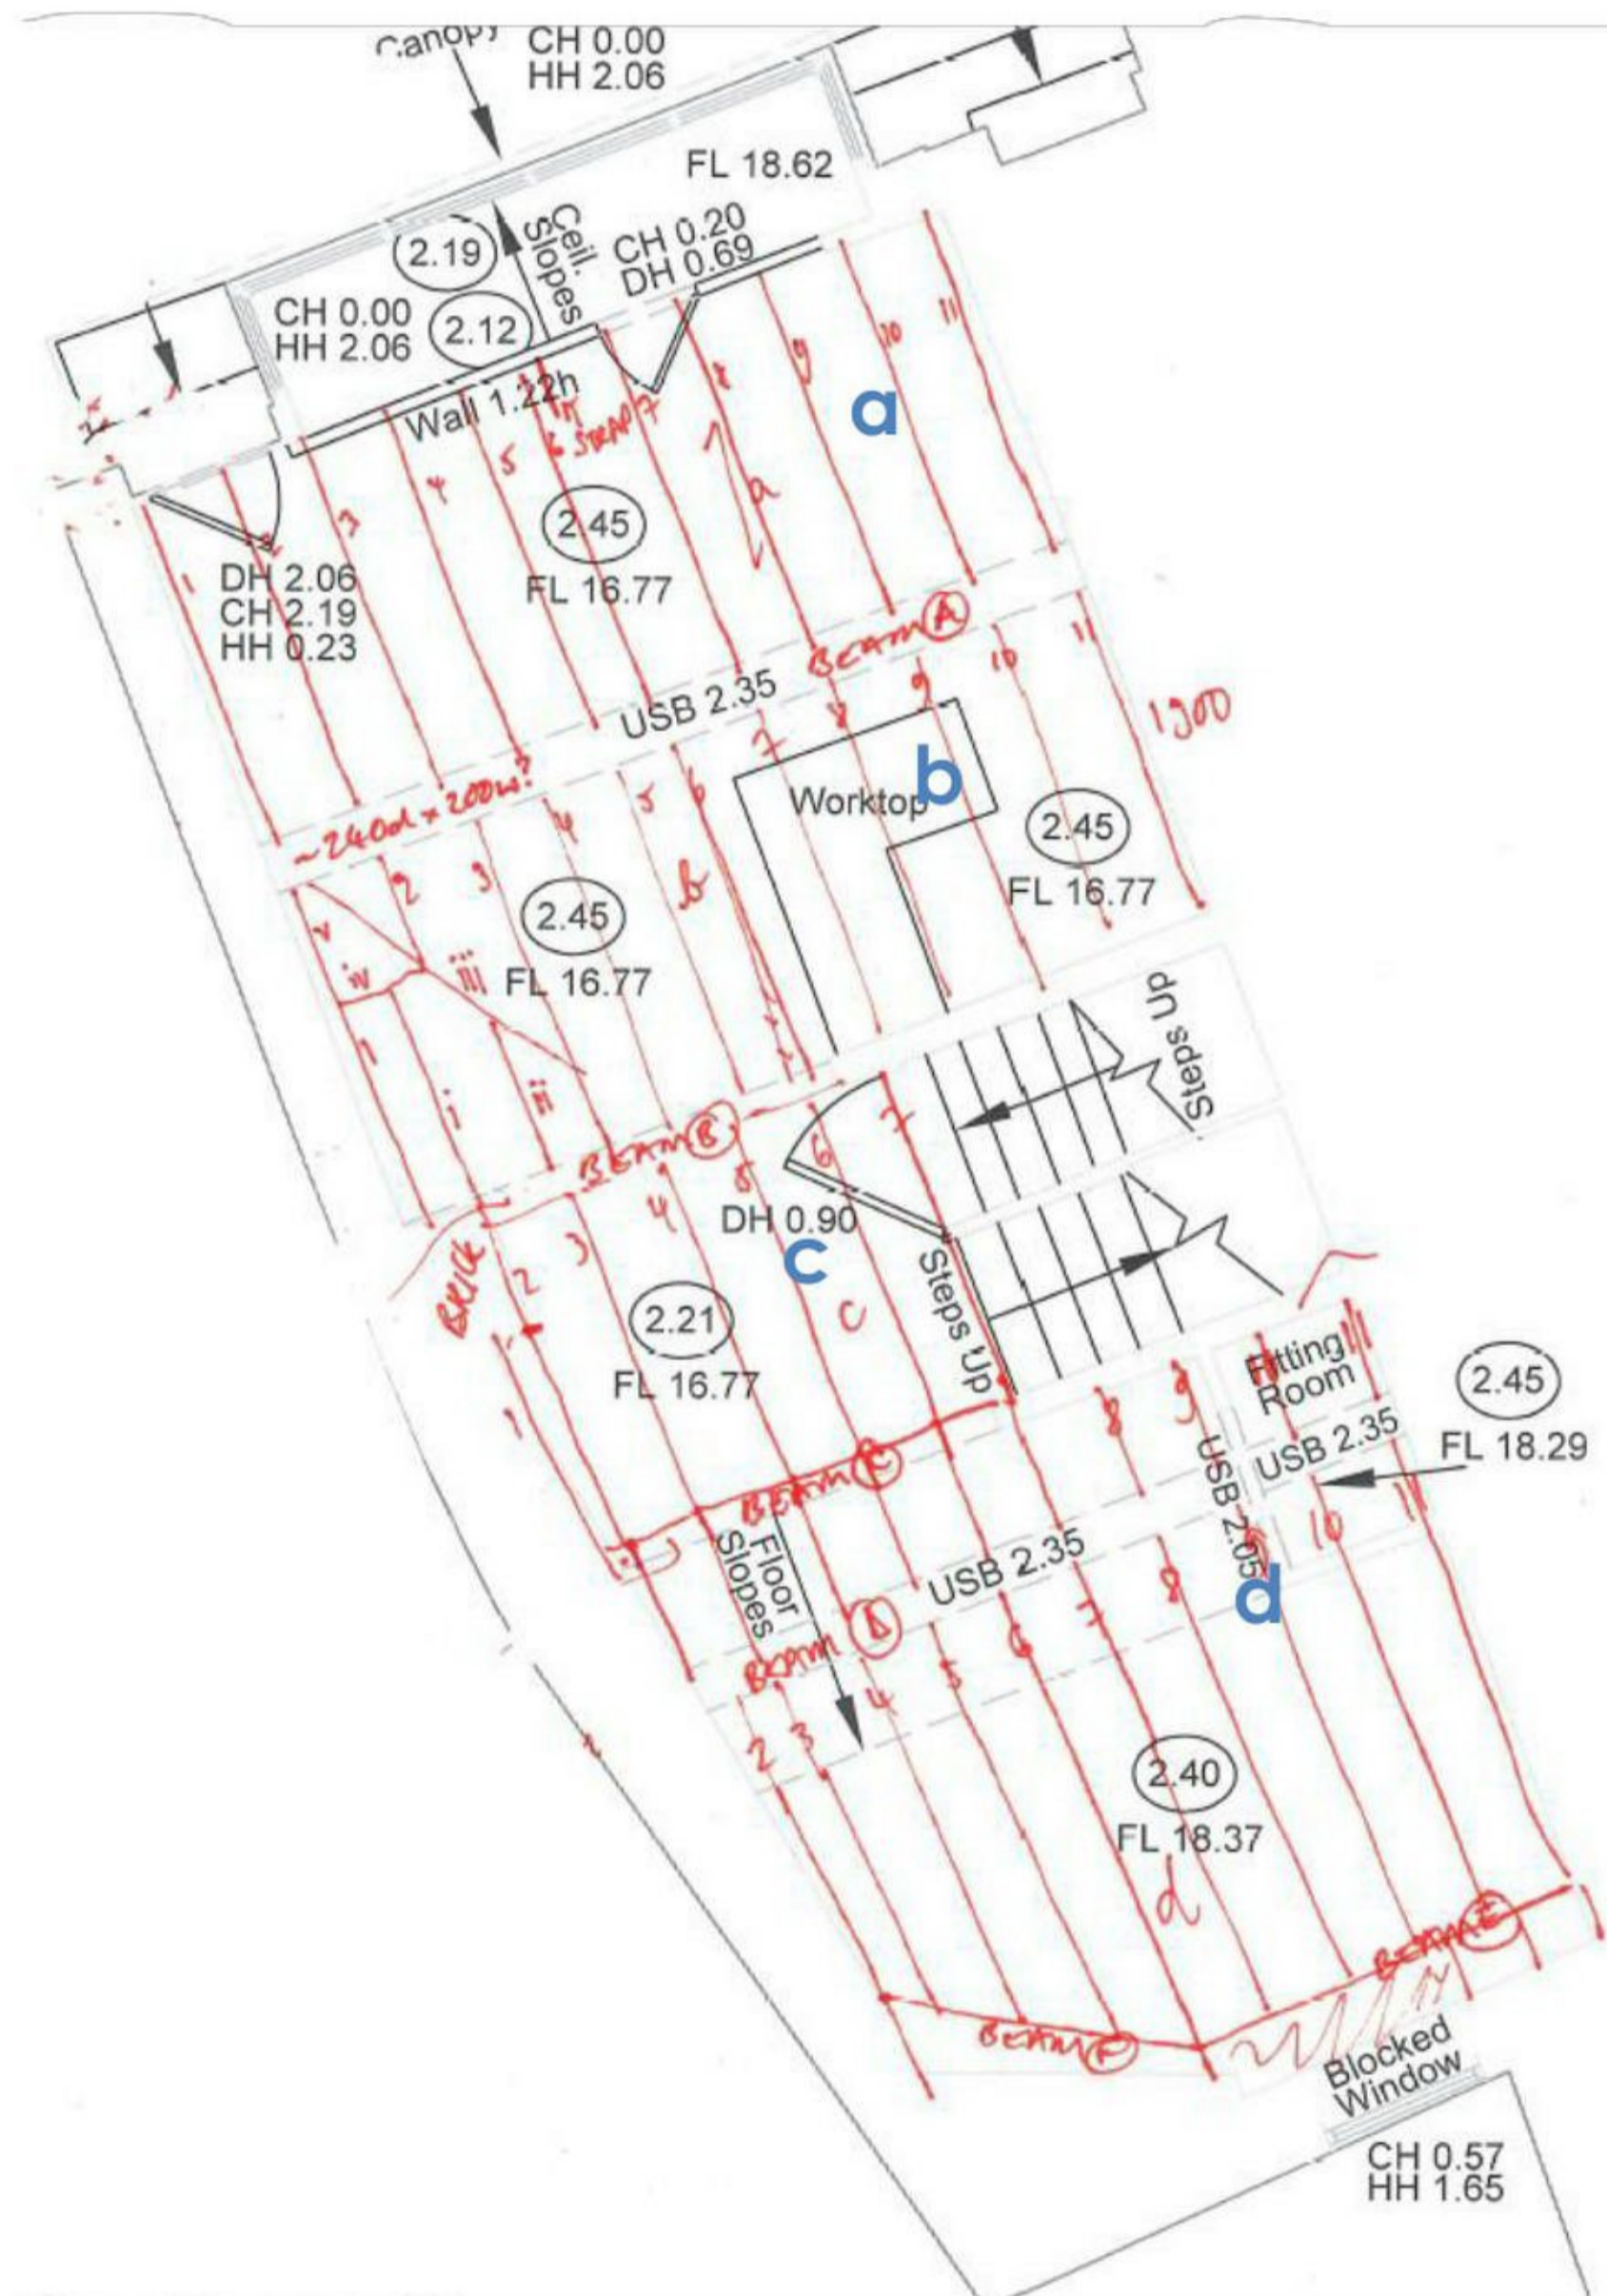
Figure 3 - Ground floor plan showing first floor structure above.  
High Street entrance and north orientation at top of plan

3. Throughout the first floor, the joists typically measure 120mm deep x 75mm wide and are spaced at 430-460mm centres.
4. The joists are typically connected to primary beams with traditional mortice and tenon joints. These may also be pegged from above, but this was not visible due to the boards being in place.
5. At the front of the shop (north end on plan) there must be a significant beam supporting the first floor masonry. The details of the beam were not visible, but the joists here are notched over a more modern timber batten.

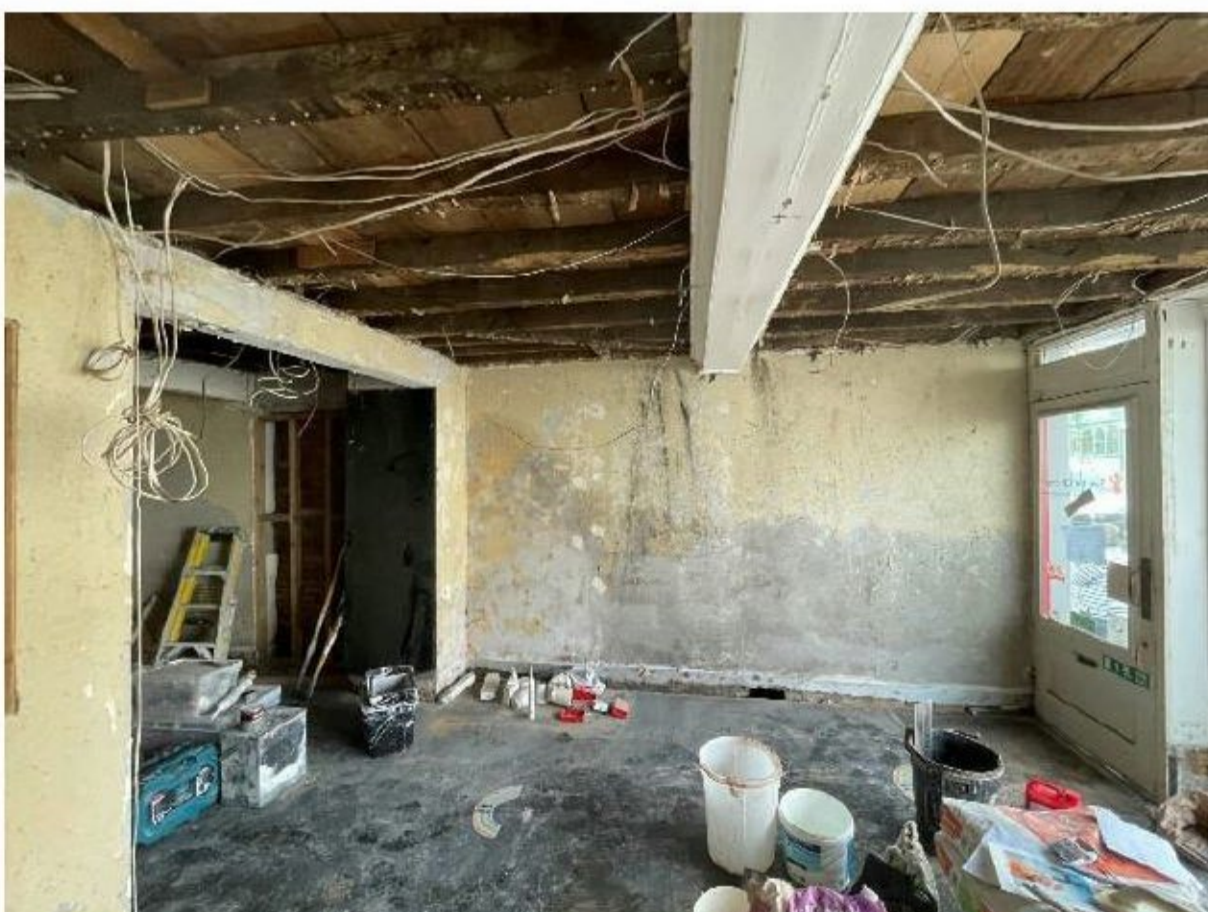
Figure 6 - View looking west of bays a and b

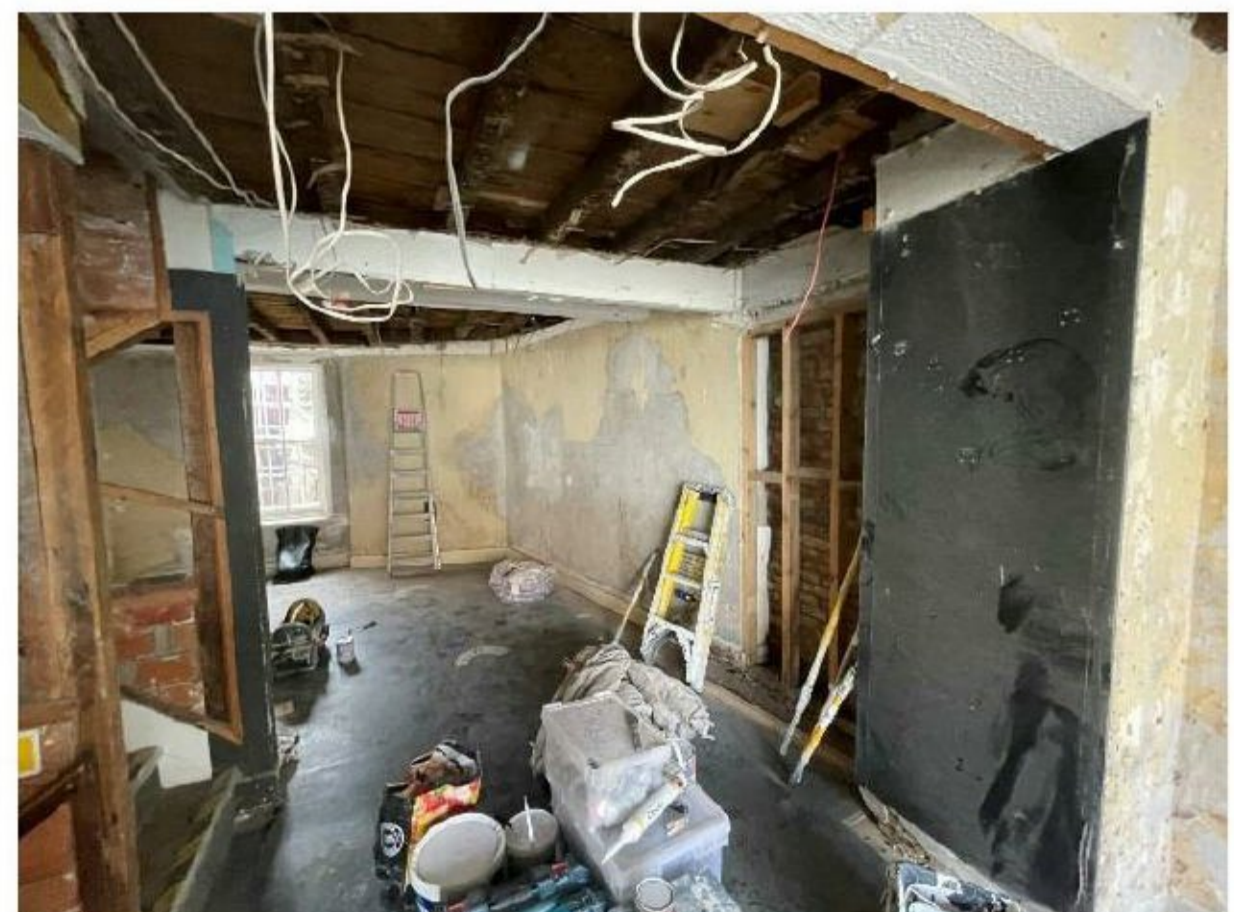
Figure 7 - View looking south of bays c and d

4. Generally, the joist size is acceptable for the span and proposed loading. However, in bay d where the span is longer than the others the joists would be slightly over deflected with the proposed loading. This is not a significant concern as the calculated deflection is less than 10% over the modern design limit, and the stresses applied to the timber are within design limits.

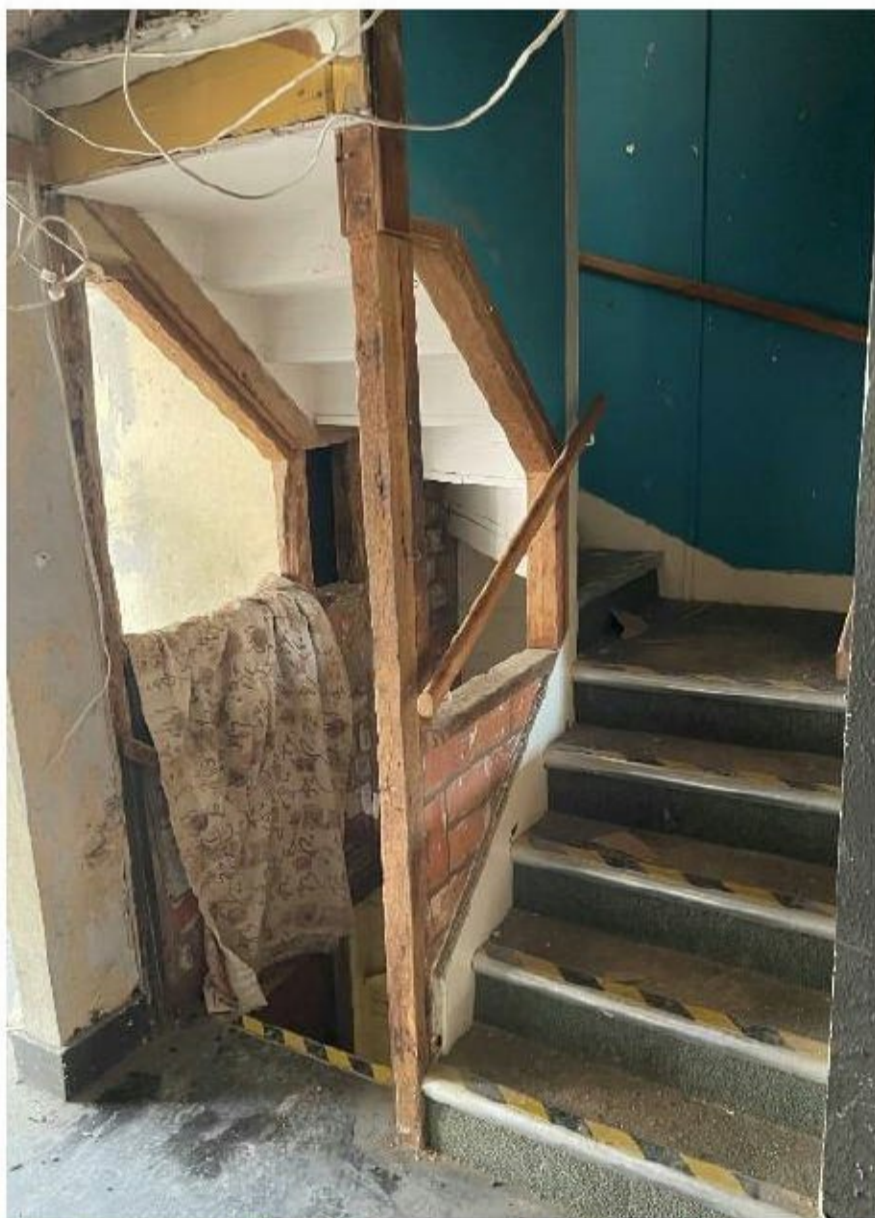
12. The internal walls adjacent to the staircase appear to be timber framed construction with infill of bricks laid on their side. The bricks measure 110mm high x 60 thick x 230 long. The southern wall below the quarter landing has suffered some collapse and will need to be repaired.

Figure 17 – Internal timber frame arrangements around staircase

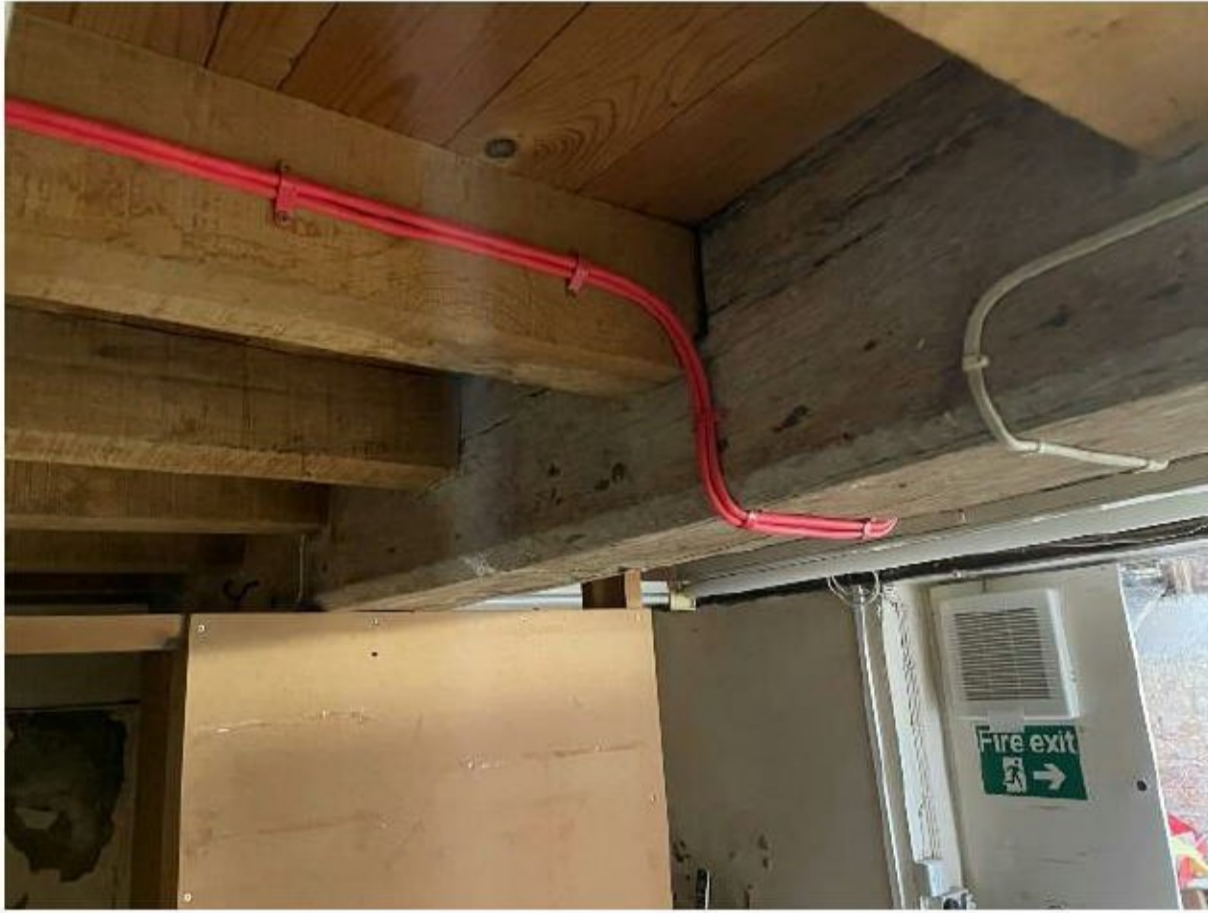
13. The basement was briefly inspected and it was noted that the majority of the ground floor joists had been replaced at some point in the past, with modern 125 x 100 oak joists, traditionally jointed into either original or replacement oak primary beams.

Figure 20 – Basement – modern joists supported on original beam

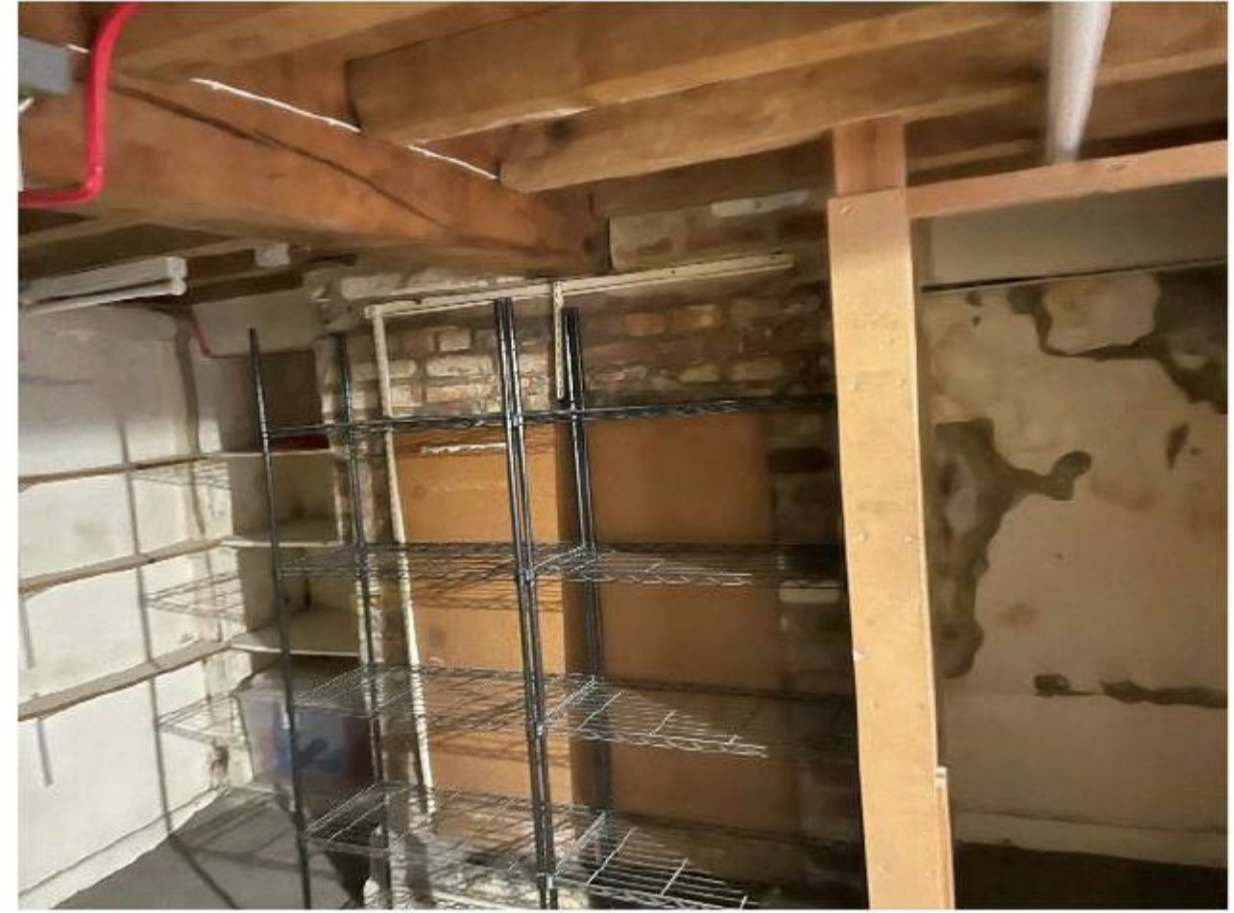
Figure 21 – Basement – modern joists supported on modern beam
