BS5837:2012 Tree Survey  
 Land adjacent to Lutterworth Road  
 Blaby  
 Leicestershire  
 NGR SP56568 96629

Report prepared by: C Barker	Date Issued: 19 July 2021
	Reviewed by: KLB	Report Version: V1
	Report ref: <b>P2129 /0721 /01</b>	C B E Consulting Highbank, 5 Grantham Road, Navenby Lincoln. LN5 0JJ. Telephone (01522) 810086. <a href="http://www.cbeconsulting.co.uk">www.cbeconsulting.co.uk</a>

# BS5837 Tree Survey, Land adjacent to Lutterworth Road, Blaby

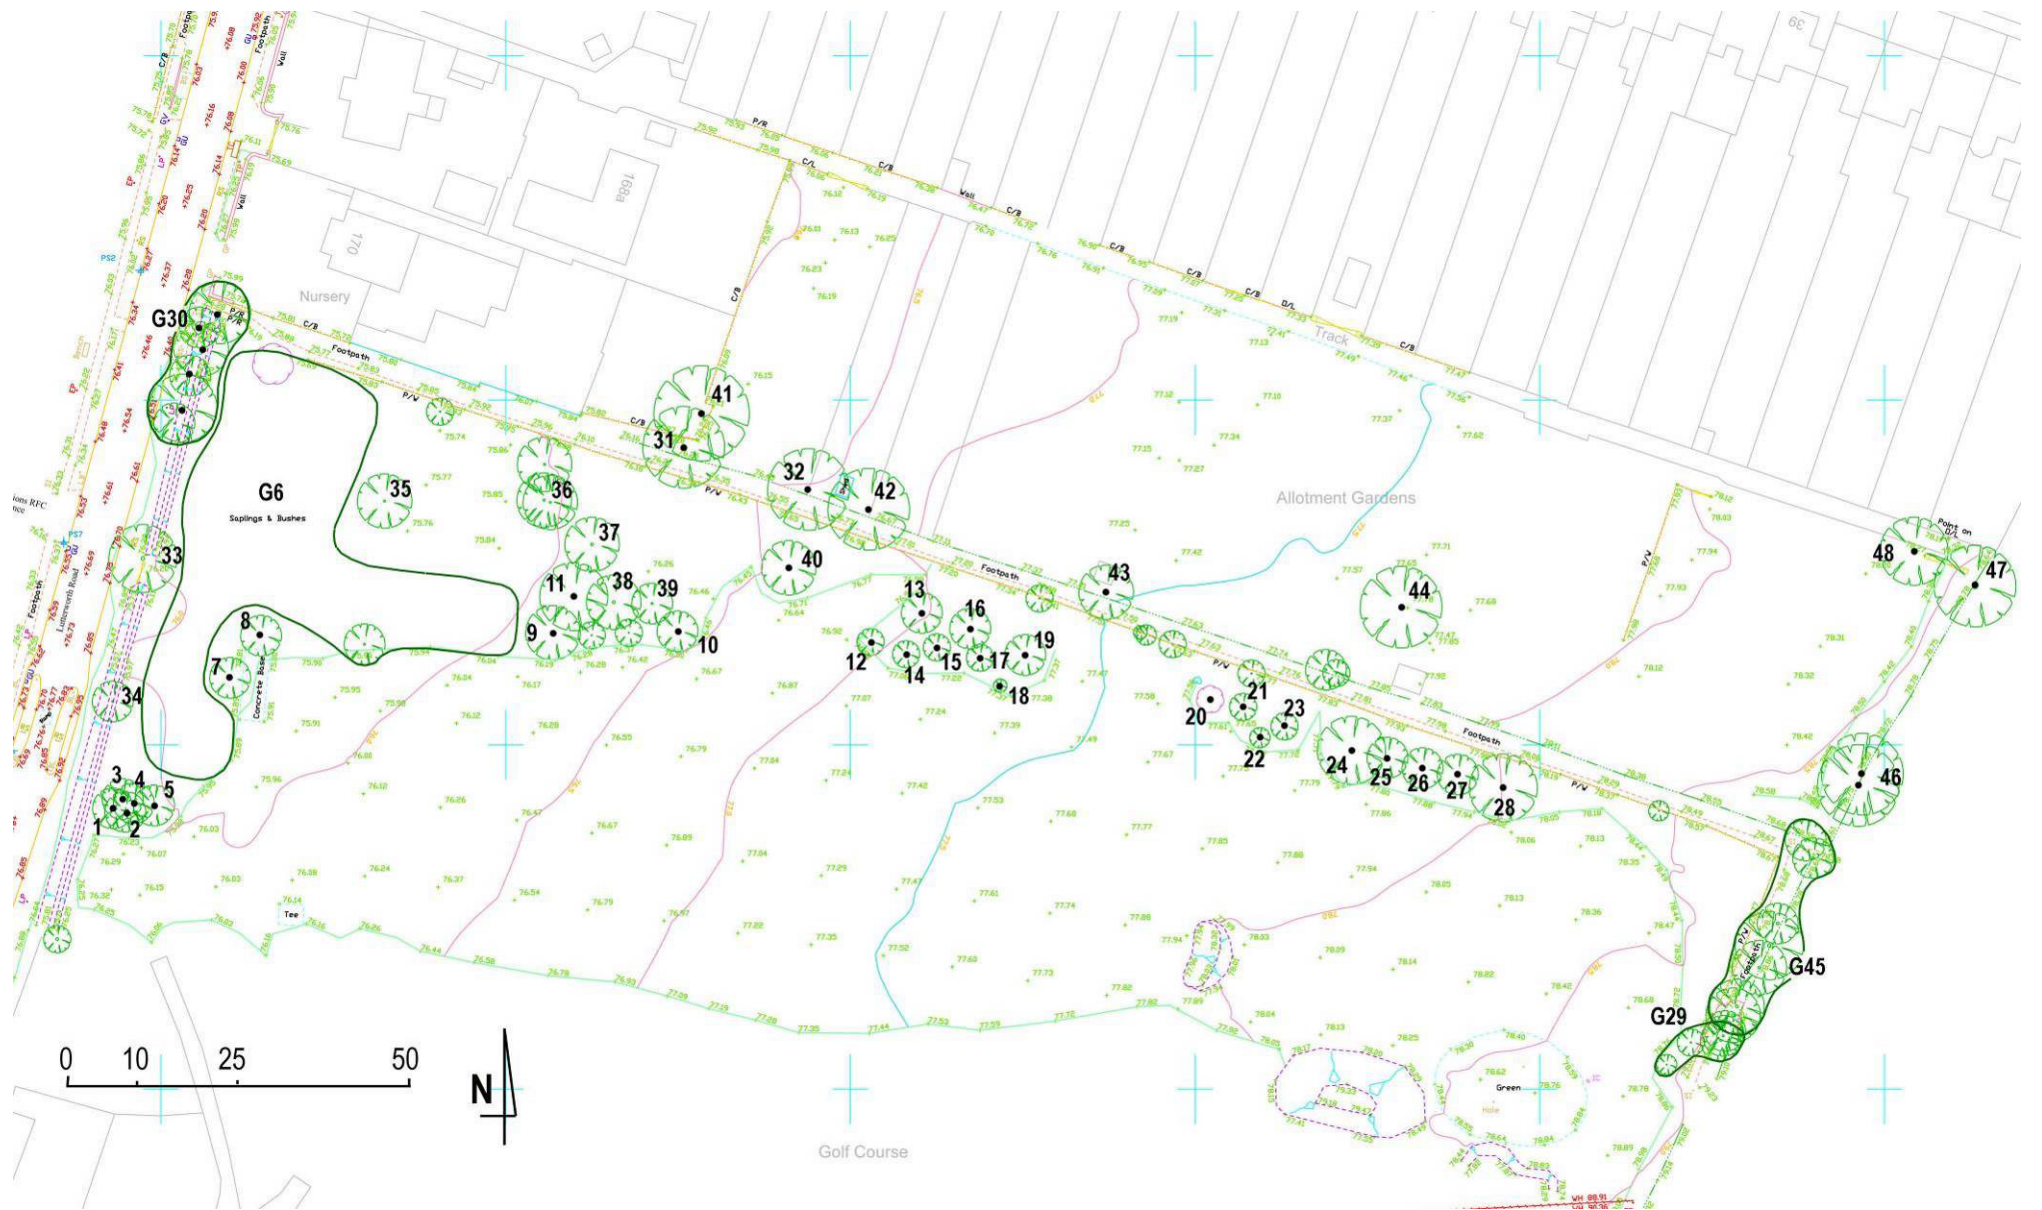
Figure 3 – Tree Location Plan

The position of significant individual trees or groups of trees measured out on the site is shown on the Tree Location Plan **Figure 3**. Within the summary table (**Appendix 1**) maximum RPA's (m<sup>2</sup>) for estimated tree diameters have been included where appropriate, as well as a calculated corresponding radius of the circle for that RPA. The Root Protection Areas are formulated to assist when designing layouts in relation to trees. At the present time no development plan has been prepared. At an appropriate time a detailed Constraints and Tree Protection Plan will need to be prepared.
