GEOTECHNICAL

for Subsidence Management Services

**Woodstock, COTTESMORE ROAD, ASHWELL, Oakham, RUTLAND,
LEICESTERSHIRE, LE15 7LJ**

Client: Subsidence Management Services
Client Contact: Fyaz Jan
Client Ref: IFS-PRE-SUB-22-0104778
Policy Holder: Mrs Yvonne Olive Walters
Report Date: 20 March 2023
Our Ref: C69569G31839

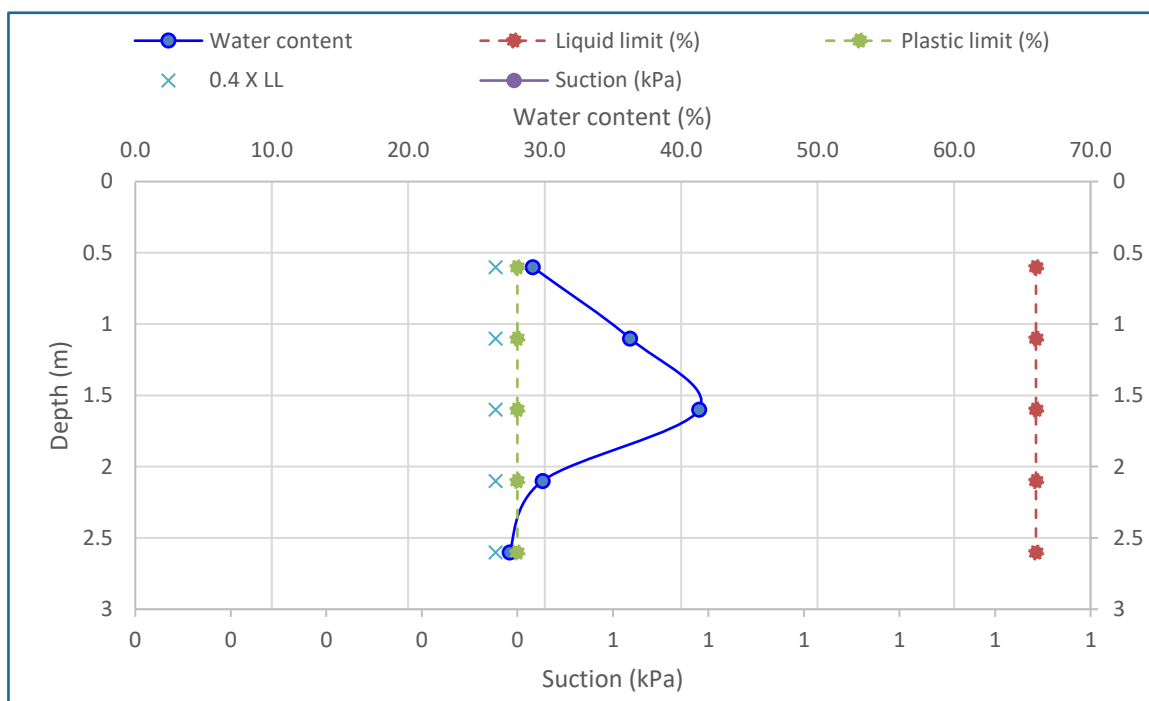
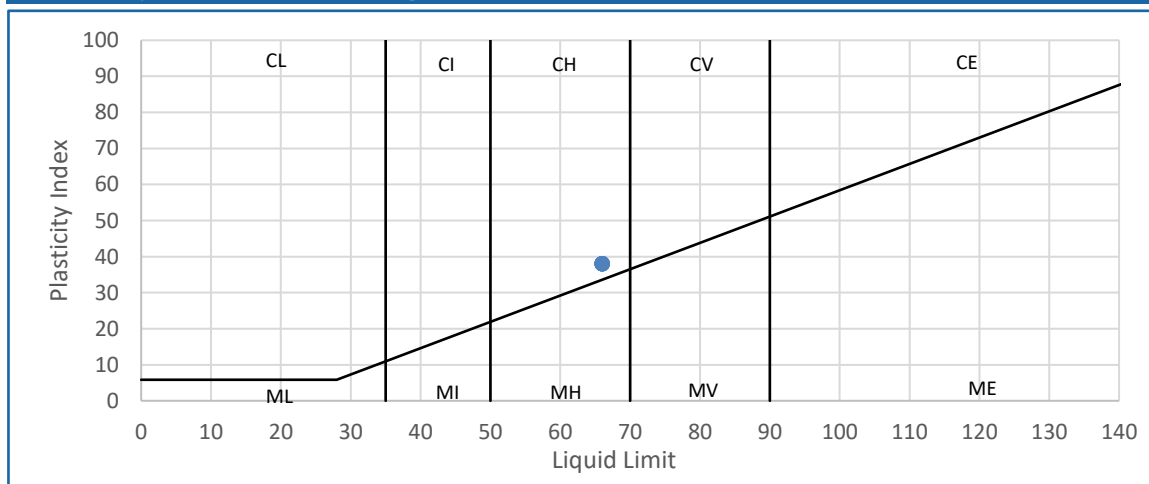
Samples from BH1

Lab Ref	Depth (m)	WC (%)	LL (%)	PL (%)	PI (%)	.425 mm(%)	mod. PI (%)	Av. Suc. (kPa)	Description
1	0.6	29.1	66	28	38	98	37		Soft to firm grey-brown silty CLAY with rare gravel. Gravel is fine
2	1.1	36.2	66	28	38	98	37		Soft to firm grey-brown silty CLAY with rare gravel. Gravel is fine
3	1.6	41.3	66	28	38	98	37		Soft to firm grey-brown silty CLAY with rare gravel. Gravel is fine
4	2.1	29.8	66	28	38	98	37		Soft to firm grey-brown silty CLAY with rare gravel. Gravel is fine
5	2.6	27.4	66	28	38	98	37		Soft to firm grey silty CLAY with rare gravel. Gravel is fine

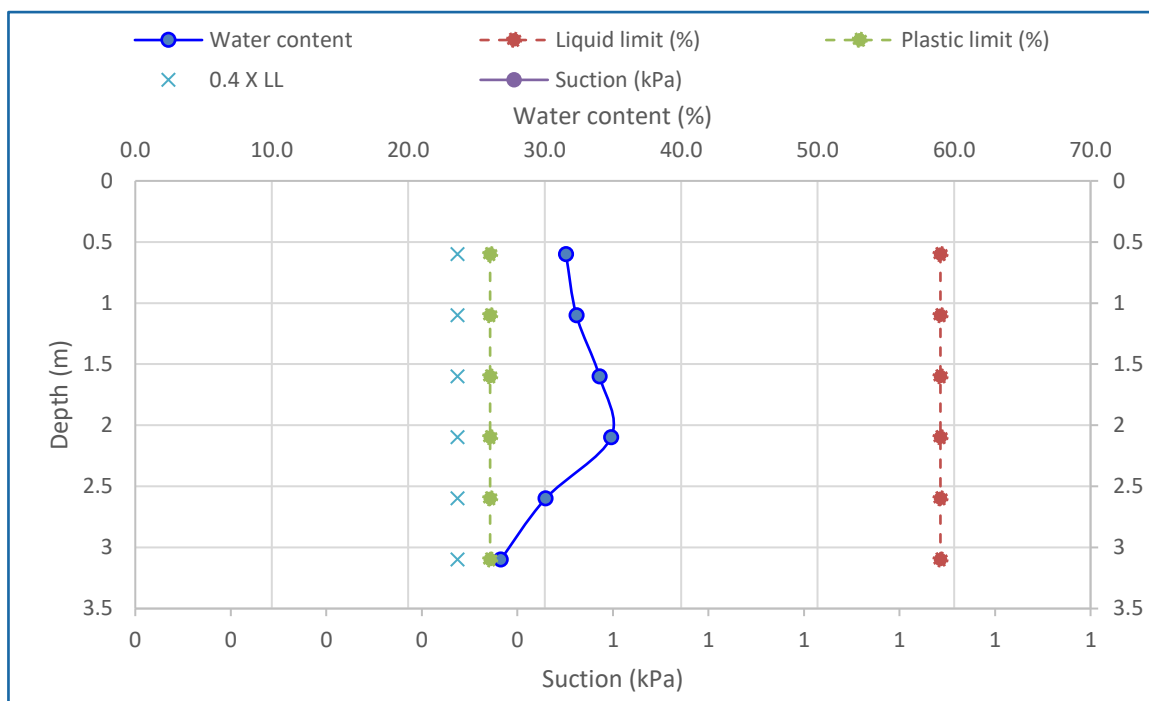
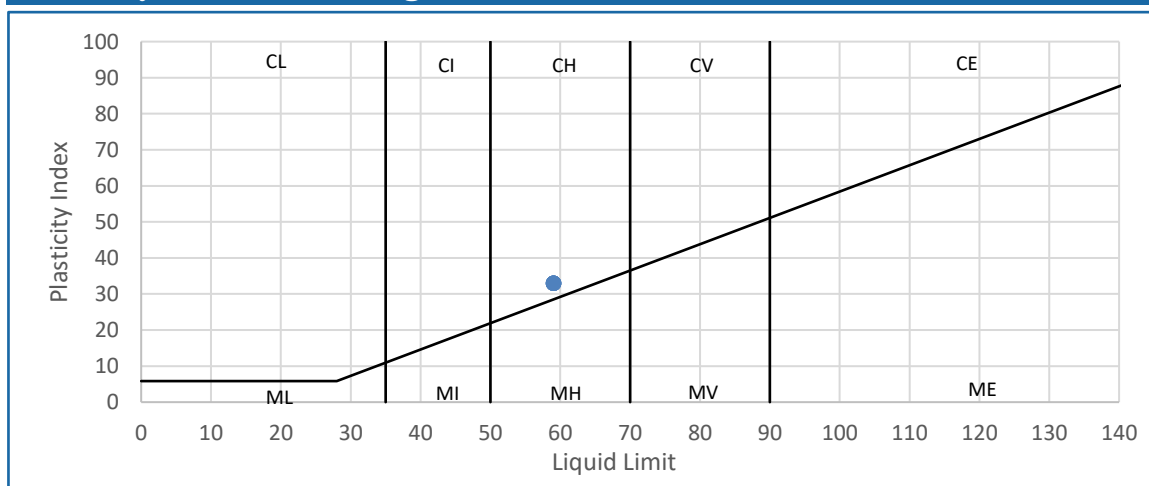
Samples from BH2

Lab Ref	Depth (m)	WC (%)	LL (%)	PL (%)	PI (%)	.425 mm(%)	mod. PI (%)	Av. Suc. (kPa)	Description
6	0.6	31.6	59	26	33	99	33		Soft to firm grey silty CLAY with rare gravel. Gravel is fine
7	1.1	32.3	59	26	33	99	33		Soft to firm grey silty CLAY with rare gravel. Gravel is fine
8	1.6	34.0	59	26	33	99	33		Soft to firm grey silty CLAY with rare gravel. Gravel is fine
9	2.1	34.9	59	26	33	99	33		Soft to firm grey silty CLAY with rare gravel. Gravel is fine
10	2.6	30.1	59	26	33	99	33		Soft to firm grey silty CLAY with rare gravel. Gravel is fine
11	3.1	26.8	59	26	33	99	33		Soft to firm grey silty CLAY with rare gravel. Gravel is fine

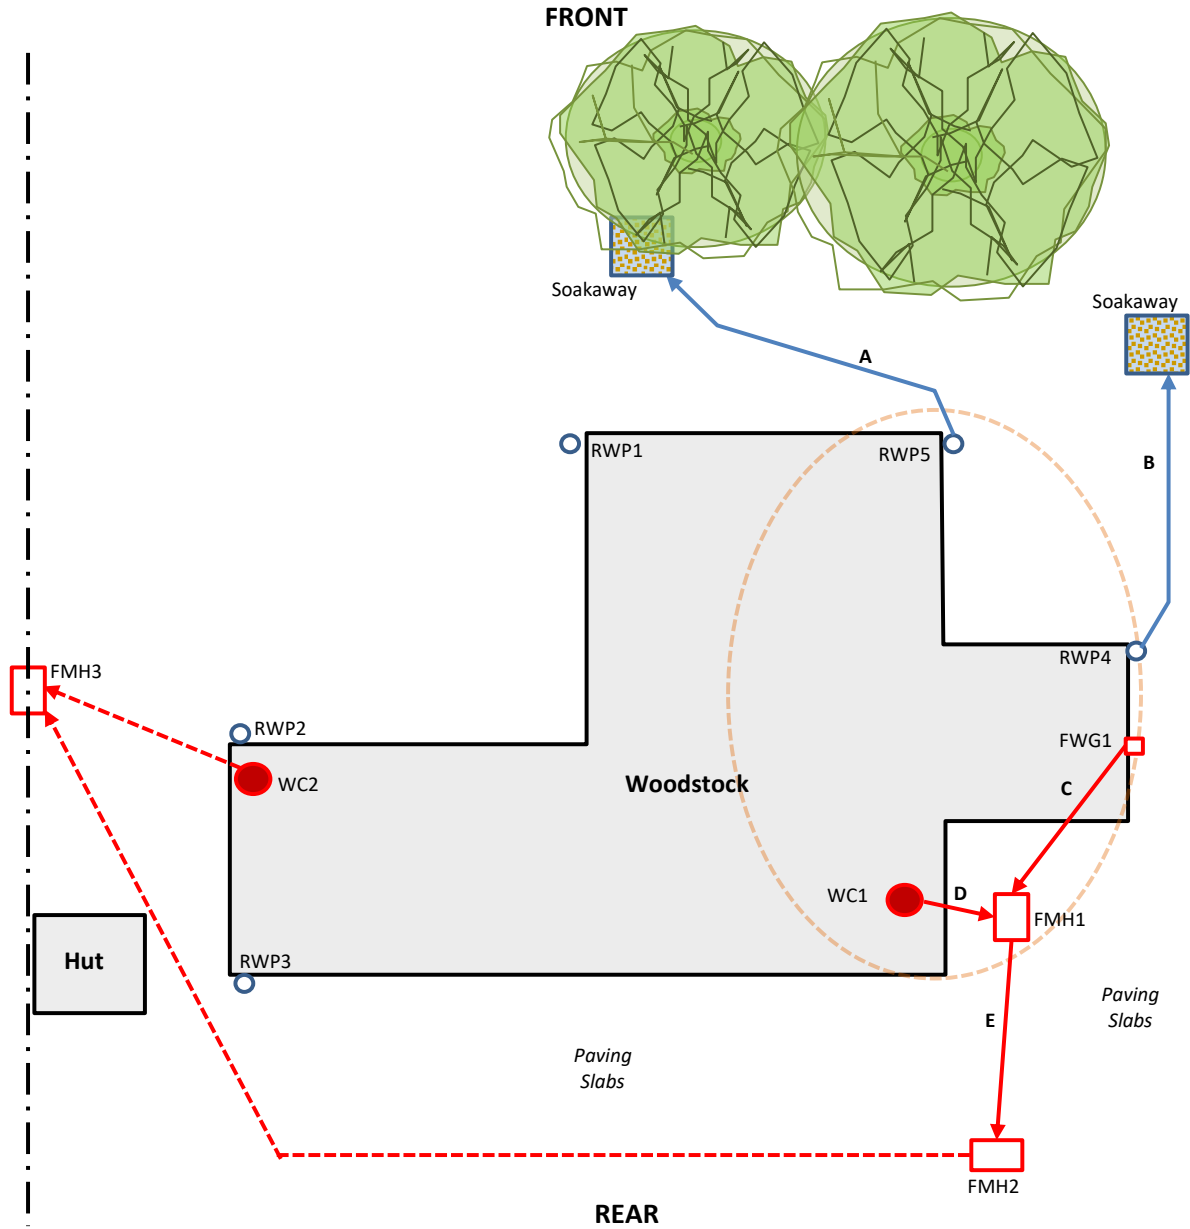
CCTV Survey Result: No structural damage

Recommended Repair: No repairs have been recommended as the drain line was found to be free from defects.
