Hampshire
Ecological Services
Consultant Ecologists

28/11/2023

Preliminary Roost Appraisal (internal/ external bat assessment) at the Rum Store, Royal Clarence Yard, Gosport, Hants.

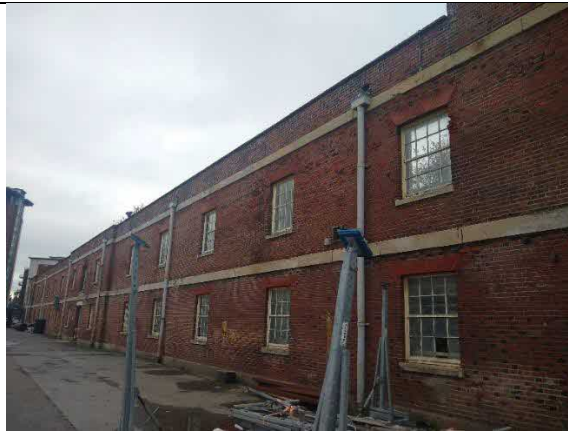
<p>East elevation</p>

There are numerous gaps in the brickwork of the building due to missing mortar and damaged bricks. These gaps potentially provide occasional external roosting locations for crevice-dwelling species of bat such as pipistrelles.
