**ARBORICULTURAL SAFETY
SURVEY**

**Bramhope Village Scout Group
Leeds Road
Bramhope
Leeds
West Yorkshire
LS16 9BQ**

21322/EW

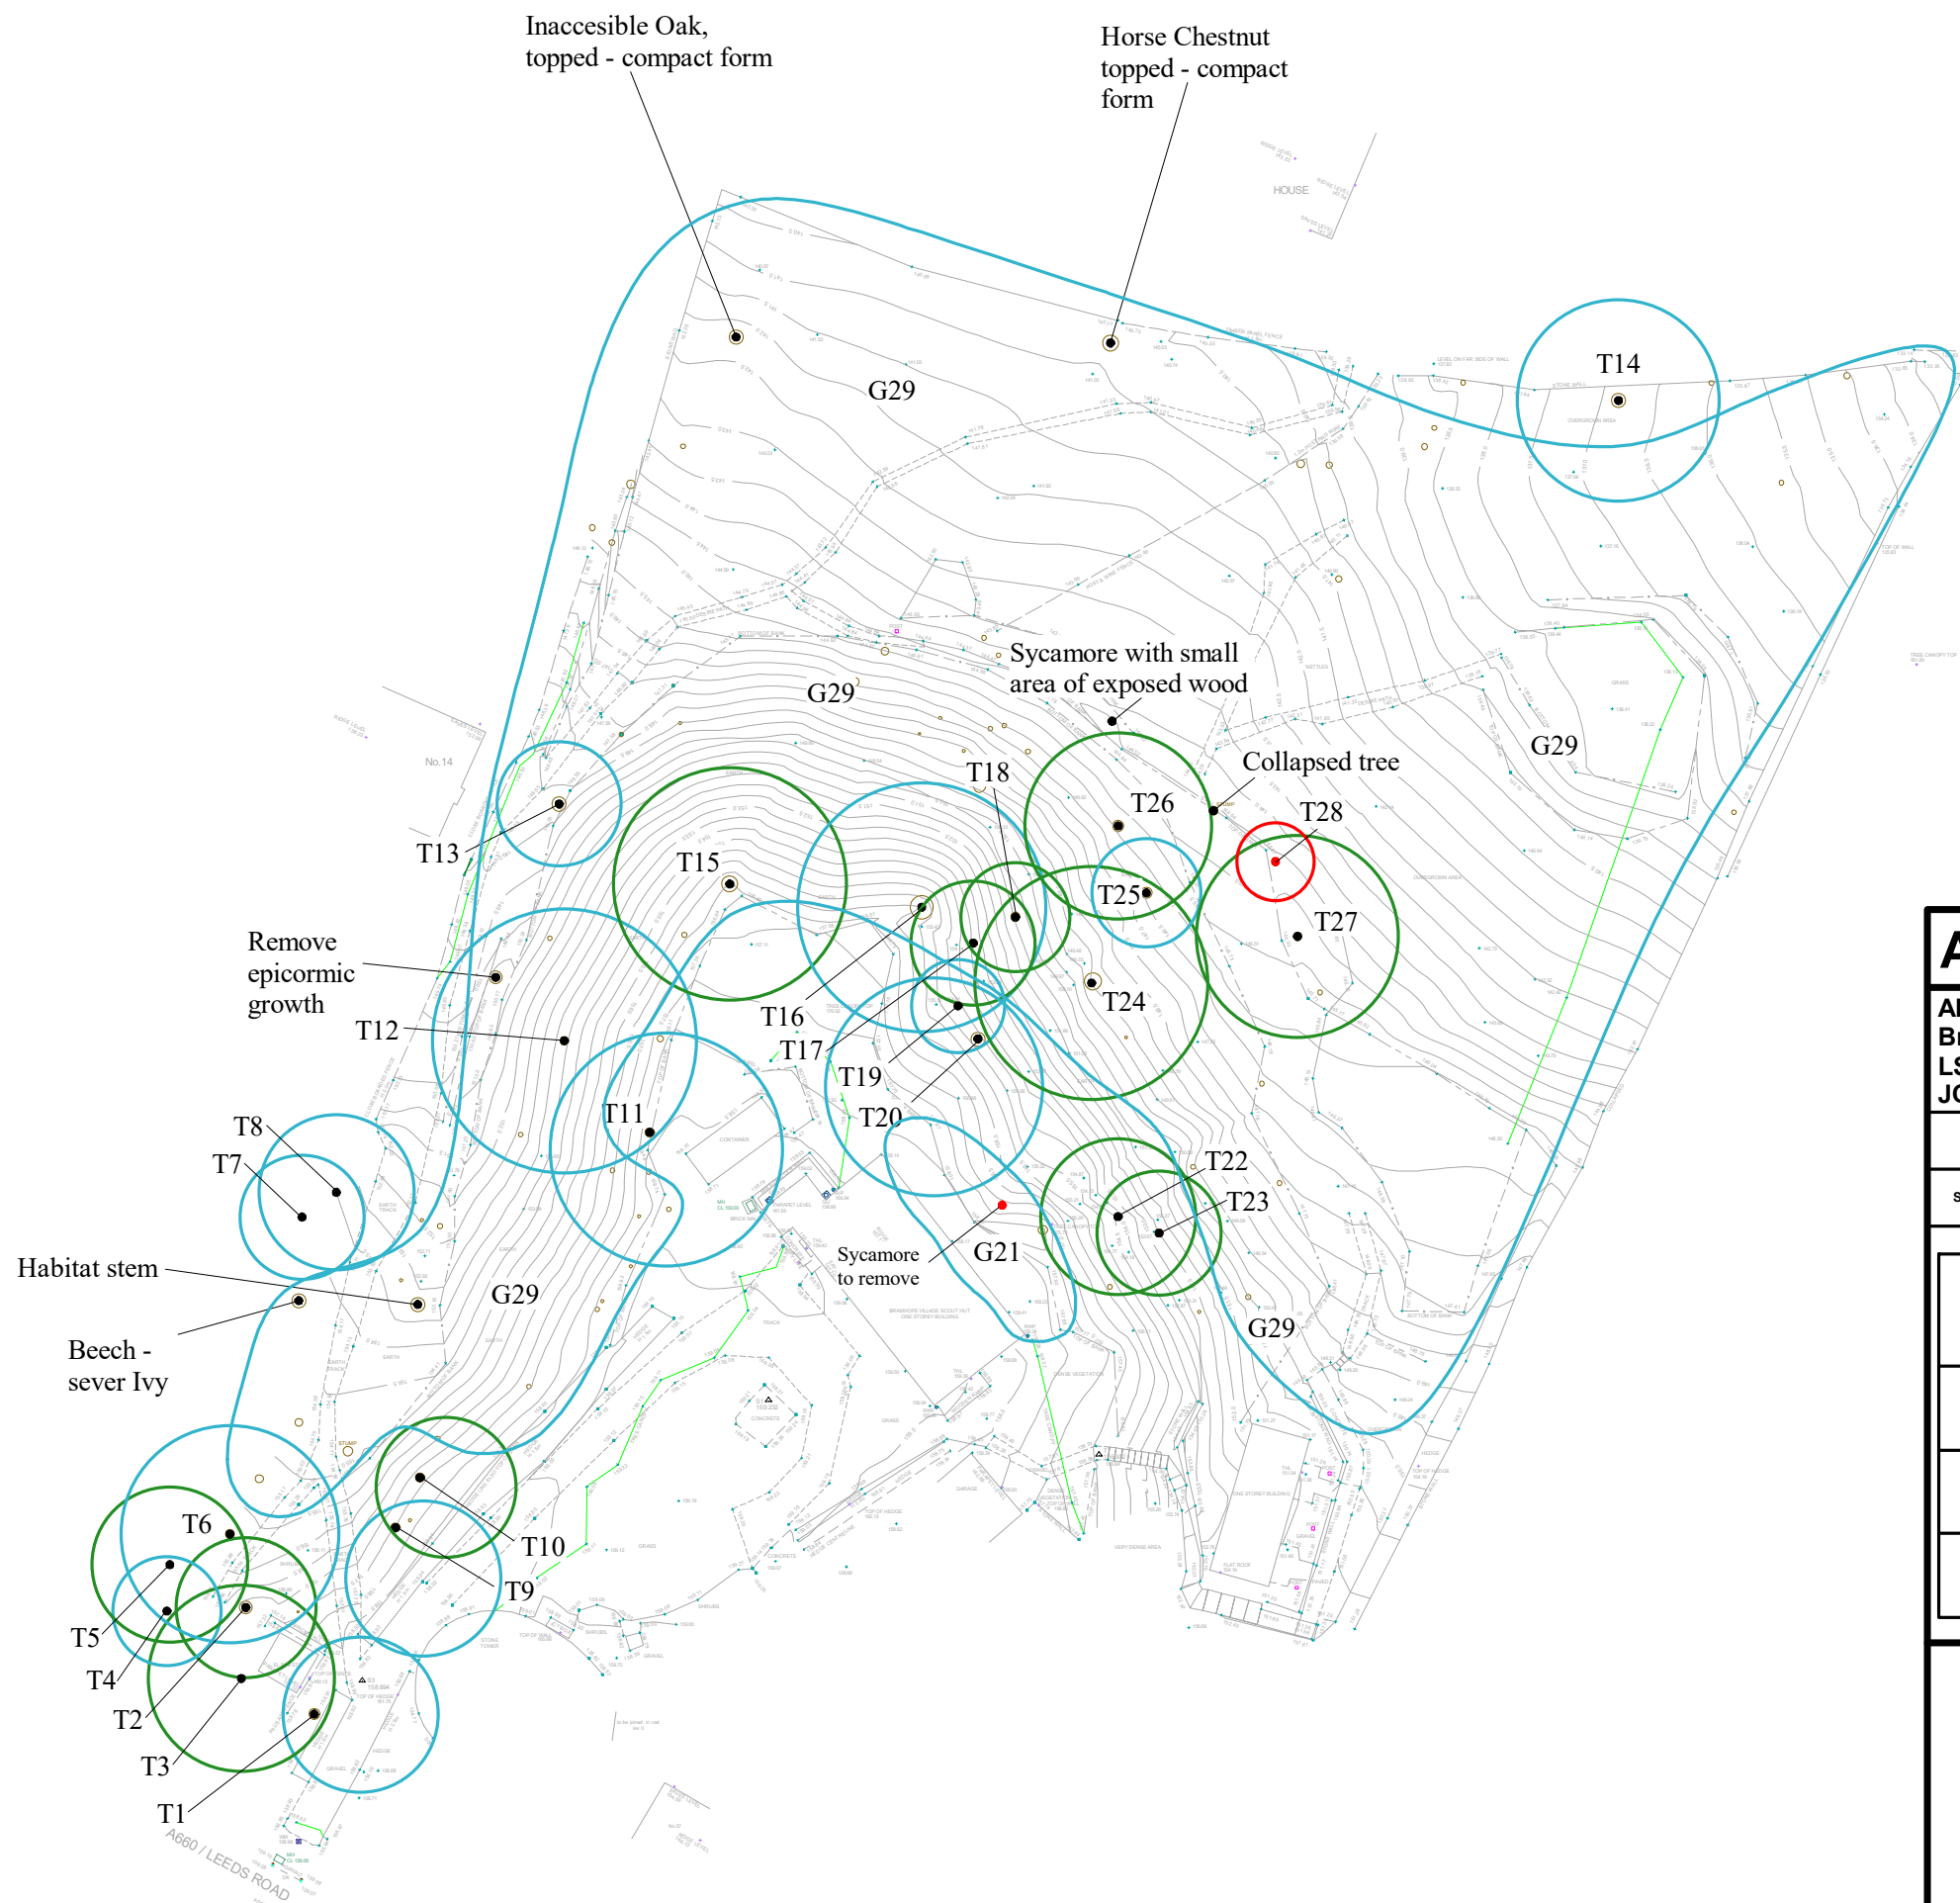
Appendix 5: Site Plan

T 28	Mature Ash <i>Fraxinus excelsior</i>	13	1	52	5	Single-stemmed tree with large decay column from 0.5m to 4m. Large area of exposed wood with some surrounding wound wood. Previously topped at 5m with regrowth. Canopy is sparse. Deadwood throughout. Poor form.	POOR	POOR	<10	MOD	Reduce main stem - leaving approximately 3m habitat stem.	MOD	R	N/A
G 29	Young to Early-mature Mixed species <i>Details in observations</i>	to 18	0	45 avg.	n/a	Other trees within the site that had no defects currently worthy of note. These trees will however require inspecting during the routine biennial surveys. Species include Ash, Beech, Oak, Sycamore, Hawthorn, Elder, Cappadocian Maple, Norway Maple, Horse Chestnut and Lime. Ivy and epicormic growth observed on some stems.	GOOD	GOOD	40+	MOD	Epicormic growth and Ivy requires removal as stated on the plan at Appendix 5 .	LOW	B	2
