Harpers, Green Street, High Easter, Essex. CM3 1HU. Historic building recording and analysis of the House. Recorded 18 09 2023.

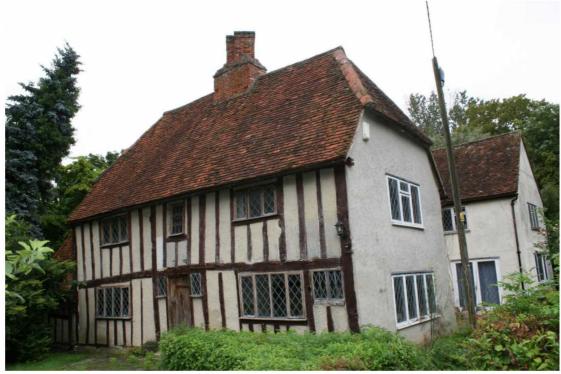
The exposed frame of the south elevation.

The south elevation has an exposed timber frame of widely spaced 4.5in oak studs with a 8in deep midrail, full height 8x7in corner posts and storey posts to form a central entrance lobby which also contains a double sided brick firestack.

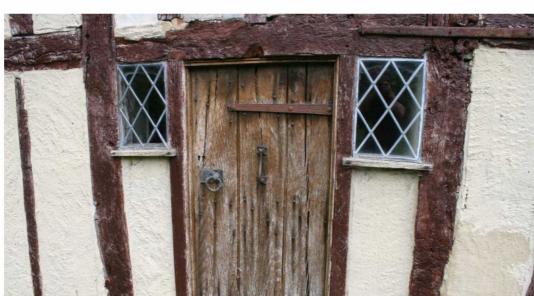
The door to the central lobby.

The central door and leaded light windows all date the 1964 development. The windows have oak frames which have shrunk badly. While the front door has aged quite badly it is obviously a C20th replica of a plank and batten door with vertical fillets added to reduce the draughts. The door furniture is MC20th and all screwed in place. The door jambs are also inserted and the peg holes for the original studs can be seen out of place. The wrought iron strap hinges may be authentic.

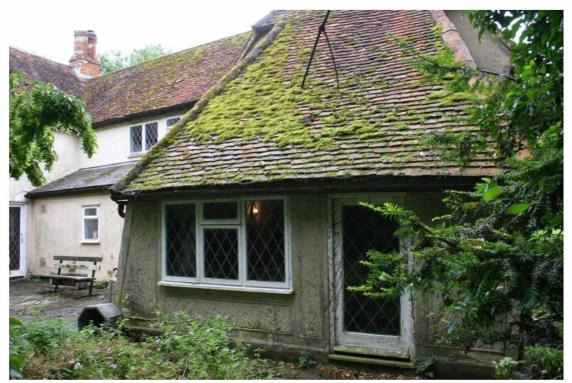
The western elevation of the outshot.

There is an outshot on the western end of the original frame under a catslide roof which is also hipped on both sides. The walls have a pargetted finish from 1964.

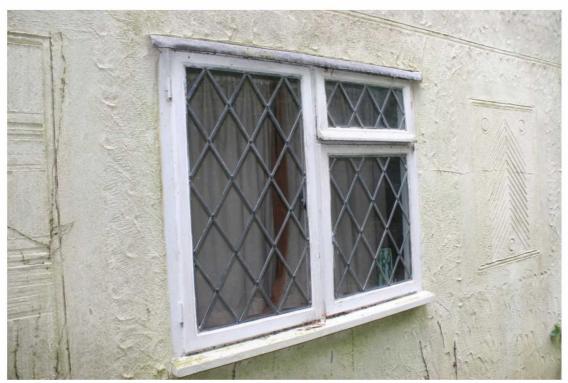
Detail of one of the 1964 casement leaded light windows.

The windows are leaded light casements of a type popularised in the 1930's and it may be they are reused units. Anecdotally, the extension was built on a part time basis by local builders who were employed on a much larger project nearby and worked on their downtime and at weekends. (Owner –pers comm).

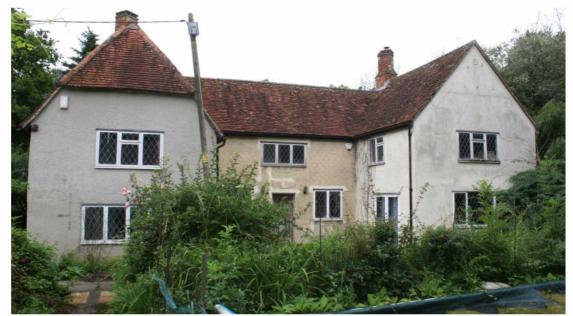
The east elevation showing the original cottage and the 1964 extension.

The east elevation has brush dabbed rough cast render over EML and has 1964 leaded lights. The upper storey has a three light casement with a top hung light. The lower floor has a four light casement. These windows have anodised aluminium stays and catches. The frames are badly rotted and can pulled apart by hand.

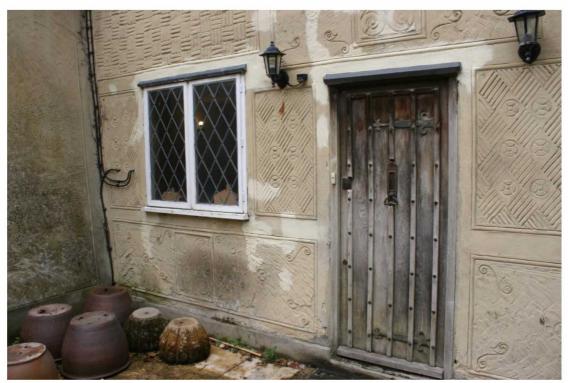
Detail of the pargetting on the east elevation of the Hallway Entrance.

Of interest in the pargetting around the Hallway Entrance as it is done to a far higher standard than the rest of the building. Itr is likely that a proper craftsman did the work as it is done authentically as raised field with raised decoration as well as pressed mouldings. The rest of the building is entirely incised work and as such is not really pargetting.

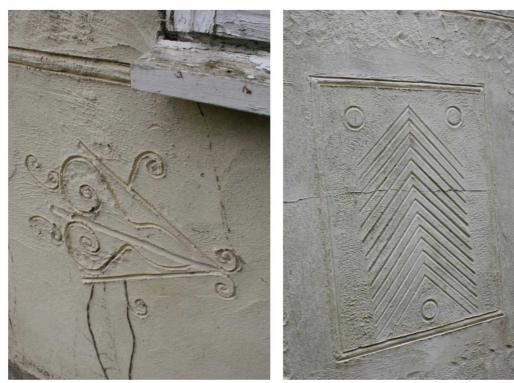
Incised or impressed decoration on the east and north elevations of the north range.

Most of the 'pargetting' is either incised or a scroll work gate panel has been used to press in a design. Some effort has been made to replicate the other designs but with obvious lesser skill.

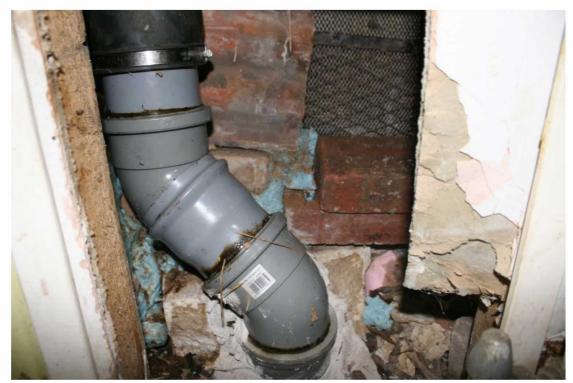
Opening in the south wall of the Utility Room showing LC20th building materials.

Situated in the western outshot of the 1994 extension there is an access panel that shows C21st repairs to the internal drainage, MC20th brickwork and plasterboard.

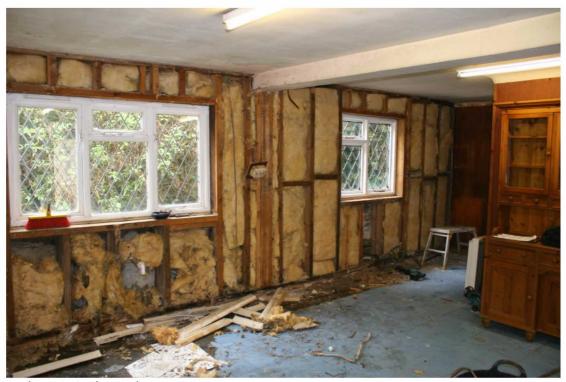
Looking NE in the Kitchen.

All the fabric dates to the 1964 works with some later intervention to install new plumbing and a water softener. The walls were clad with pressed vertical boards which suffered badly from water ingress. This hardboard product was used extensively in homes and offices in the 1960's and early 1970's.

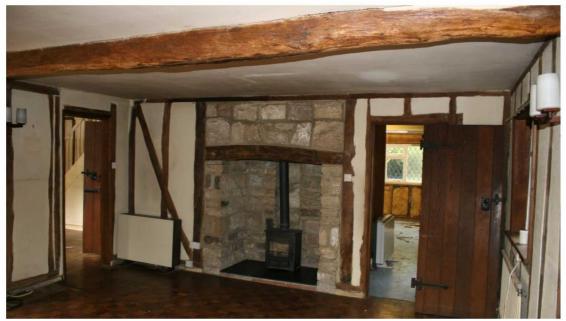
Looking W in the Living Room.

Entirely constructed in 1964, the Living room has primary braced, nailed interrupted stud fake frame made from recycled rafters. There is a large stone faced fireplace which has no place in an Essex farmhouse. The 1964 specification drawing indicates 2x5in studwork, Foil backed Gyplathe, Thistle for the walls and ceilings throughout.

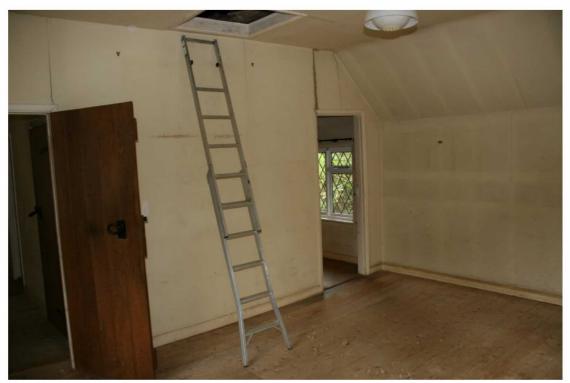
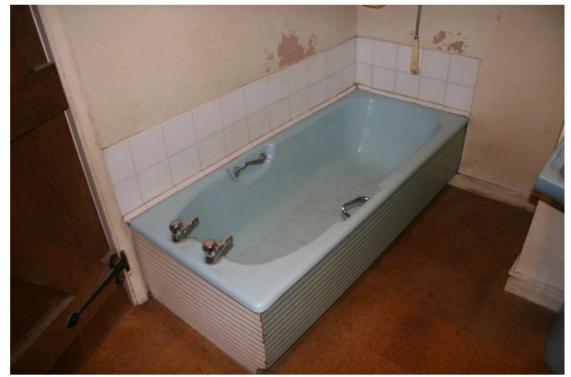
NE Bedroom

Looking NE in the NE Bedroom. Note the studwork visible in the walls.

Looking NW in the NE Bedroom.

Built on a budget, the studwork frames can be seen through the thin plasterboard.

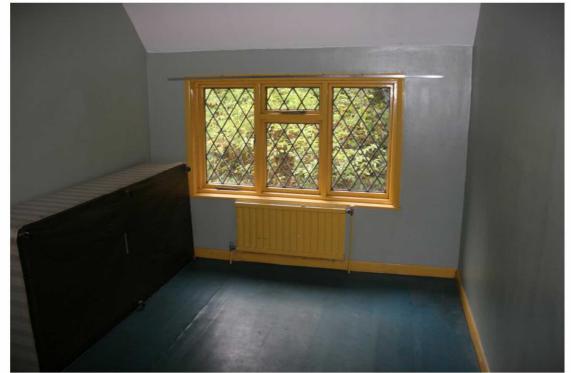
The roof above the NE Bedroom.

All the fabric dates to the 1964 works or later. The eastern wall has been refinished and has a light blue permeable membranes used from the 1980's onwards. This may account for the inferior quality pargetting as the exterior has been refinished.

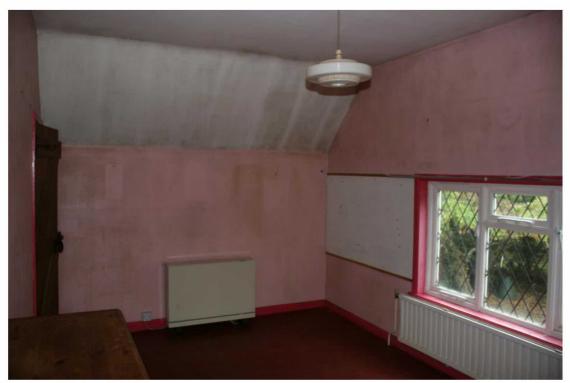
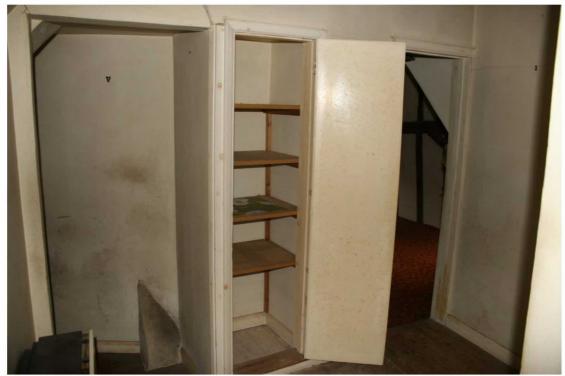
NW Bedroom

Looking N in the NW Bedroom.

Looking S in the NW Bedroom.

Like the NE Bedroom the studwork can be seen through the thin plasterboards.

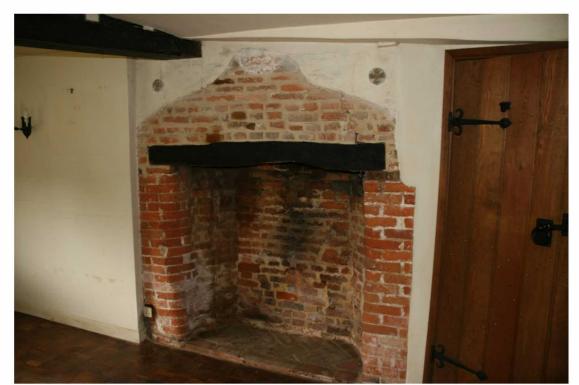
Looking W at the central firestack.

The main joist has sunk and the floor above remade to be level.

The fireplace appears to have been reduced in width and the back canted to take a cast iron insert. The bricks are 50x110x230mm red/orange typical of the C16th and C17th set in thick beds of white lime mortar. Originally, the brickwork was render over but it has been removed (most likely as part of the 1964 works) and reshaped. Two concrete moulded rosettes have been added and painted. The shortened bressummer has no apotropaic marks or taper burns. The main axial joist has lost all of the common rafters which had soffit tenons with refined entry and the floor above has been levelled and raised well above the midrails.

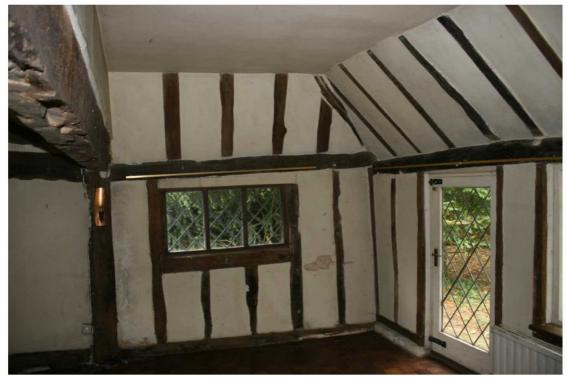
Drawing Room (SW Room)

Looking W at the original frame. The end wall has been removed.

The Drawing Room has the original first floor frame but the end wall has been removed to open the space into the western outshot. The transverse joist is a replacement beam of much deeper section than the others and is a reused item from elsewhere. The empty mortices are filled with daub so this was an early intervention of the C18th or C19th. The axial main joist is morticed for a central post that has been removed.

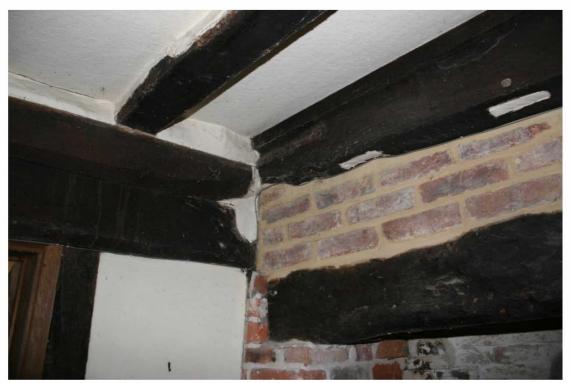
Wrought iron reinforcement on the main joist above the fireplace.

The transverse joist is morticed for a lower stud wall so it is likely the frame has been reused. The terminals are fixed with c.1800 wrought iron ties. The common joists are plan, unchamfered and extensively blackened with signs of being lath and plastered so it likely this was always the cooking side of the cottage.

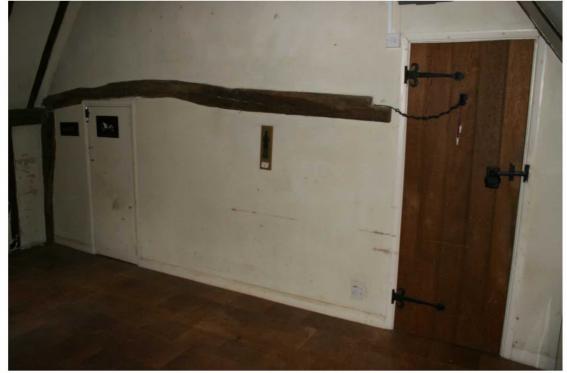
Framing in the SE corner. The corner post has been shaved back.

The frame has definitely been reordered in the eastern wall as the braces do not coincide with the original mortices. The SE corner post has been shaved back due to beetle damage.
