Tree Report: Arboricultural Impact Assessment (AIA)

Rawcliffe Lodge
Shipton Road
York
YO30 5RX

Vincent and Browns c/o Mark Smith
November 2022

<i>Title</i>	Tree Report: Arboricultural Impact Assessment (AIA)		
<i>Client</i>	Vincent and Brown		
<i>GC Project Reference</i>	J221106 – Rawcliffe Lodge		
<i>Author</i>	<i>Robert Wortley FdSc Arboriculture and Urban Forestry, BSc (hons) Applied Horticultural Sciences, MArborA Arboricultural Consultant</i>		
<i>Author Contact Details</i>	Ground Control Limited, Kingfisher House, Radford Way, Billericay, Essex, CM12 0E M: [REDACTED] T: 01277 650697 E: [REDACTED] www.ground-control.co.uk		
<i>Reviewed</i>	<i>Kevin Slezacek DipArb. MArborA. MCIHort Head of Arboricultural Consultancy</i>		
<i>Issue Status</i>	Issue	Date	Status
	1	22/11/2022	Planning
<i>Revision</i>			Revision
			Final
<i>Disclaimer</i>	<p><i>The recommendations contained in this Report represent Ground Control's professional opinions, in exercising the duty of care required of an experienced Arboricultural Consultant. The information contained has been prepared and given in accordance with the author's professional institution's Code of Professional Conduct and the opinions

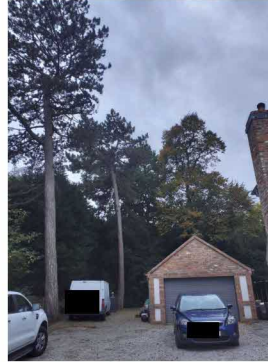
Scientific Name:	Pinus sylvestris
Physiological Condition:	Good
Stem Diameter [mm]:	690
Stem Diameter [cm]:	69
User:	RobW
Primary ID:	24469

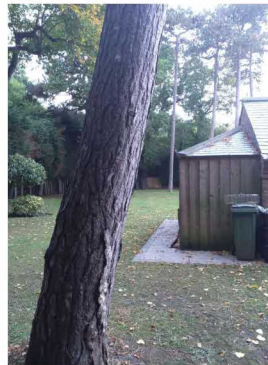
Scots pine Tree ID #2

Scientific Name:	Pinus sylvestris
Physiological Condition:	Good
Stem Diameter [mm]:	540
Stem Diameter [cm]:	54
User:	RobW
Primary ID:	24470

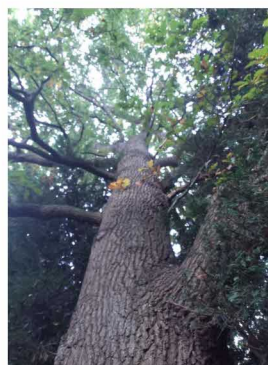
Pedunculate oak Tree ID #3

Scientific Name:	Quercus robur
Physiological Condition:	Good
Stem Diameter [mm]:	740
Stem Diameter [cm]:	74
User:	RobW
Primary ID:	24472

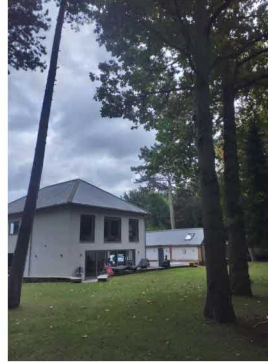
Scientific Name:	Quercus robur
Physiological Condition:	Good
Stem Diameter [mm]:	490
Stem Diameter [cm]:	49
User:	RobW
Primary ID:	24478

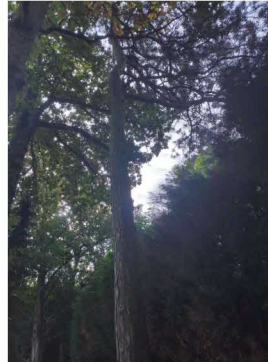
Scots pine Tree ID #8

Scientific Name:	Pinus sylvestris
Physiological Condition:	Good
Stem Diameter [mm]:	480
Stem Diameter [cm]:	48
User:	RobW
Primary ID:	24479

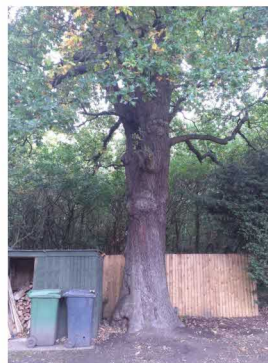
Pedunculate oak Tree ID #9

Scientific Name:	Quercus robur
Physiological Condition:	Good
Stem Diameter [mm]:	1130
Stem Diameter [cm]:	113
User:	RobW
Primary ID:	24480

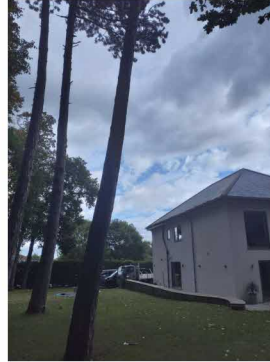
Scots pine Tree ID #10

Scientific Name:	Pinus sylvestris
Physiological Condition:	Good
Stem Diameter [mm]:	410
Stem Diameter [cm]:	41
User:	RobW
Primary ID:	24481

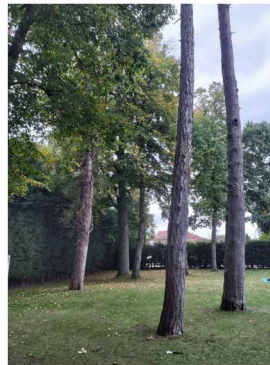
Scots pine Tree ID #11

Scientific Name:	Pinus sylvestris
Physiological Condition:	Good
Stem Diameter [mm]:	430
Stem Diameter [cm]:	43
User:	RobW
Primary ID:	24482

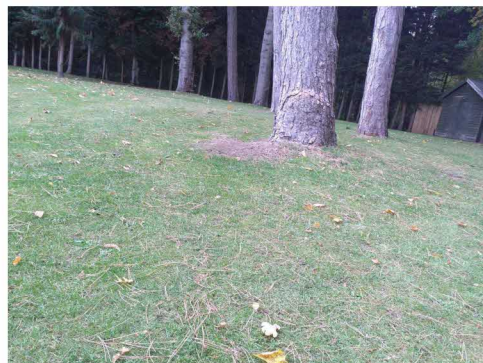
Scots pine Tree ID #12

Scientific Name:	Pinus sylvestris
Physiological Condition:	Good
Stem Diameter [mm]:	530
Stem Diameter [cm]:	53
User:	RobW
Primary ID:	24483

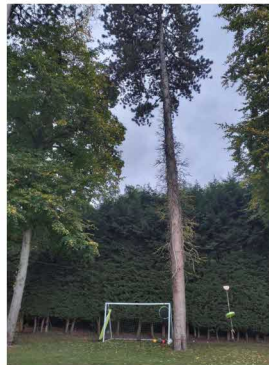
Scientific Name:	<i>Pinus sylvestris</i>
Physiological Condition:	Good
Stem Diameter [mm]:	520
Stem Diameter [cm]:	52
User:	RobW
Primary ID:	24485

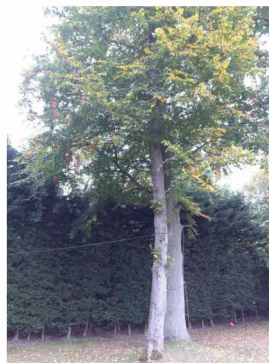
Small-leaved lime Tree ID #15

Scientific Name:	<i>Tilia cordata</i>
Physiological Condition:	Good
Stem Diameter [mm]:	410
Stem Diameter [cm]:	41
User:	RobW
Primary ID:	24486

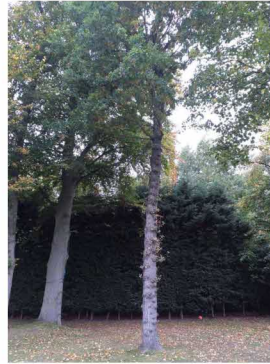
Scientific Name:	Quercus robur
Physiological Condition:	Good
Stem Diameter [mm]:	440
Stem Diameter [cm]:	44
User:	RobW
Primary ID:	24489

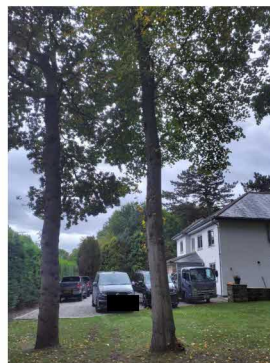
Small-leaved lime Tree ID #18

Scientific Name:	Tilia cordata
Physiological Condition:	Good
Stem Diameter [mm]:	420
Stem Diameter [cm]:	42
User:	RobW
Primary ID:	24490
