## Photographic Schedule of Condition

**Kings Buildings, 16 Smith Square, London, SW1P 3HQ**

October 2023

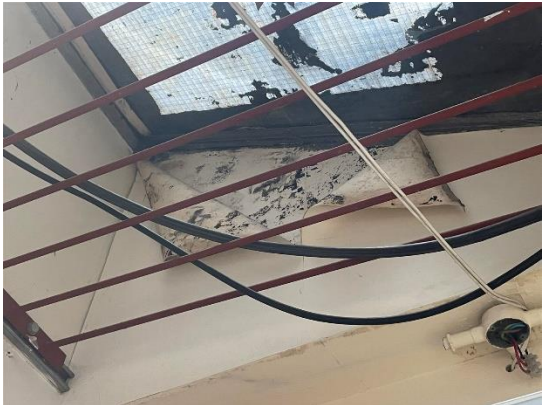
19.	Representation of build-up of debris on glazing blocking the gutter behind the parapet wall causing water ingress and subsequent peeling of decoration and mould.
