FAIRFIELD ROAD, DROYLSDEN

SITE COMPLETION REPORT

Job: Number: LKC 20 1761
Date: 1st December 2023
Client: J Greenwood (Builders) Ltd

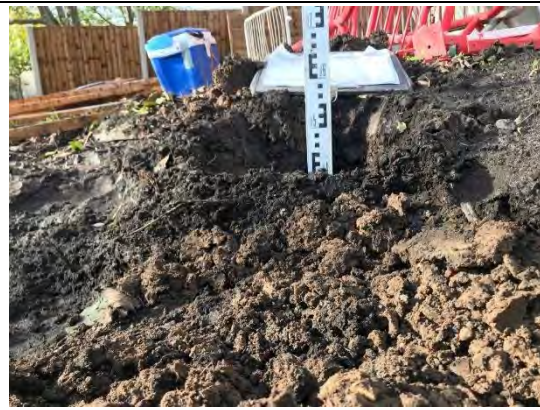
Photograph 5: View of depth of soil within the rear (N) garden of Plot 37.

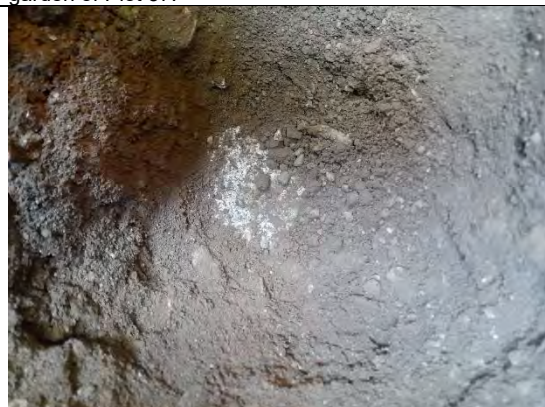
Photograph 3: View of soil within cover system and geotextile at base in front of Plot 37.

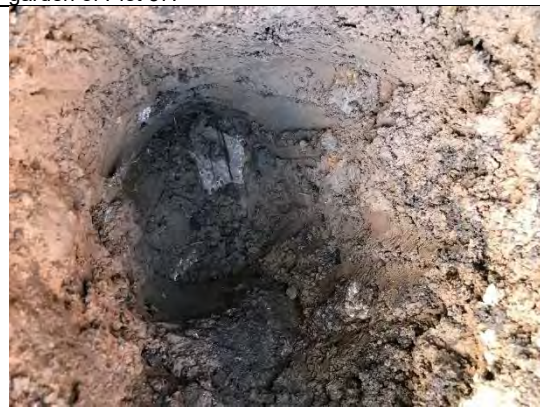
Photograph 6: View of soil within cover system and geotextile at base in rear (N) of Plot 37.

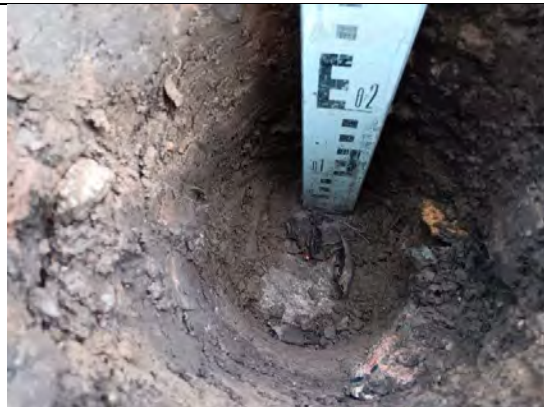
Photograph 9: View of soil within cover system and geotextile at base in rear (S) of Plot 37.

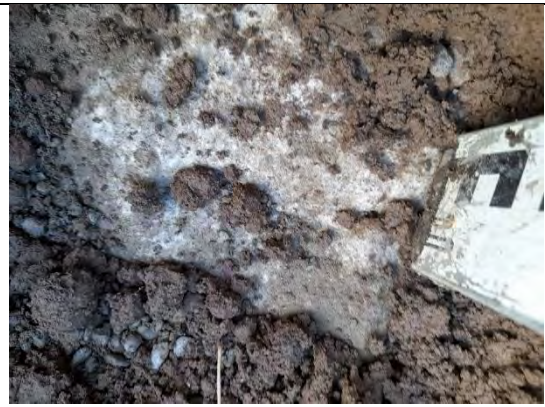
Photograph 12: View of soil within cover system and geotextile at base in front of Plot 38.

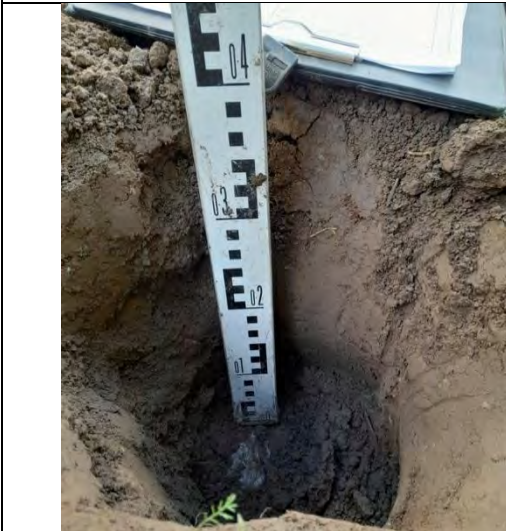
Photograph 14: View of depth of soil within the rear (N) garden of Plot 38.

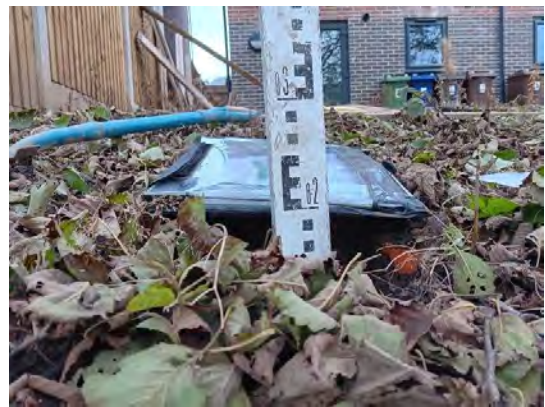
Photograph 17: View of depth of soil within the rear (S) garden of Plot 38.

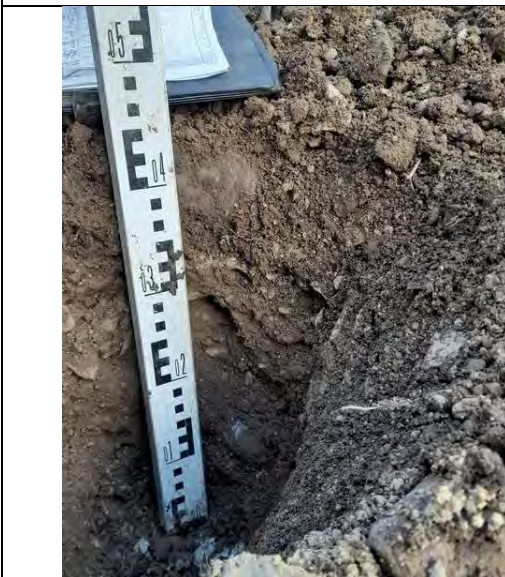
Photograph 20: View of depth of soil within the front garden of Plot 39.

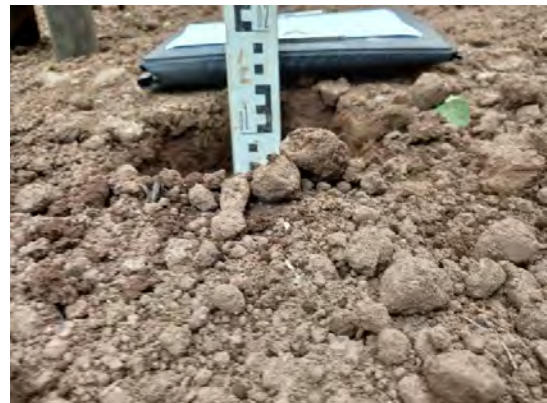
Photograph 23: View of depth of soil within the rear (S) garden of Plot 39.

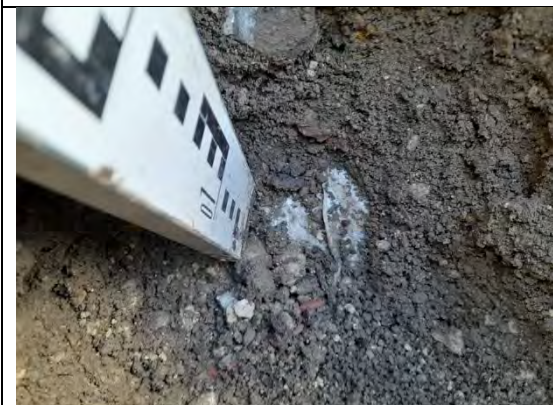
Photograph 21: View of soil within cover system and geotextile at base in front of Plot 39.

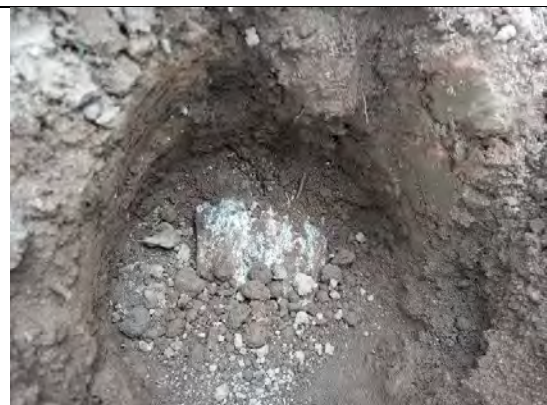
Photograph 24: View of soil within cover system and geotextile at base in rear (S) of Plot 39.

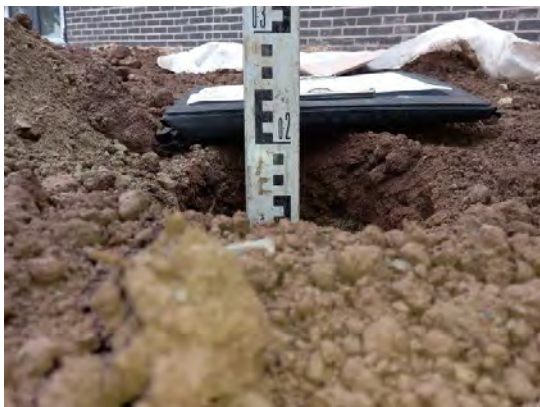
Photograph 26: View of depth of soil within the rear (N) garden of Plot 39.

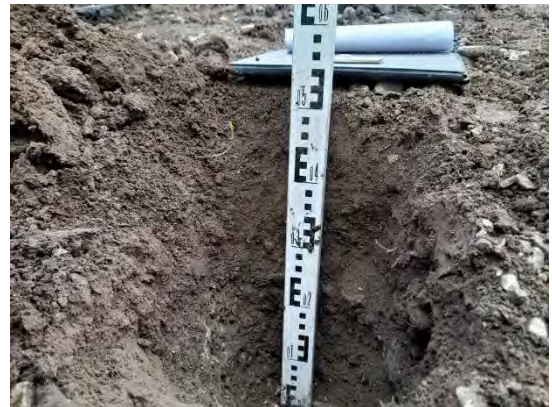
Photograph 29: View of depth of soil within the front garden of Plot 40.

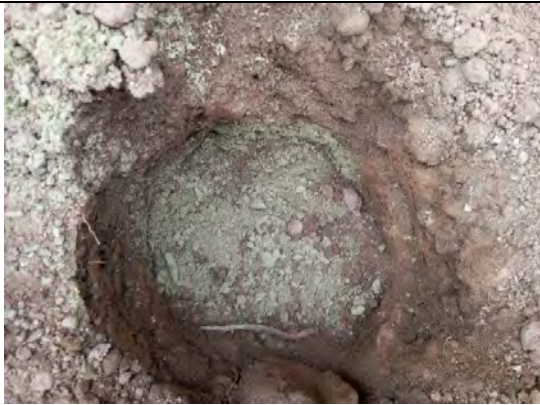
Photograph 27: View of soil within cover system and geotextile at base in rear (N) of Plot 39.

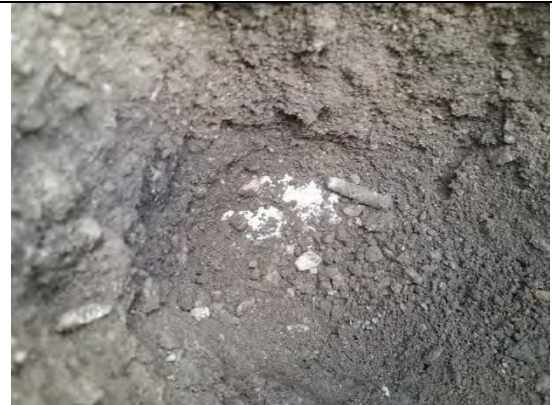
Photograph 30: View of soil within cover system and geotextile at base in front of Plot 40.

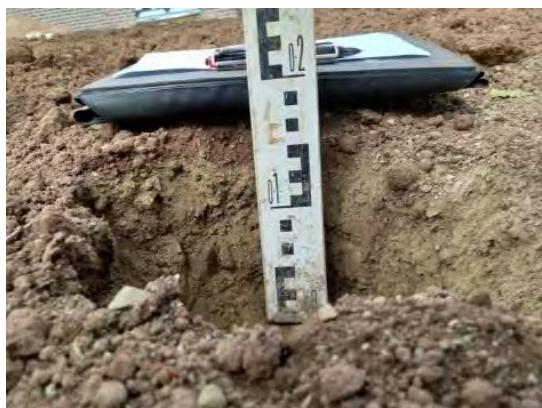
Photograph 32: View of depth of soil within the rear (N) garden of Plot 40.

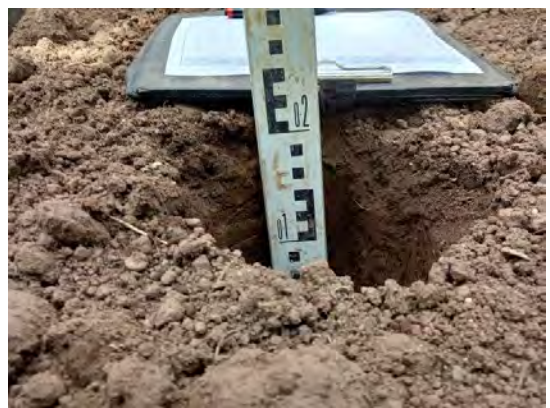
Photograph 35: View of depth of soil within the rear (S) garden of Plot 40.

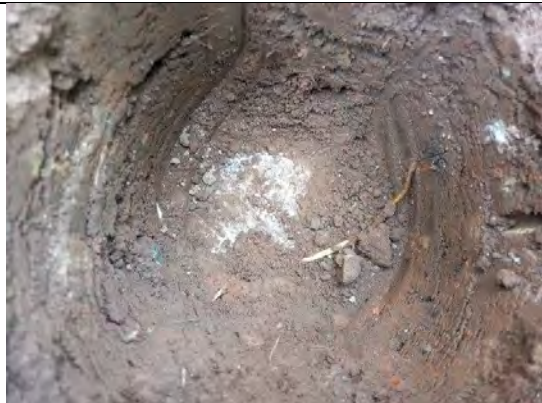
Photograph 33: View of soil within cover system and geotextile at base in rear (N) of Plot 40.

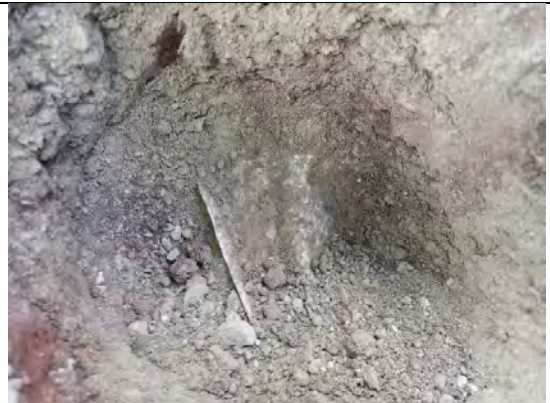
Photograph 36: View of soil within cover system and geotextile at base in rear (S) of Plot 40.

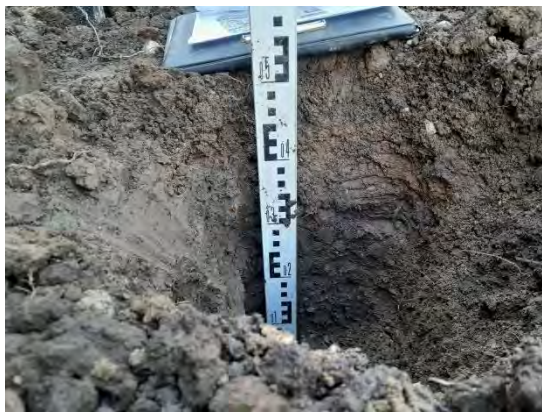
Photograph 38: View of depth of soil within the front garden of Plot 41.

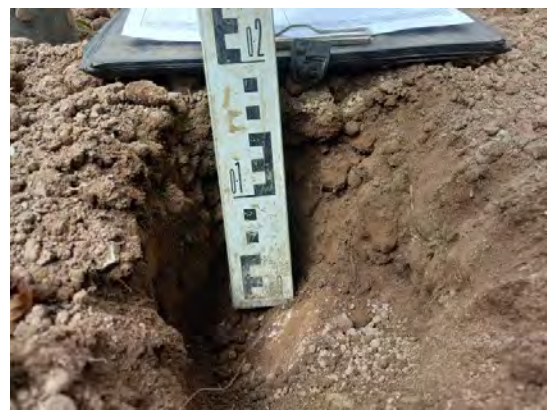
Photograph 41: View of depth of soil within the rear (N) garden of Plot 41.

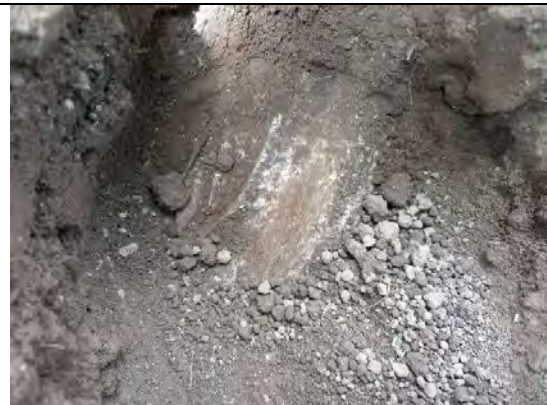
Photograph 39: View of soil within cover system and geotextile at base in front of Plot 41.

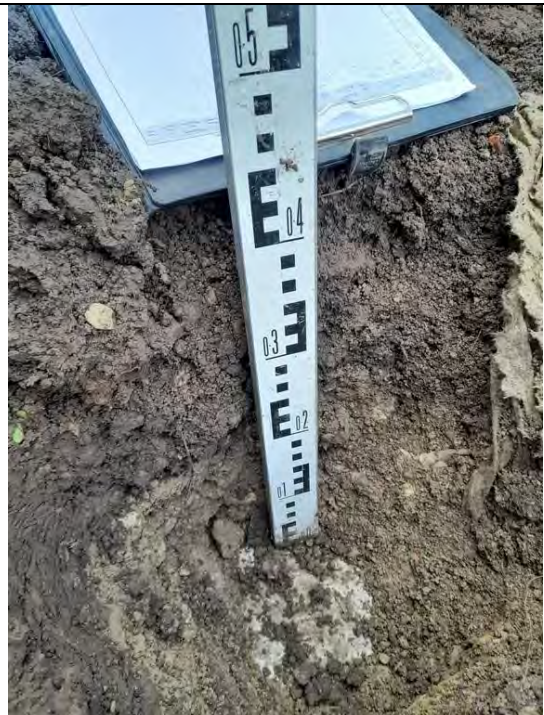
Photograph 44: View of depth of soil within the rear (S) garden of Plot 41.

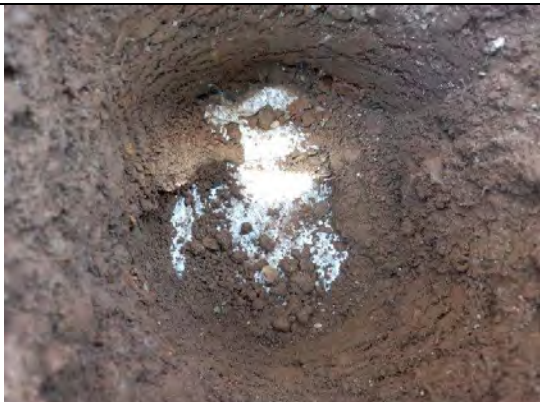
Photograph 47: View of depth of soil within the front garden of Plot 42.

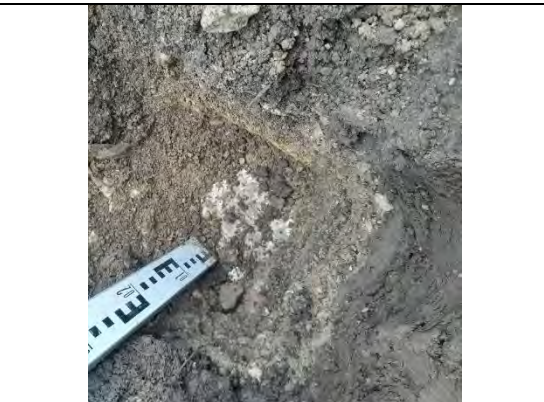
Photograph 45: View of soil within cover system and geotextile at base in rear (S) of Plot 41.

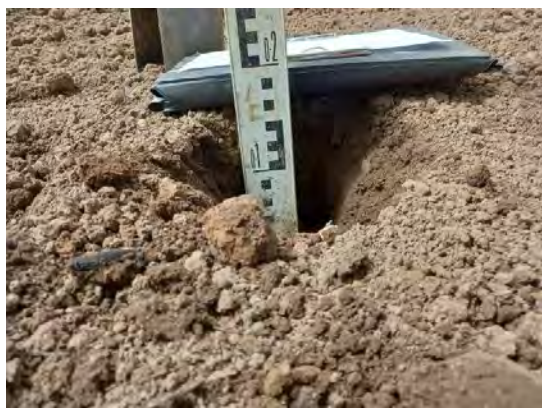
Photograph 52: View of rear (S) garden in Plot 42.

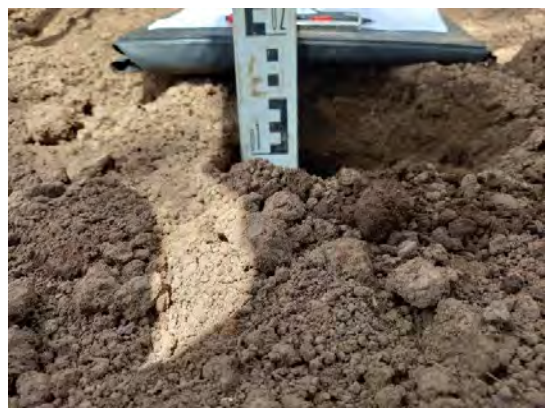
Photograph 50: View of depth of soil within the rear (N) garden of Plot 42.

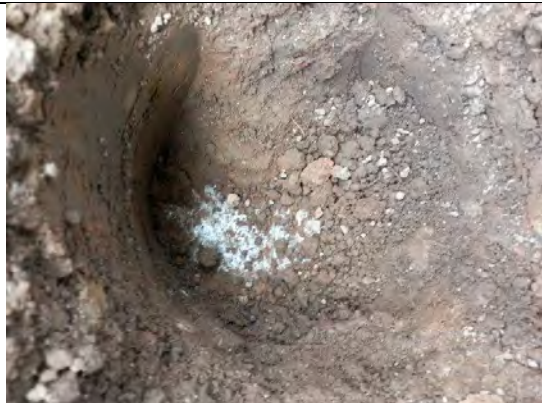
Photograph 53: View of depth of soil within the rear (S) garden of Plot 42.

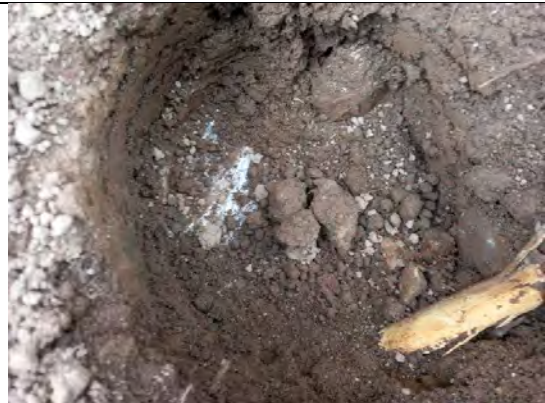
Photograph 51: View of soil within cover system and geotextile at base in rear (N) of Plot 42.

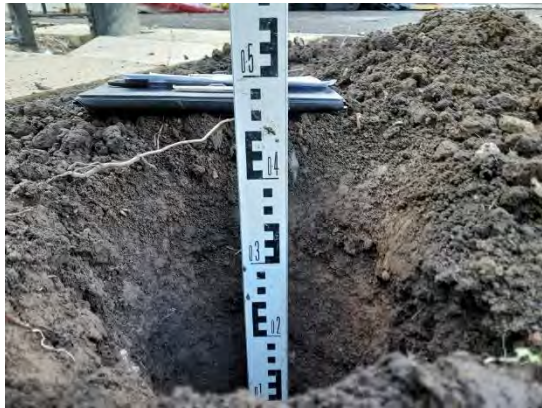
Photograph 58: View of rear garden in Plot 43.

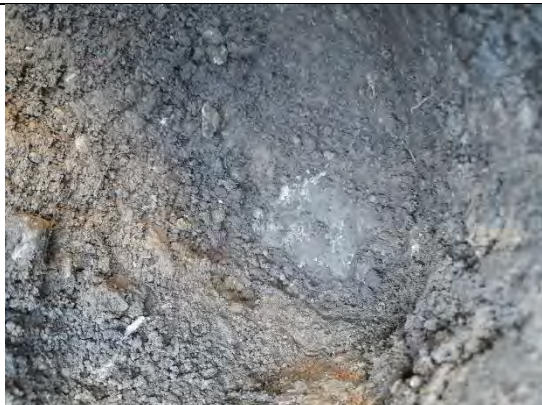
Photograph 59: View of depth of soil within the rear garden of Plot 43.

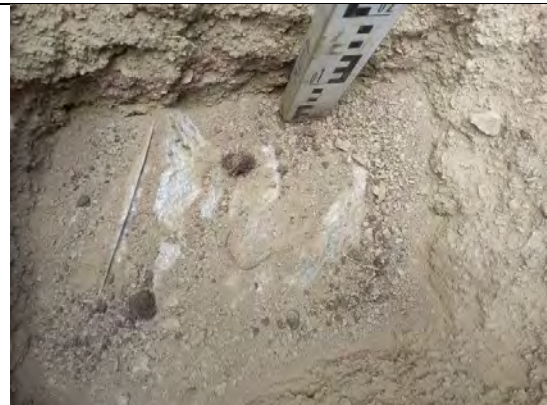
Photograph 57: View of soil within cover system and geotextile at base in front of Plot 43.

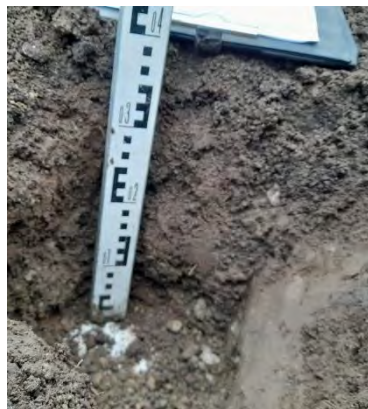
Photograph 64: View of rear garden in Plot 44.

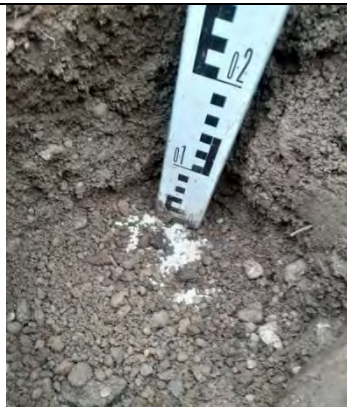
Photograph 65: View of depth of soil within the rear garden of Plot 44.

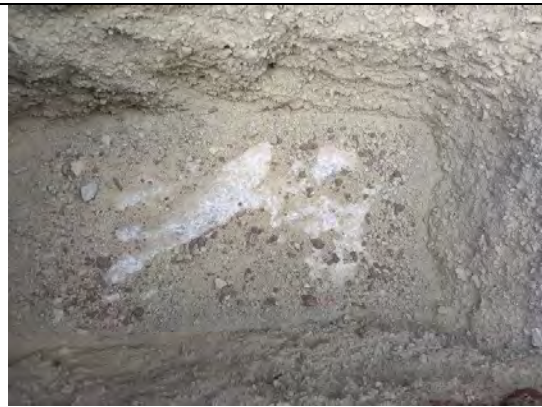
Photograph 63: View of soil within cover system and geotextile at base in front of Plot 44.

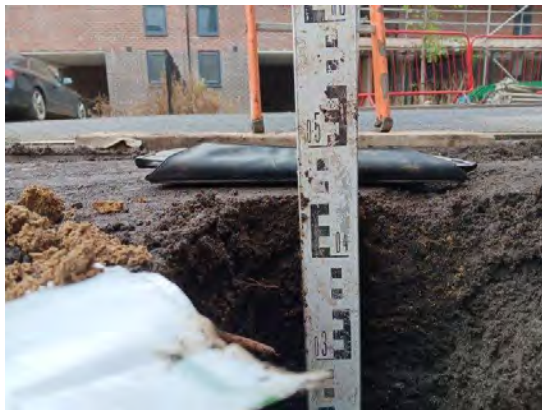
Photograph 70: View of rear garden in Plot 45.

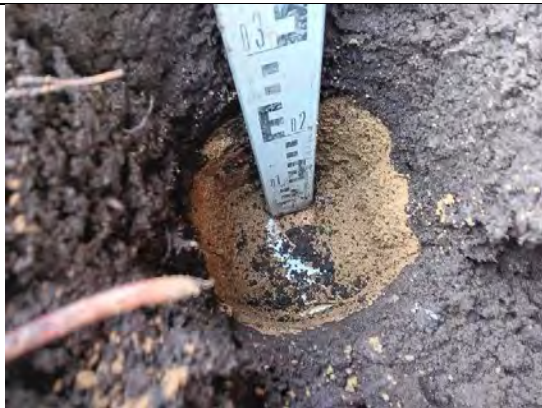
Photograph 71: View of depth of soil within the rear garden of Plot 45.

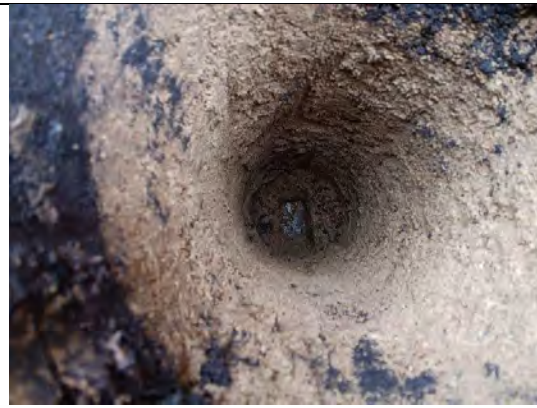
Photograph 69: View of soil within cover system and geotextile at base in front of Plot 45.

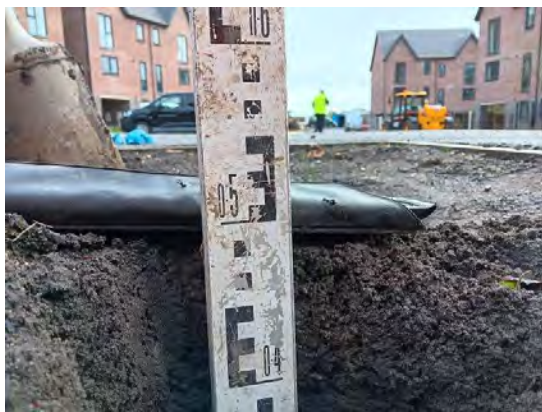
Photograph 76: View of rear garden in Plot 46.

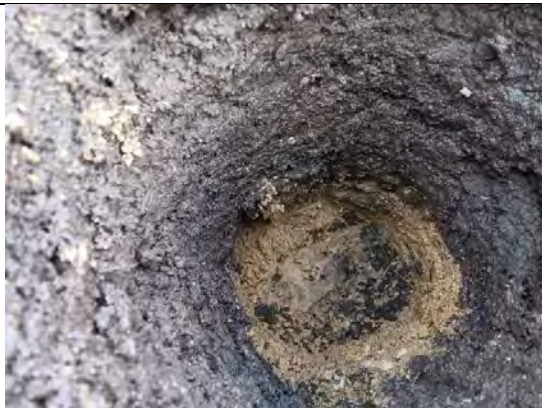
Photograph 77: View of depth of soil within the rear garden of Plot 46.

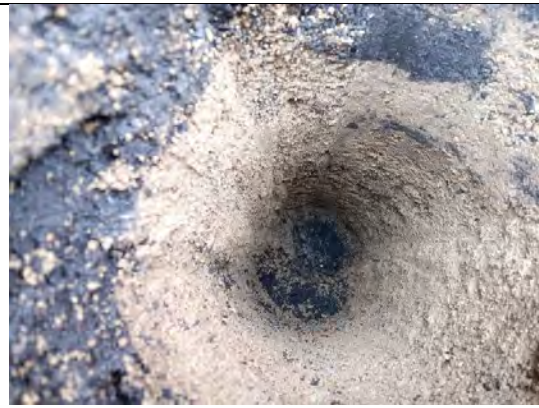
Photograph 75: View of soil within cover system and geotextile at base in front of Plot 46.

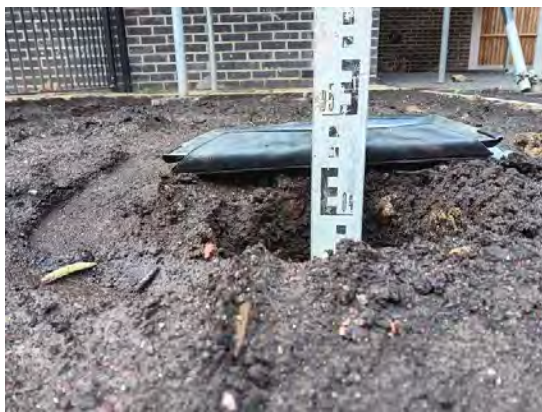
Photograph 86: View of depth of soil within the front garden of Plot 48.

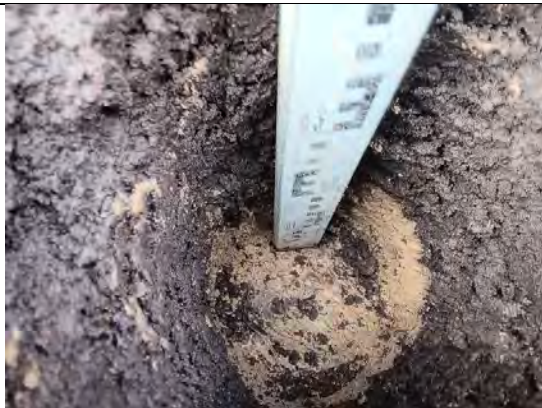
Photograph 87: View of soil within cover system and geotextile at base in front of Plot 48.

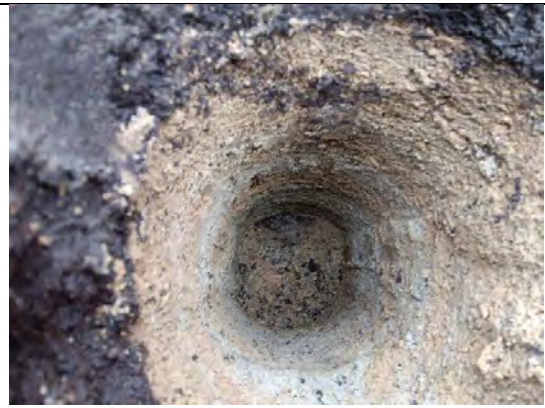
Photograph 90: View of soil within cover system and geotextile at base in rear of Plot 48.

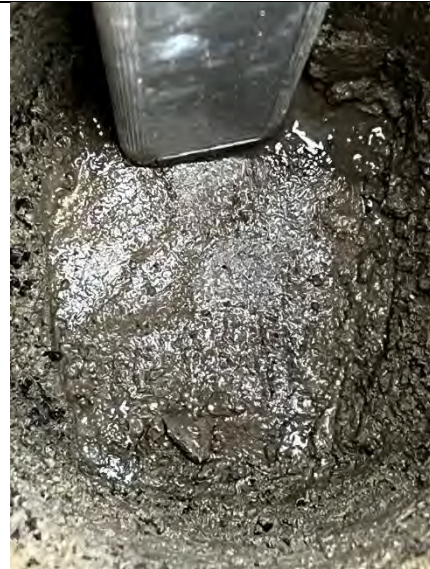
Photograph 96: View of soil within cover system and geotextile at base in rear of Plot 49.

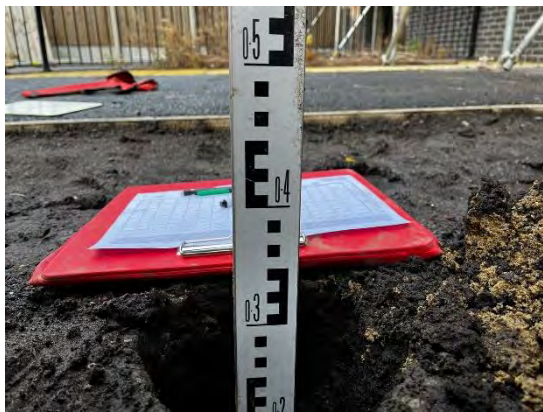
Photograph 98: View of depth of soil within the front garden of Plot 50.

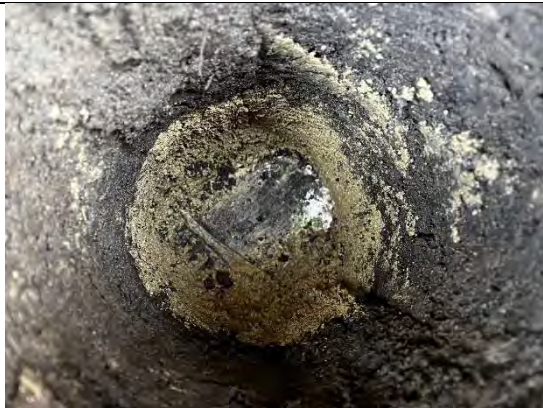
Photograph 99: View of soil within cover system and geotextile at base in front of Plot 50.

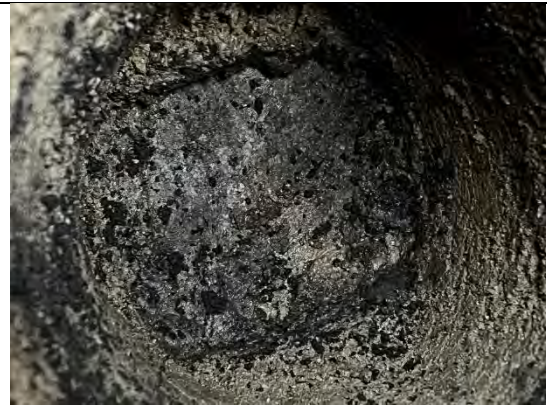
Photograph 102: View of soil within cover system and geotextile at base in rear of Plot 50.

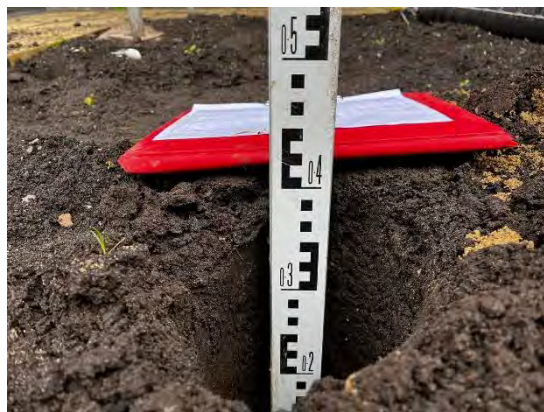
Photograph 104: View of depth of soil within the front garden of Plot 51.

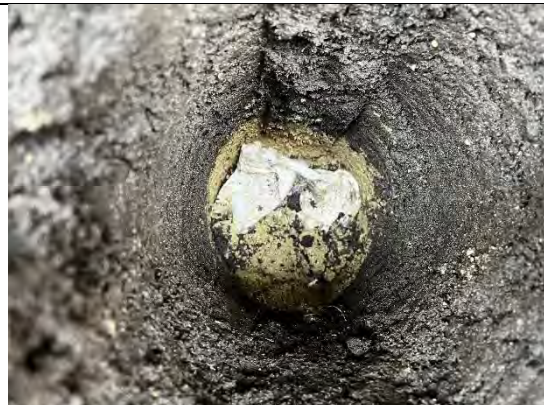
Photograph 105: View of soil within cover system and geotextile at base in front of Plot 51.

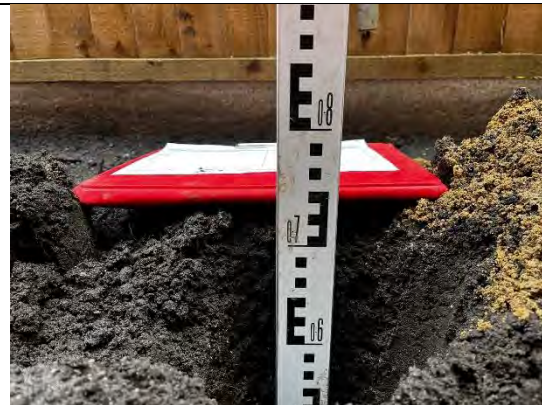
Photograph 108: View of soil within cover system and geotextile at base in rear of Plot 51.

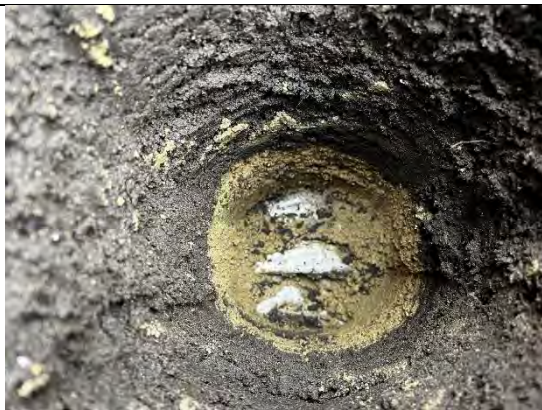
Photograph 111: View of soil within cover system and geotextile at base in front of Plot 52.

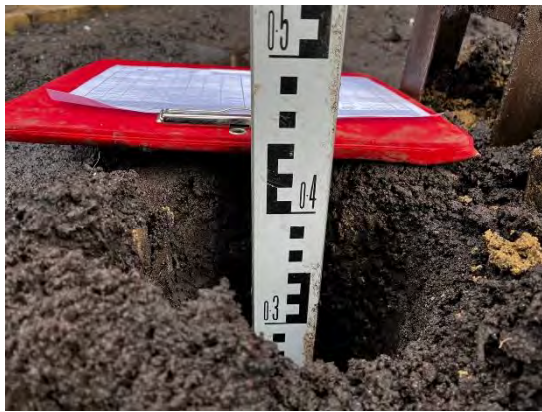
Photograph 114: View of depth of soil within the front garden of Plot 53.

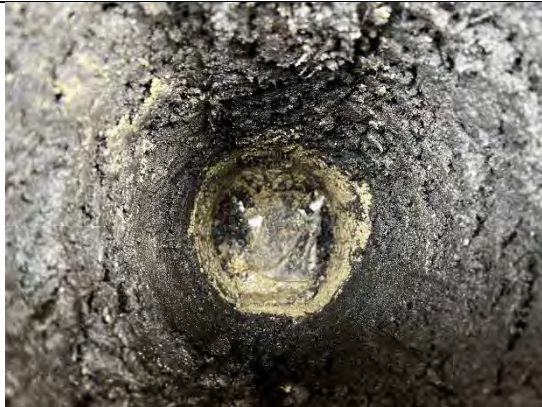
Photograph 115: View of soil within cover system and geotextile at base in front of Plot 53.

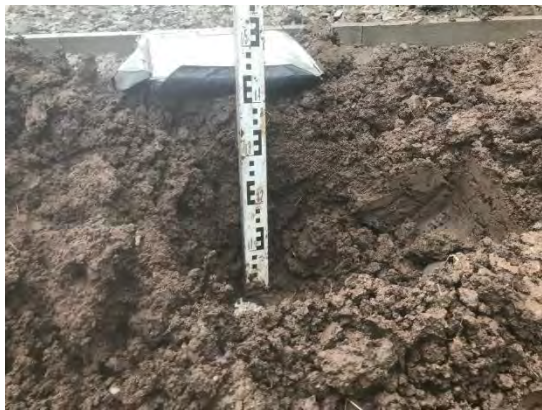
Photograph 119: View of depth of soil within the front gardens of Plot 54/55.

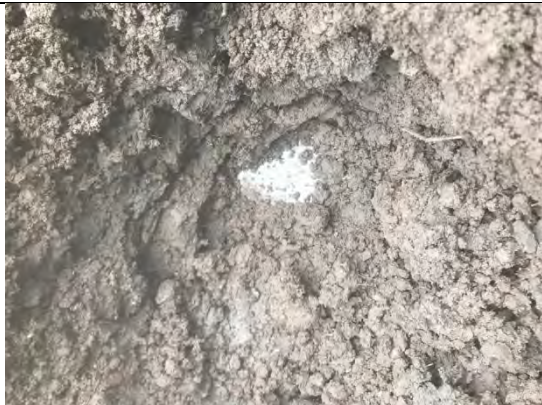
Photograph 120: View of soil within cover system and geotextile at base in front of Plots 54/55.

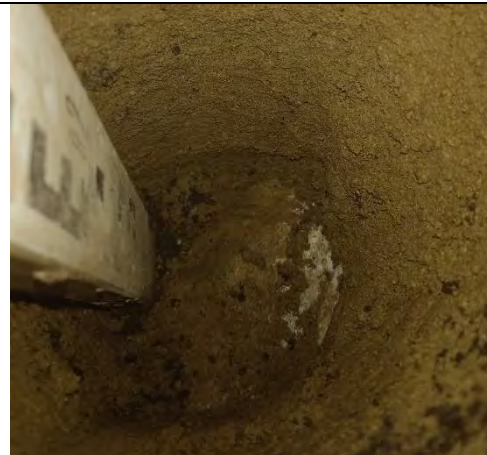
Photograph 133: View of soil within cover system and geotextile at base in rear of Plot 56.

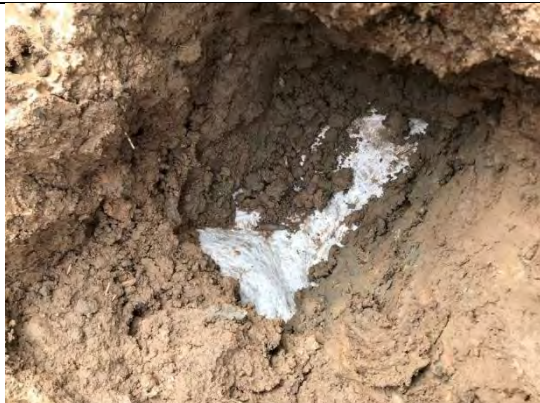
Photograph 136: View of soil within cover system and geotextile at base in front of Plots 57/58.

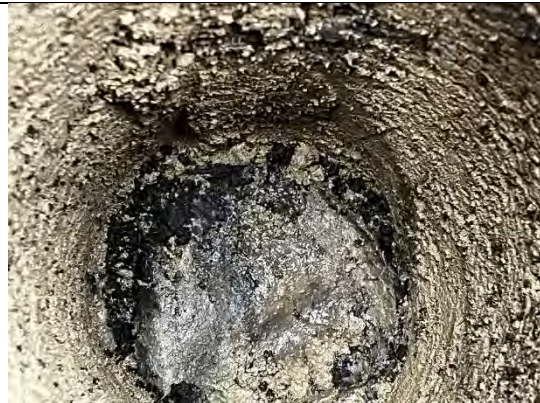
Photograph 139: View of soil within cover system and geotextile at base in rear of Plot 57.

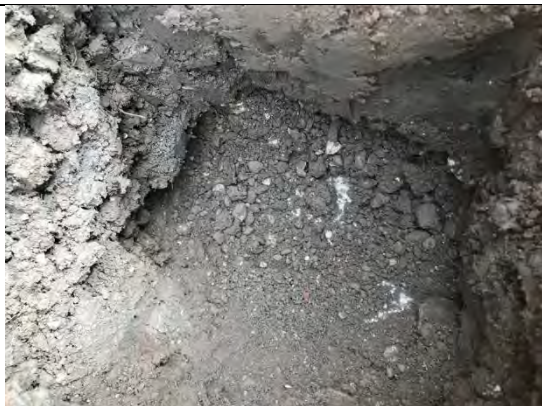
Photograph 142: View of soil within cover system and geotextile at base in front of Plots 58/59.

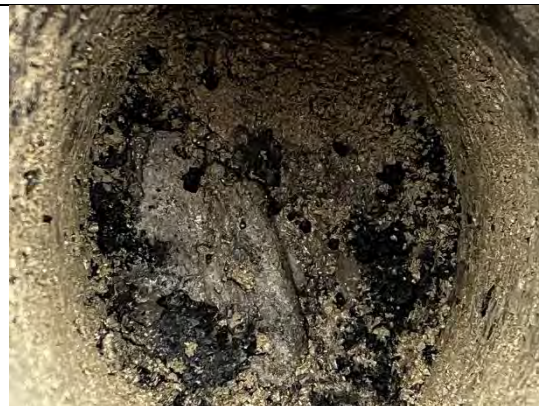
Photograph 145: View of soil within cover system and geotextile at base in rear of Plot 58.

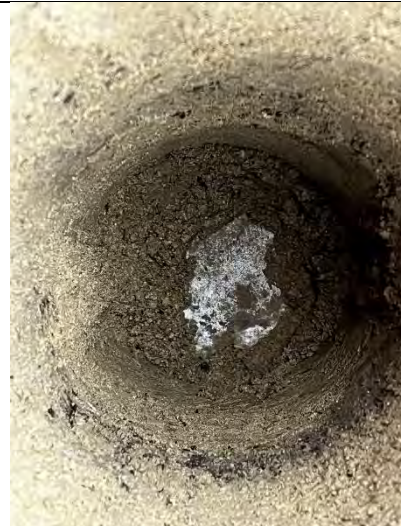
Photograph 151: View of soil within cover system and geotextile at base in rear of Plot 59.

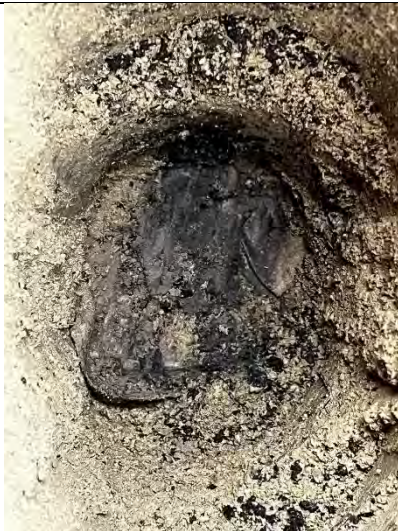
Photograph 154: View of soil within cover system and geotextile at base in rear of Plot 60.

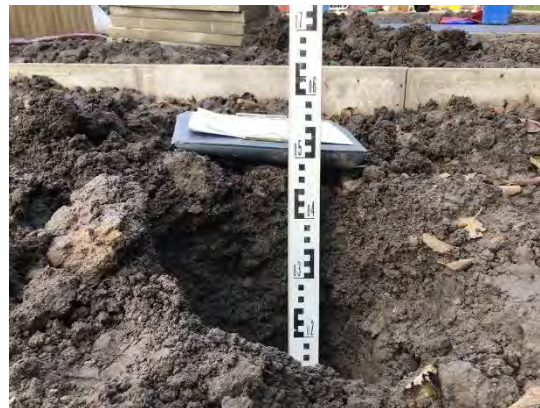
Photograph 162: View of depth of soil within the front garden of Plot 62.

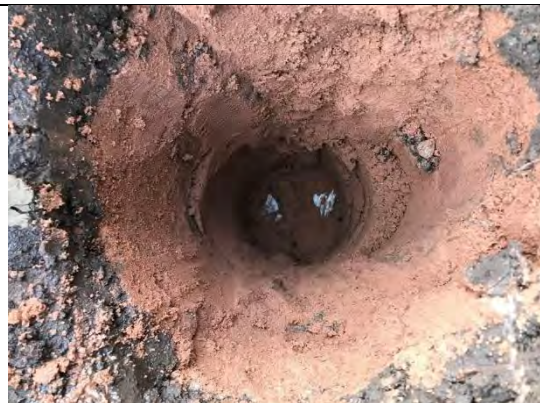
Photograph 160: View of soil within cover system and geotextile at base in rear of Plot 61.

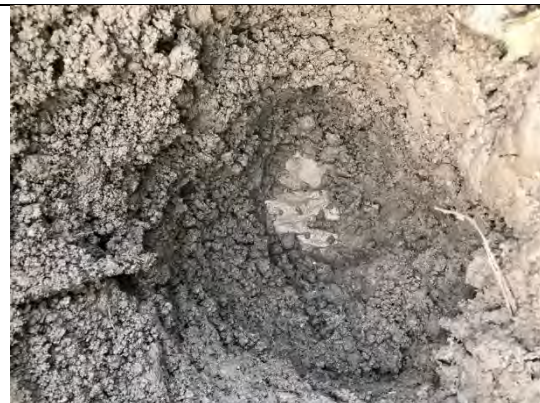
Photograph 163: View of soil within cover system and geotextile at base in front of Plot 62.

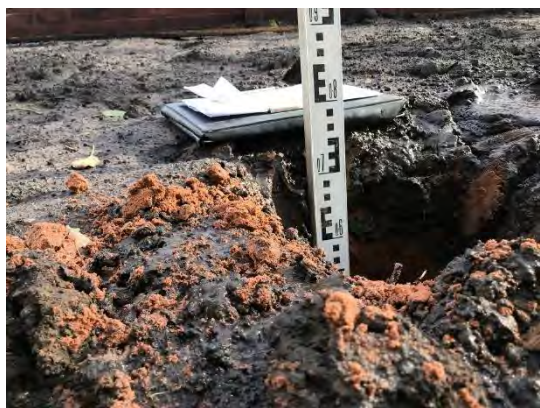
Photograph 165: View of depth of soil within the rear garden (N) of Plot 62

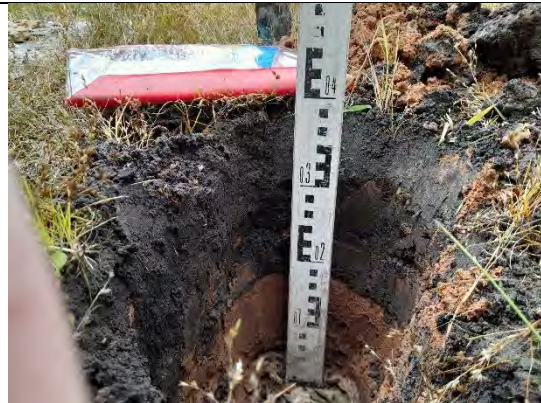
Photograph 168: View of depth of soil within the rear garden (S) of Plot 62

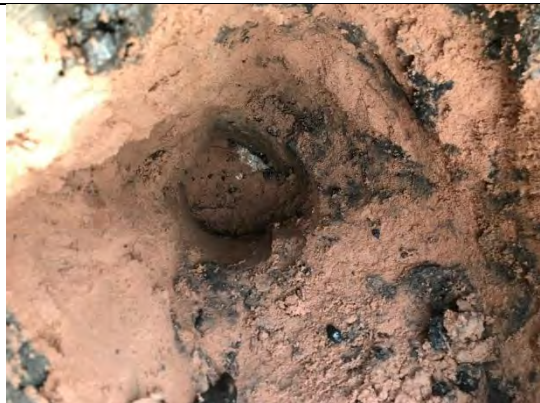
Photograph 166: View of soil within cover system and geotextile at base in rear (N) of Plot 62.

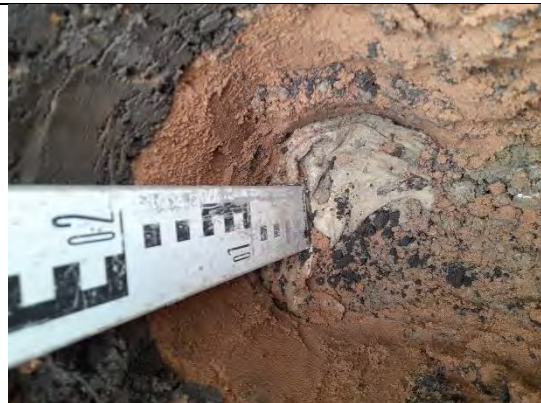
Photograph 169: View of soil within cover system and geotextile at base in rear (S) of Plot 62.

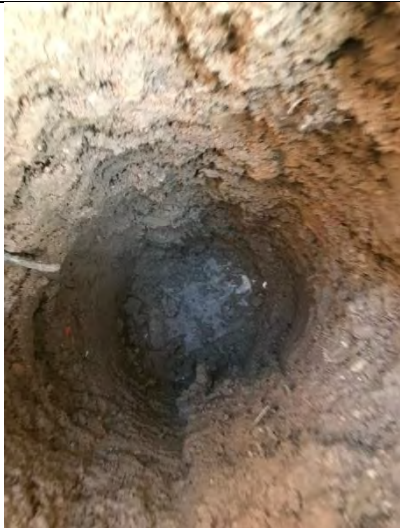
Photograph 172: View of soil within cover system and geotextile at base of shared soft landscaping A1.

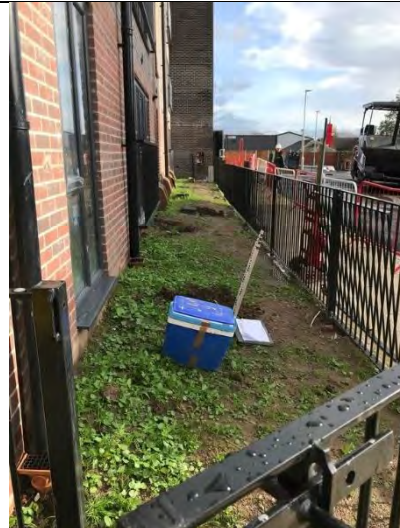
Photograph 174: View of soil within cover system and geotextile at base of shared soft landscaping A2.

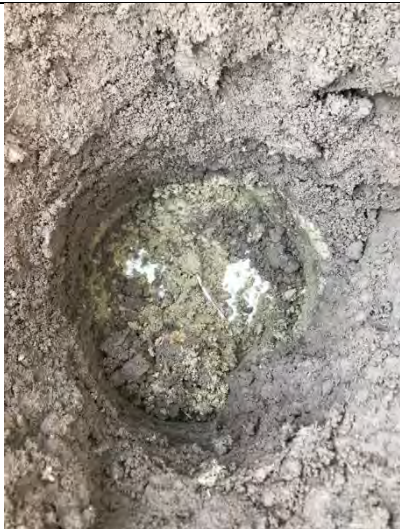
Photograph 177: View of soil within cover system and geotextile at base of shared soft landscaping A3.

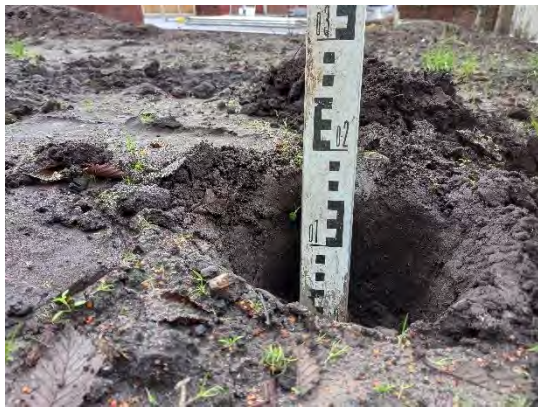
Photograph 182: View of depth of soil within the shared soft landscaping B2.

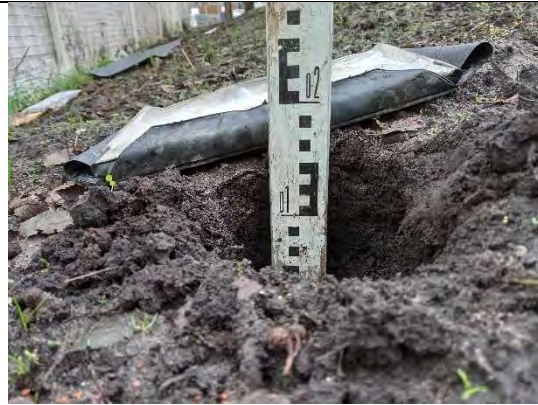
Photograph 185: View of depth of soil within the shared soft landscaping B3.

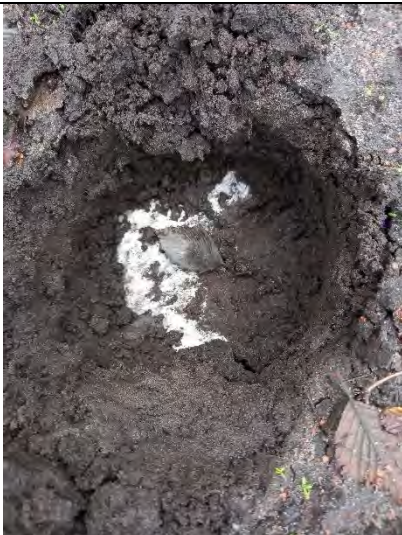
Photograph 183: View of soil within cover system and geotextile at base of shared soft landscaping B2.

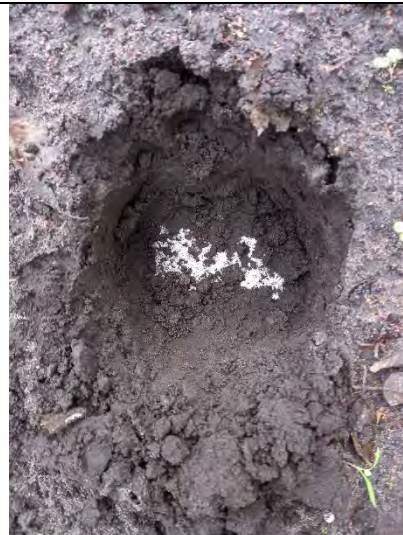
Photograph 186: View of soil within cover system and geotextile at base of shared soft landscaping B3.

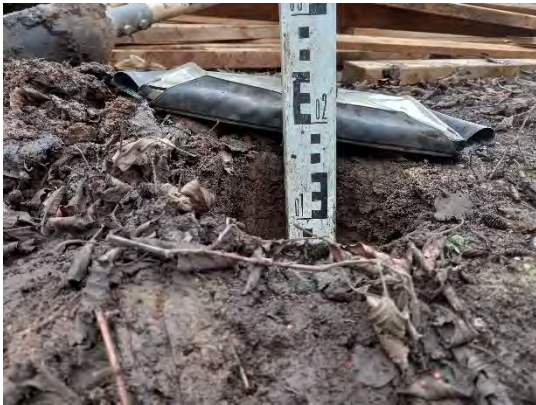
Photograph 188: View of depth of soil within the shared soft landscaping B4.

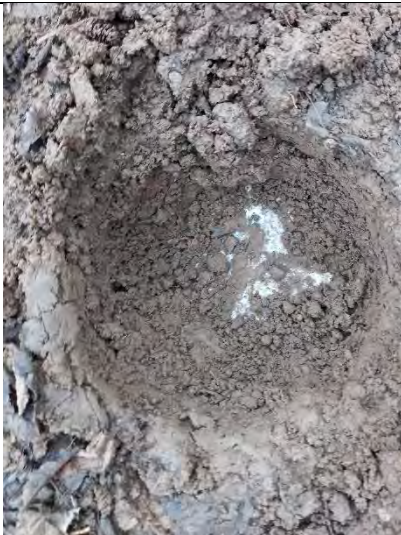
Photograph 189: View of soil within cover system and geotextile at base of shared soft landscaping B4.

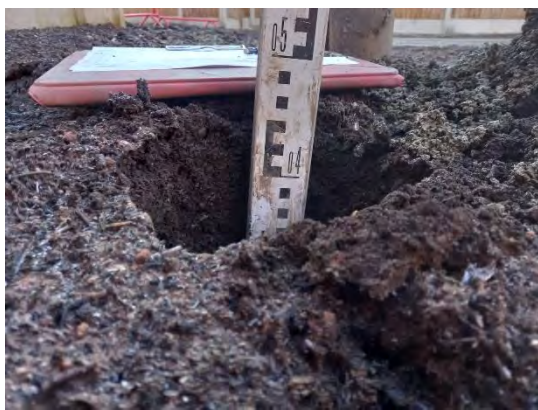
Photograph 194: View of depth of soil within the shared soft landscaping C2.

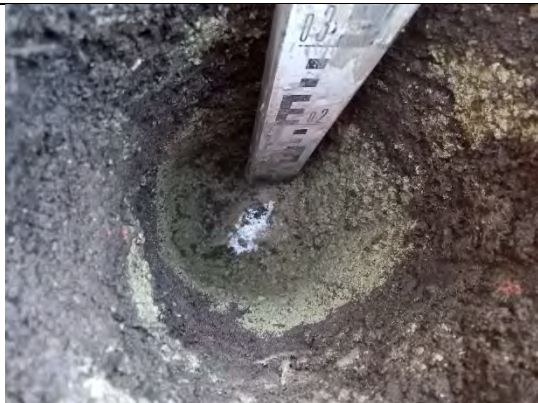
Photograph 195: View of soil within cover system and geotextile at base of shared soft landscaping C2.
