Site: Fairfield Road, Droylsden
Plots: Ground Floor of Apartment Block (Plots 1-9) & Plots 37-62
Date: 23rd November 2023
LKC Ref.: CL-602-LKC 20 1791-02 Plots 1-9 & 37-62 R1

GAS MEMBRANE VALIDATION REPORT

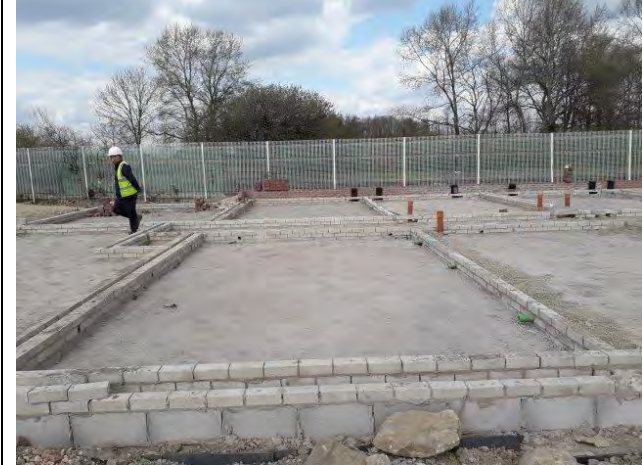
Photograph 5:
Evidence of sub-floor void in Plot 1.

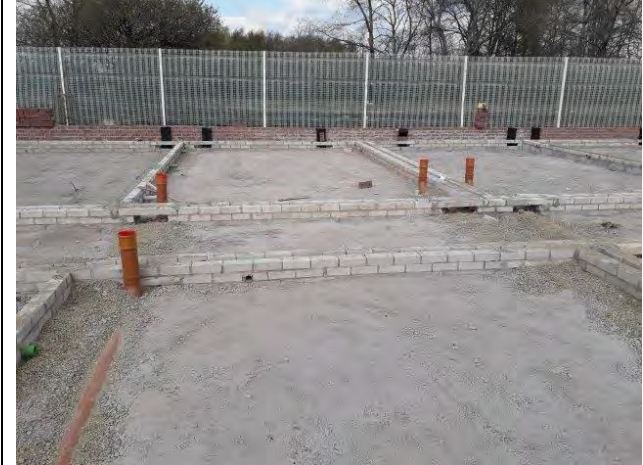
Photograph 5:
Evidence of sub-floor void in Plot 3.

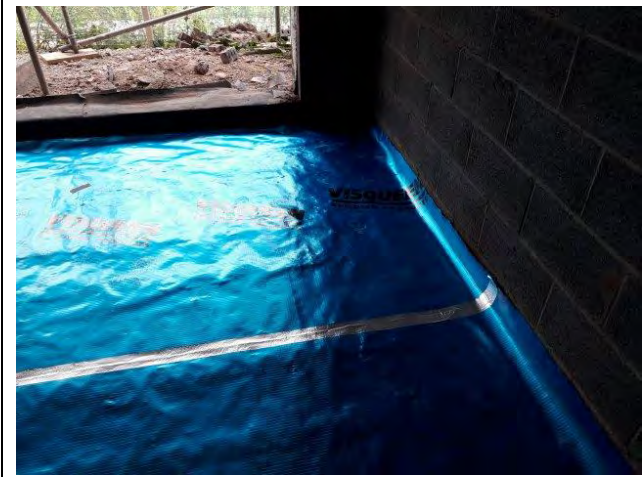
Photograph 3:
Evidence of appropriate sealing of membrane to DPC with appropriate overlap for Plot 4.

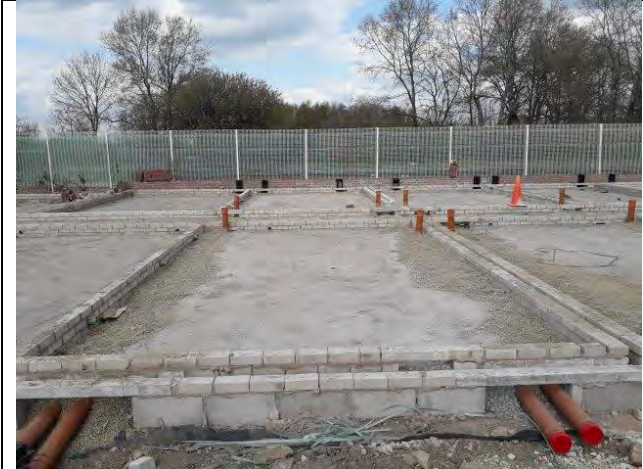
Photograph 5:
Evidence of sub-floor void in Plot 4.

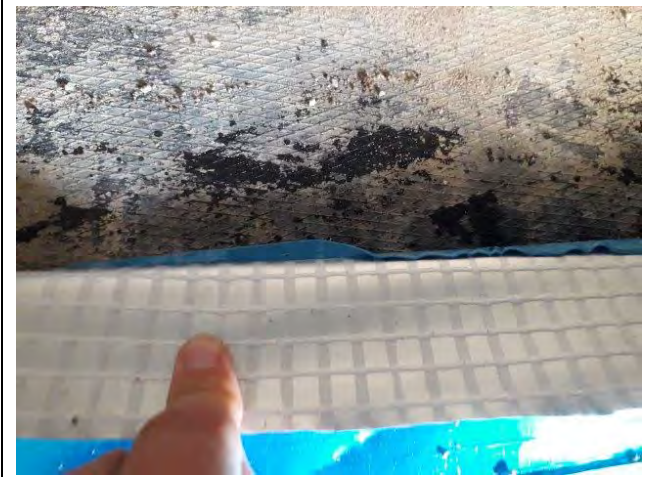
Photograph 3:
Evidence of appropriate sealing of membrane to DPC with appropriate overlap for Plot 8.

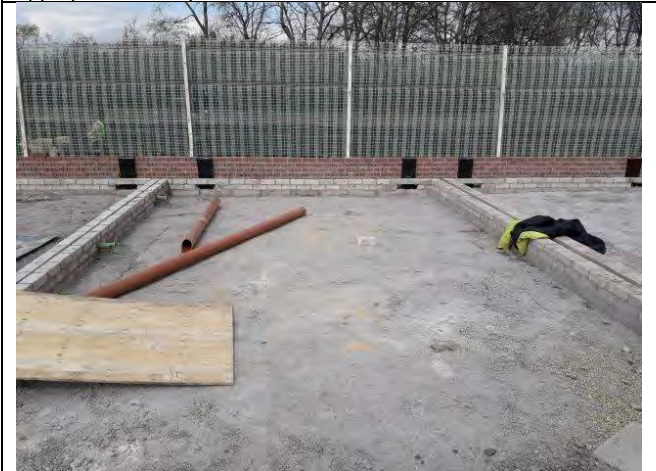
Photograph 5:
Evidence of sub-floor void in Plot 8.

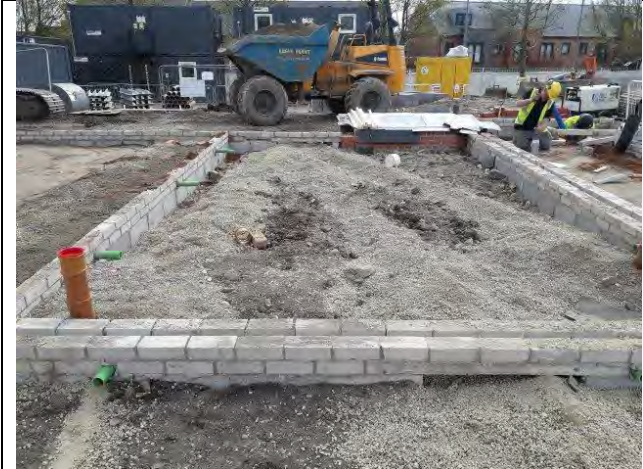
Photograph 5:
Evidence of sub-floor void in Plot 9.

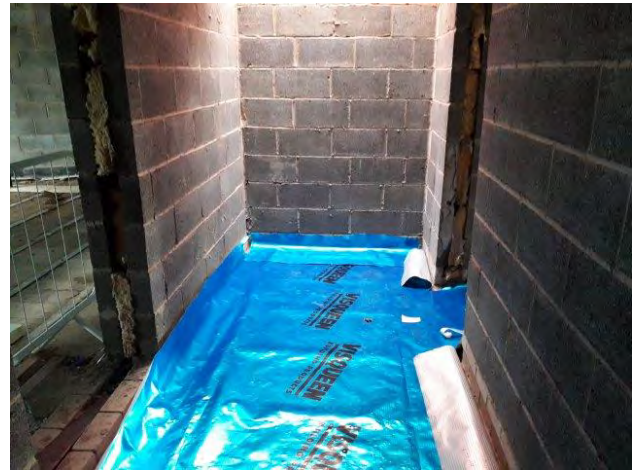
Photograph 2:
Evidence of gas membrane coverage across corridor.

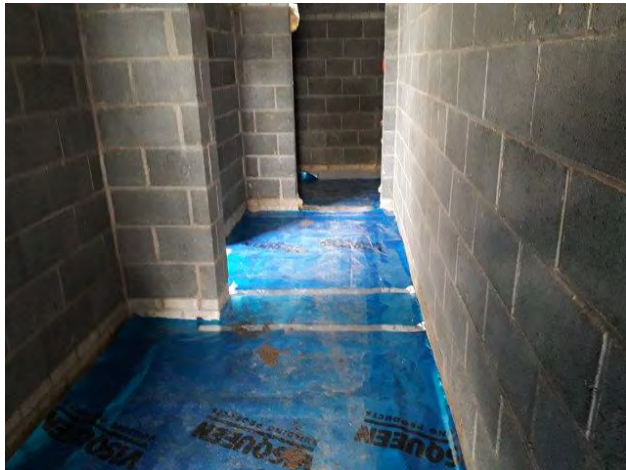
Photograph 3:
Evidence of gas membrane coverage across corridor.

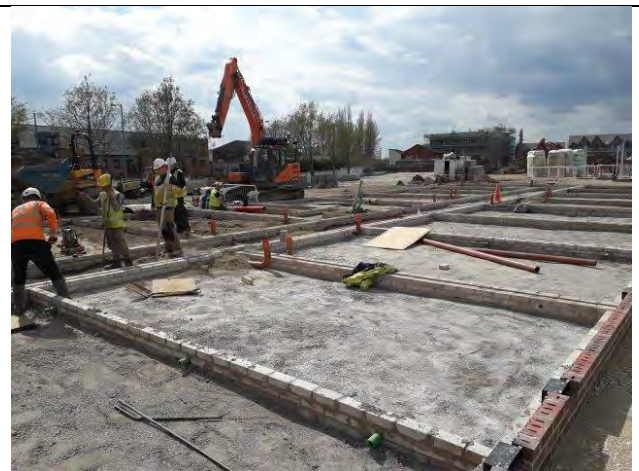
Photograph 6:
Evidence of sub-floor void across apartment block.

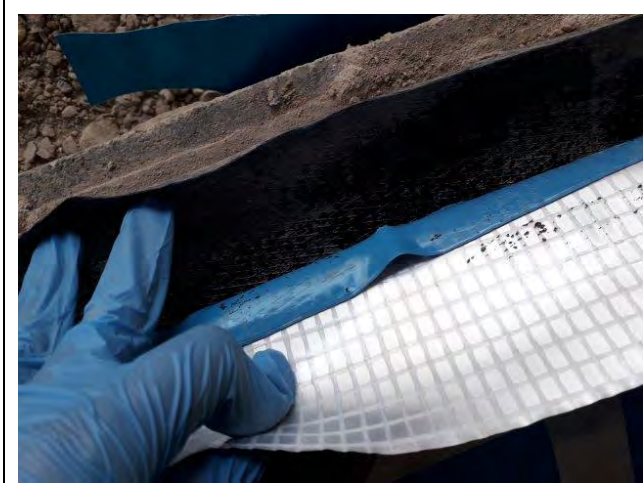
Photograph 3:
Evidence of appropriate sealing of membrane to DPC with appropriate overlap for Plot 37.

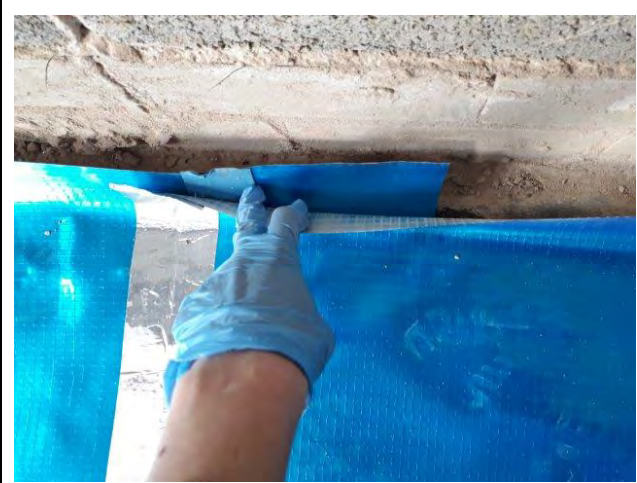
Photograph 4:
Evidence of appropriate overlap of the membrane for Plot 37.

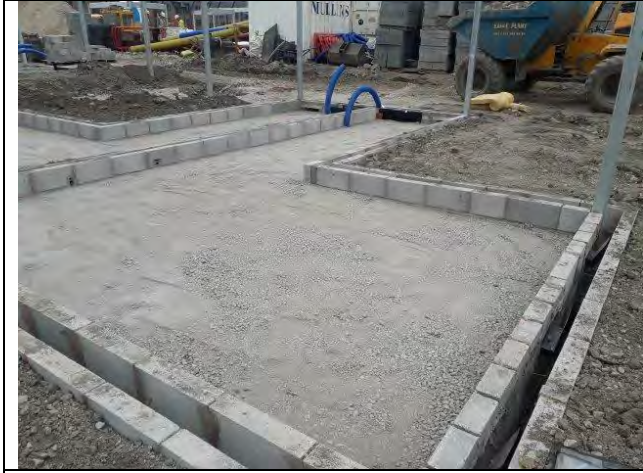
Photograph 5:
Evidence of sub-floor void in Plot 37.

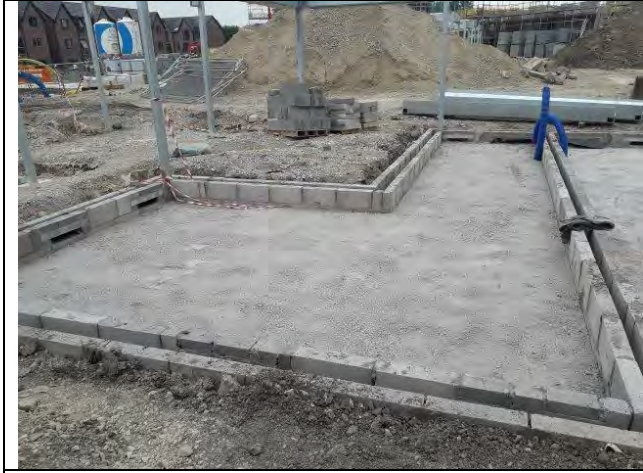
Photograph 5:
Evidence of sub-floor void in Plot 42.

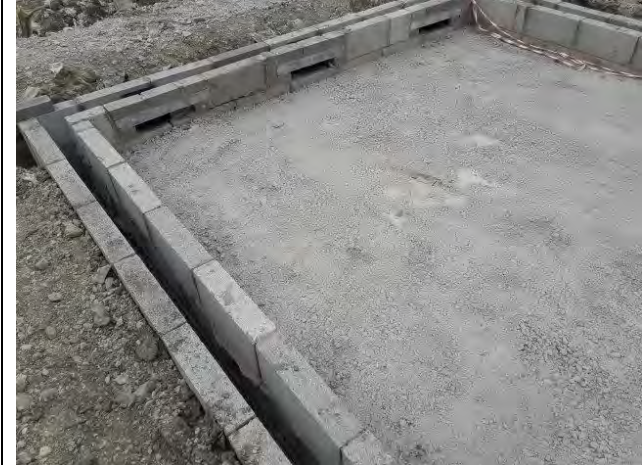
Photograph 5:
Evidence of sub-floor void in Plot 43.

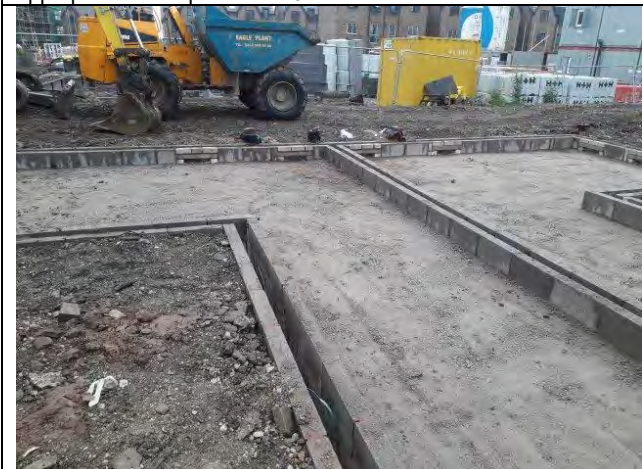
Photograph 5:
Evidence of sub-floor void in Plot 45.

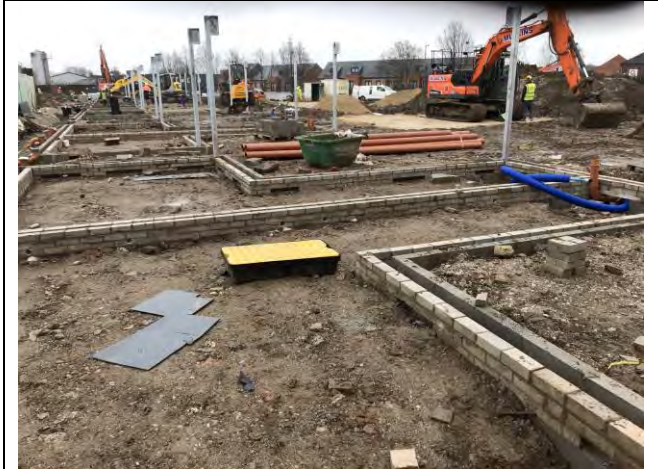
Photograph 5:
Evidence of sub-floor void in Plot 49.

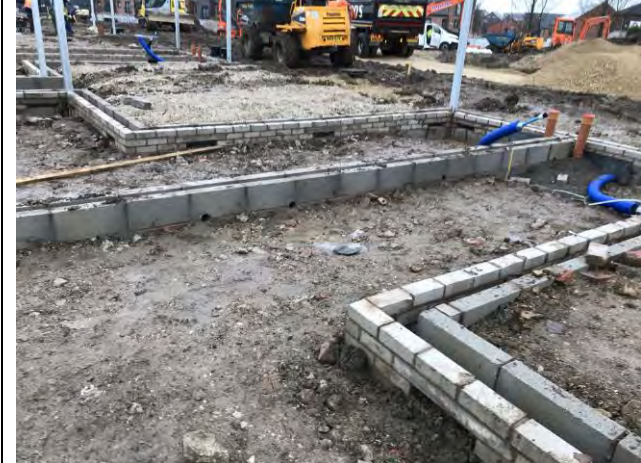
Photograph 5:
Evidence of sub-floor void in Plot 50.

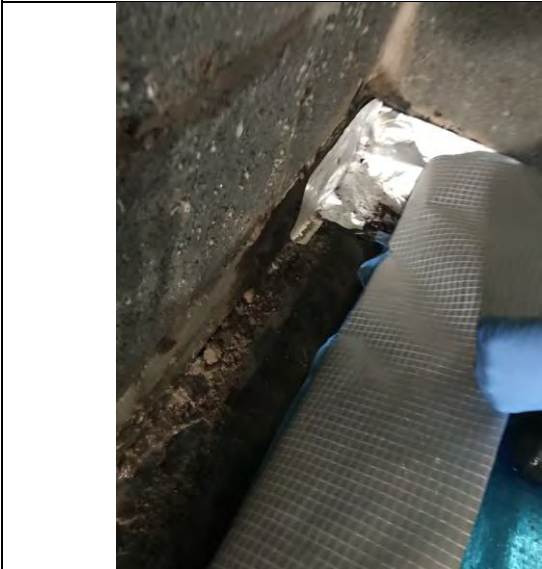
Photograph 3:
Evidence of appropriate sealing of membrane to DPC with appropriate overlap for Plot 51.

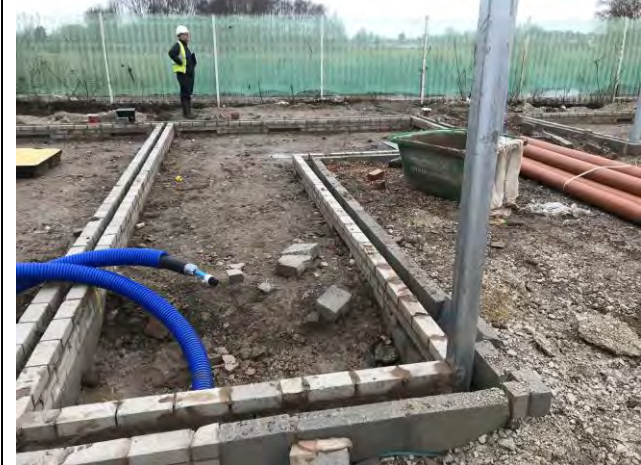
Photograph 5:
Evidence of sub-floor void in Plot 51.

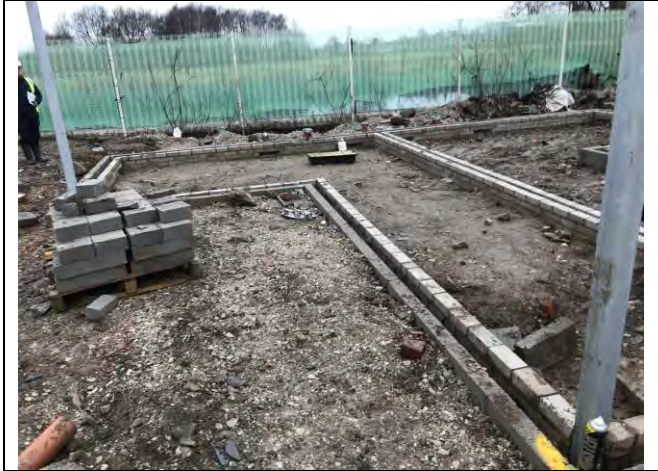
Photograph 5:
Evidence of sub-floor void in Plot 52.

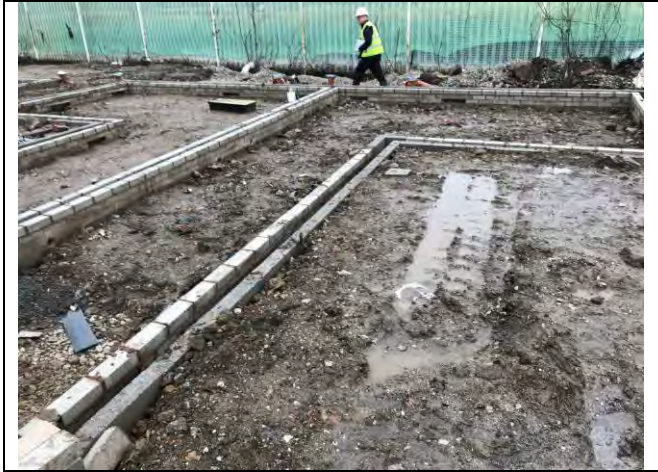
Photograph 5:
Evidence of sub-floor void in Plot 53.

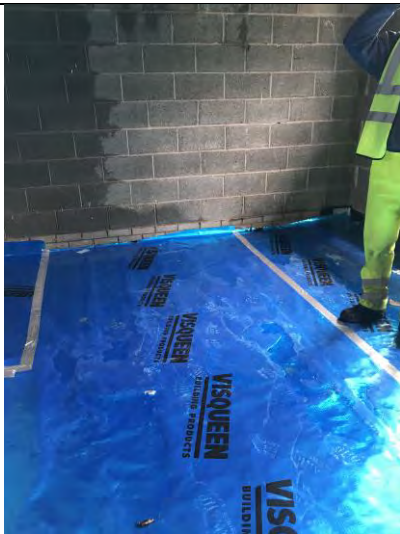
Photograph 1:
Evidence of gas membrane coverage across Plot 54.

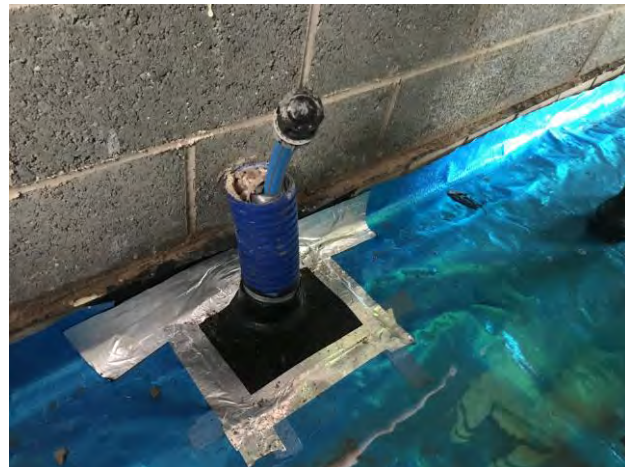
Photograph 2:
Evidence of appropriate sealing around services for Plot 54.

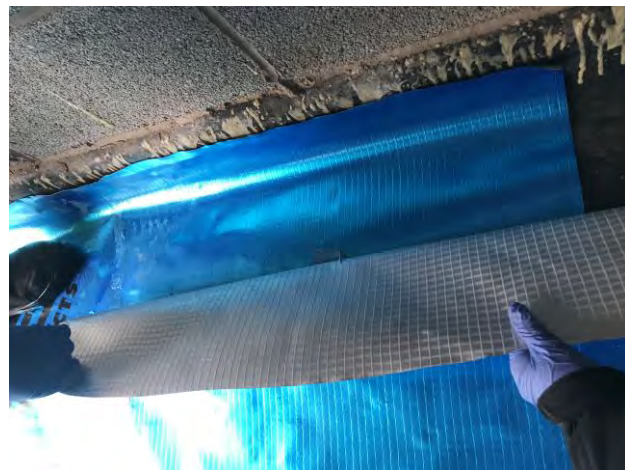
Photograph 4:
Evidence of appropriate overlap of the membrane for Plot 54.

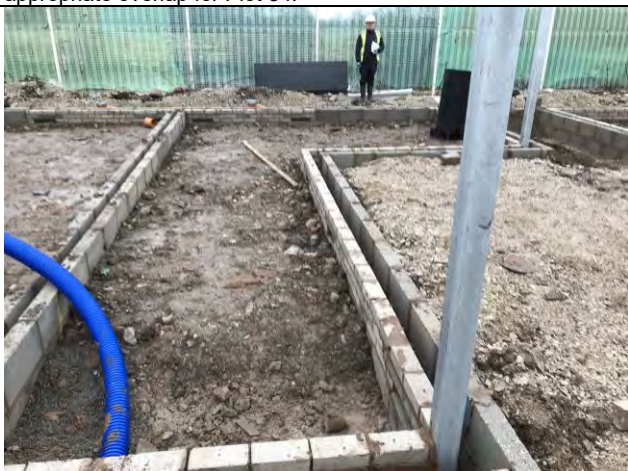
Photograph 5:
Evidence of sub-floor void in Plot 54.

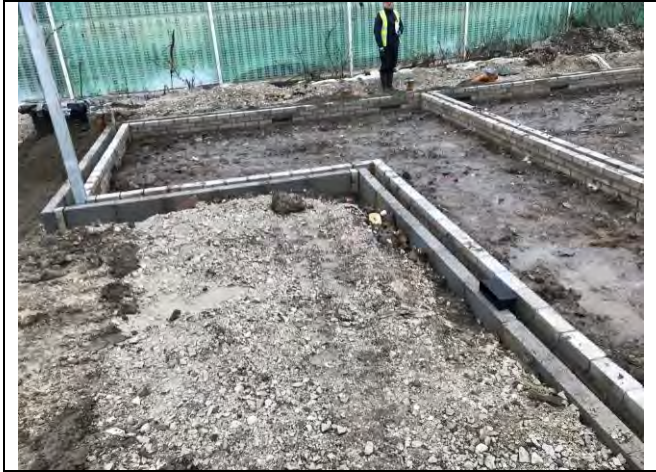
Photograph 5:
Evidence of sub-floor void in Plot 55.

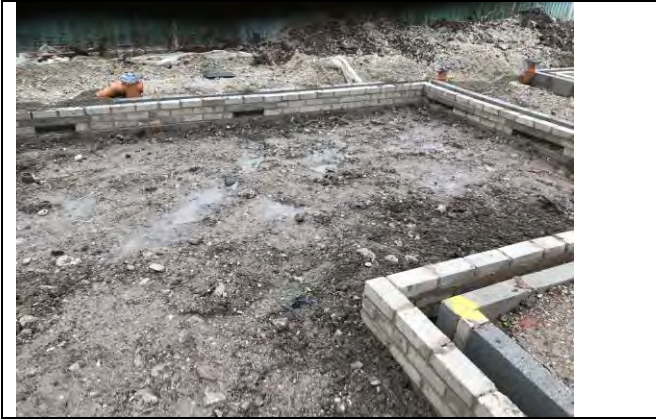
Photograph 5:
Evidence of sub-floor void in Plot 56.

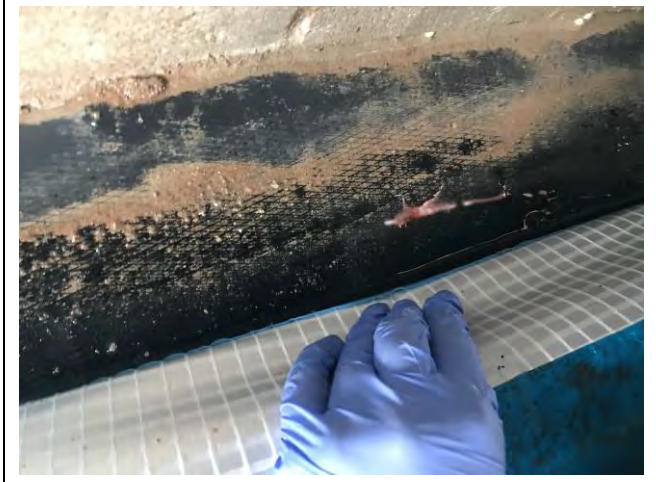
Photograph 3:
Evidence of appropriate sealing of membrane to DPC with appropriate overlap for Plot 57.

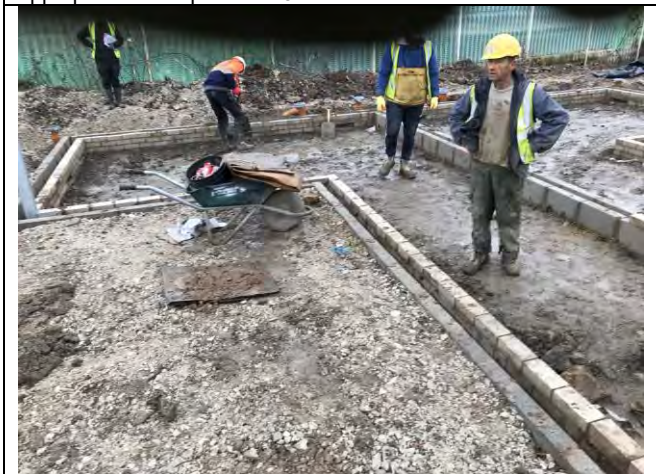
Photograph 5:
Evidence of sub-floor void in Plot 57.

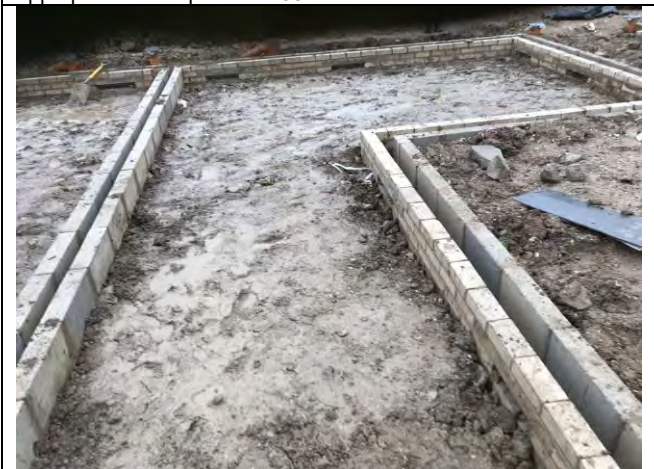
Photograph 5:
Evidence of sub-floor void in Plot 58.

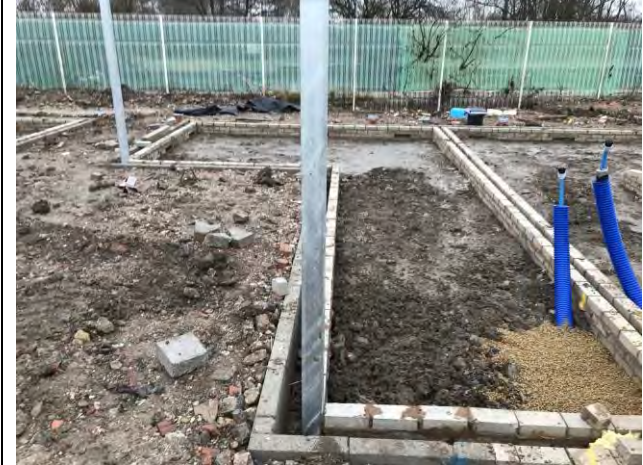
Photograph 5:
Evidence of sub-floor void in Plot 59.

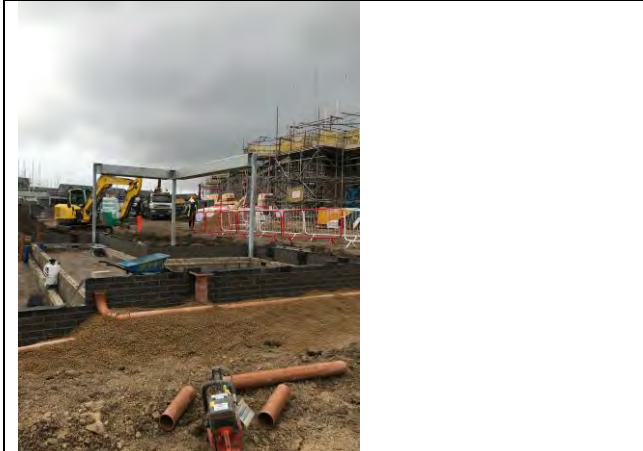
Photograph 5:
Evidence of sub-floor void in Plot 61.
