Arboricultural Consultancy for Lloyds Bank

1. Case Details

Insured	Mr Mark Buckley	Address	11 Butts Lane, Egglecliffe, Stockton-on-Tees, TS16 9BT		
Client	Subsidence Management Services	Contact	Stephen Rutherford	Claim No.	IFS-LBG-SUB-22-0102249
ES Ref	SA-250976	Consultant	Giles Mercer	Contact No.	0330 380 1036
Report Date	18/11/2022

11 Butts Lane, Egglecliffe, Stockton-on-Tees, TS16 9BT

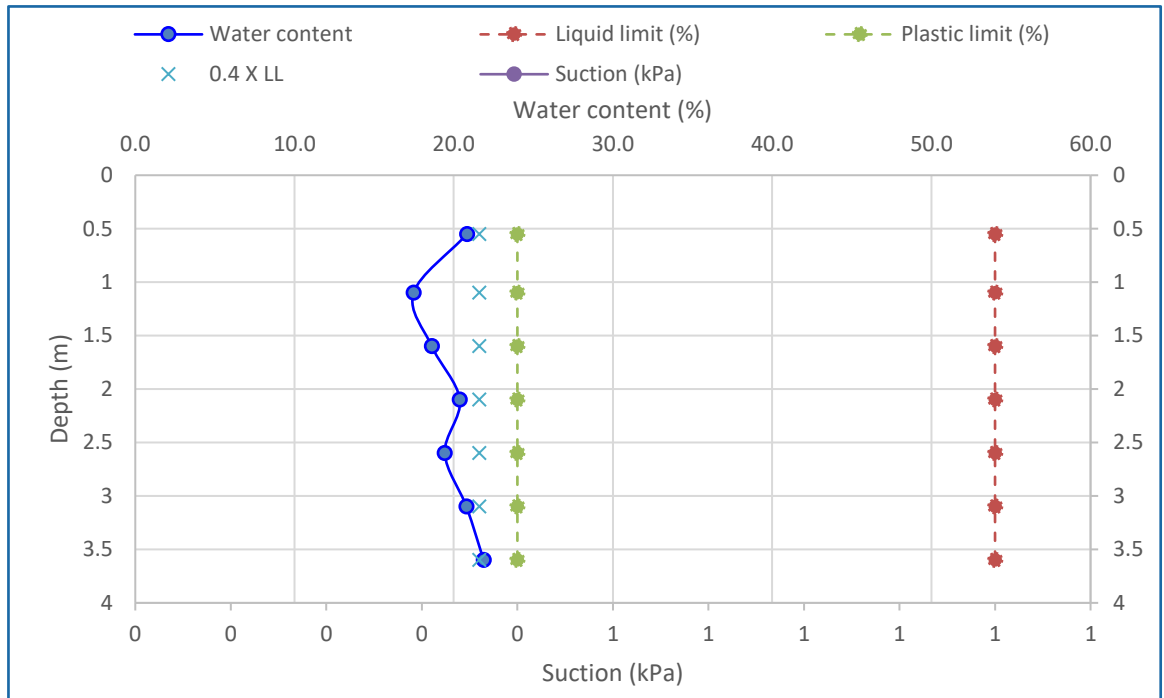
Plasticity Chart for Casagrande Classification

Lab Ref	Depth (m)	WC (%)	LL (%)	PL (%)	PI (%)	.425 mm(%)	mod. PI (%)	Av. Suc. (kPa)	Description
1	0.55	20.8	54	24	30	95	29		Firm brown/orange-brown/light grey/white silty CLAY with rare gravel and sand. Gravel is fine
2	1.1	17.5	54	24	30	95	29		Firm brown/orange-brown/light grey/white silty CLAY with rare gravel and sand. Gravel is fine
3	1.6	18.6	54	24	30	95	29		Firm brown/orange-brown/light grey/white silty CLAY with rare gravel and sand. Gravel is fine
4	2.1	20.4	54	24	30	95	29		Firm brown/orange-brown/light grey silty CLAY with rare gravel and sand. Gravel is fine
5	2.6	19.4	54	24	30	95	29		Firm brown/dark brown/light grey silty CLAY with rare gravel and sand. Gravel is fine
6	3.1	20.8	54	24	30	95	29		Firm brown/dark brown/light grey silty CLAY with rare gravel and sand. Gravel is fine
7	3.6	21.9	54	24	30	95	29		Firm brown/dark brown/light grey silty CLAY with rare gravel and sand. Gravel is fine
