Templar Consultants

Report

**Flat 8
46 Lancaster Gate
London
W2 3NA
(‘the property’)**

13 February 2021

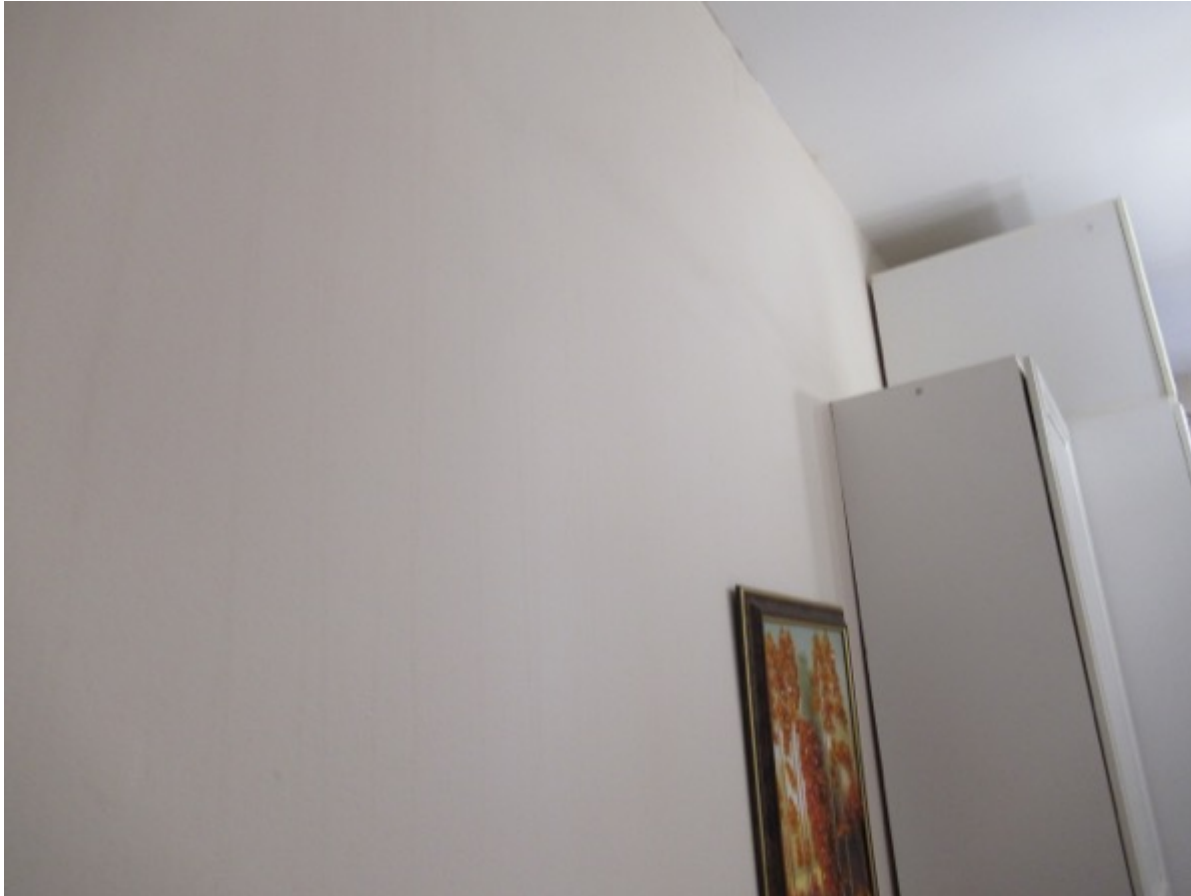
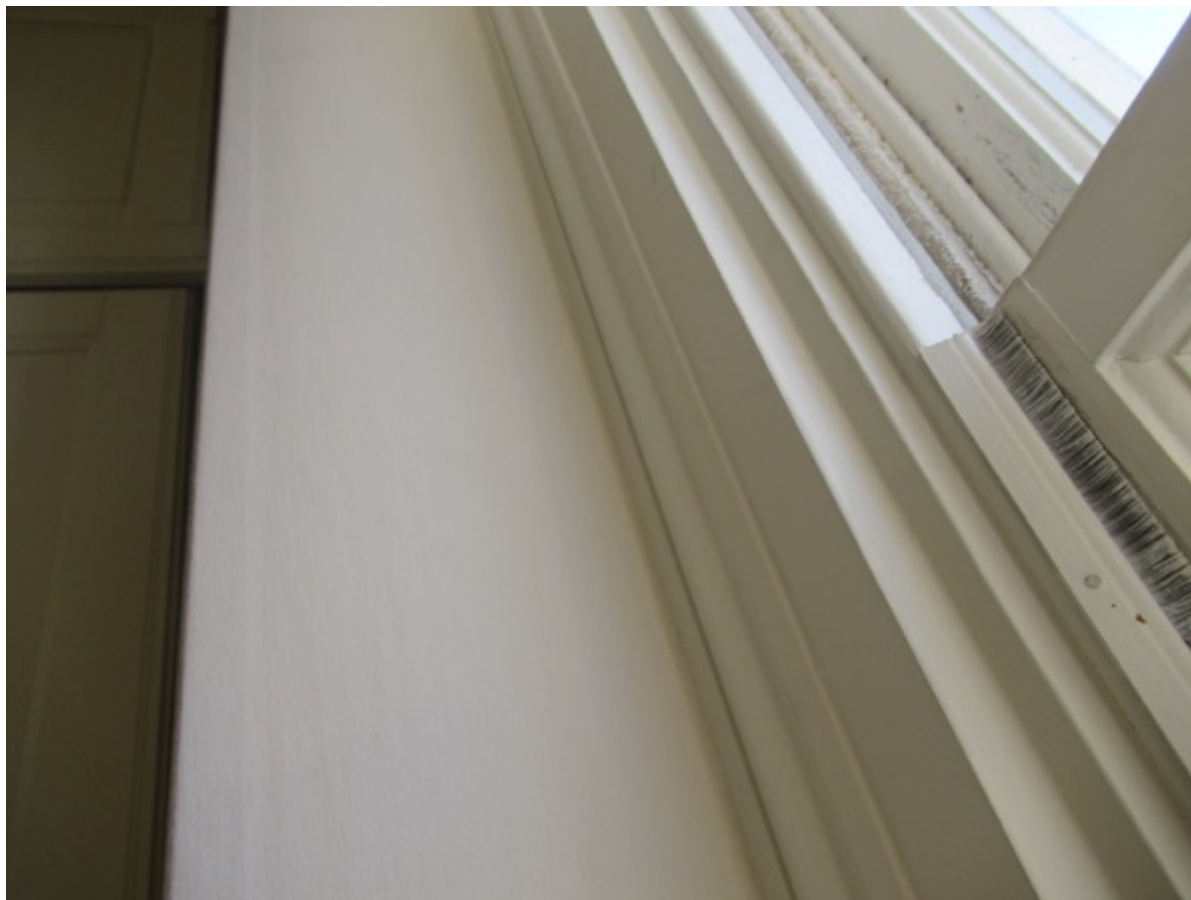
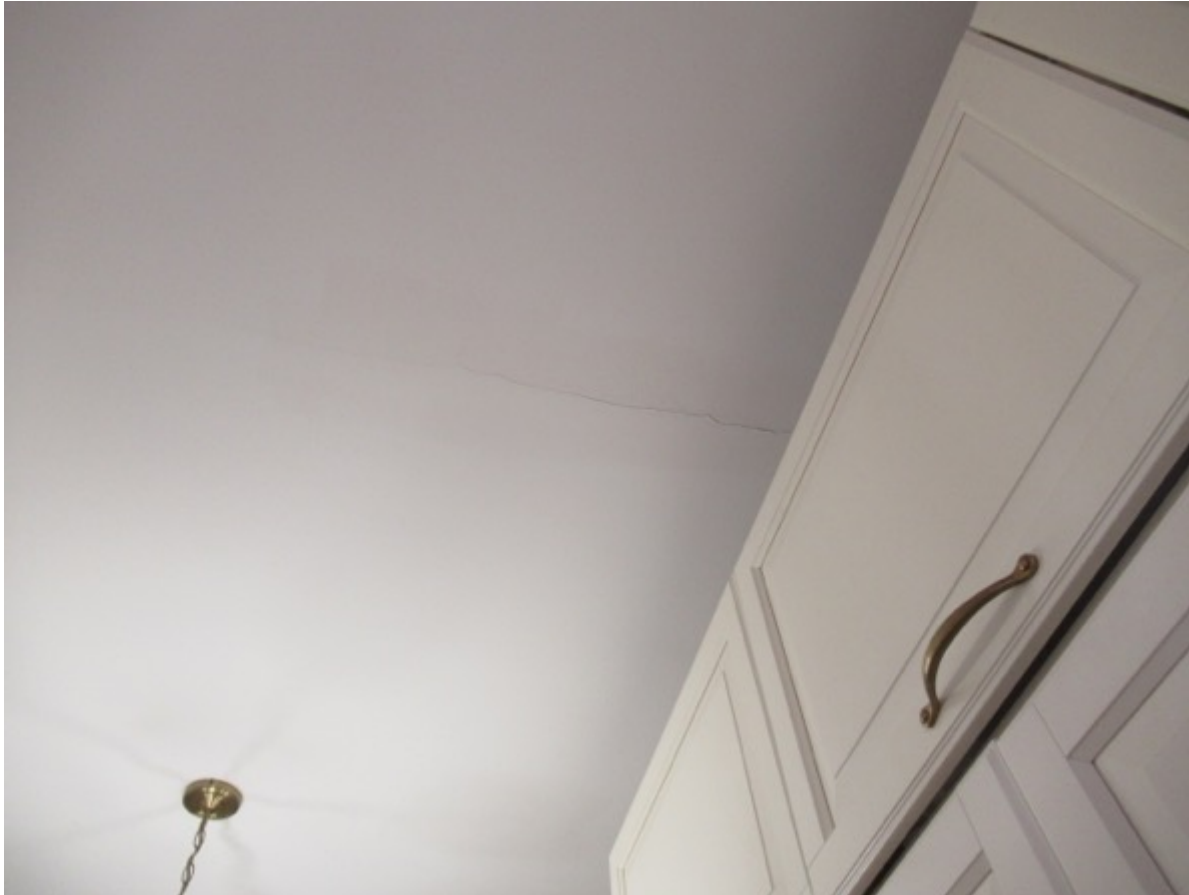
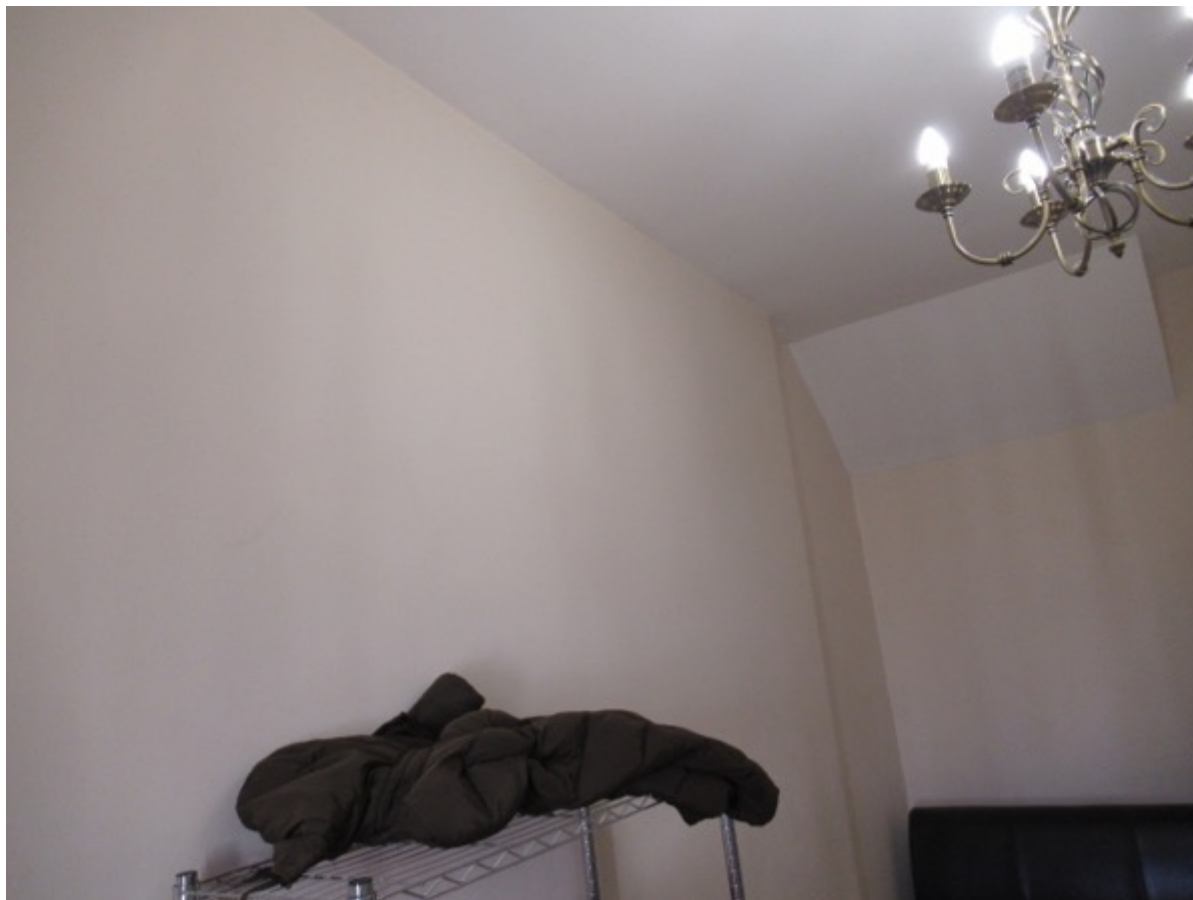
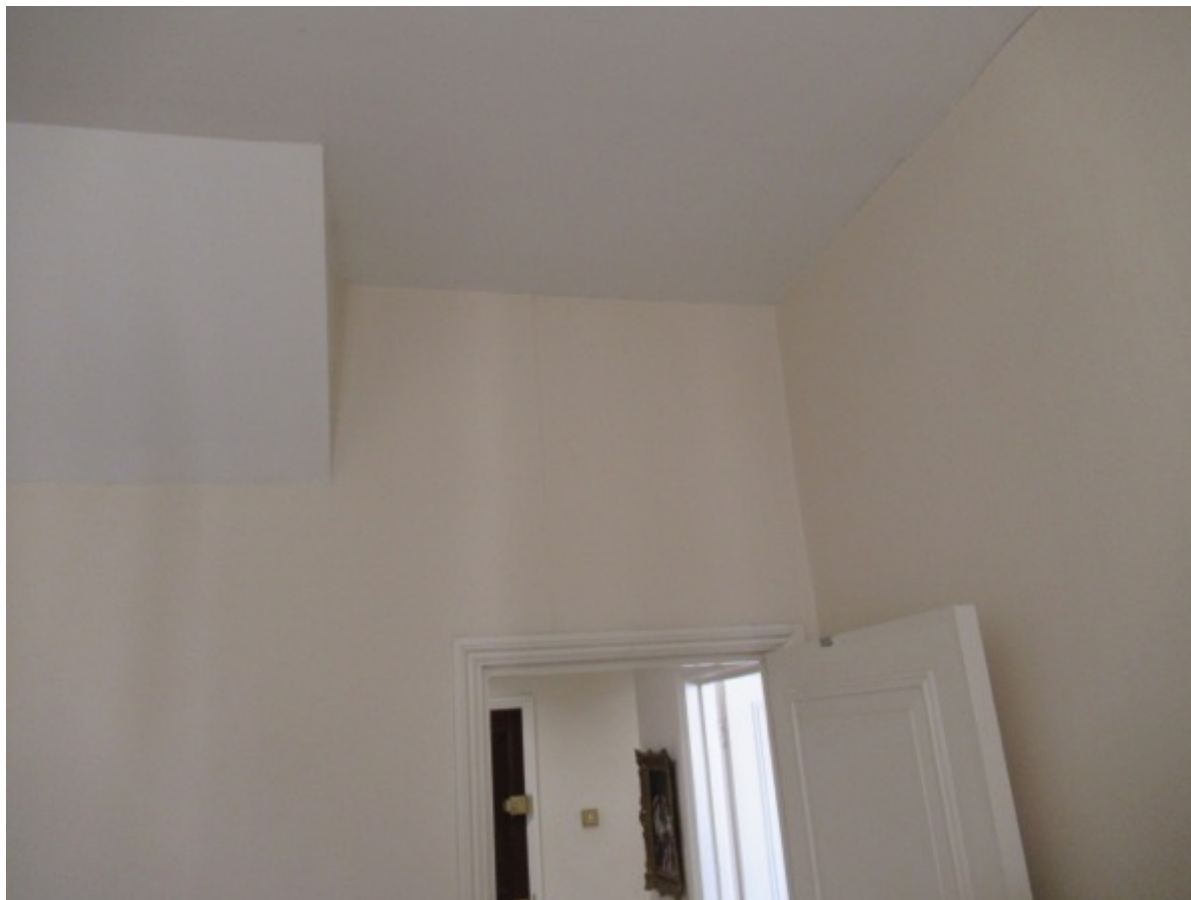
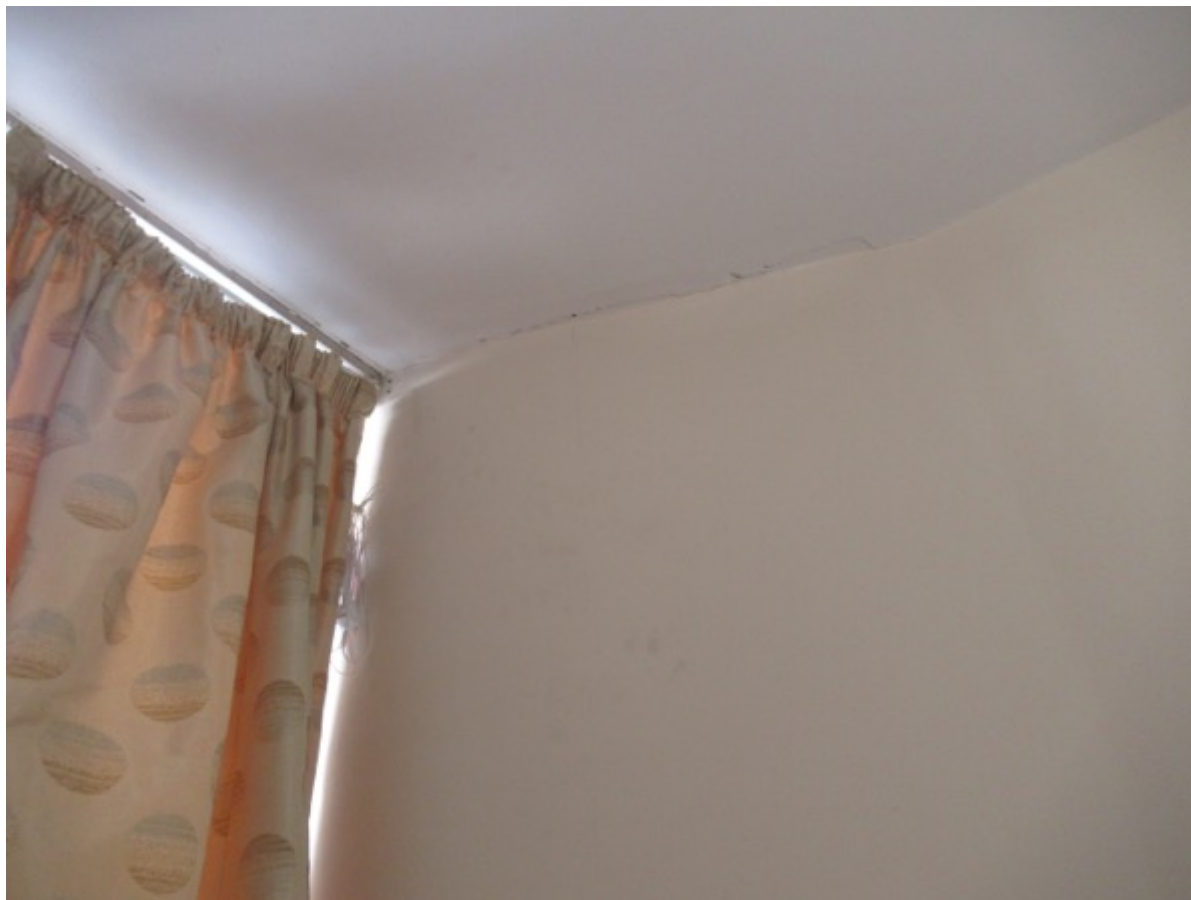
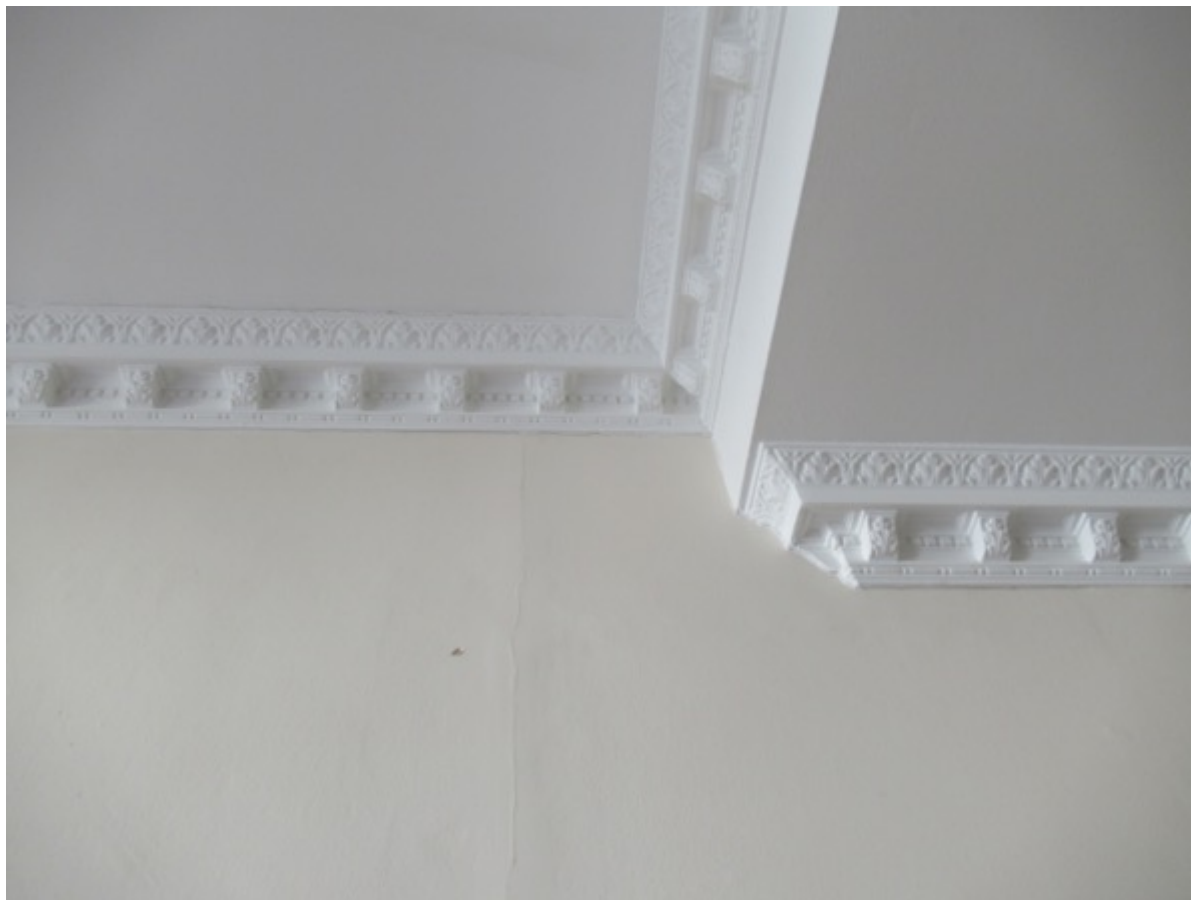
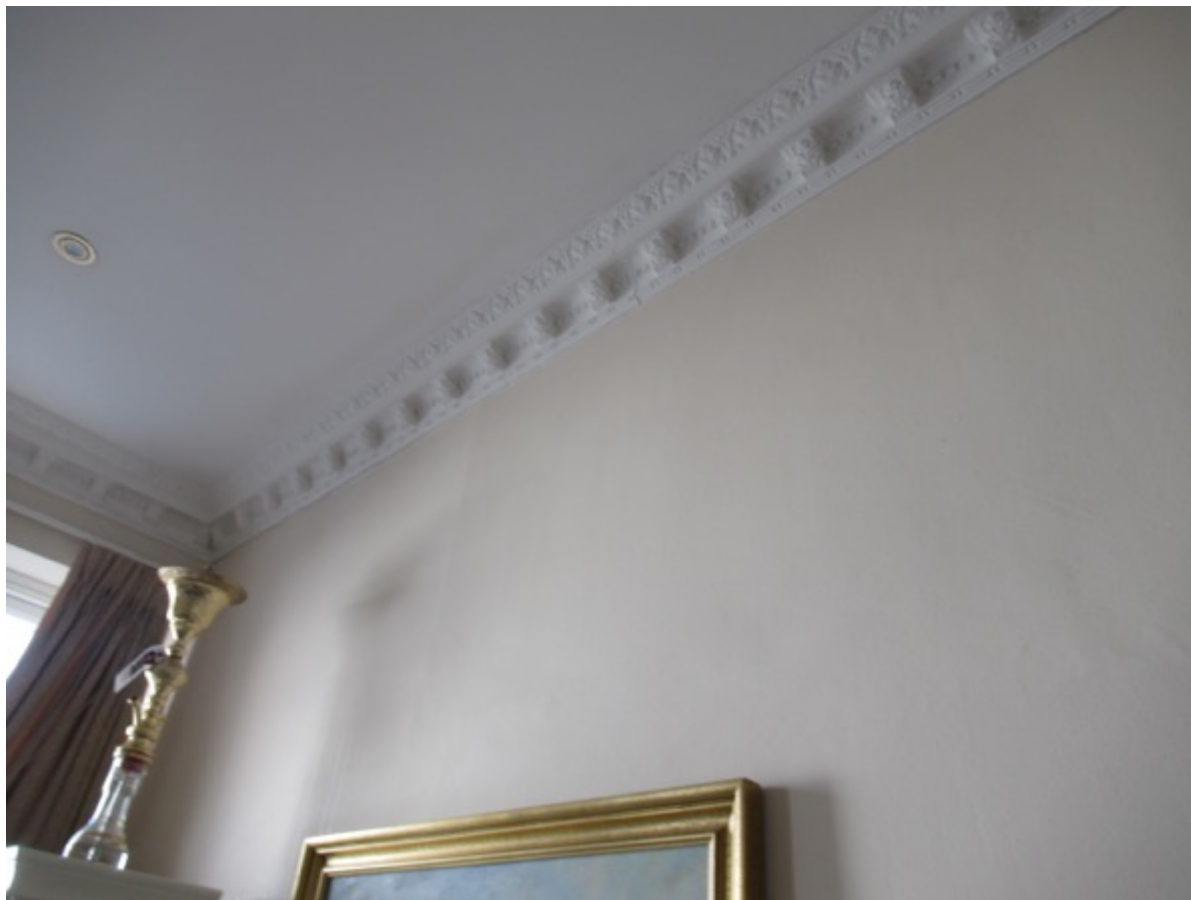
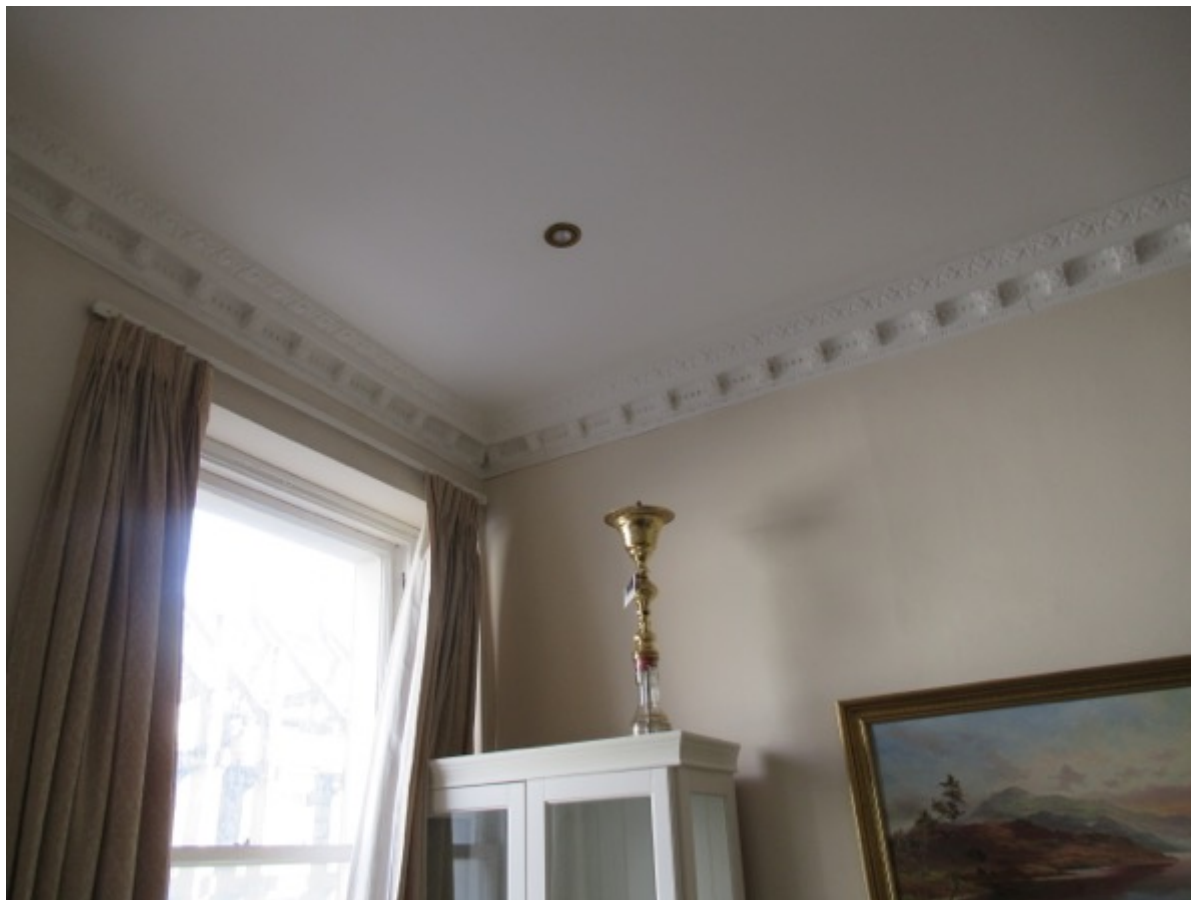
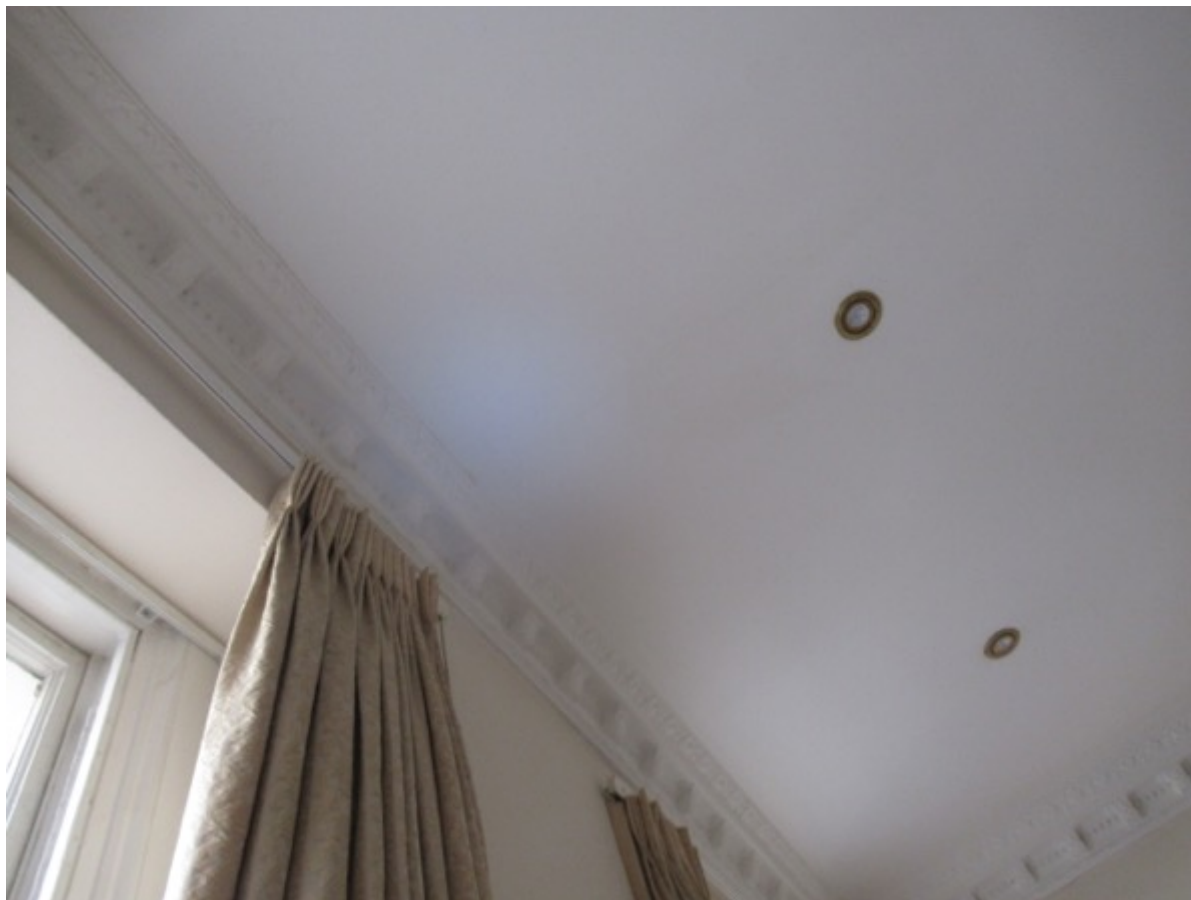
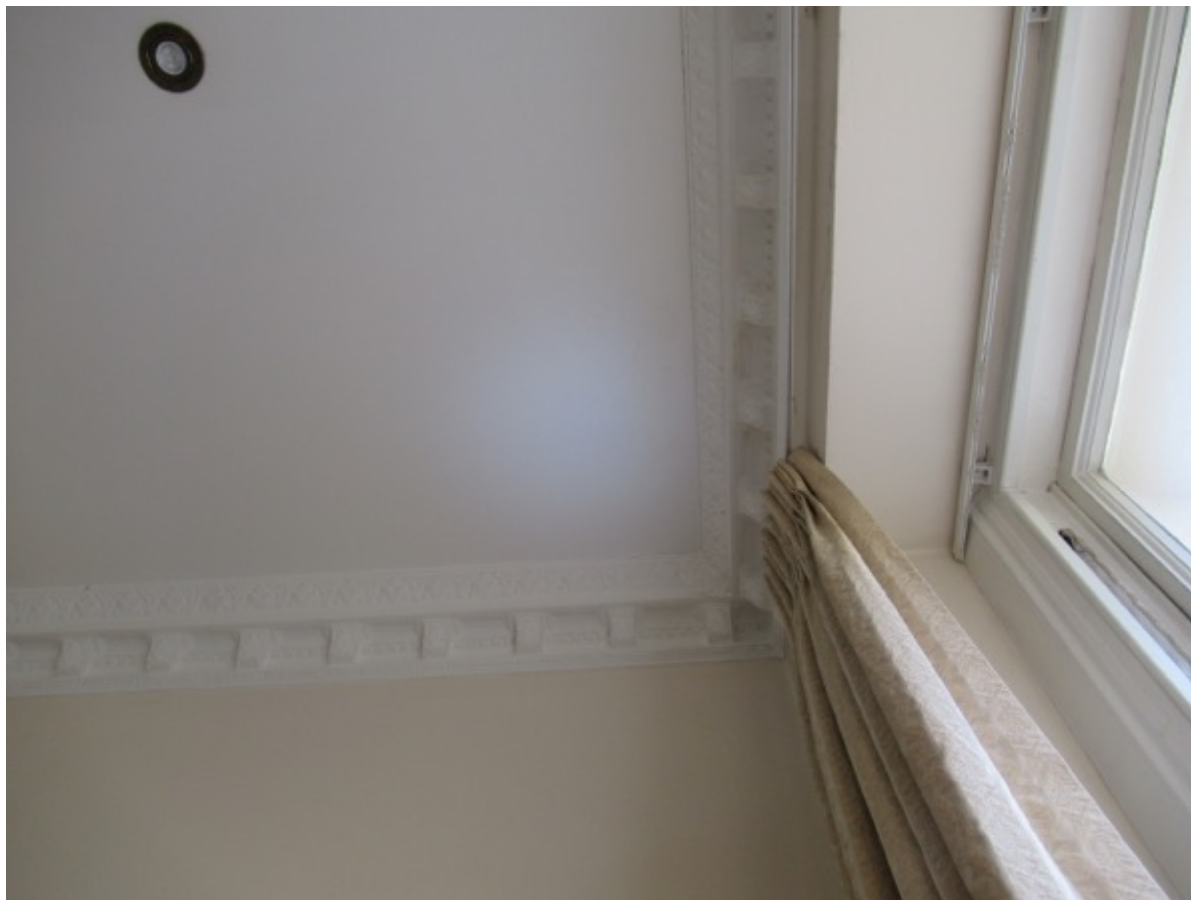
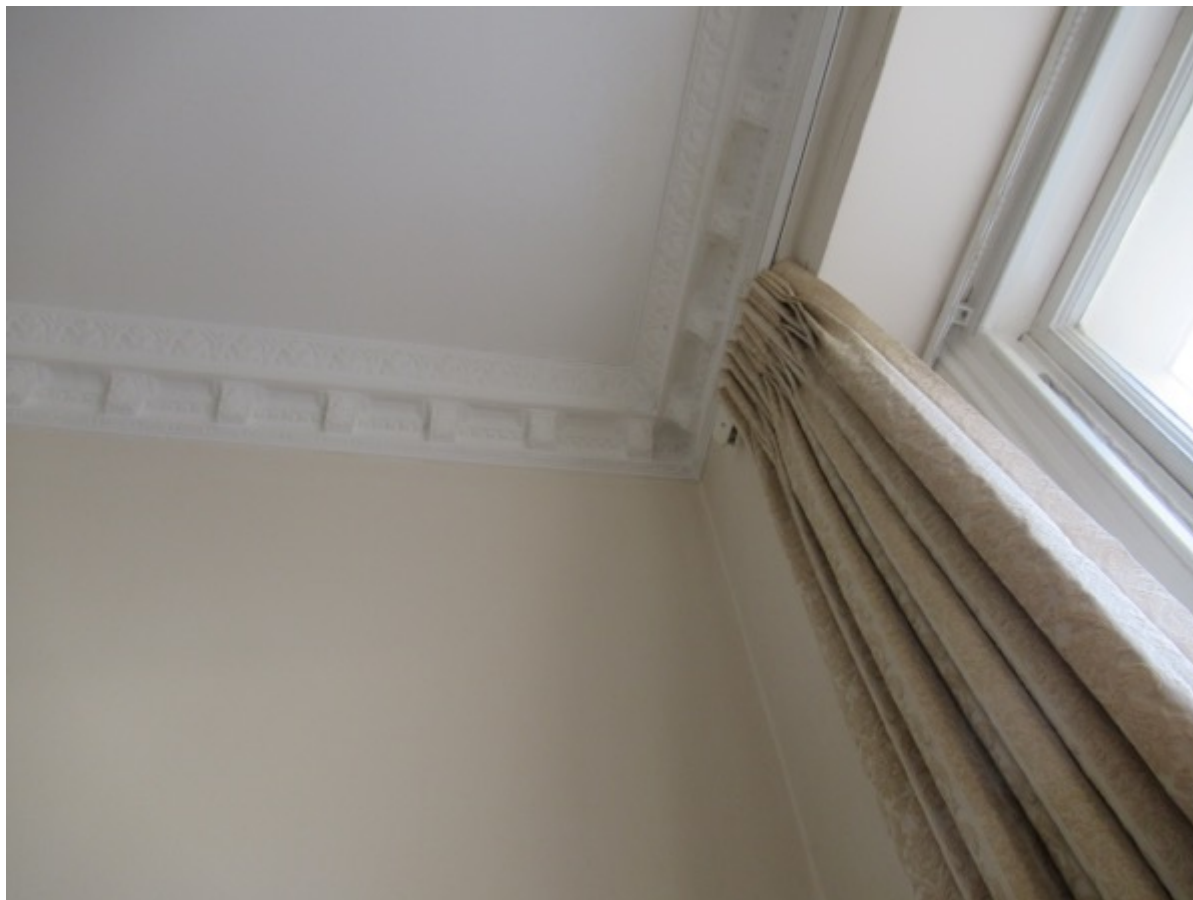
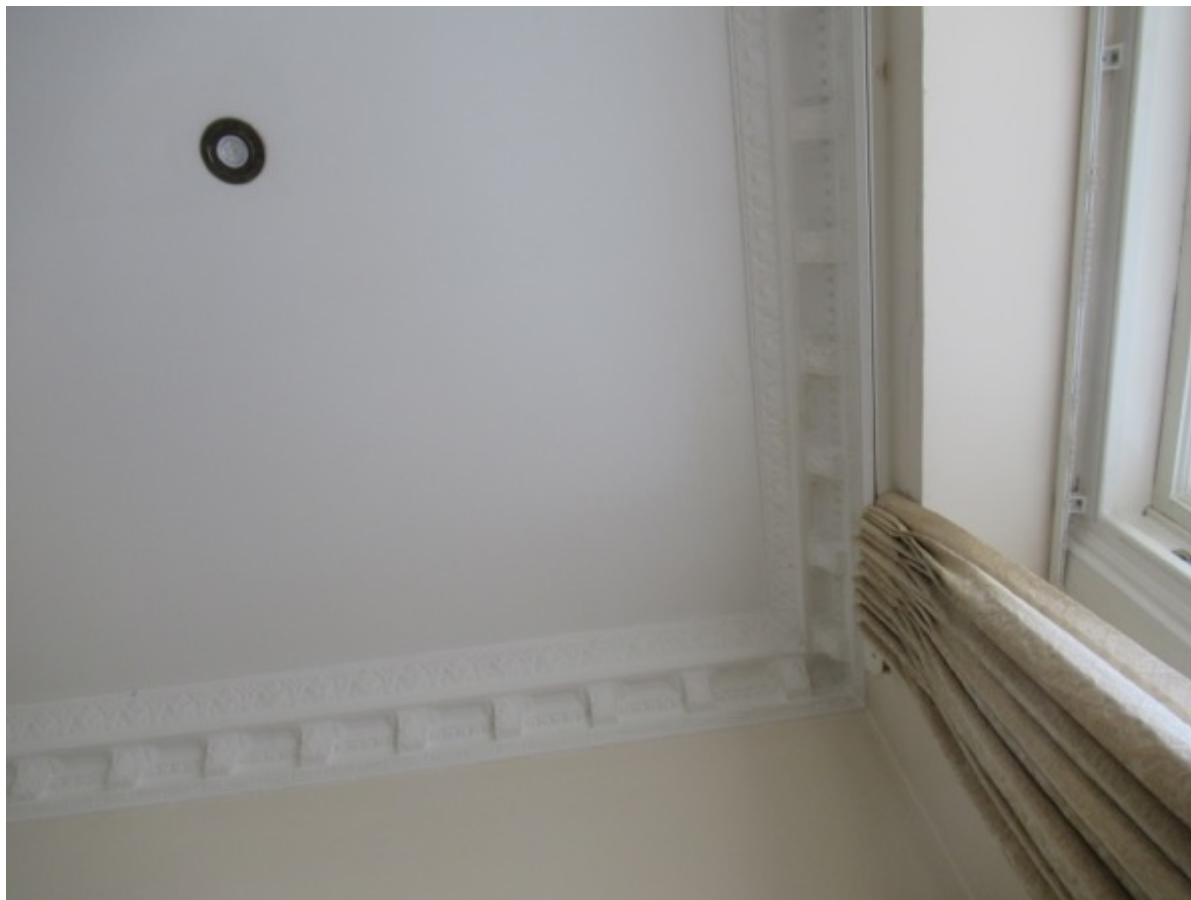
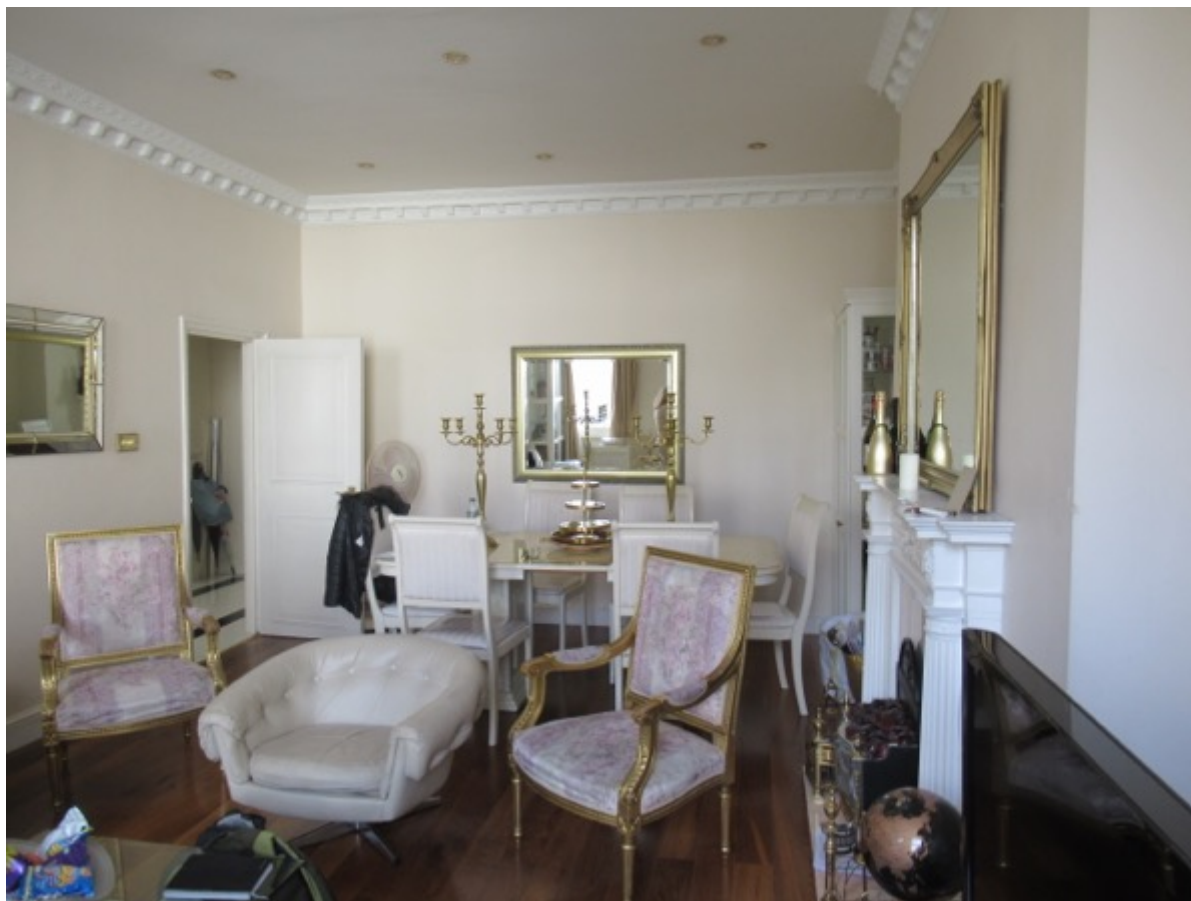
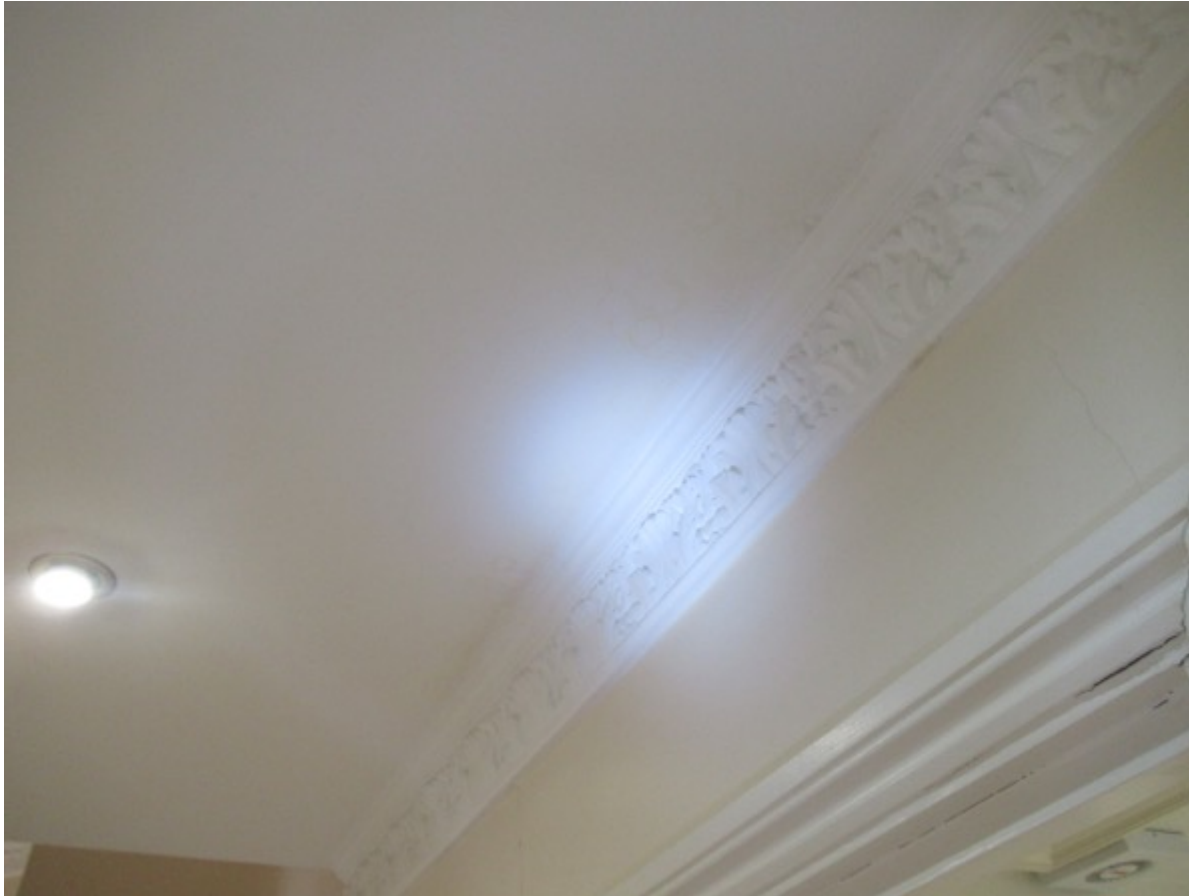
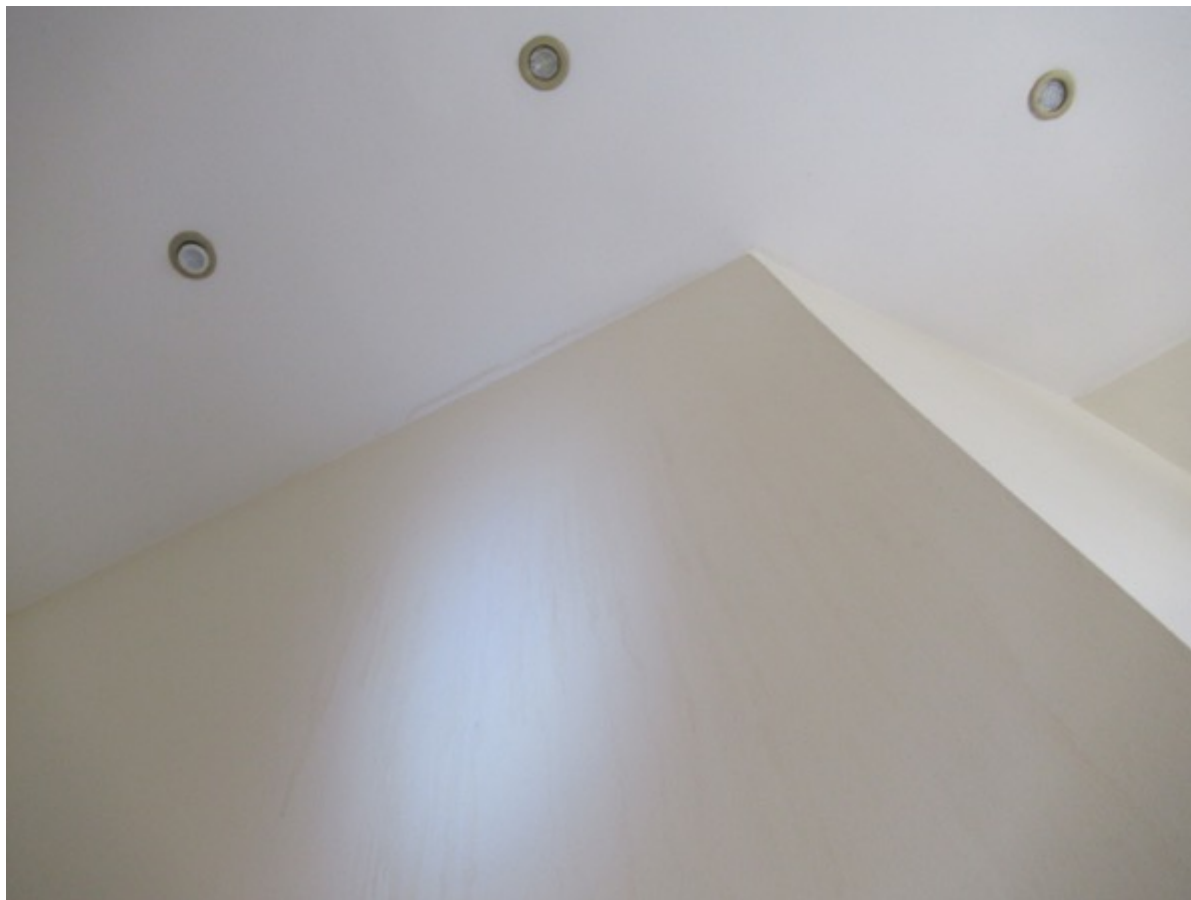
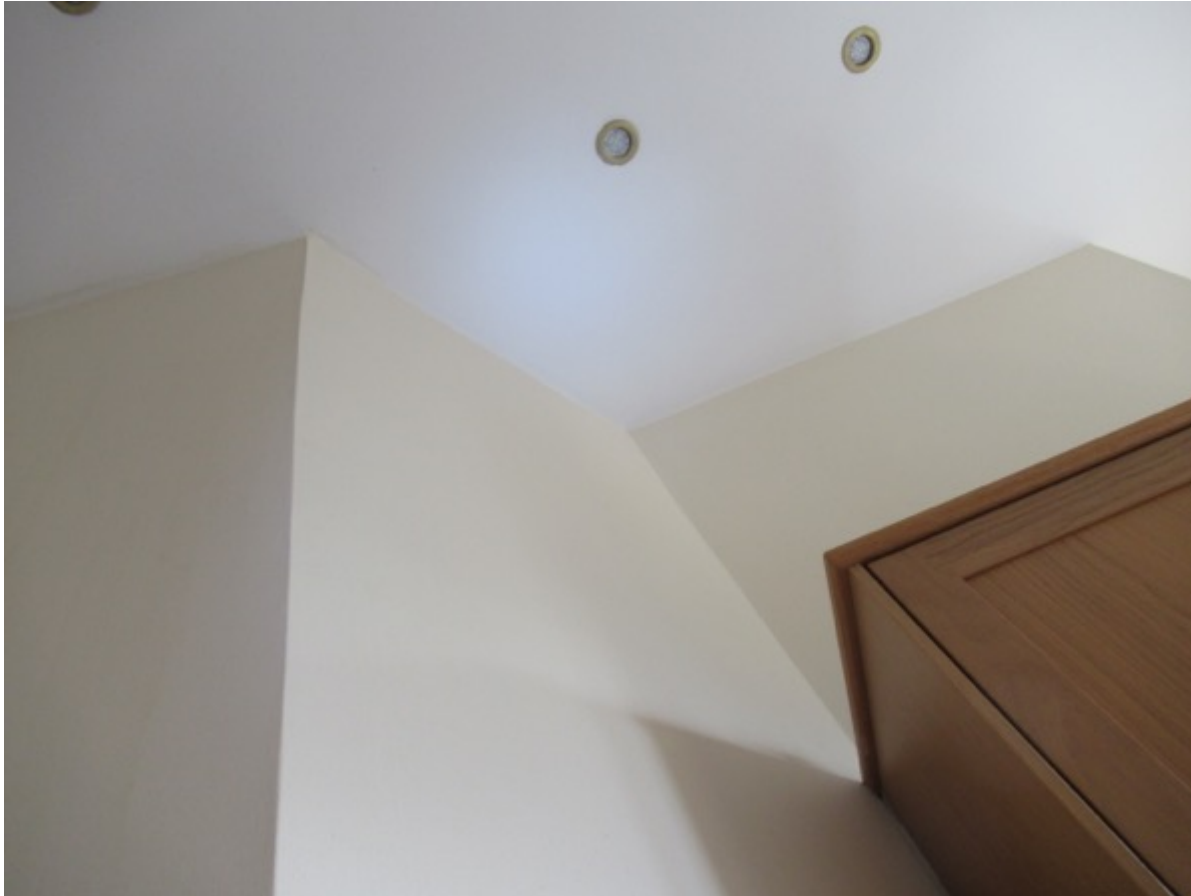
The immediate issue to this property is likely and understood to be due to a roof leak from a roof immediately adjacent the areas damaged which is likely have passed through an adjoining flat which has then been allowed to pass into this property.

I identified water ingress staining throughout the ceiling voids above all rooms.

I witnessed mildew staining and moisture stains to the ceiling voids and staining in the rooms, notable to the ceilings and walls, including a lounge, all 3 bedrooms, bathroom and kitchen and including the corridors.

Water staining to walls and ceilings

Due to the cause of the damage in the property it is essential to fully remedy all such water ingress prior to completing any internal repairs.
