Templar Consultants

Report

**Flat 8
46 Lancaster Gate
London
W2 3NA
(‘the property’)**

13 February 2021

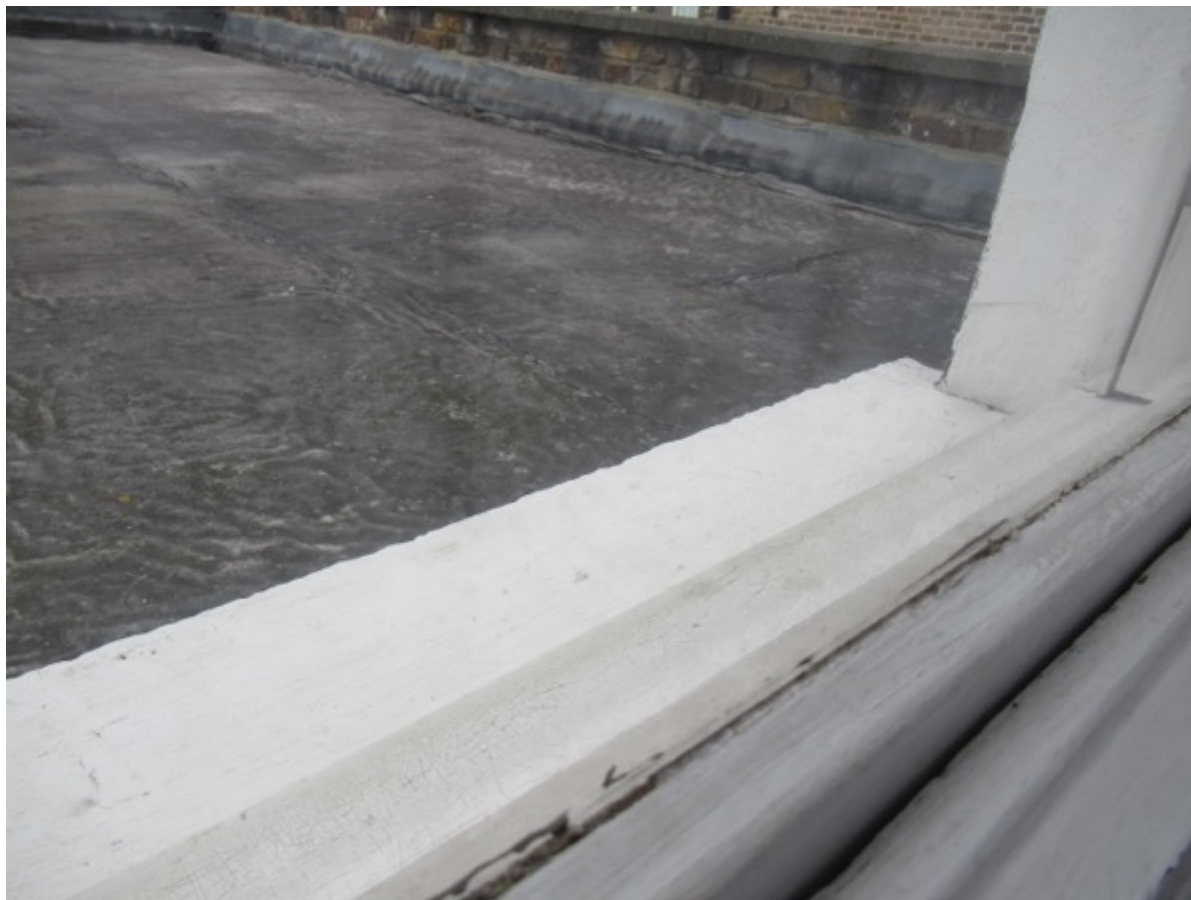
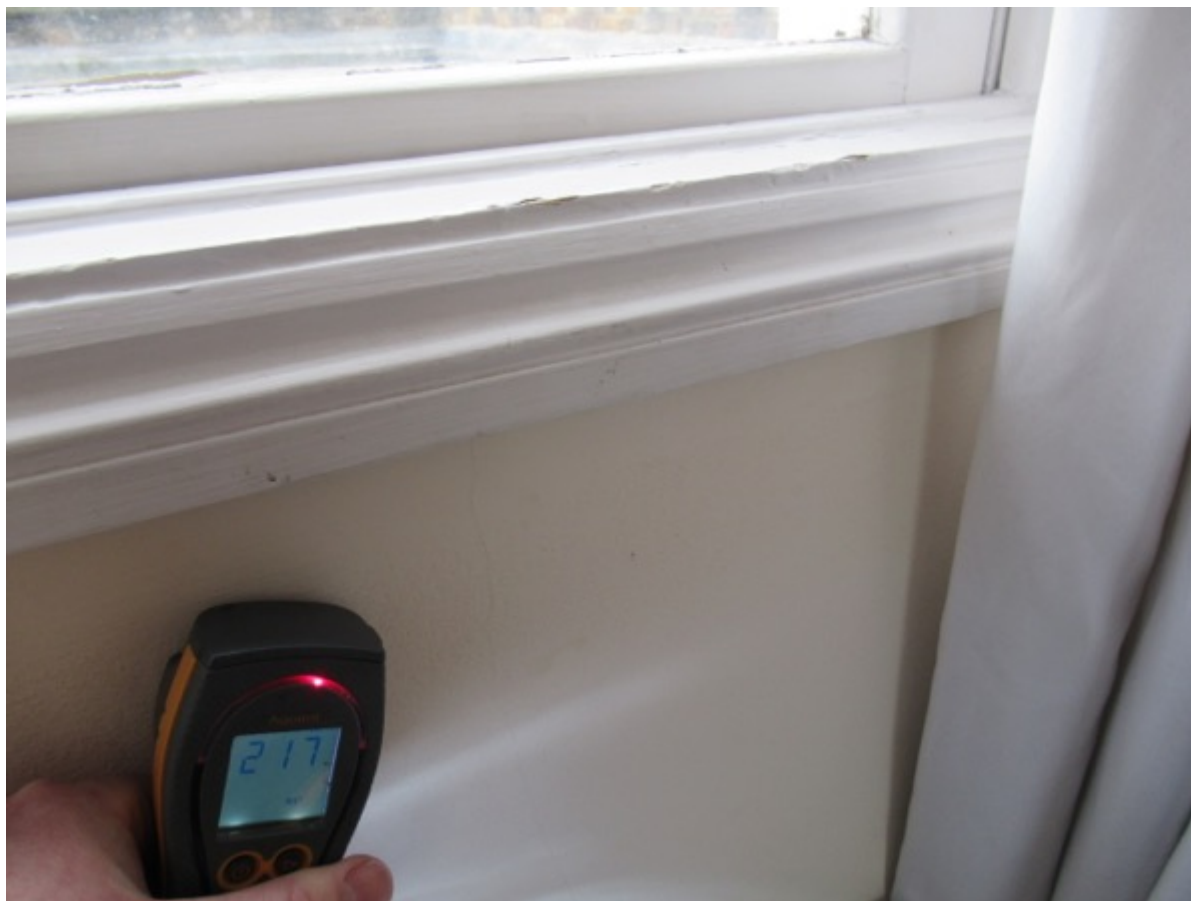
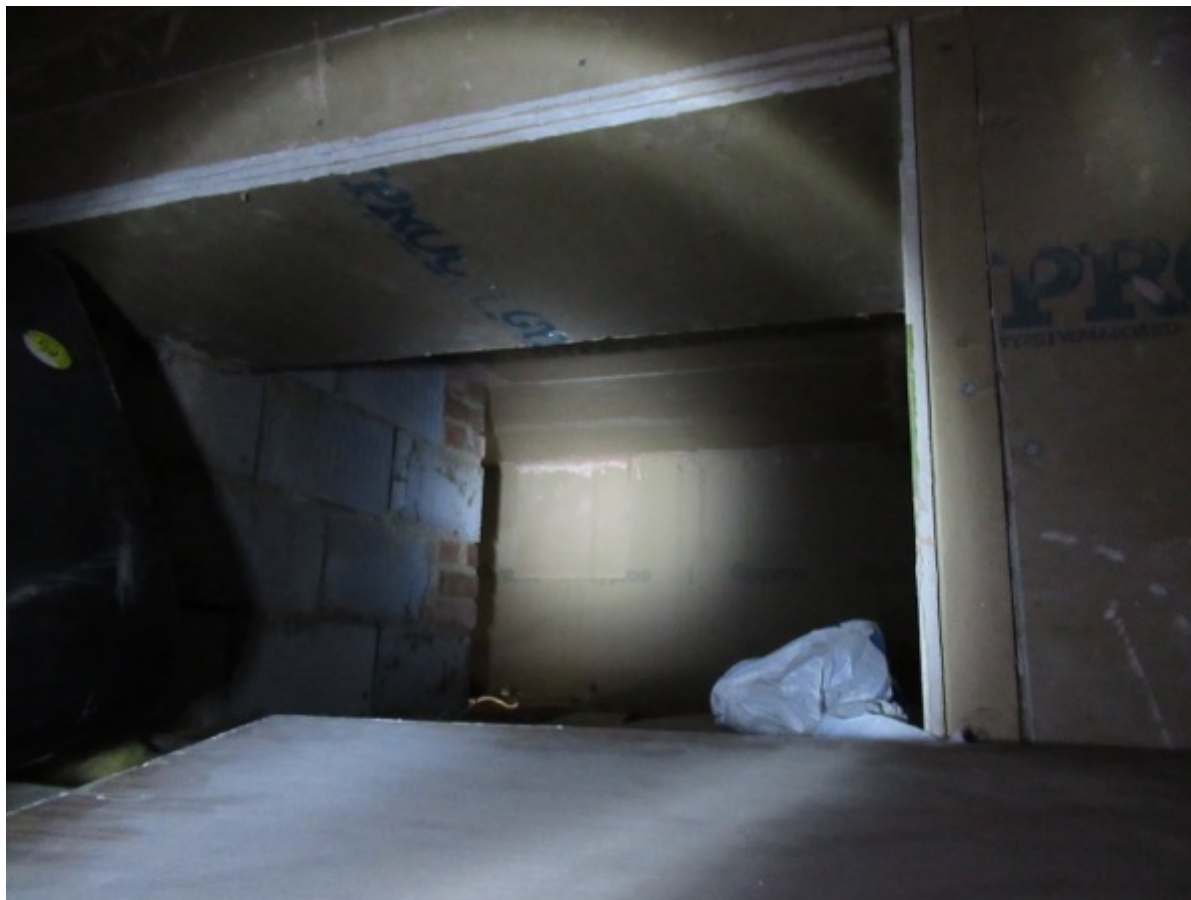
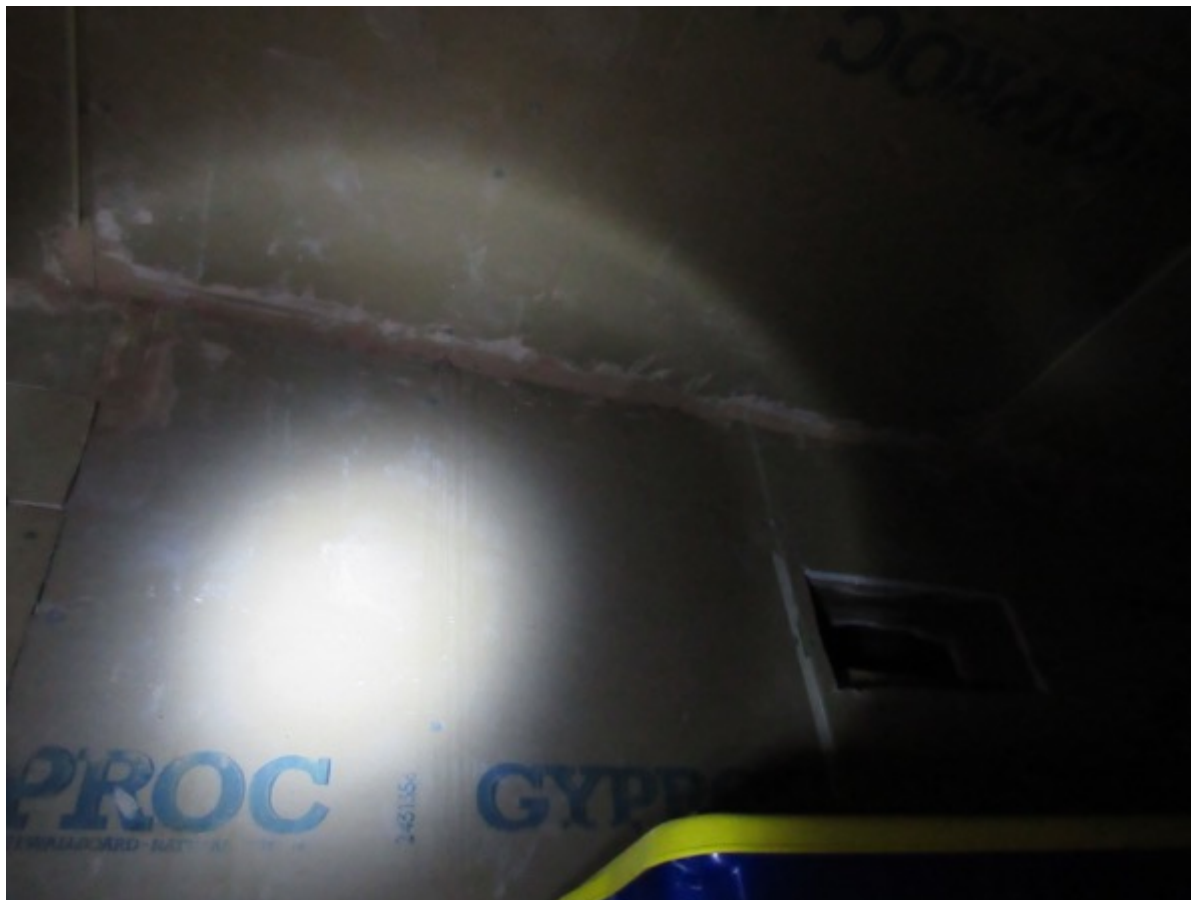
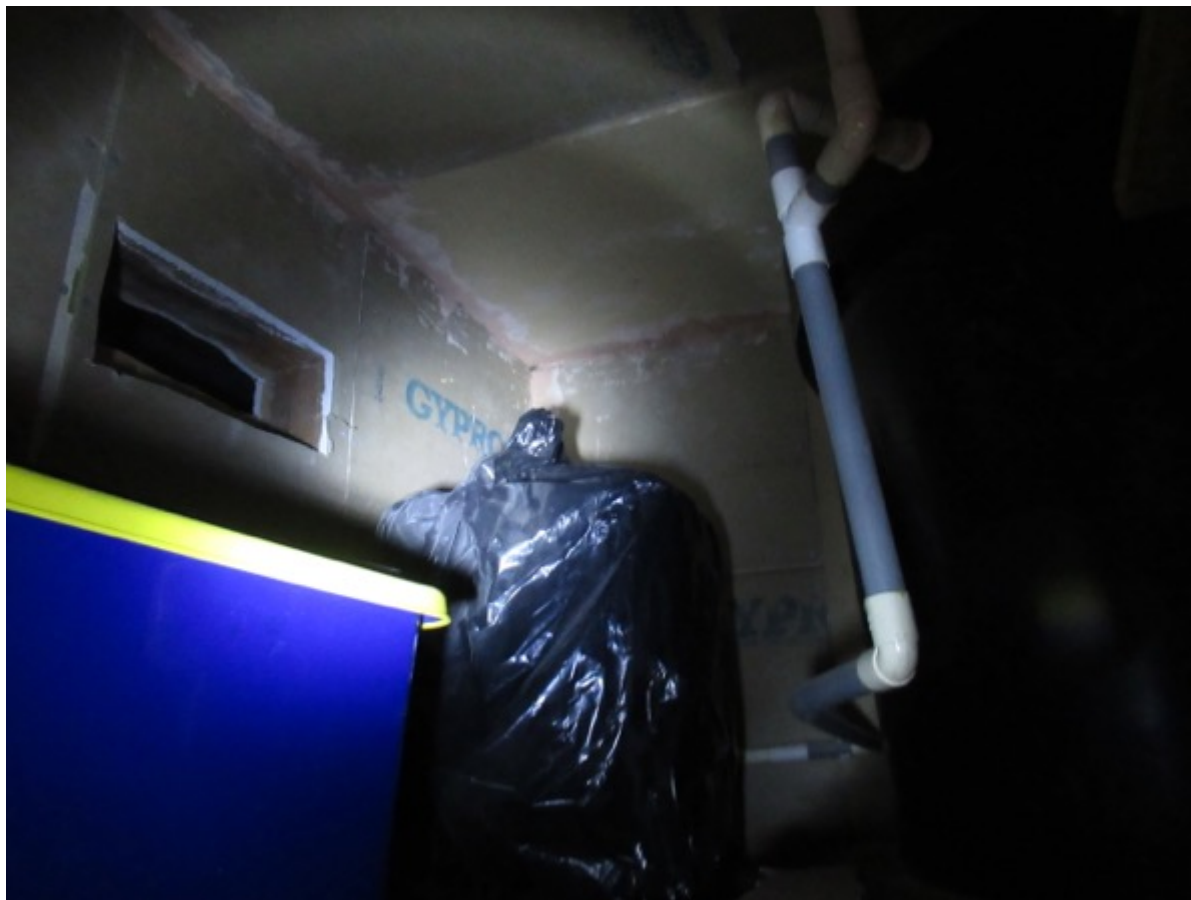
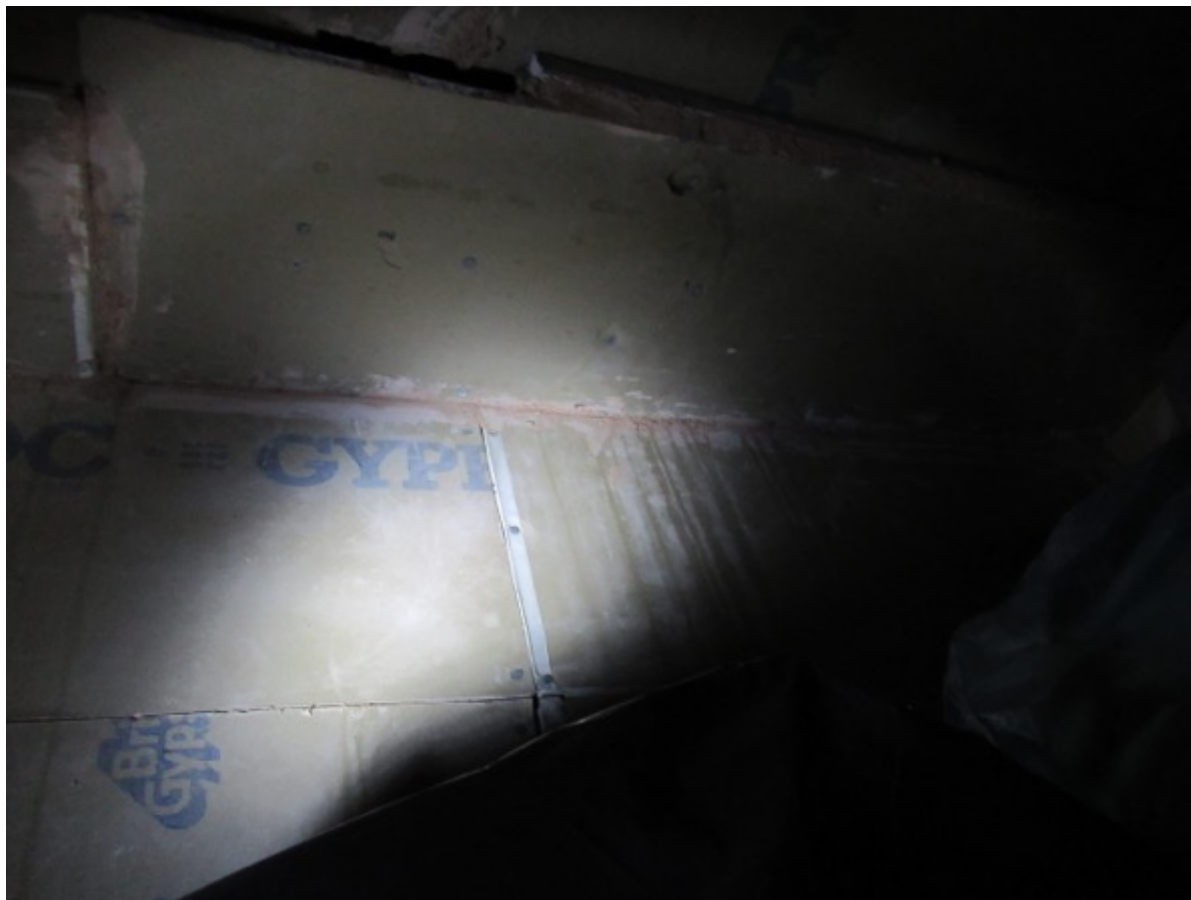
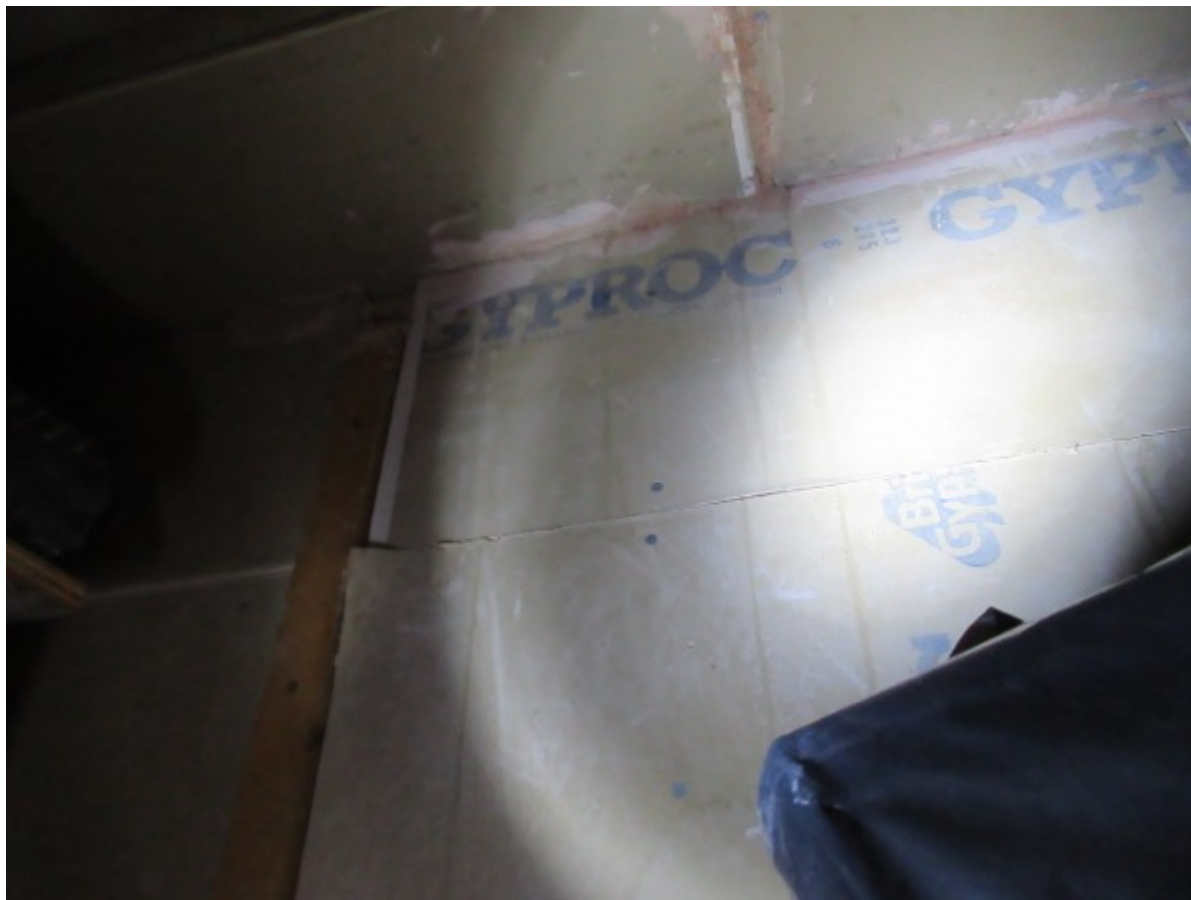
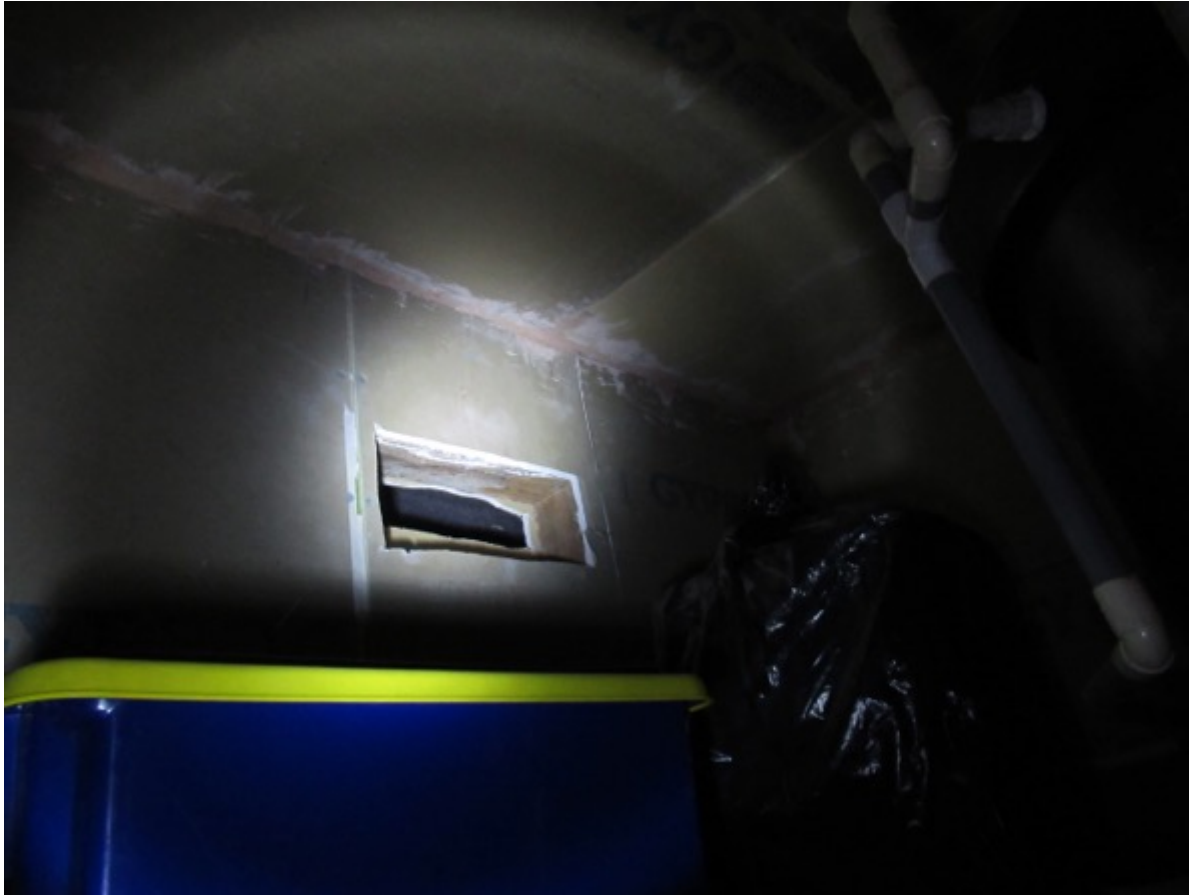
Water staining to walls and ceilings

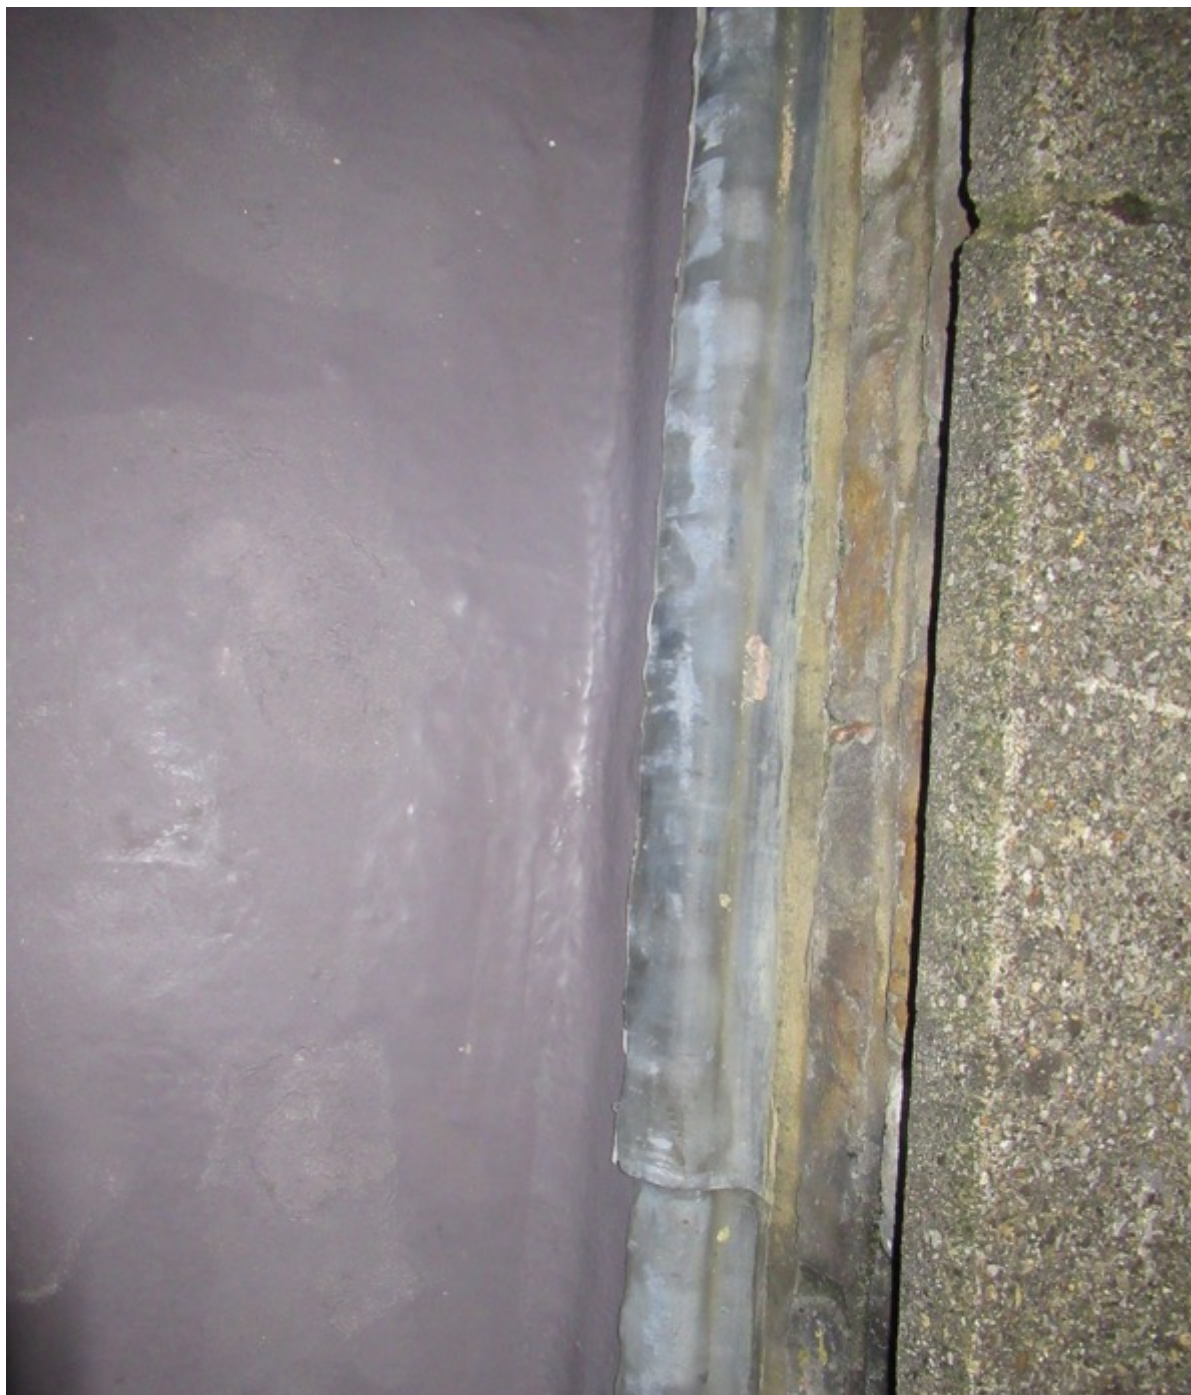
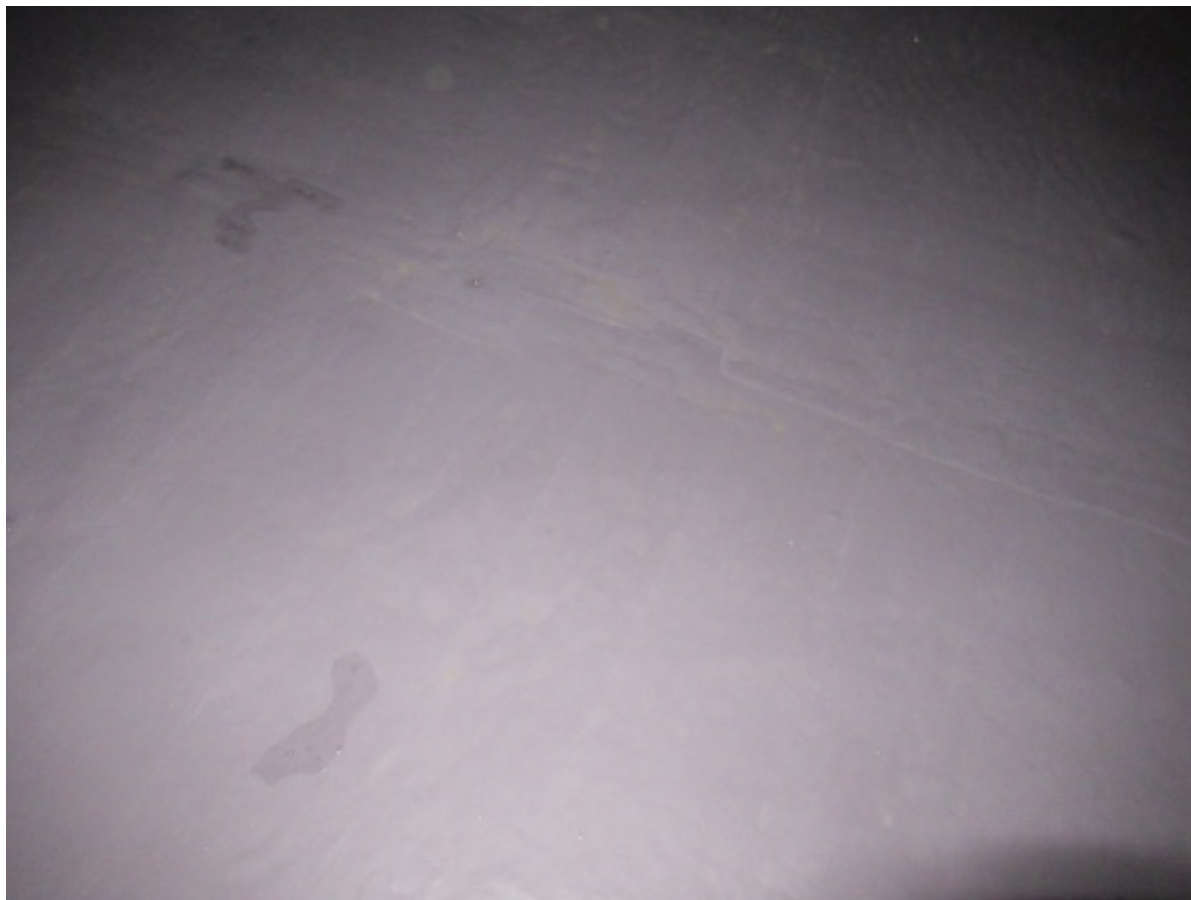
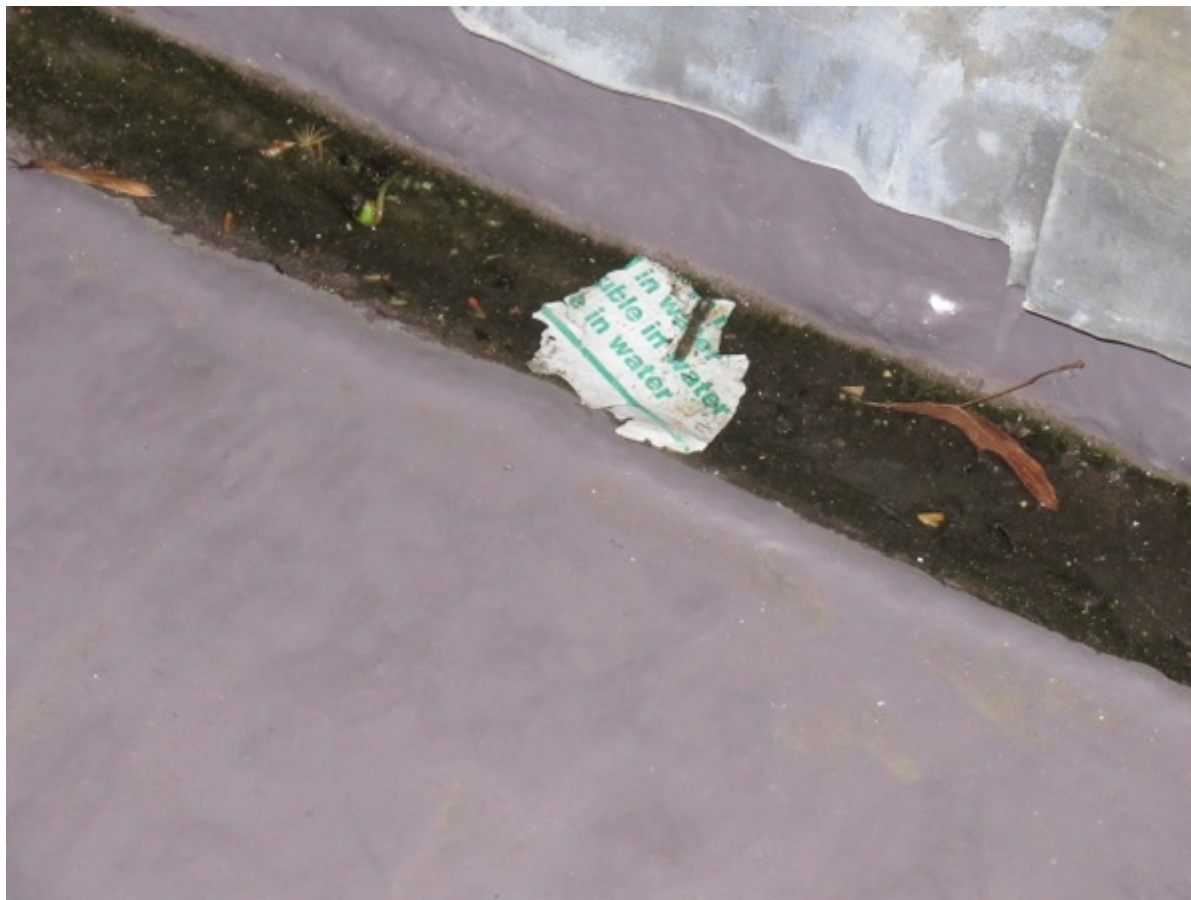
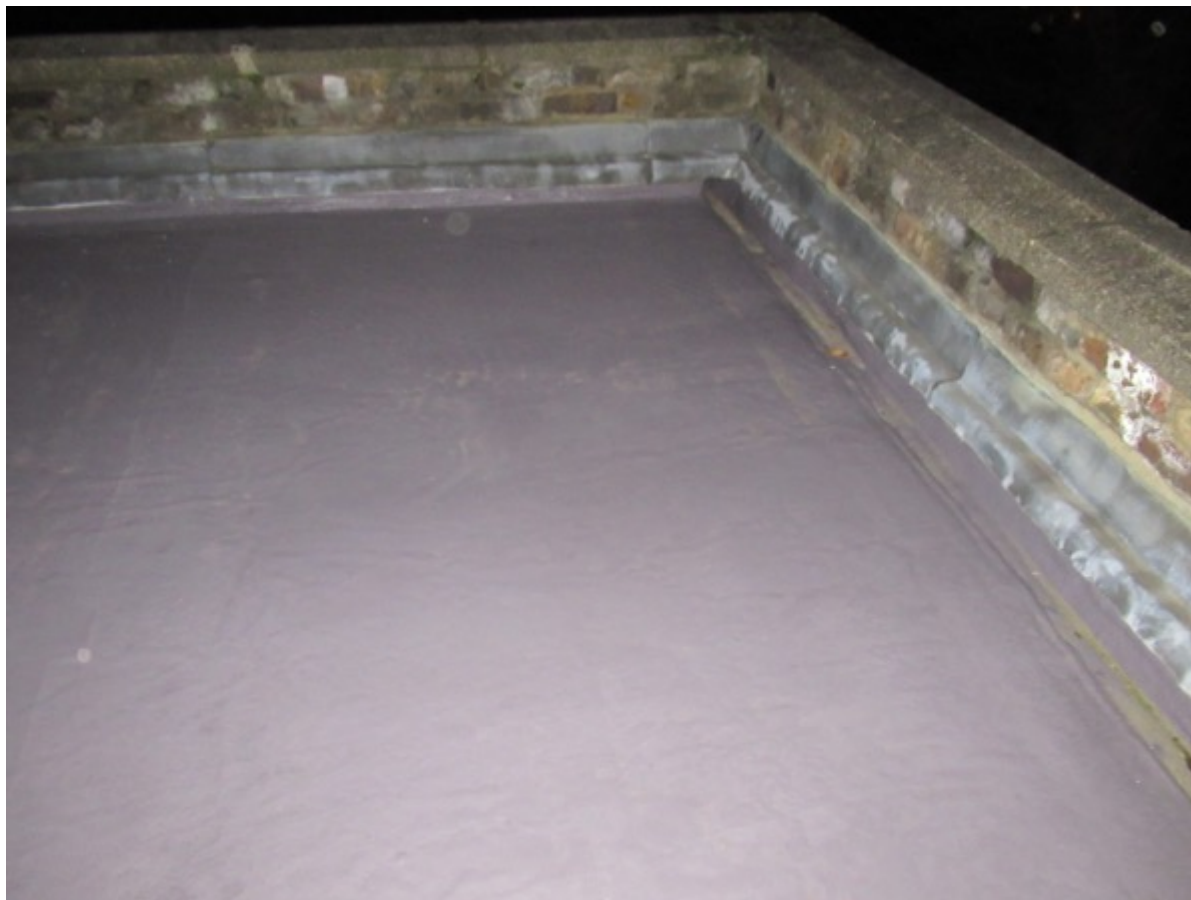
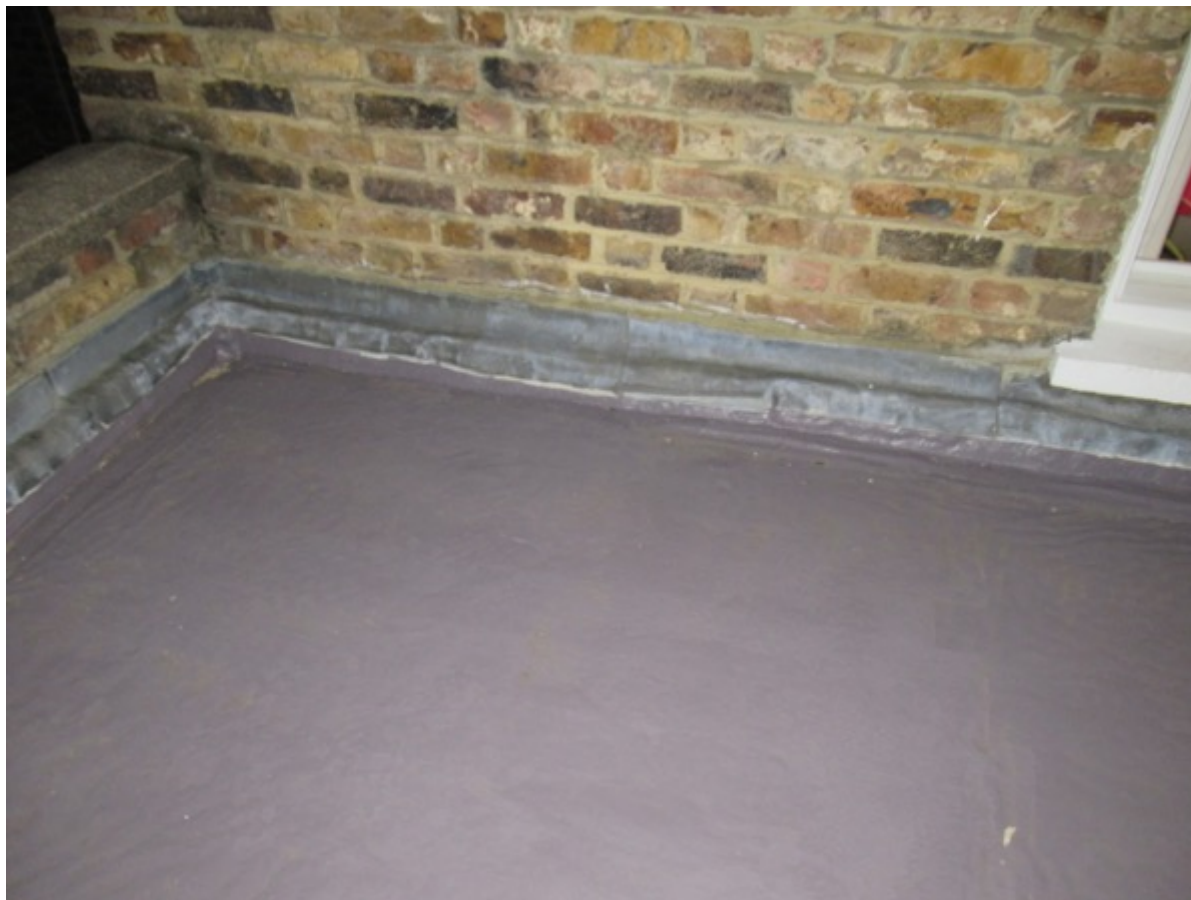
Water staining is clearly visible to the walls of the property which indicate that water appears not to be only from one source above and appears would not for example be from a single pipe leak whereas it appears to be from a gutter line.
