Heritage Impact Assessment

St Cuthberts Vicarage, Billingham

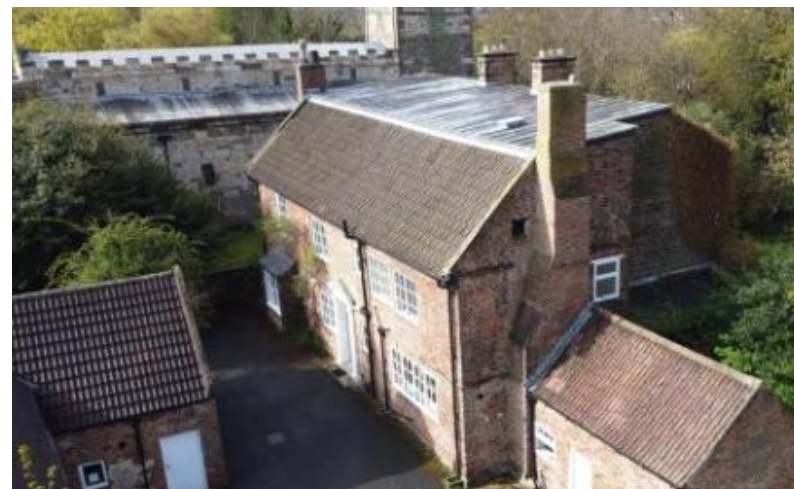
Figure 6 Existing roof Arrangement

rather awkward arrangement. With the staircase continuing to second floor running into the attic of the house. There are no obvious planning records which suggest when these works were carried out. However, at some point the valley gutter between the two bays of the building has been covered by a rather odd mono pitch roof insertion. By raising the gable end brick work and installing a flatter area of roof between the two phases of build, presumably to remove a valley gutter. This arrangement can be seen in figure 6 below. This alteration carried out prior to the applicants purchase has been somewhat visually harmful to the building however, is not appreciated in main views of the Vicarage.

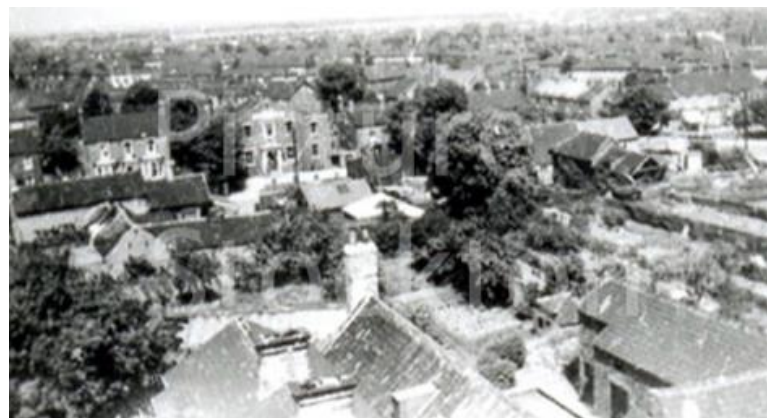
Figure 8 View from the Church Tower showing the valley gutter in place (date unknown)

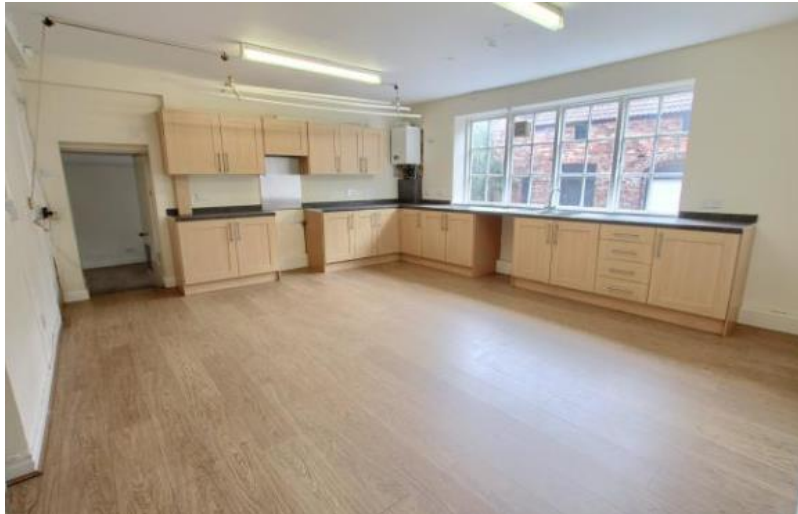
Figure 19 The previous kitchen image prior to purchase

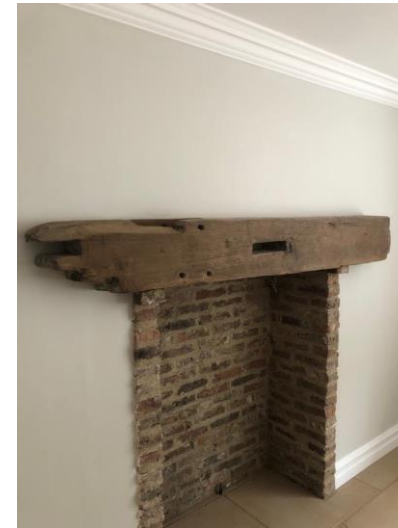
- 3.28 The window cill has been spliced and repaired. Other works in the kitchen area are general decorating and new kitchen fitting, the owner has opened up the original fireplace on the north wall of the kitchen. However, this was blocked over with modern boarding and no features were uncovered when removed. The reconfiguration of the kitchen has allowed the fireplace opening to be retained as a feature. A decorative lintel has been installed which was sourced from a reclamation yard (Aztec Stone in Bishop Auckland) to add interest into the space. This is a completely new feature to the building and is a reversible alteration. This is clearly not sourced from the building itself with the reclamation yard advising it came from a demolished mill complex.

Figure 20 New reclaimed kitchen feature, coving also a new addition

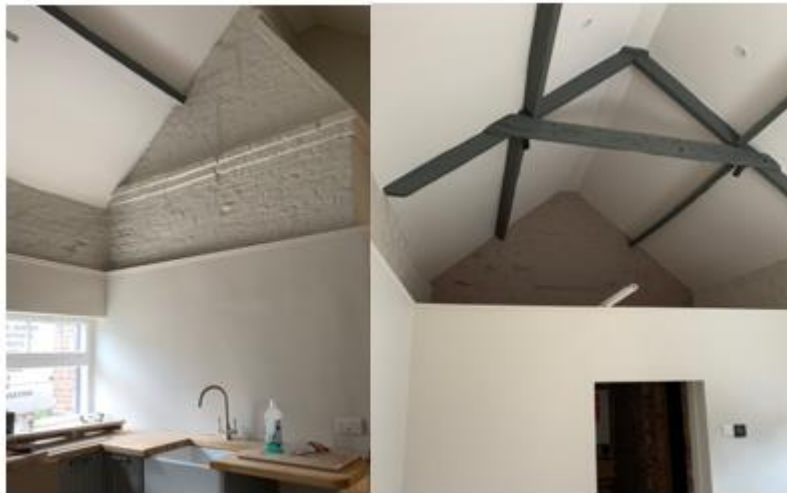
Figure 21 Internal images of Utility Room

- 3.29 The utility area has existing wall tanking, carried out historically, not by the current owner with the walls lined. The roof structure displays attractive trusses and these are left exposed. There are areas of lathe and plaster ceiling in the store beyond which have been retained including a traditional batten door and attractive wooden lock. The walls in this area are a mix of exposed brick, generally more modern construction. A new boiler system and associated pipework has been added into the store area. A new timber door to the exterior garden from the utility has been added replacing the previous timber door.

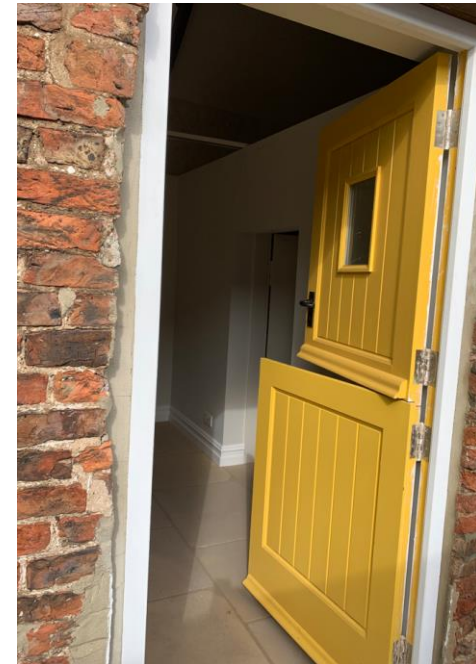
Figure 22 New external door to utility area

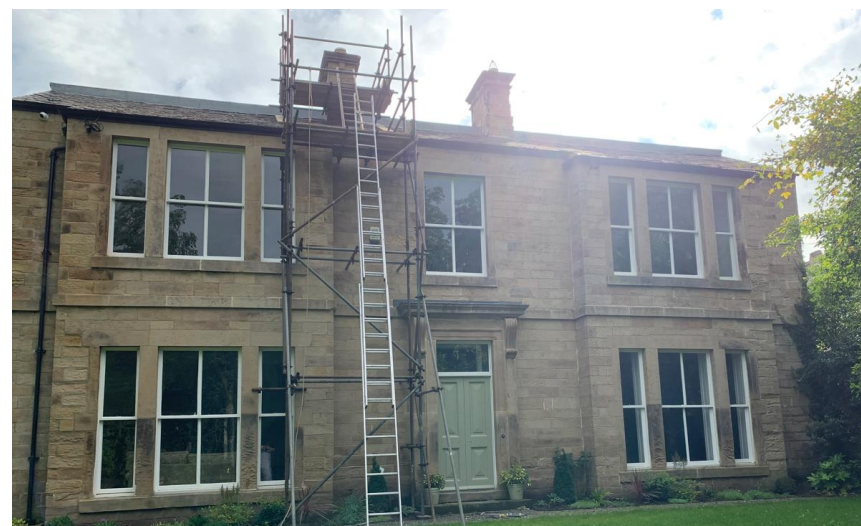
Figure 24 West Elevation frontage

- 3.43 The front elevation overlooking the garden (west) elevation is of stone work. Some limited repair works, and cleaning works have been carried out to this façade. The specification of the works carried out by a specialist contractor Facade of Middlesbrough. The specification is attached as an appendix to the application, the method of cleaning was the Doff system, recognised for use on historic buildings.

- 3.44 The central chimney was recently struck by lightning with stonework landing in the front garden area as can be seen in the image opposite. This has since been repaired and reinstated in a like for like manner and thankfully the falling chimney caused no further damage to the structure of the house.

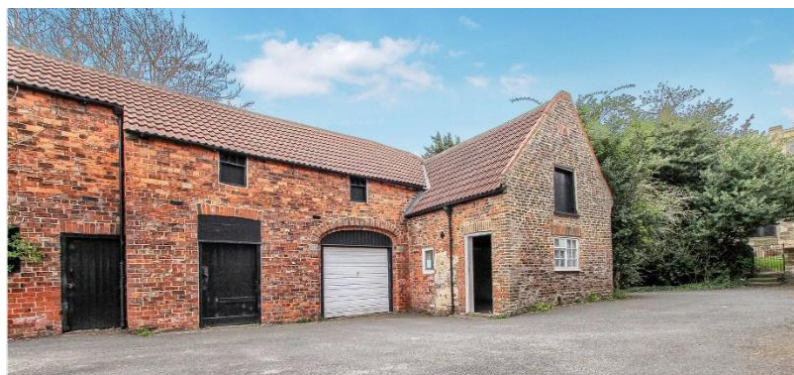
Figure 27 Existing outbuilding viewed from the east front of the Vicarage.

- 3.48 The outbuilding shows two phases of distinct historic build. The element running in line with the cottages on Church Road is of smaller brick work with a matching stringcourse and dental cornice. There is clear evidence of change to window openings and evidence of an archway on the south elevation.
- 3.49 In comparison the parallel range is a later addition, larger Victorian brick is evident and also evidence of more modern change internally to this element. Internally there are remaining quarry tiles and a fireplace. This is a building that has been used as accommodation in the past with drainage and water connection. There is also a modern staircase leading to a first-floor level and the roof structure in the outbuilding is largely of modern construction and is reroofed in concrete tiles. There is a modern up and over door on the west elevation.

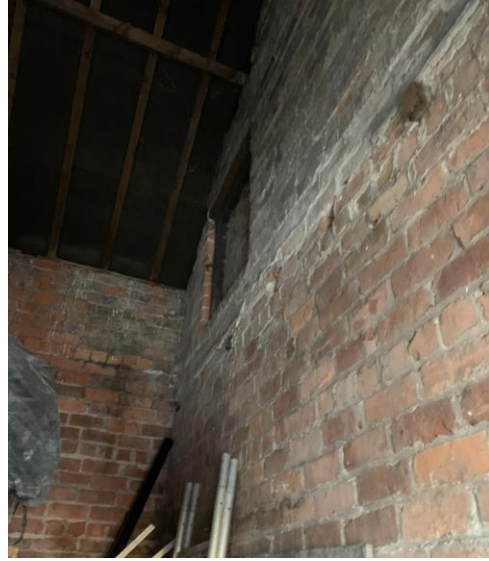
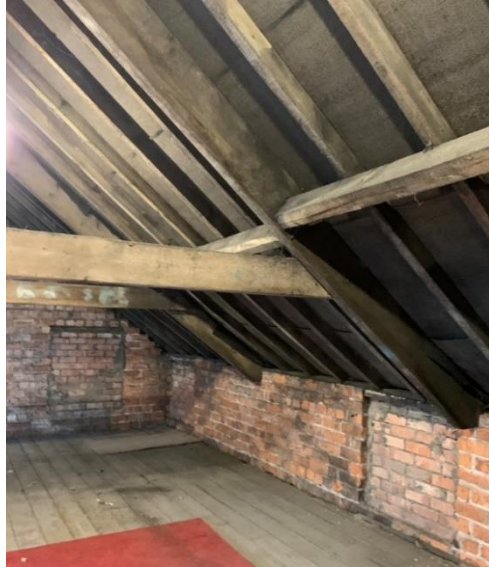
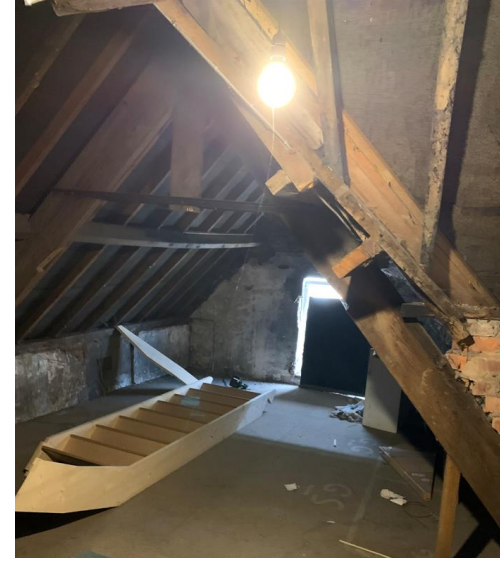
Figure 30 Internal photos of the outbuilding

3.53 The internal finish of this building is mixed with a modern staircase providing access to the first floor.

- 3.50 The works carried out by the applicant have included stripping of modern timber boards from the wall that were trapping moisture, no new wall coverings have yet been installed. It is intended that these are skimmed in lime plaster. The windows have been replaced in timber single glazed style although the styles have varied across the building depending on window type. The external timber door has been replaced with a timber door. There is also the intention to remove the existing up and over roller shutter and replace with more appropriate timber doors in keeping with the architectural form of the existing building.
