(As Proposed By Architect-Over marked with Structural Recommendations)
(Scale 1:100)

## PROPOSED GROUND FLOOR PLAN

Drw No. 1852 / F02

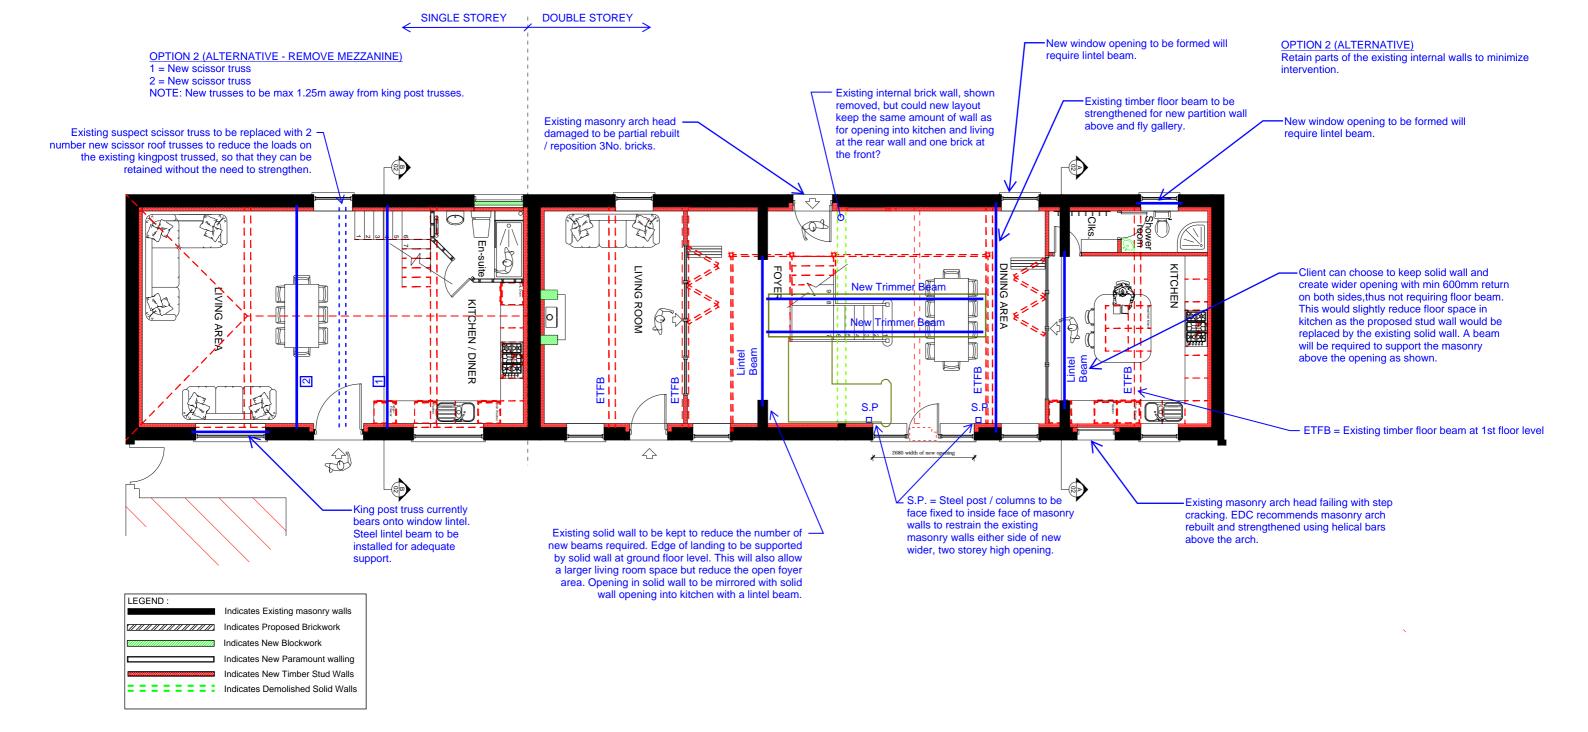
(Over marked with Alternative Layout's Structural Recommendations)
(Scale 1:100)

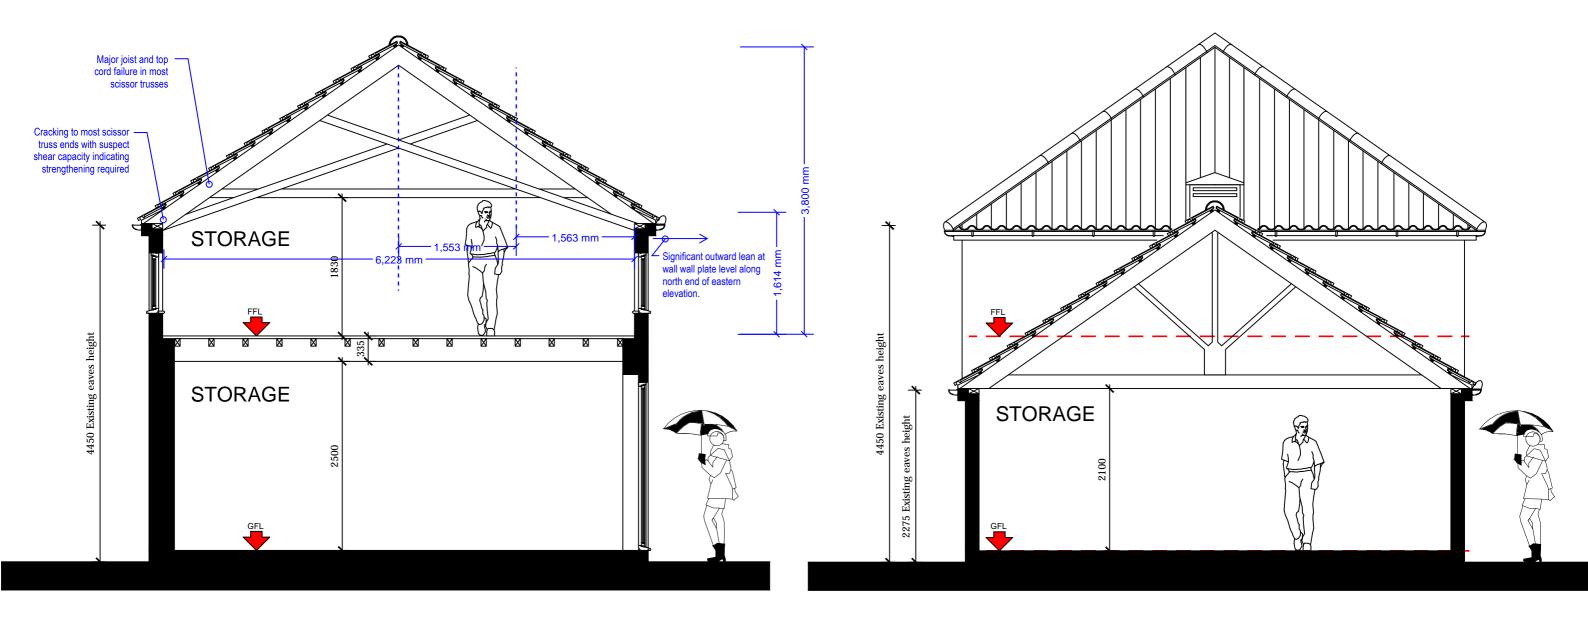
SECTION A-A

with the calculated findings. A ridge purlin is required to reduce the load on the slope purlins and to reduce the horizontal thrust at the top of the masonry walls, particularly as a timber ceiling tie are not present.
