# Structural Report

Property Address	8, Greenside, Waterbeach, Cambridge, CB25 9HP
Client	Mr Theo Anderson
Date of Report	14 November 2023
Project Nr	192603 (23-1009)

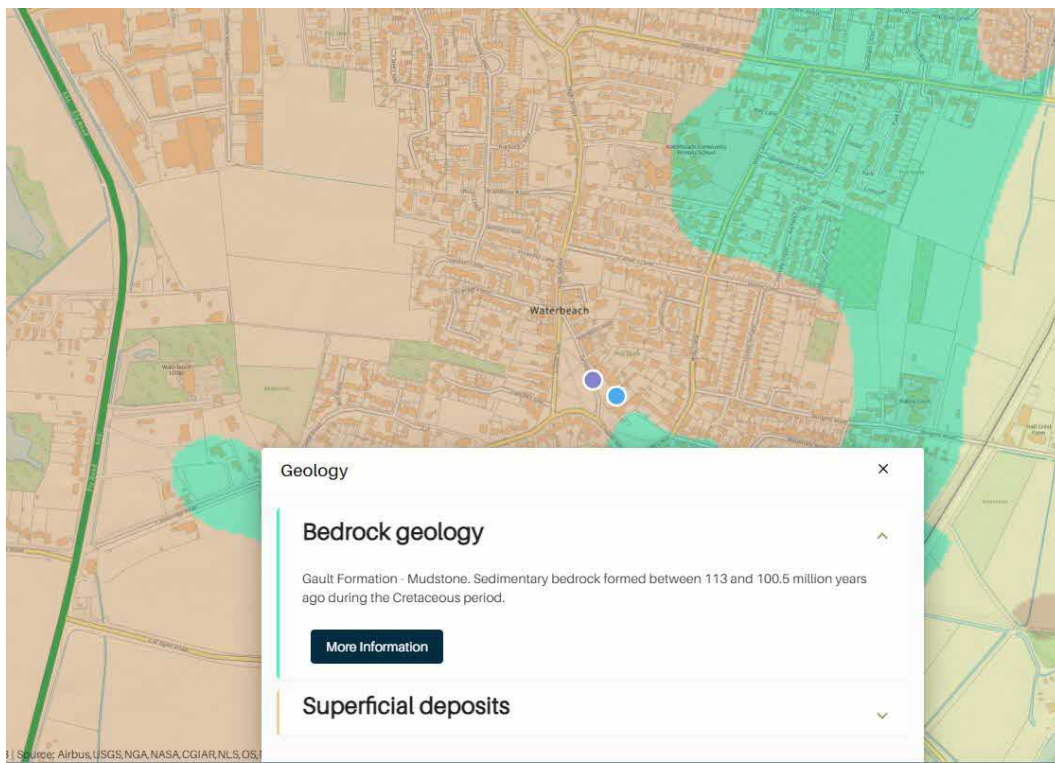
Fig 1.1 Existing Drift map to show likely soil conditions (Source Geology of Britain viewer) Ref: <https://geologyviewer.bgs.ac.uk/>

The local geology seems to be of a clay nature. Drift maps would suggest that clay is in place below the existing outbuilding. This can be seen in Fig 1.1 below.
