Outbuilding at Dillacks Farm, Assington, Suffolk

Heritage Asset Assessment

Outbuilding at Dillacks Farm Colchester Road, Assington, Suffolk

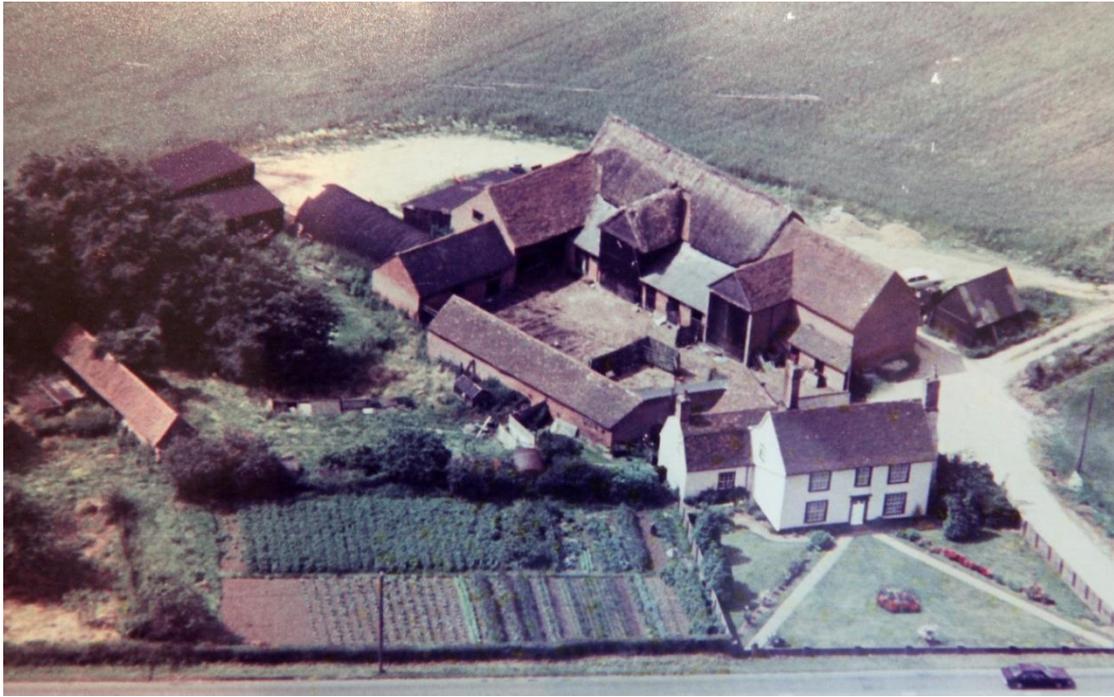
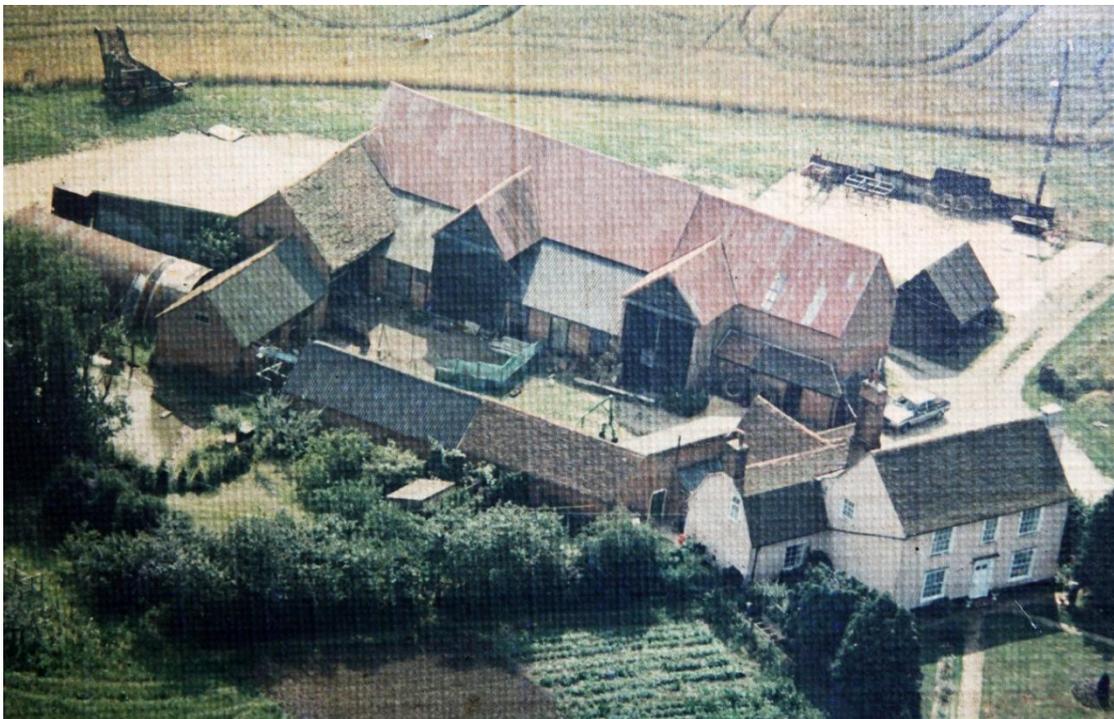
Figure 15
Aerial photographs probably from the 1970s and 90s in the current owners' possession. The southern threshing barn retains its original thatch in the former while the later image below shows corrugated iron on both the barn and the southern half of the outbuilding in the foreground. The walls of the small cattle yard to the north of the outbuilding still survived in the 1970s but had been lost by the 1990s.

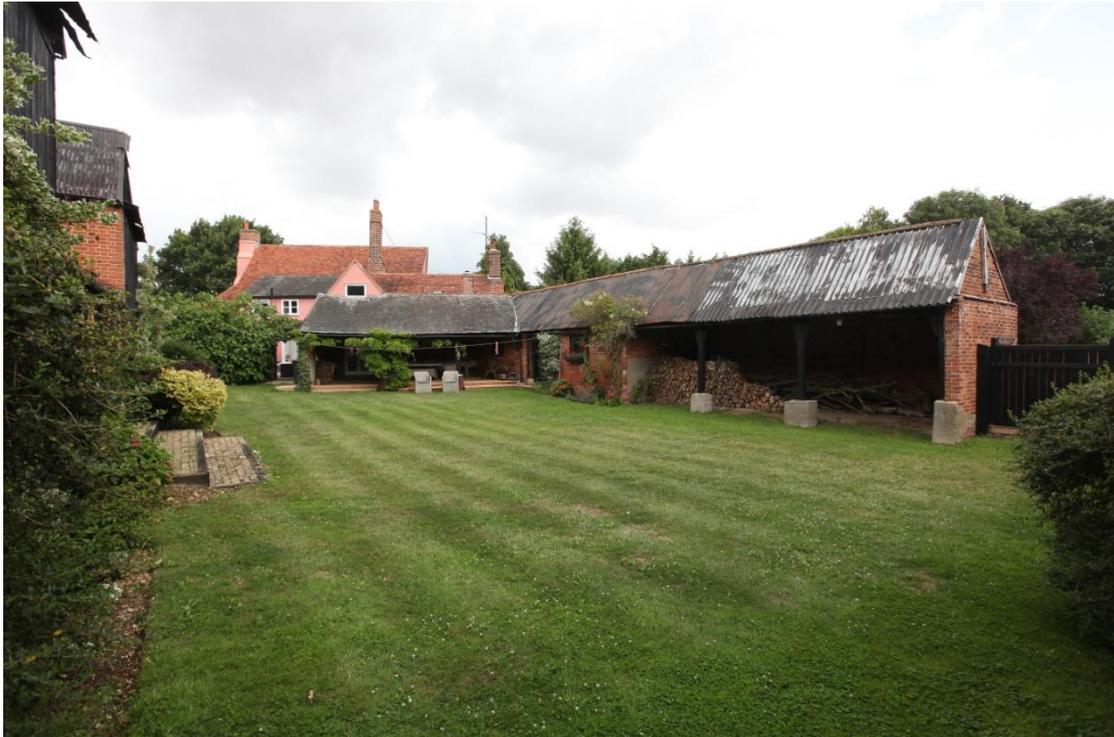
Illus. 3. The enclosed farm yard from its south-western corner showing the L-shaped outbuilding on the right with the 3-bay open shelter-shed of the horse yard (1) on the right, the cow shed (2) in the centre and the shelter-shed of the cow yard (3) on the left. The threshing barn is visible to the extreme left with the house in the rear.

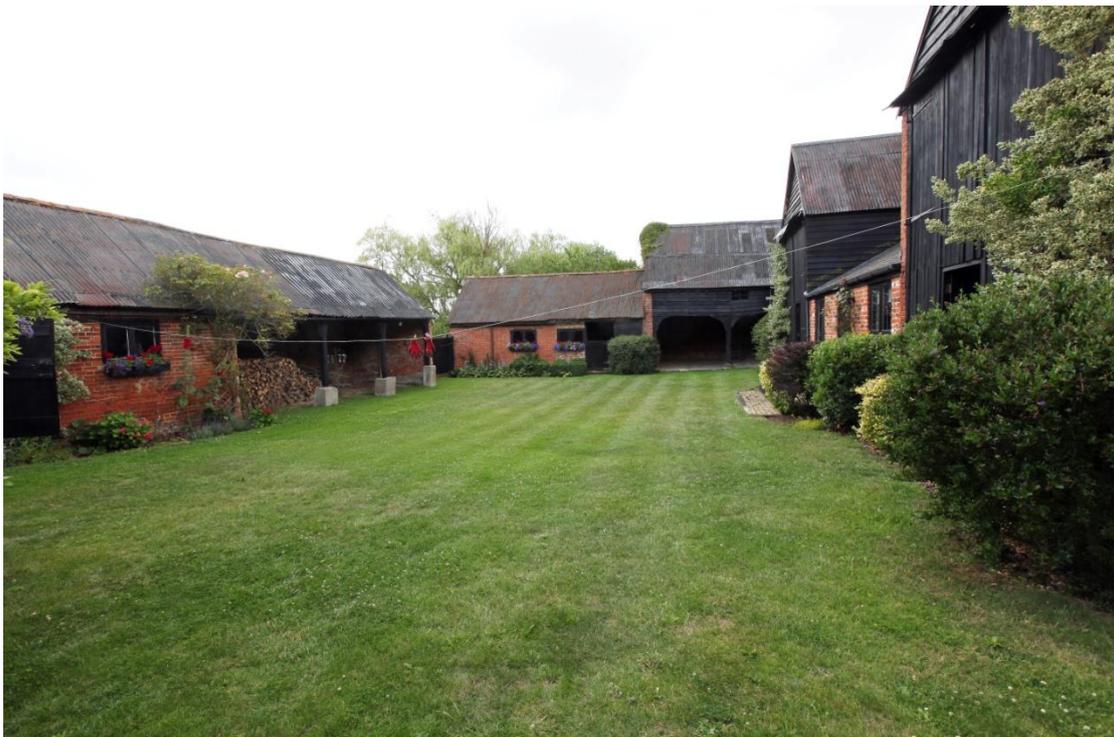
Illus. 4. The enclosed farm yard from the north showing the outbuilding on the left with the brick stable and boarded granary in the rear and the threshing barn on the right. The buildings are all consistent with the date in the 1820s or 30s indicated by the historic maps.

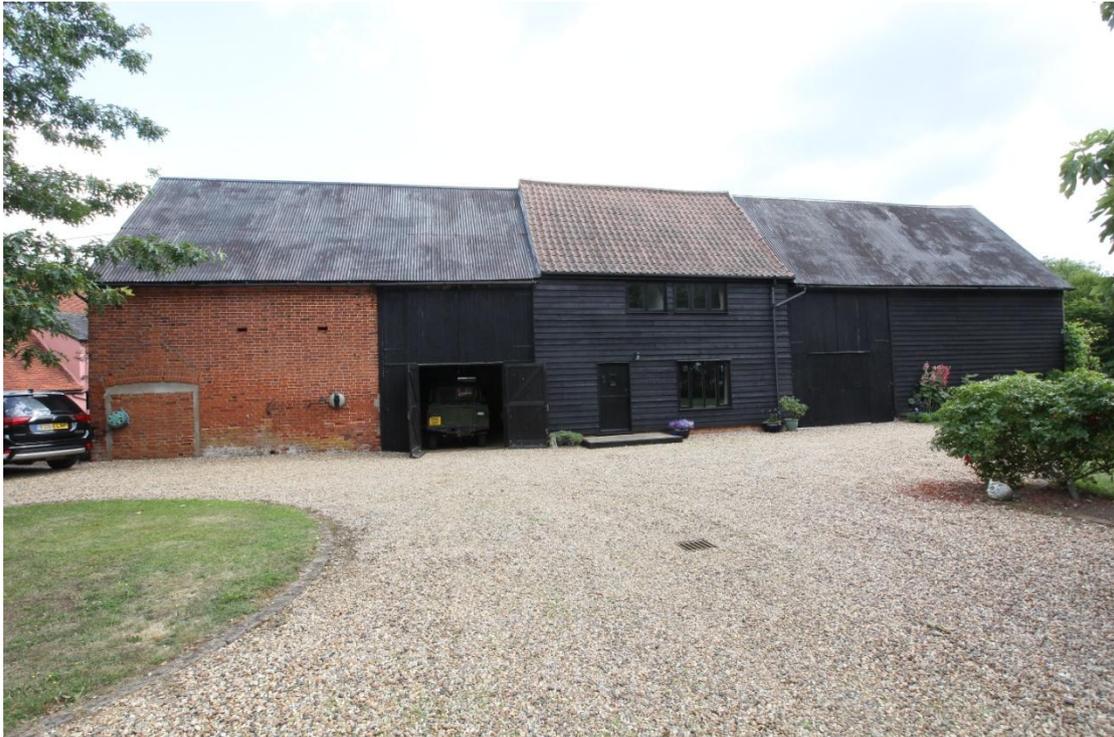
Illus. 7. The barn from the west showing the raised roof of the central section which has been converted into a dwelling (included for site context). The brick bay on the left was described as a corn barn in 1938 and contains a blocked unusual arched entrance to the extreme left. It probably operated in the manner of a modern grain store.

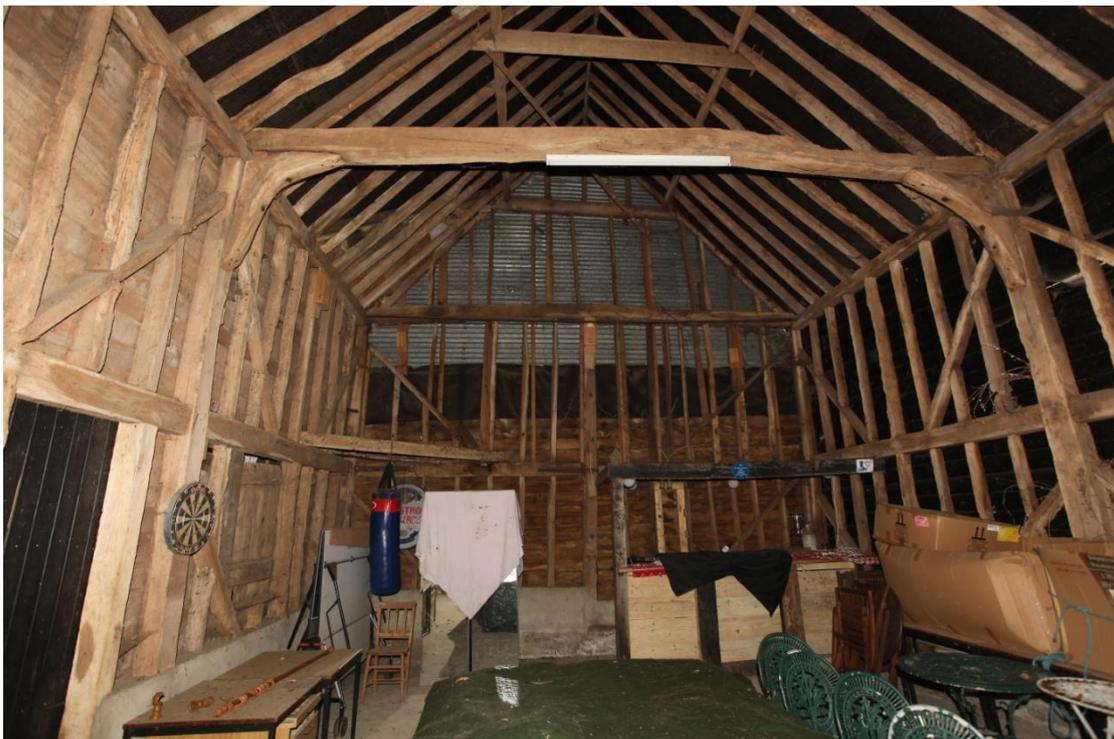
Illus. 8. The internal southern gable of the threshing barn showing its typically early-19th century framing with original bolted knee-braces rather than arch-braces to the tie-beam (included for site context). It is stylistically slightly later than the house as its diagonal wall braces are nailed rather than pegged, although the roof collars are pegged.

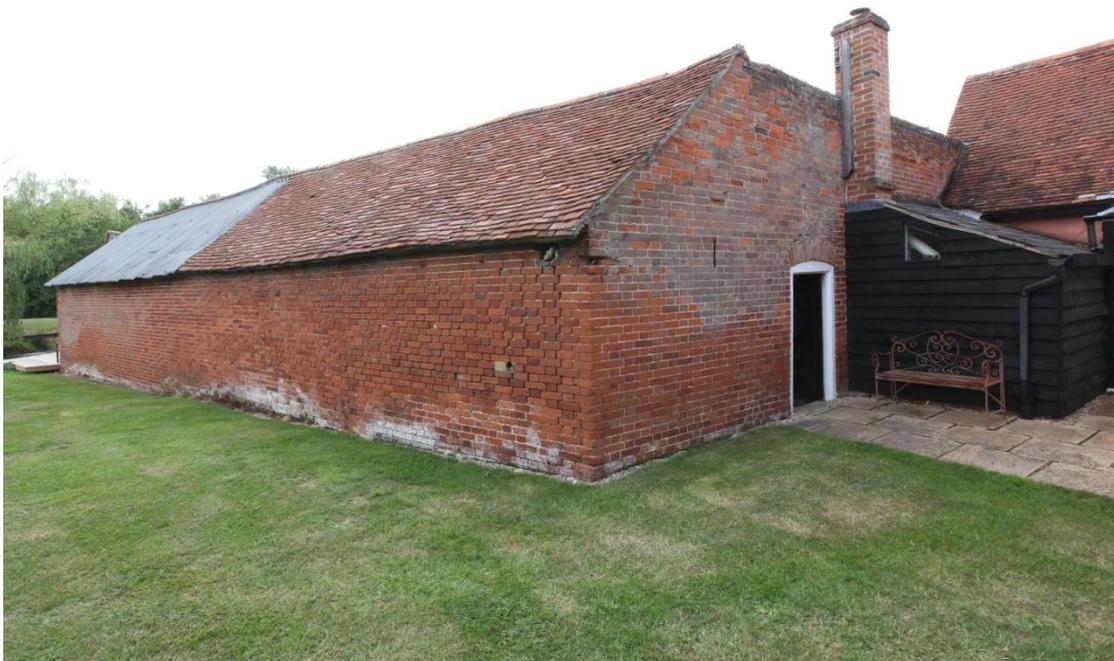
Illus. 10. The outbuilding from the north-east showing its Flemish Bond fabric with the boarded shed of the house adjoining on the right and the original entrance doorway in the northern gable of the feed-mixing shed (2a).

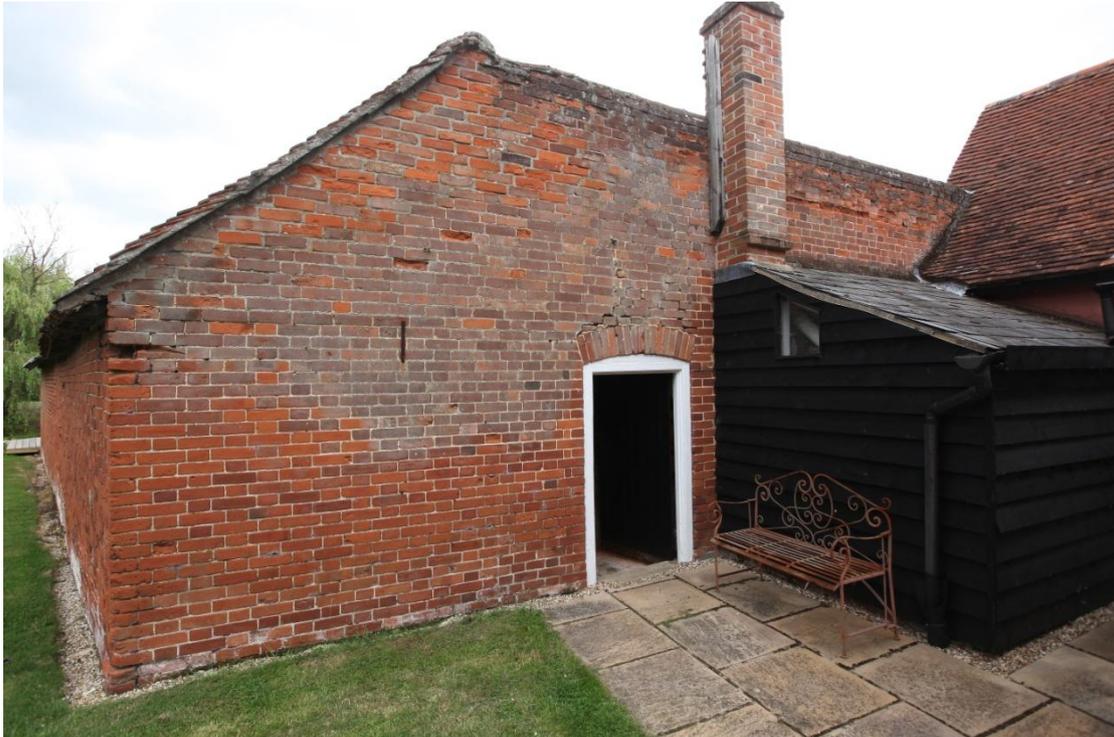
Illus. 11. The northern gable of the outbuilding which is integral to the wall of the cow-yard's shelter-shed (3) on the right and effectively screens the farm yard from the house. The arched doorway is also integral to the Flemish Bond brickwork and opens directly into the compartment described in 1938 as a mixing house (2a).

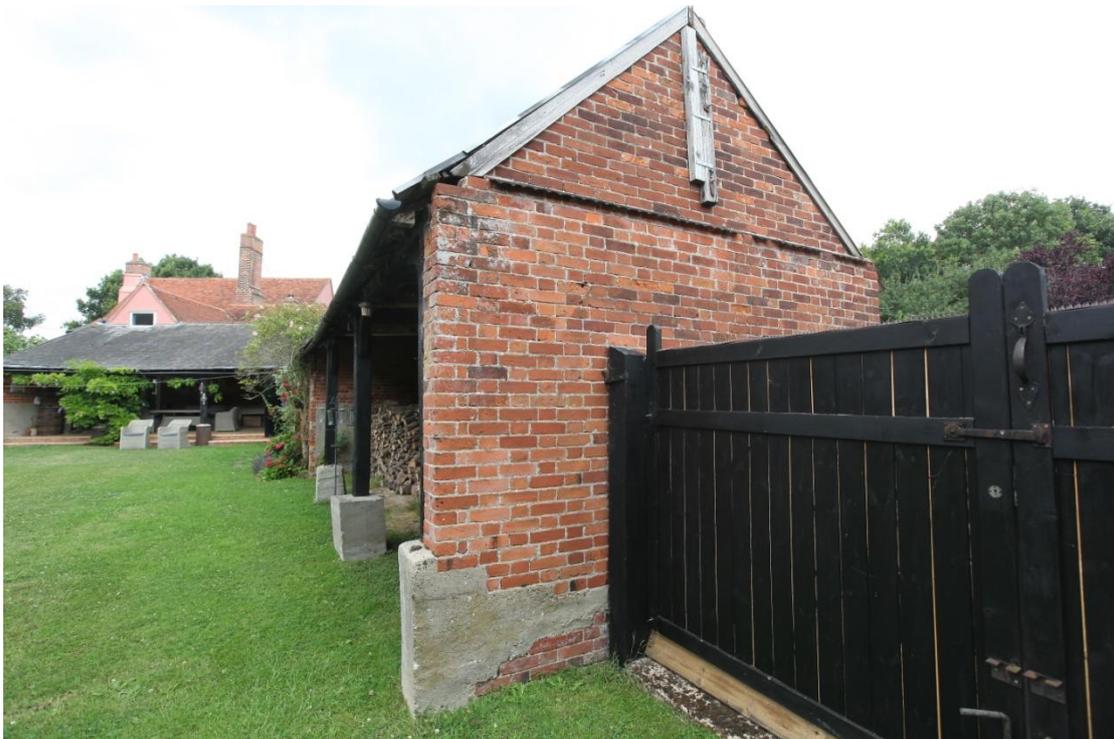
Illus. 12. The original Flemish Bond external southern gable of the horse yard's shelter-shed (1) at the southern end of the outbuilding.

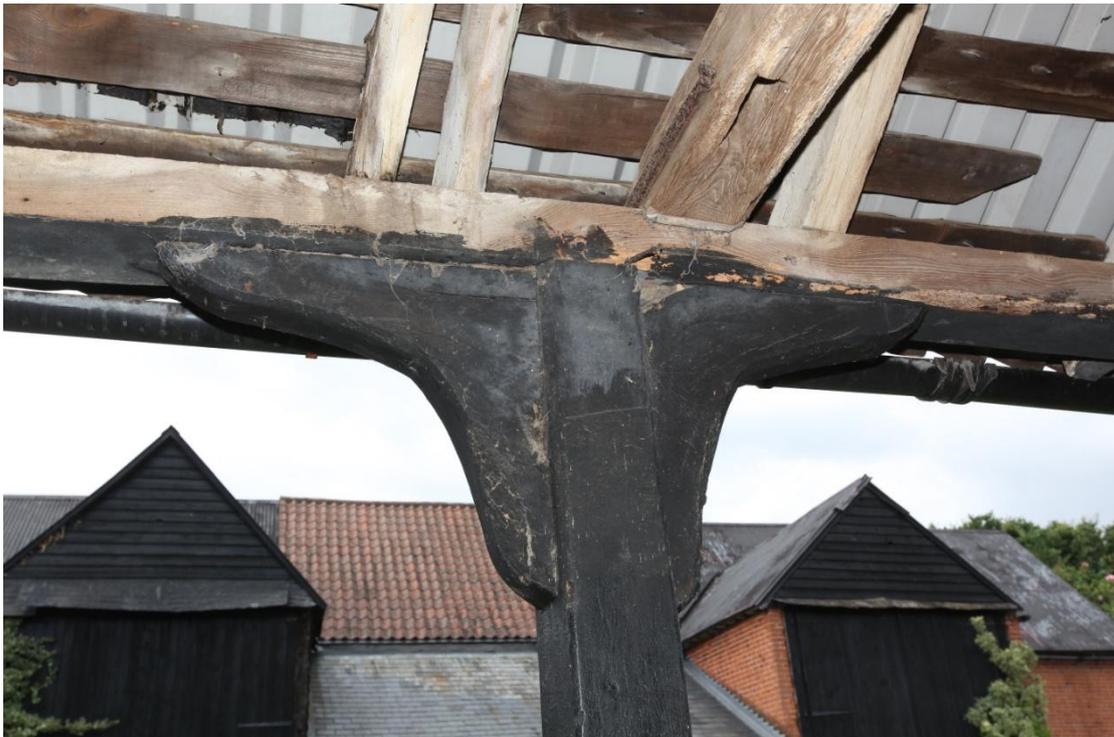
Illus. 16. A detail of the original tarred and bolted knee-braces linking the arcade post of the horse shelter-shed's western interior to its roof-plate (1).

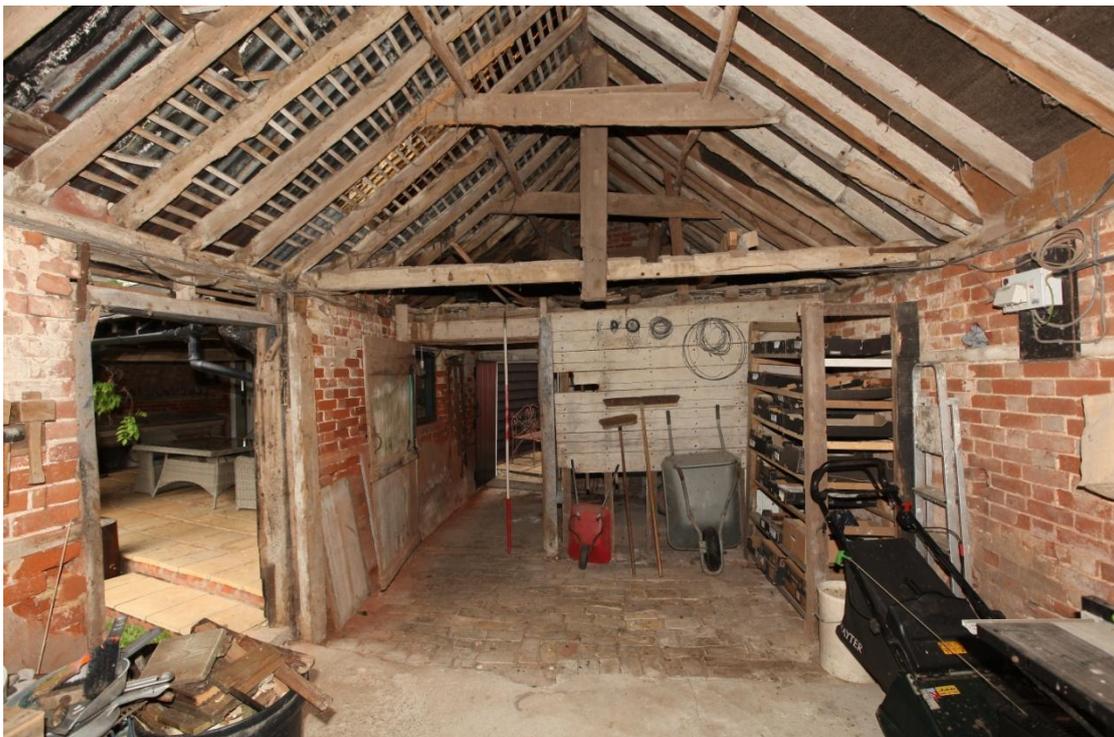
Illus. 20. The interior from the south of the cow shed (2) showing its original wide doorway to the missing enclosed cow yard on the left. The boarded partition of the feed mixing house (2a) is visible in the rear along with a section of original floor bricks.

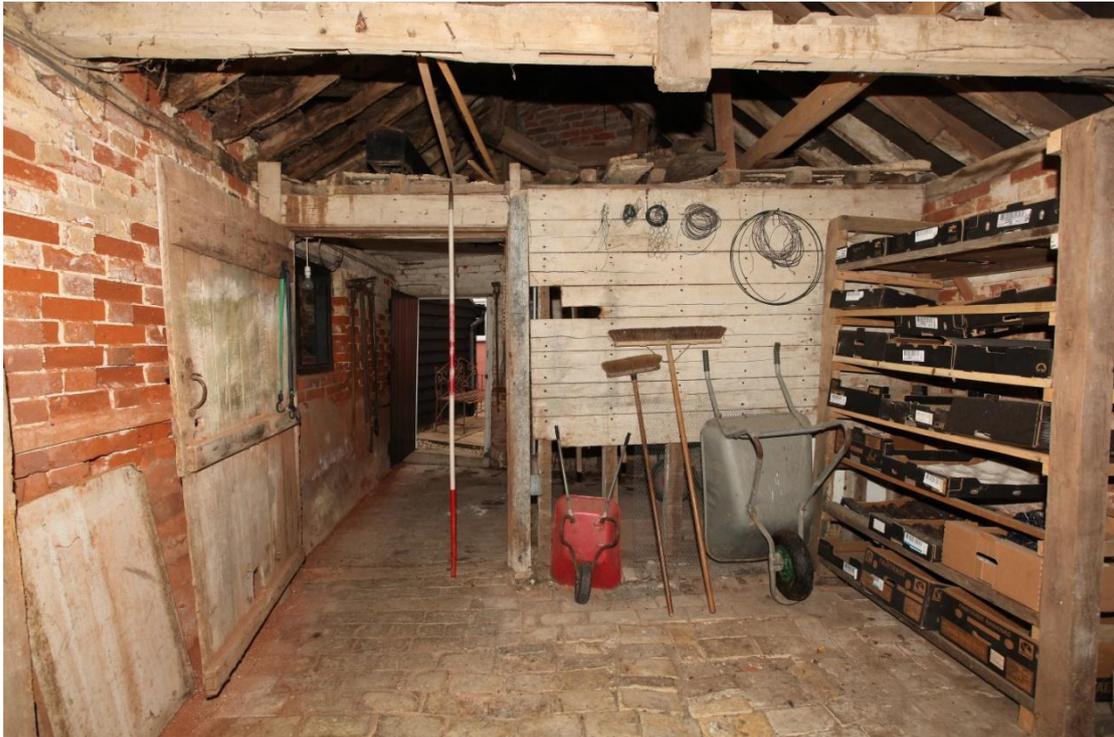
Illus. 21. The boarded partition and door of the mixing house (2a) at the northern end of the cow shed as seen from the south with the empty mortices of a re-used tie-beam in the foreground. The external gable door lies in the rear and the joist ends of the unusual double ceiling are visible at top right with details in illustrations 22-23.

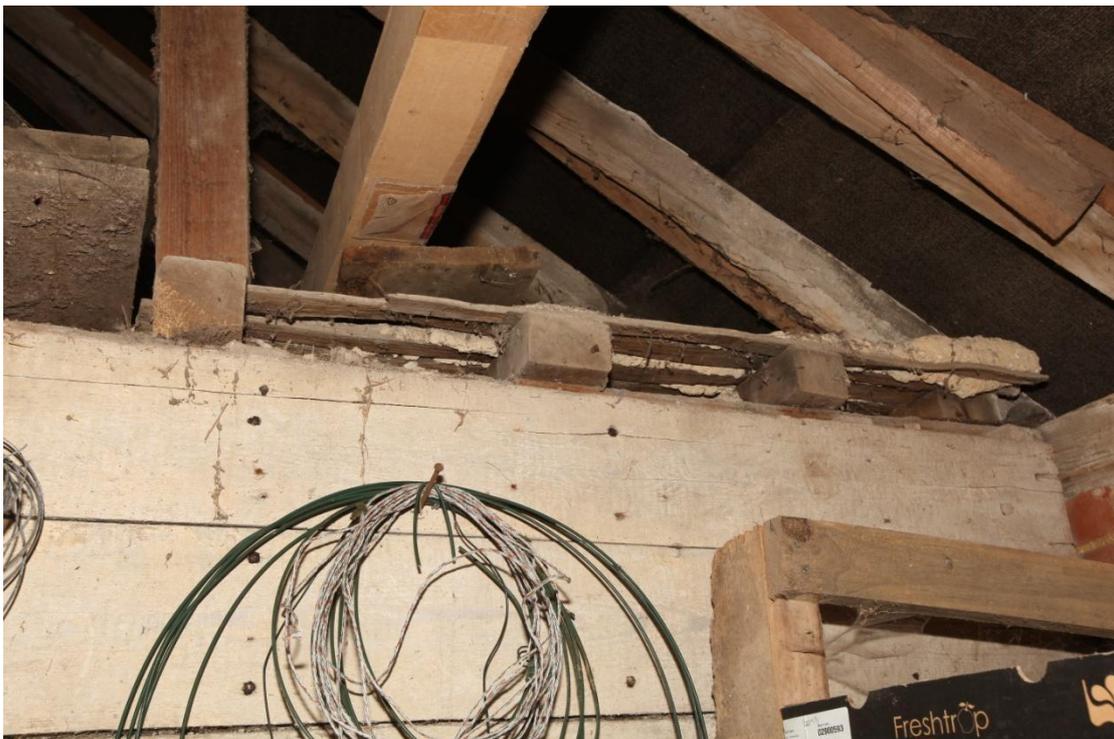
Illus. 22. A detail of the joist ends above the boarded southern wall of the mixing house in illustration 21 (2a). A small section of the original split laths of a daub attic 'floor' remains *in situ*. The attic floors of farmhouses were often constructed in this way when there was no access to the attic rooms and therefore no need for floorboards. They offered additional protection from dust and water ingress from above.

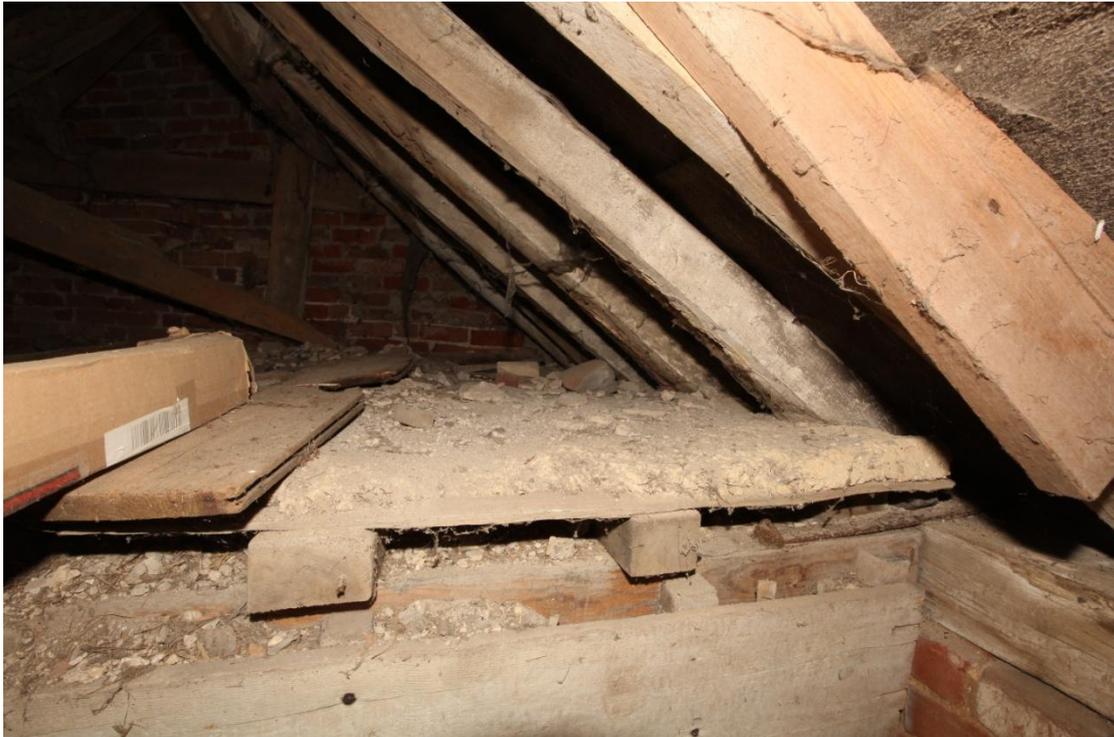
Illus. 23. A further detail of the rare original ‘floor’ of clay daub to the roof void above the mixing house (2a), consisting of a thick layer of clay, straw and hair applied to split oak laths laid across the joists. The lath-and-plaster of the inner ceiling is also visible beneath the joists.

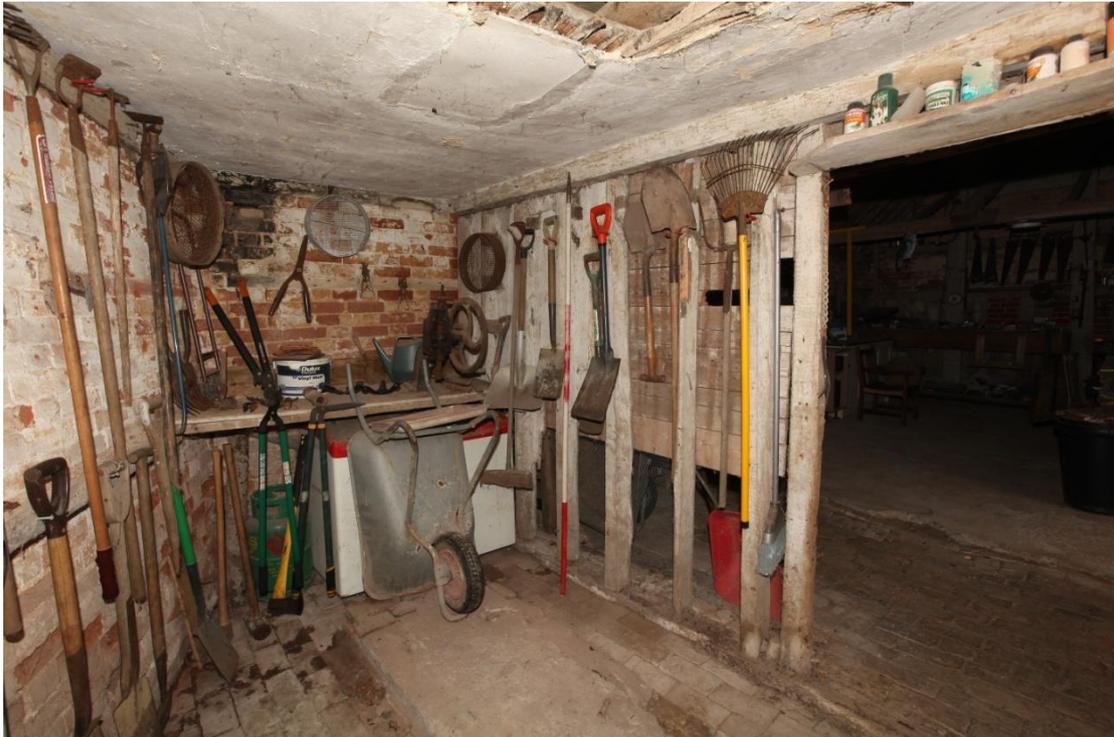
Illus. 25. The interior from the west of the mixing house (2a) showing the brick northern gable on the left and the entrance to the main cow shed (2) on the right. The mixing house varies from 1.4 m in length against the eastern wall in the centre to 3 m on the west, reflecting the irregular angle of the building's corner.

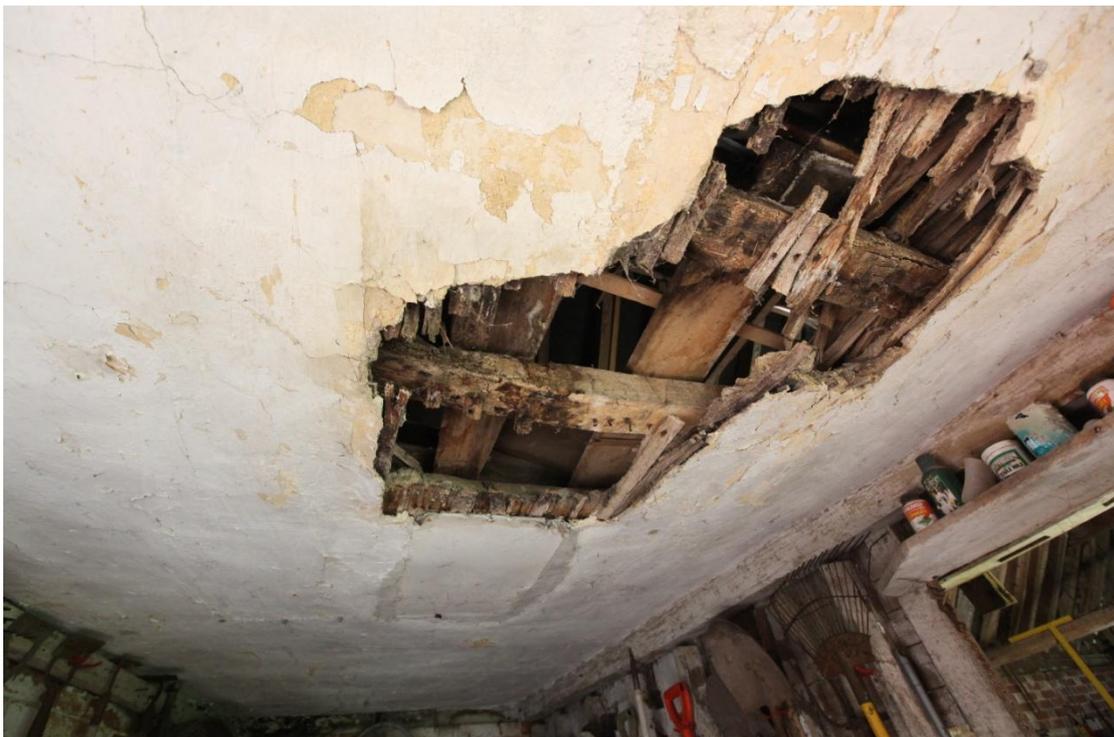
Illus. 26. A detail of the 19th century lath-and-plaster ceiling of the mixing house (2a) as seen from the west. The laths are nailed to the undersides of the original common joists. There is no evidence of whitewash on either the joists or the upper laths in illustration 22 that might suggest this plaster post-dates the layer of clay daub above.

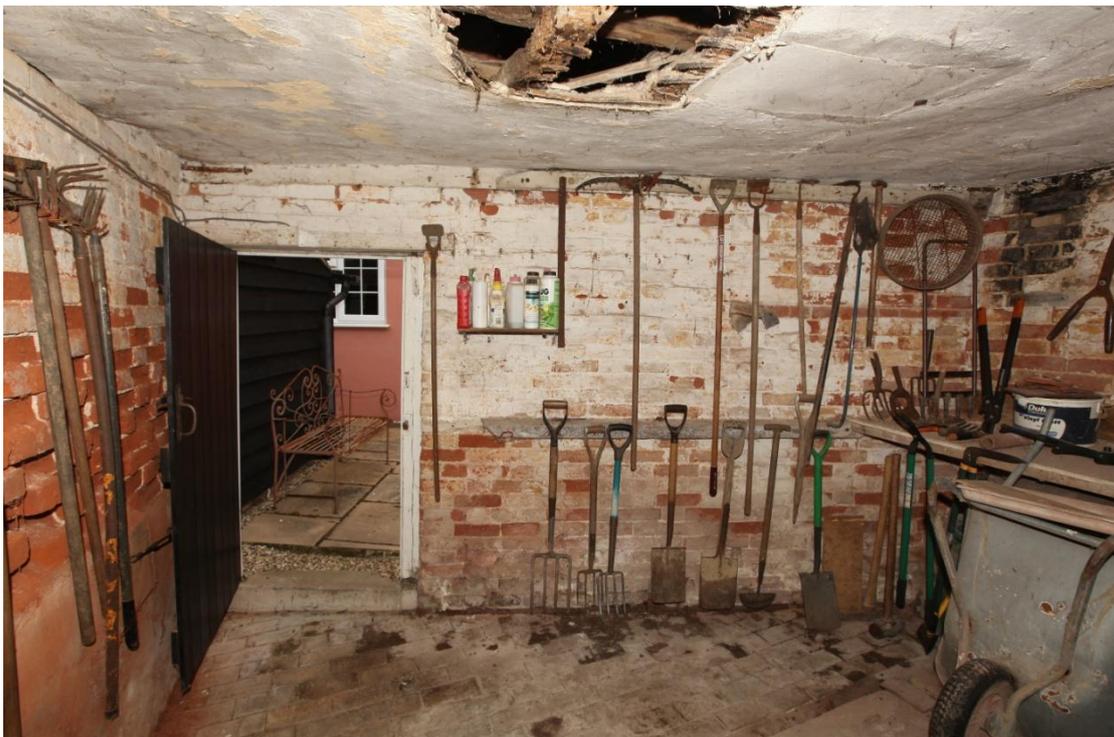
Illus. 28. The brick northern internal gable of the mixing house (2a) showing the original doorway which communicated with the house.

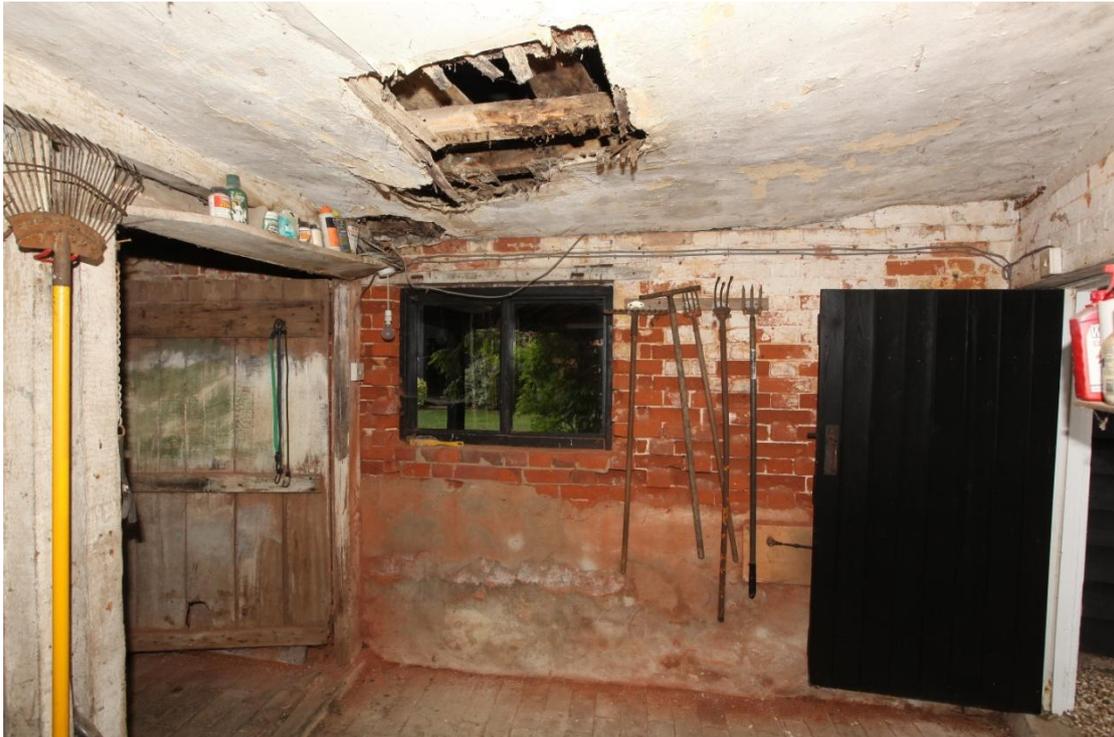
Illus. 29. The western interior of the mixing house (2a) showing the original plank-and-batten door to the main cow shed (2) on the left with the renewed door to the house on the right and the modern window to the shelter-shed (3) in the centre.

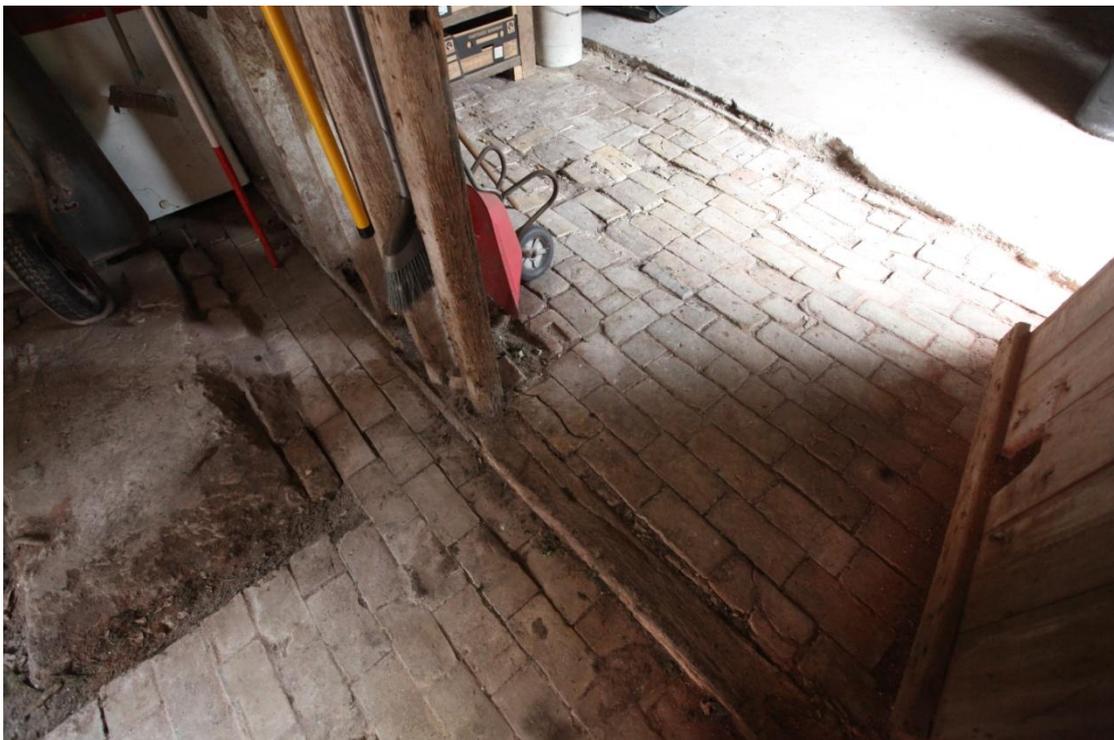
Illus. 30. The 19th century floor bricks of the mixing house (2a) on the left and the main cow shed (2) on the right. The bricks respect the sill of the partition between these spaces, suggesting it is contemporary with the building. The concrete blocked to the left supported a missing 20th century tank.

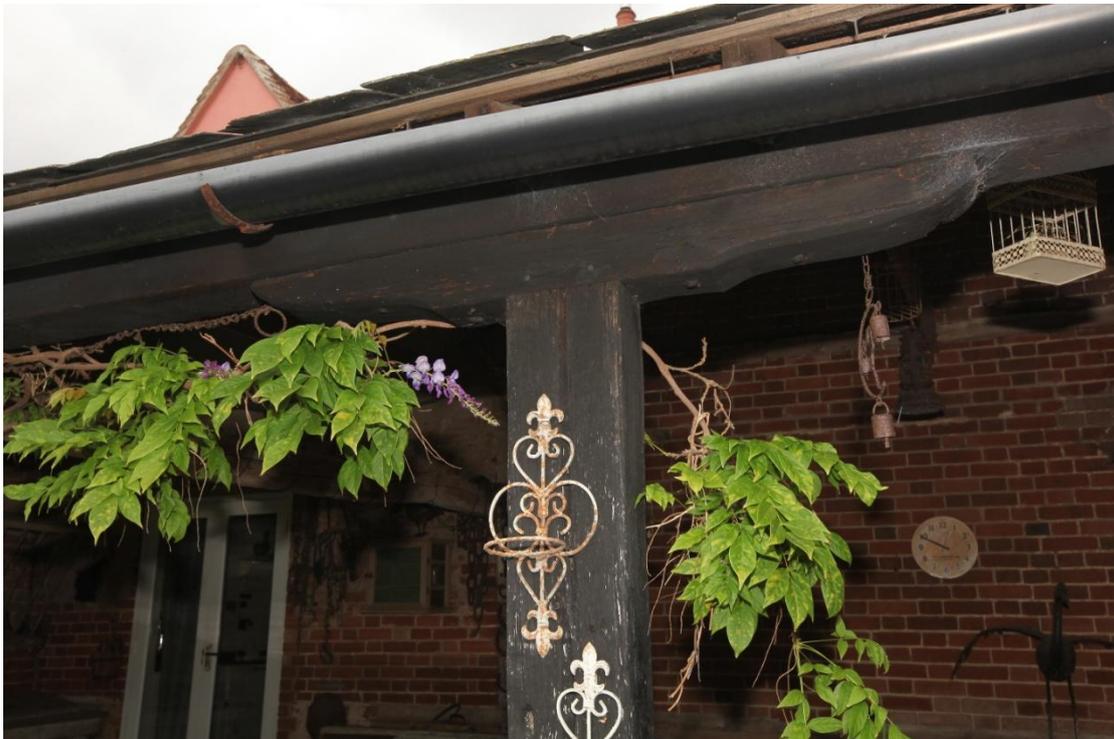
Illus. 32. A detail of the original shaped lintel dividing the arcade post of the cow-yard's shelter-shed (3) to the right in illustration 31 from its roof-plate.

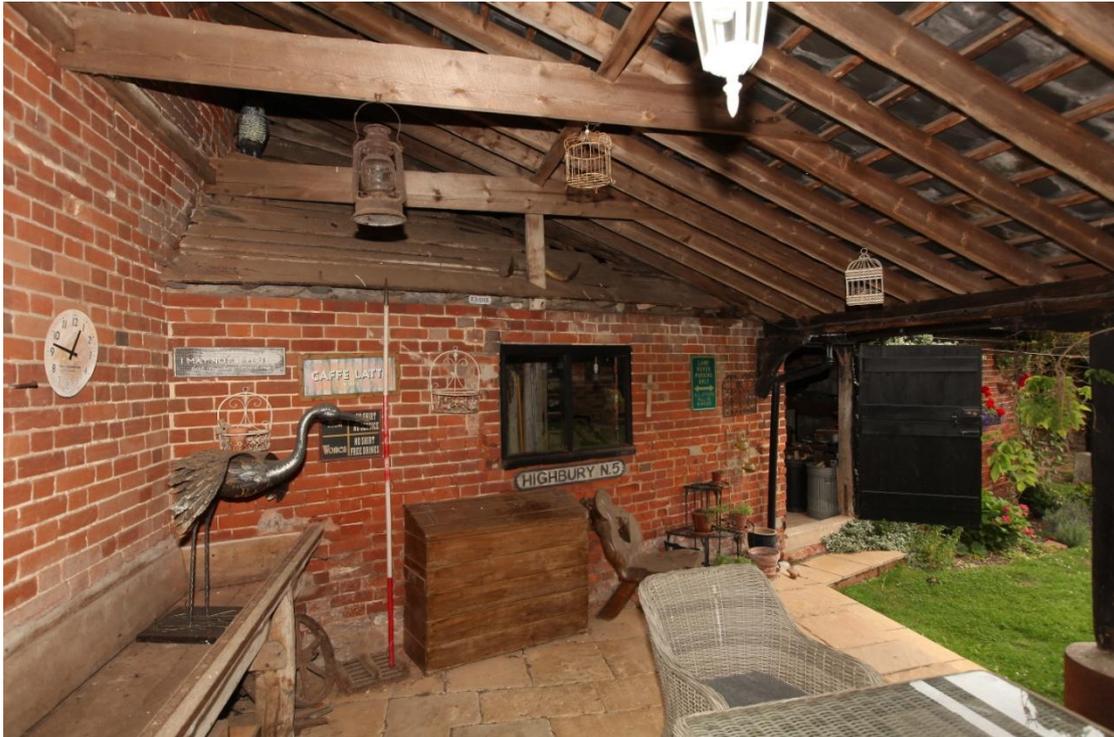
Illus. 33. The interior of the shelter-shed (1) to the north of the farm yard showing the window to the mixing house (2a) in the cow shed. This window is modern but its aperture is respected by closers in the brickwork.

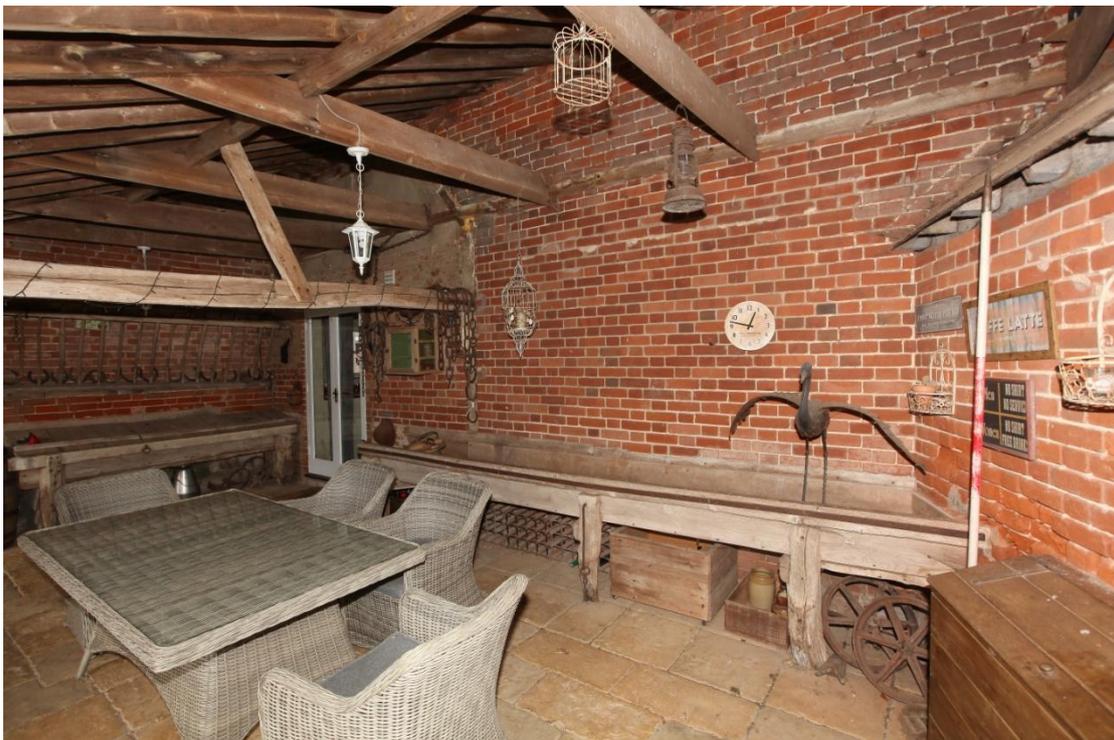
Illus. 34. The 19th century boarded manger against the northern internal wall of the shelter-shed in the cow yard (3) with the modern French doors to the house on the left. This manger is understood to have been moved from the horse yard's shelter-shed to the south of the outbuilding (1).

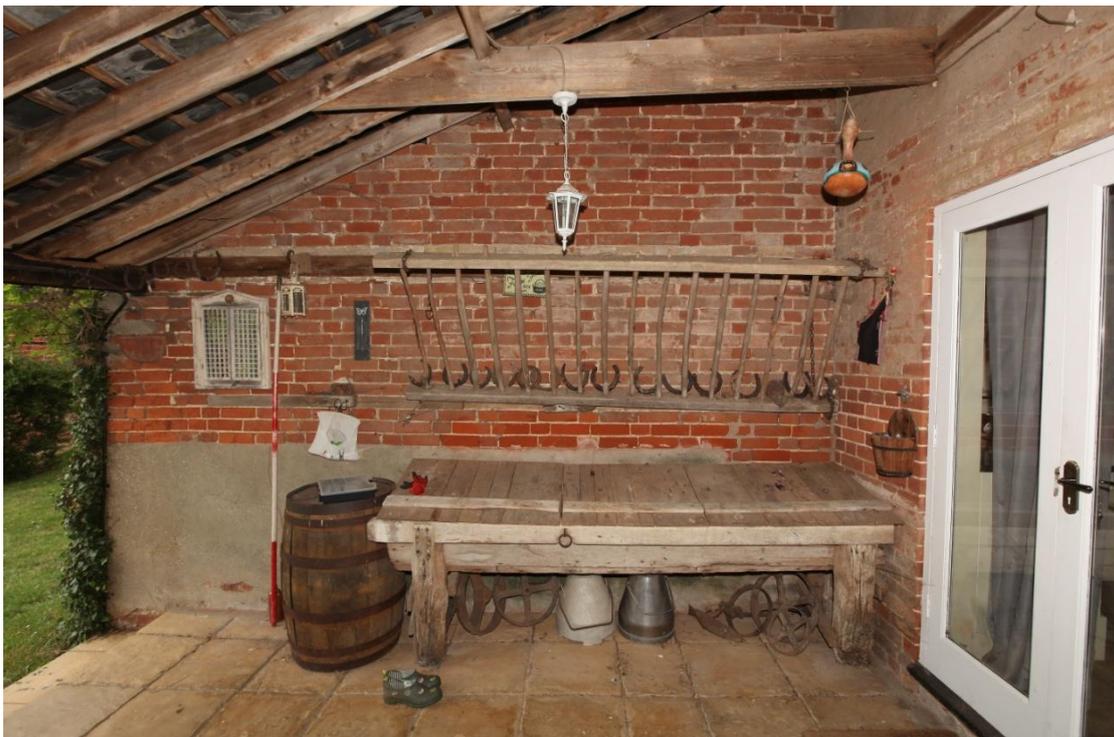
Illus. 36. The western interior of the shelter-shed that served the cow yard (3) showing a 19th century hay rack with wooden tines above a low boarded manger of the same period. The French doors on the right are 20th century insertions that connect the building directly to the house.
