# Your survey report

80 Granbrook Lane, Mickleton,  
Gloucestershire, GL55 6TF

11th August 2023

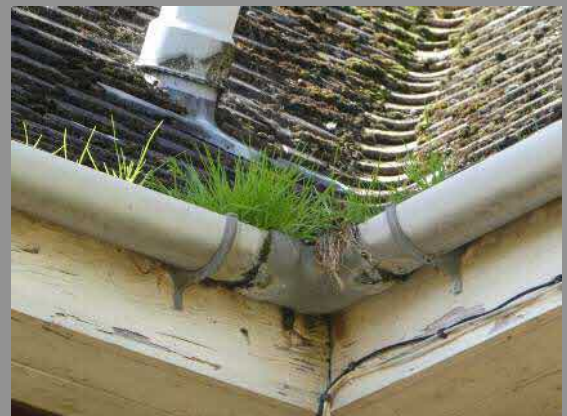
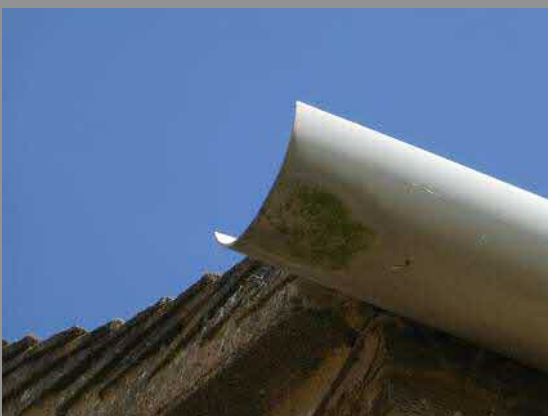
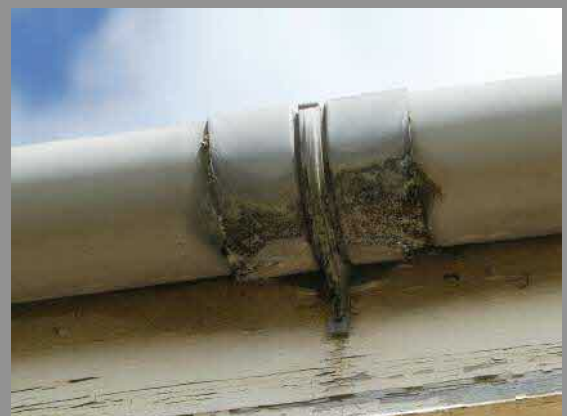
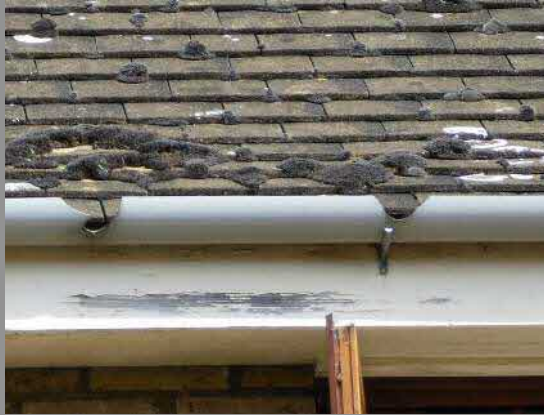
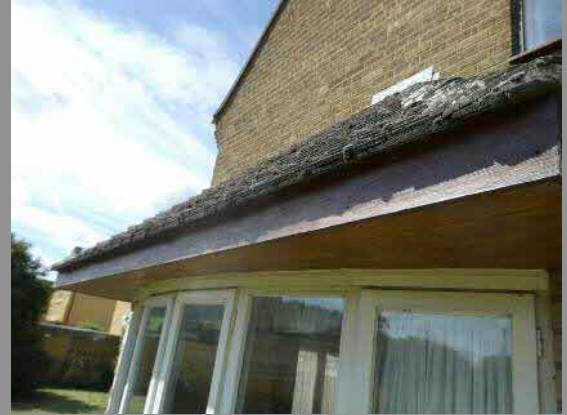
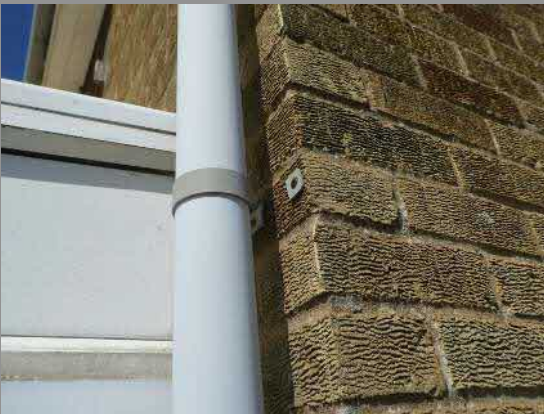
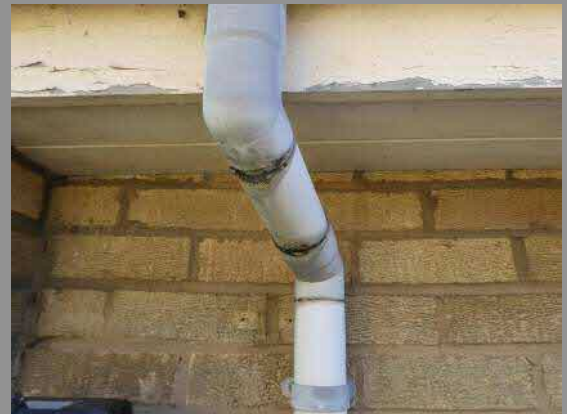
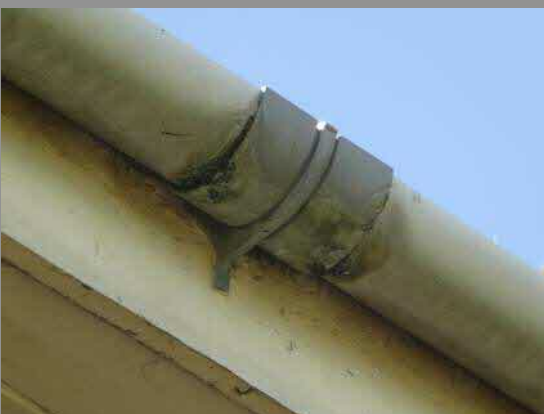
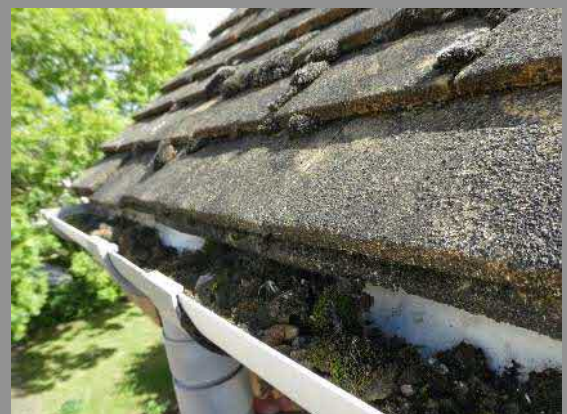
The rainwater gutters are made of plastic with plastic downpipes, discharging to ground, presumably to a separate foul and storm water disposal system. The following defects were noted:

- the downpipe to the front north-east corner has come away from the ground connection and is discharging over the ground
- the gutters are blocked with vegetation to the base of the east valley to the front gable
- there is staining and leaking at joints to the rear gutter
- the end stop to the west end of the rear gutter is missing
- the rear gutter is broken/damaged, causing water to splash back against the base of the rear wall
- there are no gutters to the side extension roof.
- the middle bracket is broken to rear south-east corner downpipe
- there is general staining at joints and the gutters are partly blocked with vegetation

These defects are causing damp penetration internally and rot to the timber floors (see D4 Main Walls, E3 Walls and Partitions and E4 Floors). Condition rating 3. This should be repaired now. Given the extent of the repairs required, it is likely to be more economical to simply replace all the rainwater goods

You should instruct a competent roofing contractor to provide an estimate for these works and any necessary associated repairs prior to exchange of contracts. To repair or replace rainwater goods safely and without damaging the roof covering, contractors will have to use appropriate access equipment (for example scaffolding, hydraulic platforms, etc.).

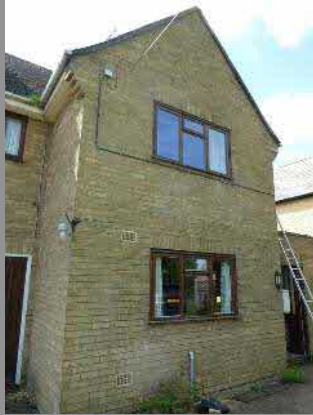
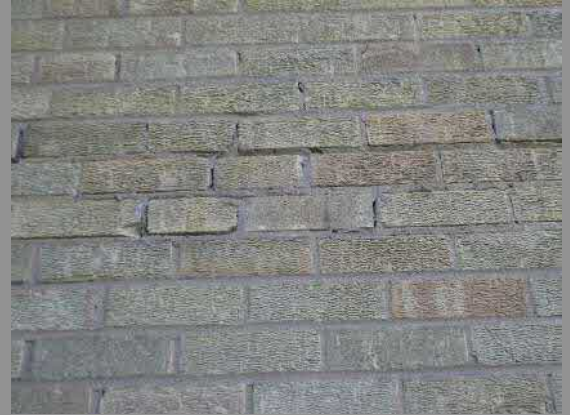
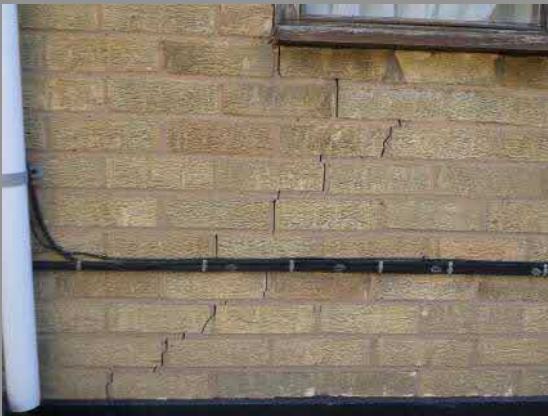
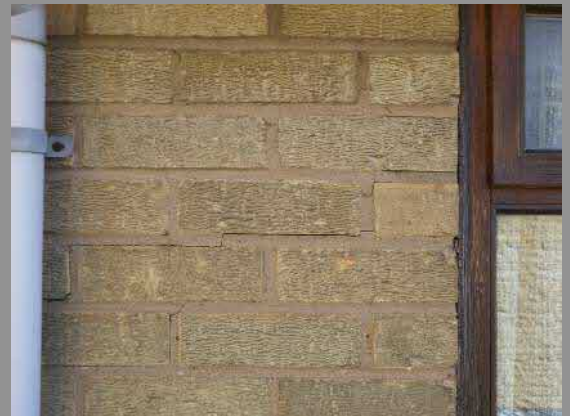
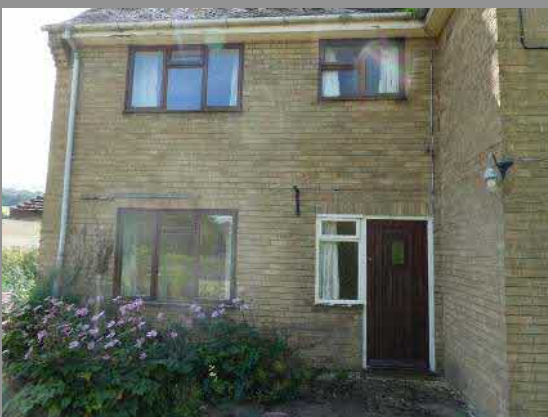
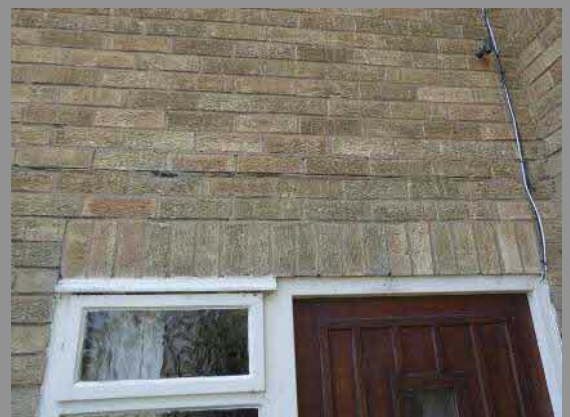
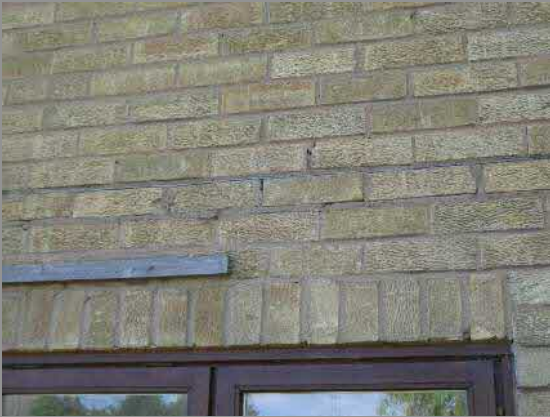
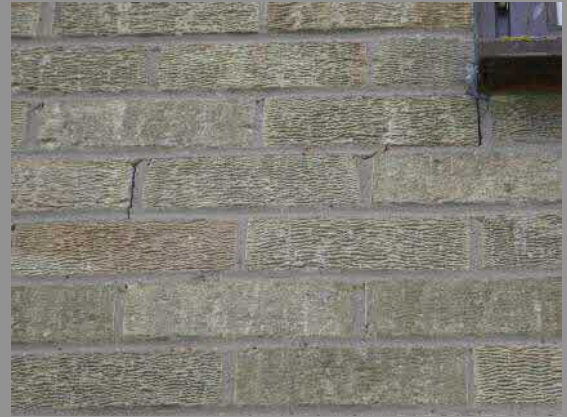
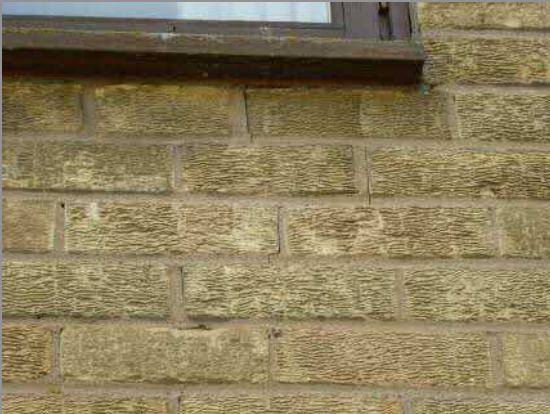
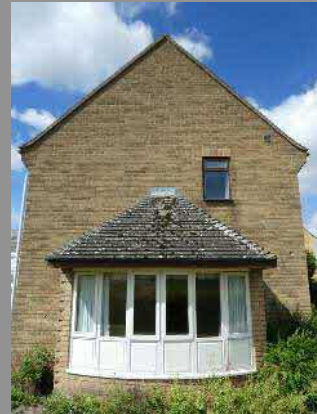
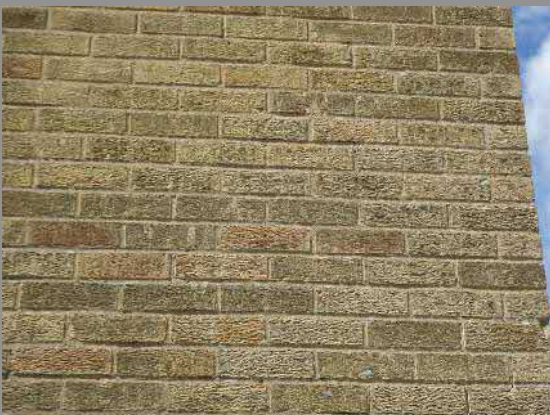
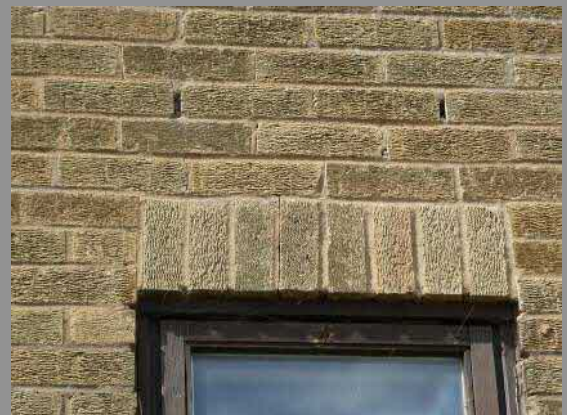
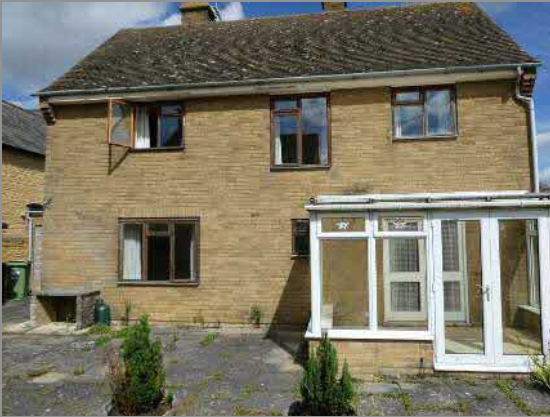
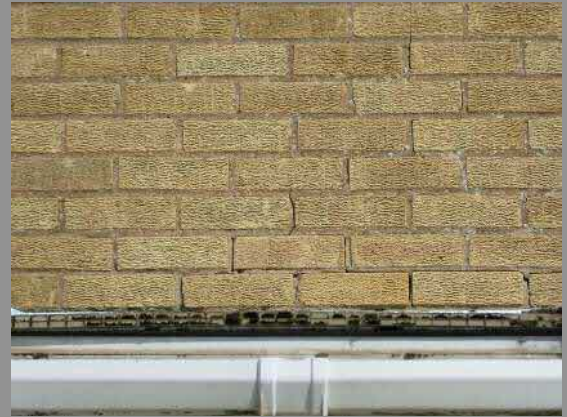
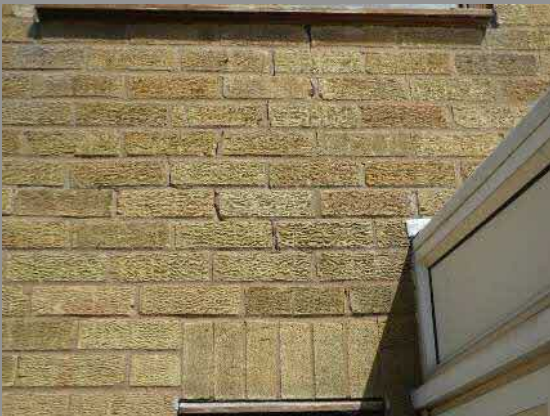
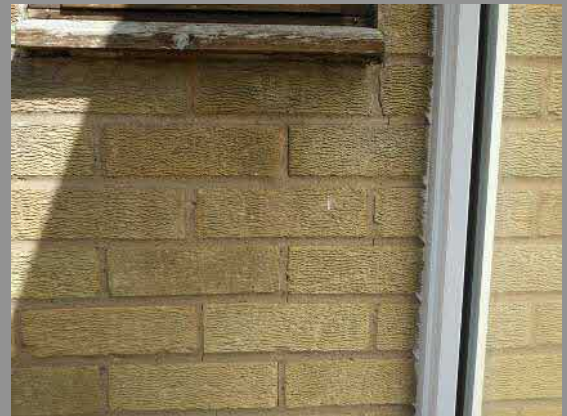
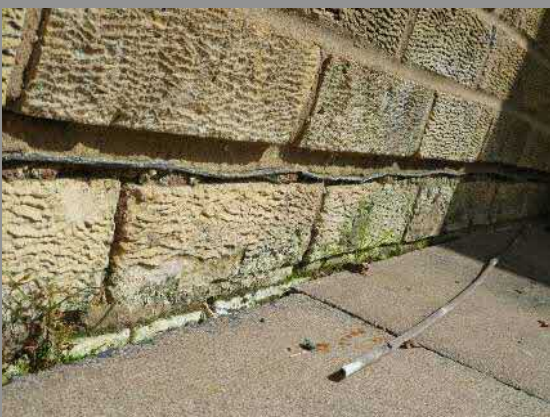
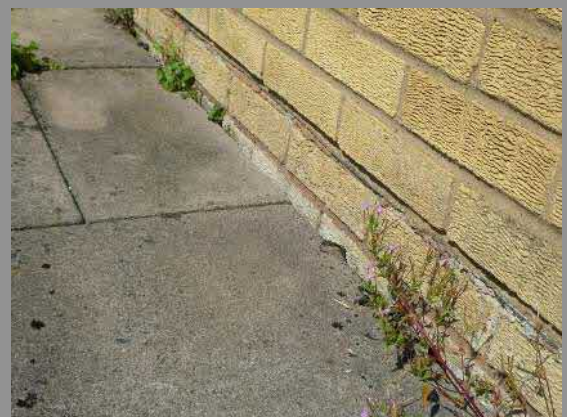
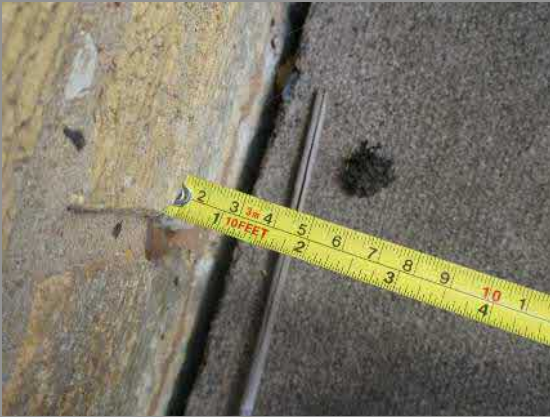
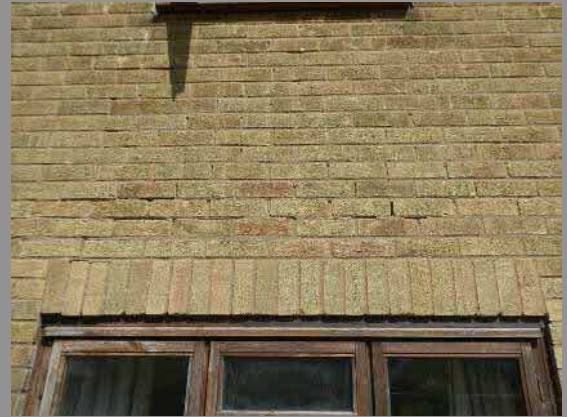
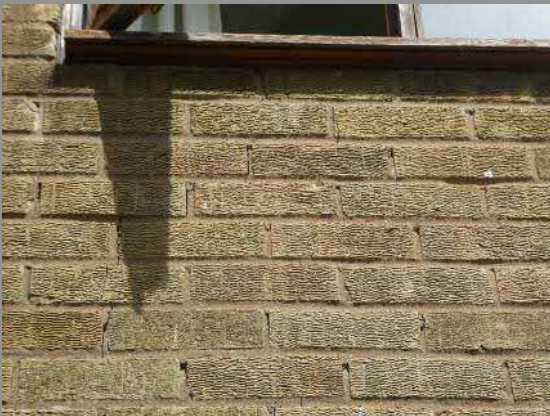
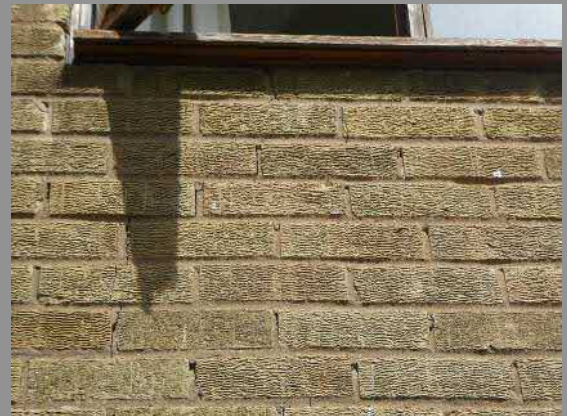
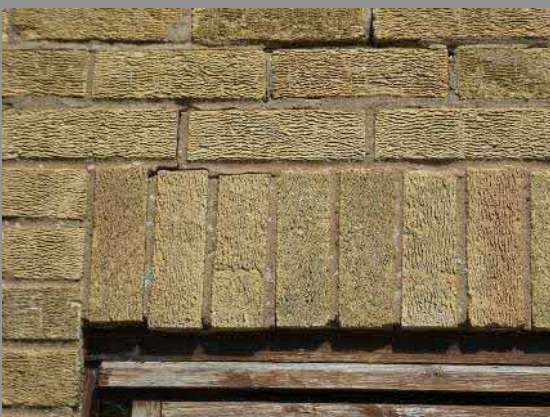
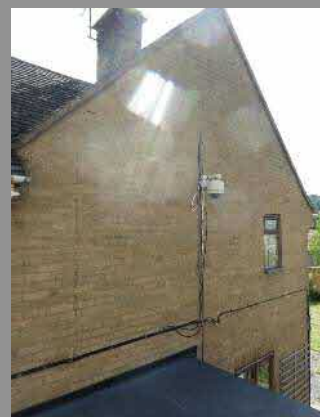
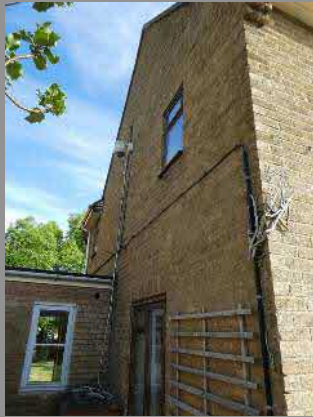
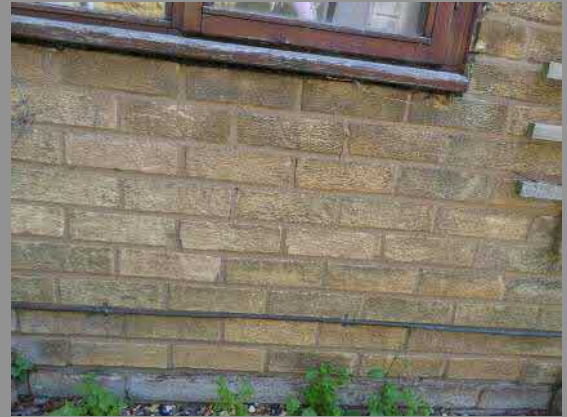
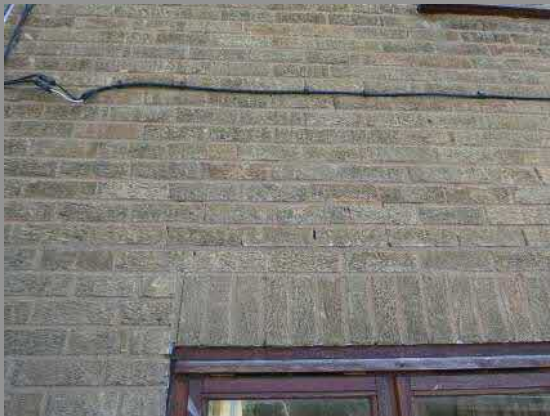
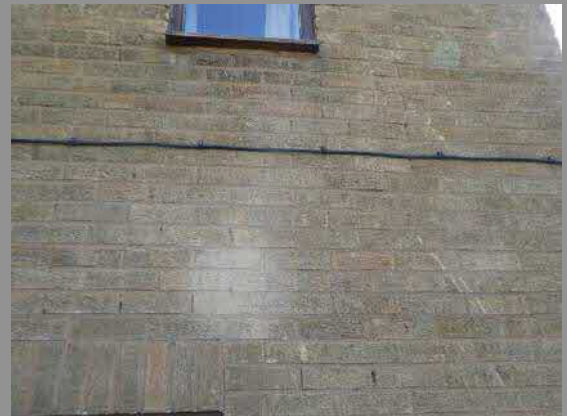
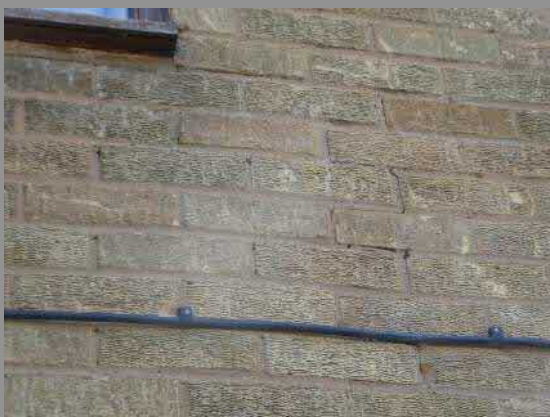
the ground (called a damp proof course or DPC) consisting of a layer of bituminous felt built into the walls. The following cracking to the mortar joints and/or bricks to the outside walls was noted:

- horizontal cracking and perished mortar joints to the east elevation wall
- stepped cracking below the side west window to bedroom 1
- horizontal cracking to the left-hand side of the side west window to bedroom 1

- horizontal and vertical cracking over the front door
- stepped cracking above the left-hand corner of the sitting room window up to the corner of the side gable
- stepped cracking below both corners of the window to bedroom 3

- stepped cracking from the roof of the extension up to the front corner
- stepped cracking over the window to bedroom 3

- stepped cracking above the conservatory roof up to the window to bedroom 4
- stepped cracking above the small window to the dining room up to the landing window
- stepped cracking below the small window to the dining room
- the bricks above the dpc oversail the bricks below by approximately 15mm
- stepped cracking and dropped soldier brickwork above the dining room window up to the underside of the window to bedroom 2

- stepped cracking below the dining room window
- stepped cracking above the left-hand and right-hand corners of the dining room window
- stepped cracking above the left-hand corner of the window to bedroom 2

A range of factors common to properties of this type and age can cause the outside walls of a property to move over time. Possible causes could include subsidence due to shrinkage of clay sub-soils, lack of lintel support over openings, lack of lateral restraint at roof level and thermal expansion. Condition rating 3. Further investigation. Movement in this property is serious and it could get worse. Parts of the property could become unstable. You should ask an appropriately qualified person to investigate the problem and recommend a scheme of repair. To do this properly, parts of the property will have to be disturbed, so you should discuss this with the building owner. Evidence of former building movement (even where satisfactorily resolved) can affect future suitability for mortgage and saleability of the property.

Tests were taken with a moisture meter at regular intervals in a structured, methodical manner to the internal face of the outside walls. The following areas had elevated moisture content readings.

- moderate moisture content readings to the front wall in the hall
- low moisture content readings to the front corner of the sitting room, resulting in rot to timber floor (see E4 Floors)
- moderate moisture content readings to the rear corner of the sitting room, resulting in rot to timber floor (see E4 Floors)
- moderate to high moisture content readings to the rear wall of the dining room, resulting in rot to timber floor (see E4 Floors)

No evidence of any significant dampness was detected to the remaining outside walls, although you should be aware that kitchen fittings, pipe boxing, wall tiles, and floor coverings restricted our ability to test all areas. Condition rating 3. Further investigation. The dampness in the walls is

The mortar joints are eroded and cracked in places. Condition rating 2. This should be repointed/ repaired soon.

You should instruct a competent building contractor to provide an estimate for these works and any necessary associated repairs prior to exchange of contracts. To repair the walls safely, contractors will have to use appropriate access equipment (for example scaffolding, hydraulic platforms, etc.).

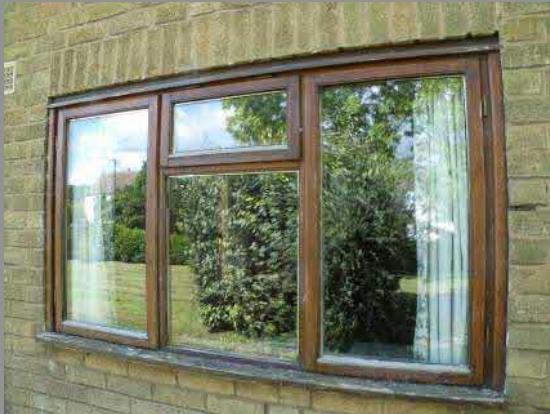
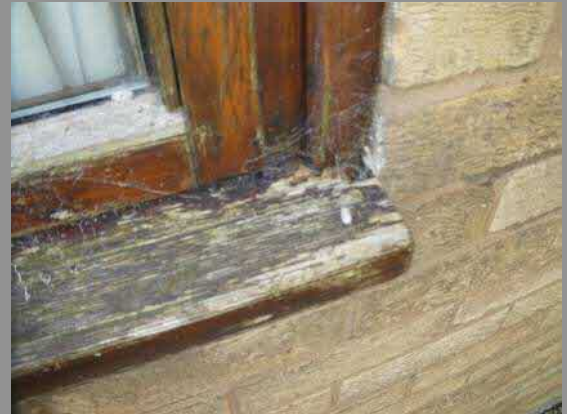
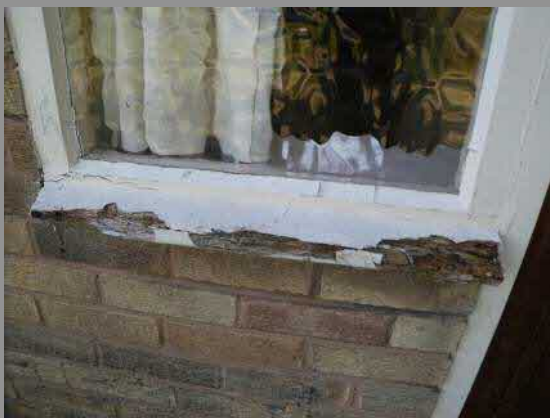
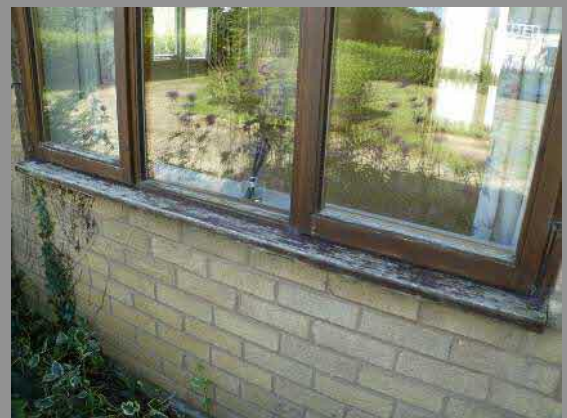
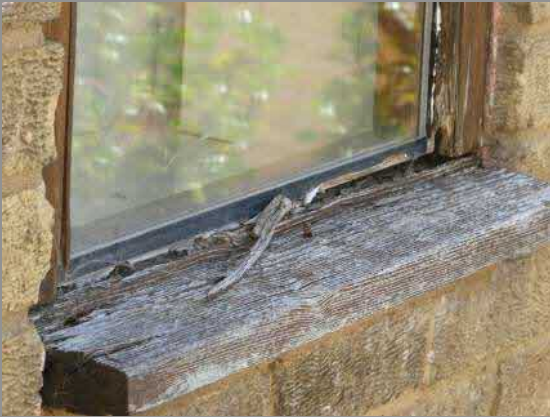
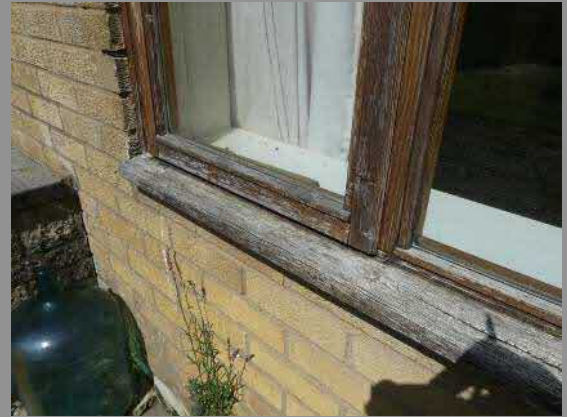
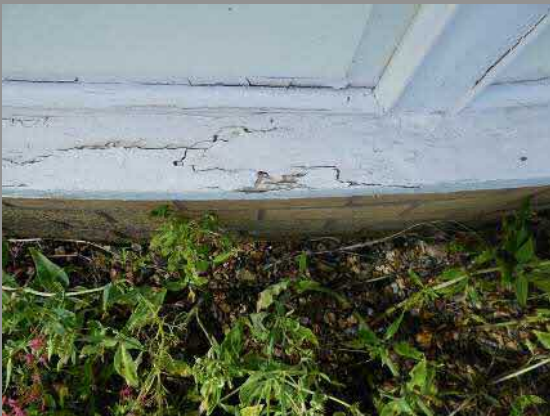
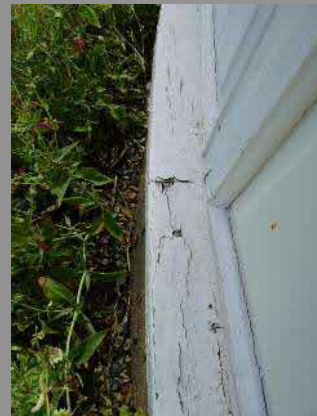
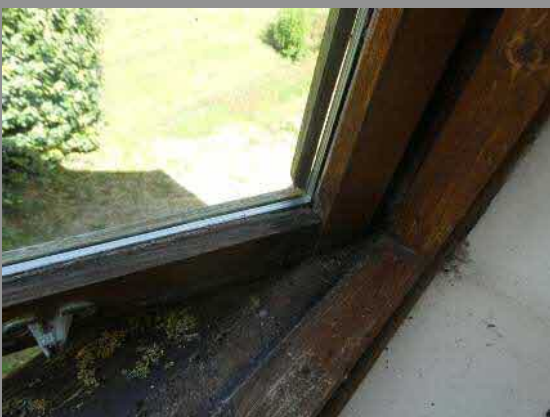
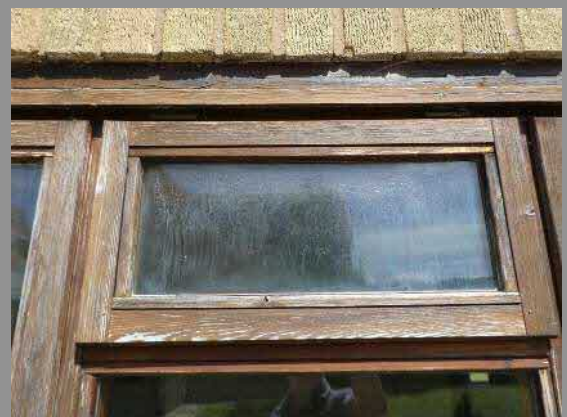
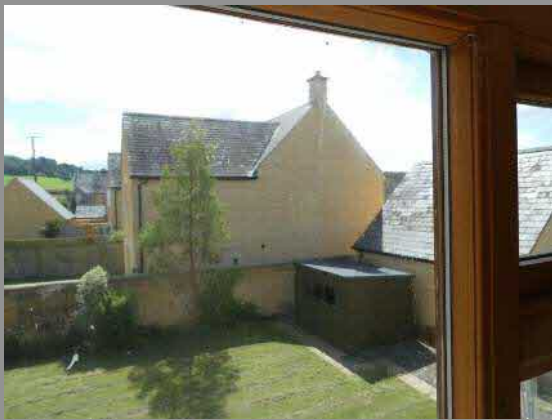
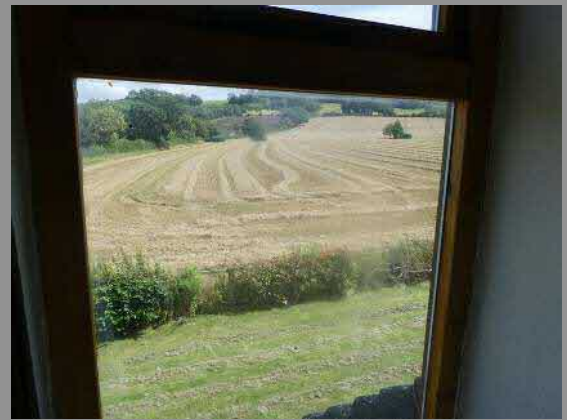
The windows are extensively rotten, and the decoration is in flaking/worn. Condition rating 3. This should be repaired now. However, it may be more economical to replace all the windows entirely. Outside decorations help keep the property in satisfactory condition. Without a protective finish, parts will quickly deteriorate, requiring extensive repairs. To prevent this, the external surfaces should be redecorated soon following repairs if the windows are to be retained.

The double glazing units to the top hung casement to the dining room, the landing window and side window to bedroom 3 have failed and the space between the glass panes has 'misted' over. Condition rating 2. This is not a serious defect, but is unsightly and can reduce the thermal efficiency of the double glazing. You should replace these soon. Where some double-glazed panels have failed, the remainder could suffer similar problems, and you should plan to replace more in the near future. It can be difficult to replace just the double-glazed units on older windows. In these cases, you may have to plan to replace the whole window. Double glazing has a limited

You should instruct a competent contractor to provide an estimate for these works and any necessary associated repairs prior to exchange of contracts.

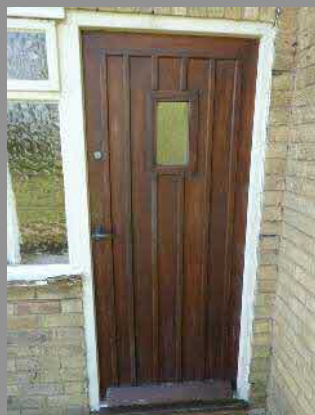
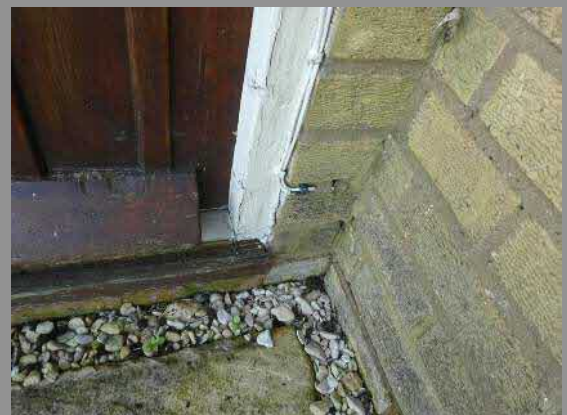
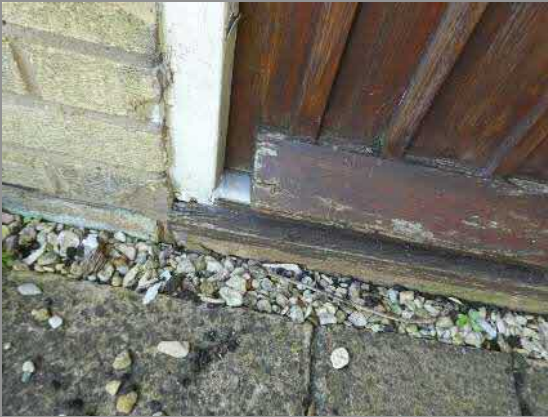
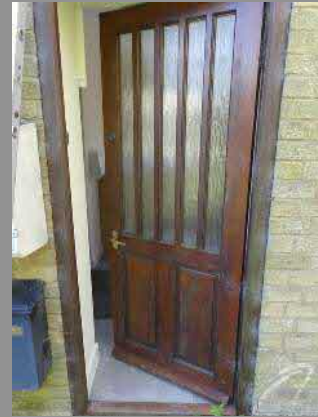
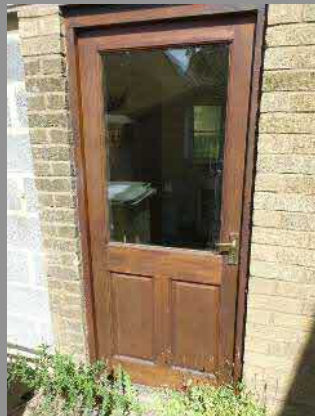
Stained timber door and painted timber sub-frame with glazed insert. The door/frame is rotten, and the decorations are flaking/worn. Condition rating 2. This should be repaired soon.

Stained timber door and sub-frame with glazed inserts. The decorations are flaking/worn. Condition rating 2. This should be redecorated soon.

Stained timber door and sub-frame with glazed upper panel. Condition rating 1. No repair is currently needed. The property must be maintained in the normal way.

You should instruct a competent contractor to provide an estimate for these works and any necessary associated repairs prior to exchange of contracts.

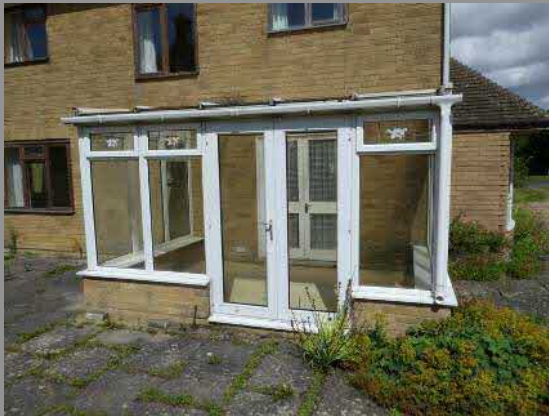
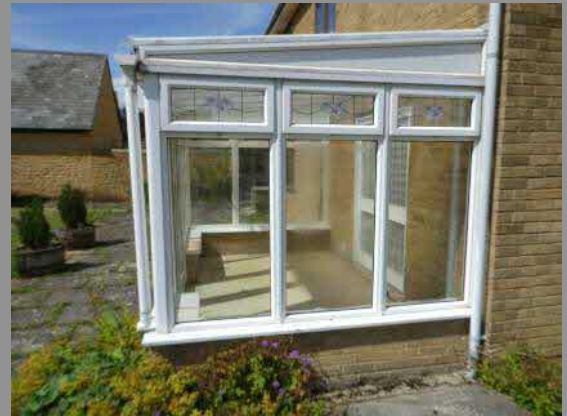
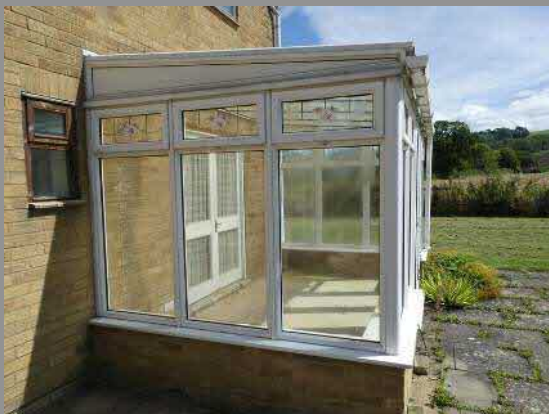
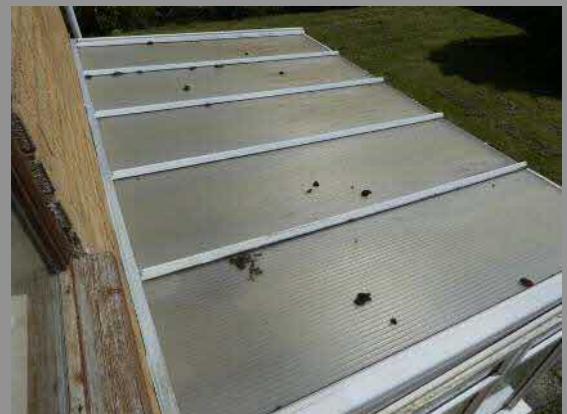
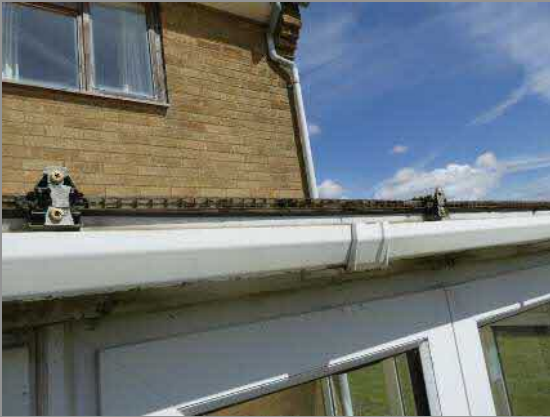
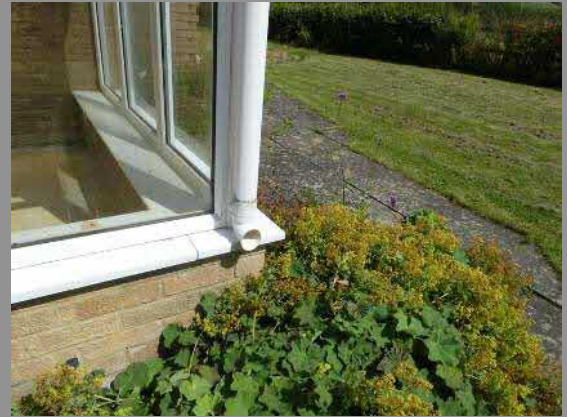
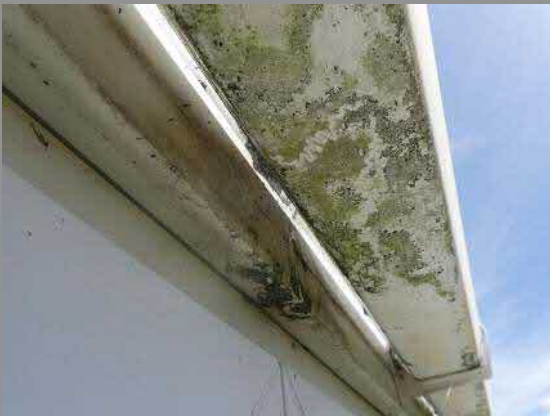
- the edge strips to the ends of the roof panels and cover plates to the ends of the glazing bars are missing
- the polycarbonate panels are dirty
- downpipe discharges over ground
- water running down fascia board as no overhang to roof panels into gutter
- several of the double-glazed windows have misted over, indicating the seals have failed

Condition rating 2. This should be repaired soon. However, given the very poor quality of the conservatory, it now requires replacement.

Failed double-glazed units is not a serious defect, but is unsightly and can reduce the thermal efficiency of the double glazing. You should replace these soon. Where some double-glazed

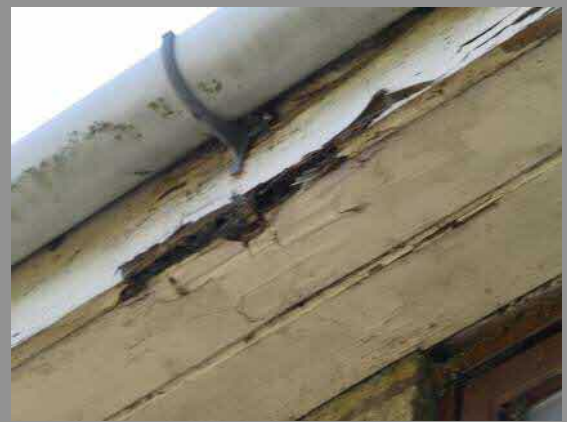
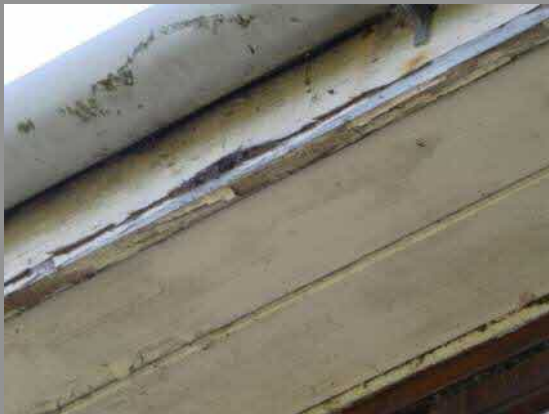
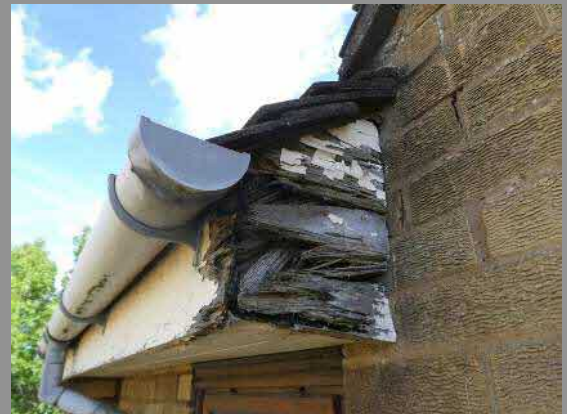
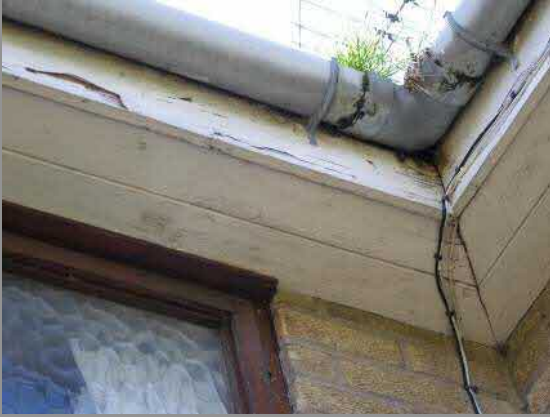
There are painted timber fascia and soffit boards around the edges of the roofs, not fitted with any vents to the soffit boards (see E1 Roof Structure). The fascia and soffit boards are extensively rotten, and the decoration is in flaking/worn. Condition rating 3. This should be repaired now.

General deterioration was noted from ground level, to eaves level fascia/soffit boards. A closer inspection may also reveal areas of wet rot, especially behind guttering. External timbers at eaves level require regular maintenance to help prevent against rot. Outside decorations help keep the property in satisfactory condition. Without a protective finish, parts will quickly deteriorate, requiring extensive repairs. To prevent this, the external timber surfaces should be redecorated soon if to be retained.

However it may be more economical to replace all the fascia/soffit boards entirely.

You should obtain an estimate from a reputable contractor for these works prior to purchase. To safely repair parts of the property at higher levels, contractors will have to use appropriate access equipment (for example scaffolding, hydraulic platforms, etc.).

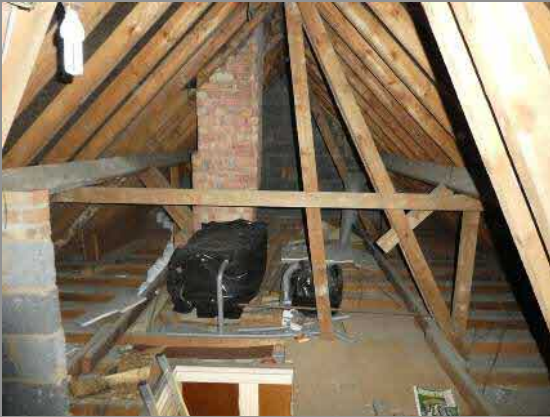
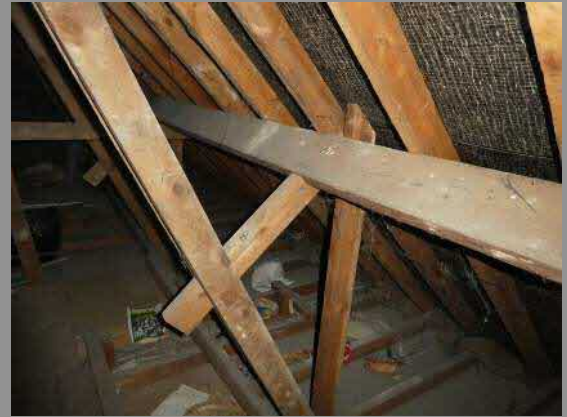
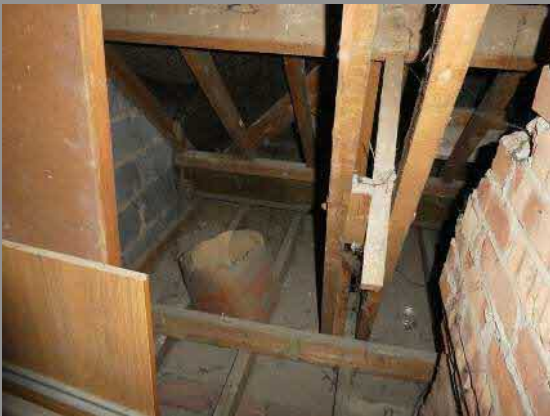
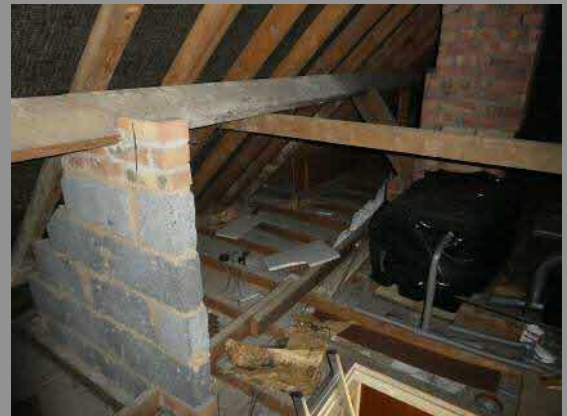
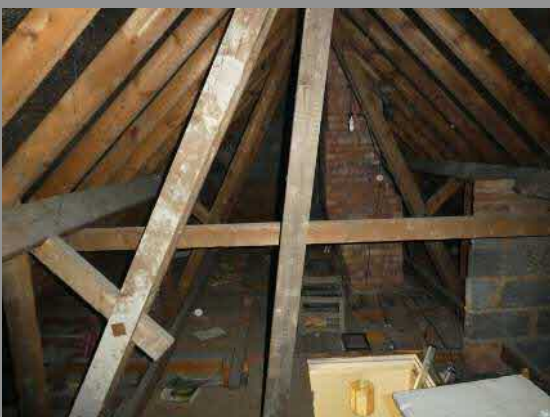
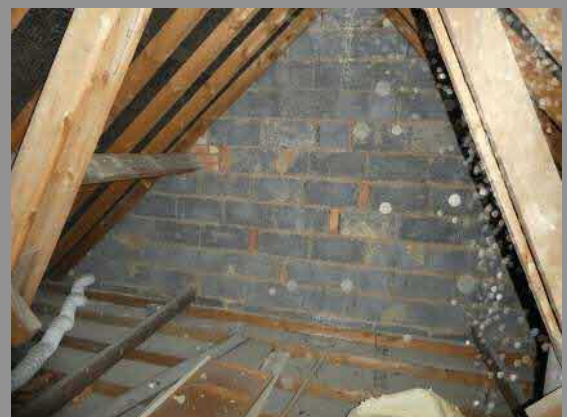
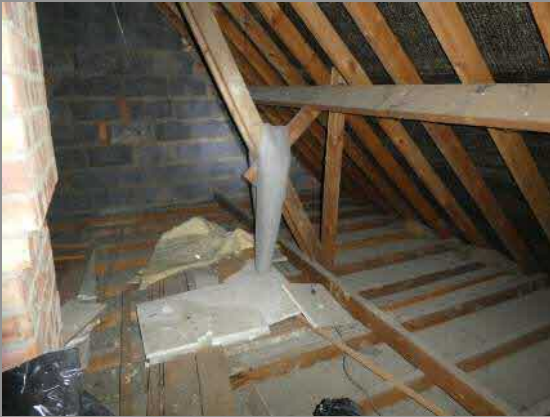
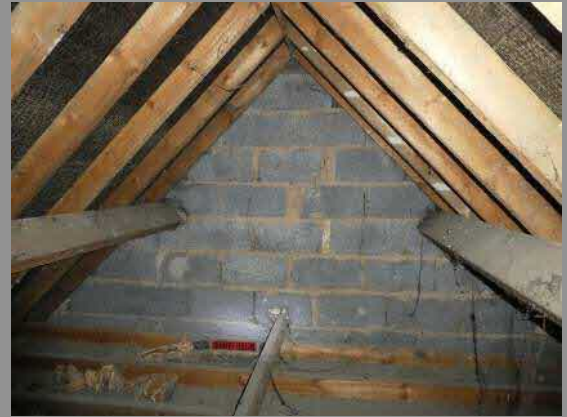
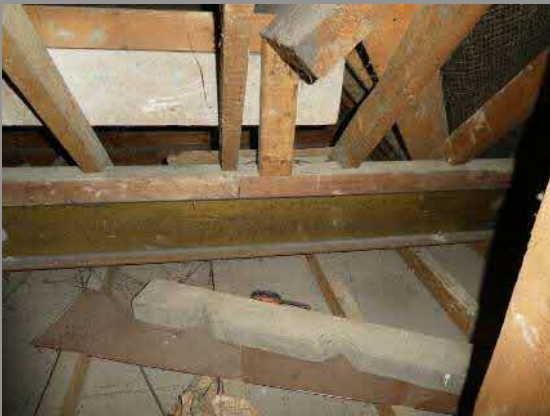
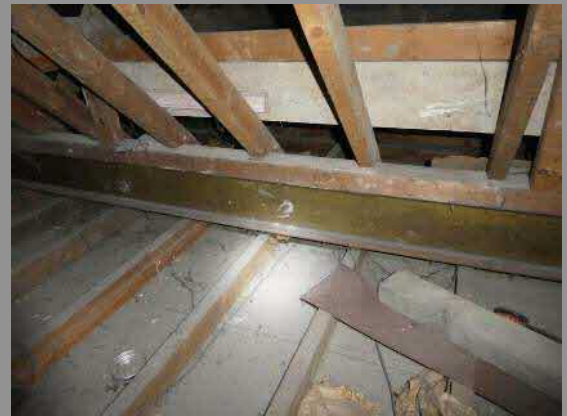
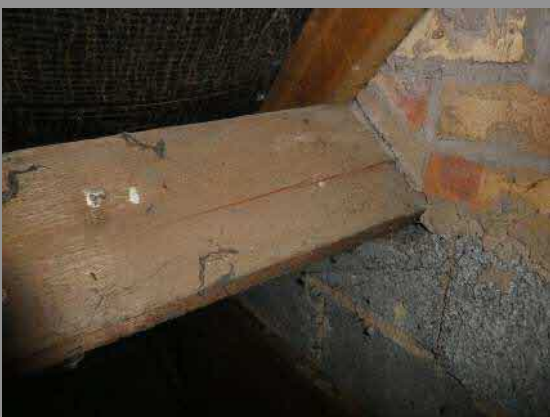
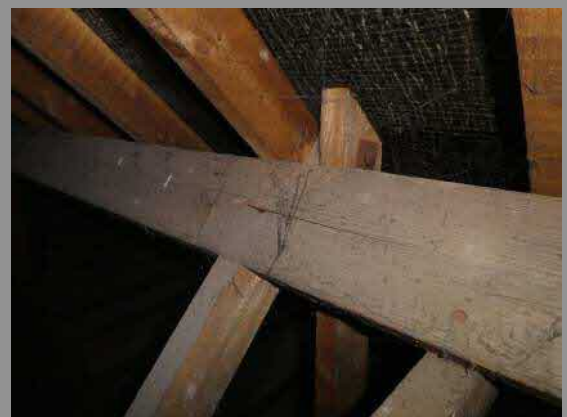
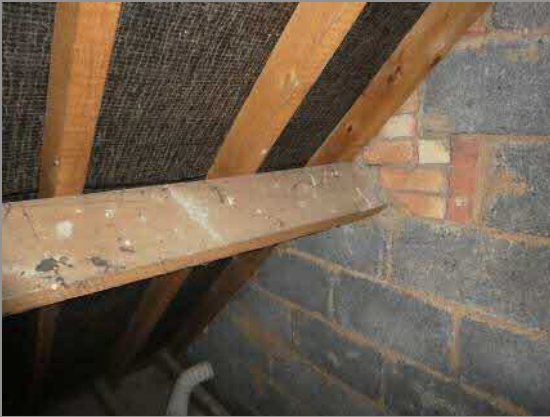
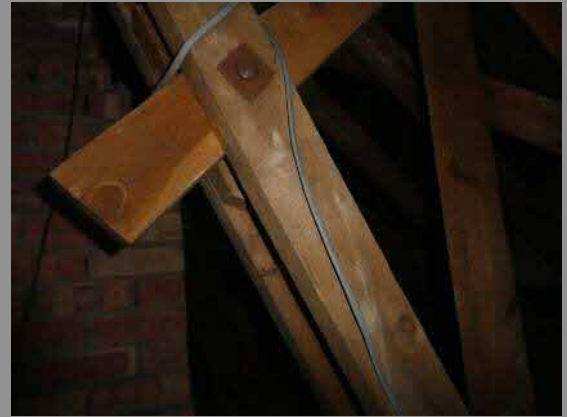
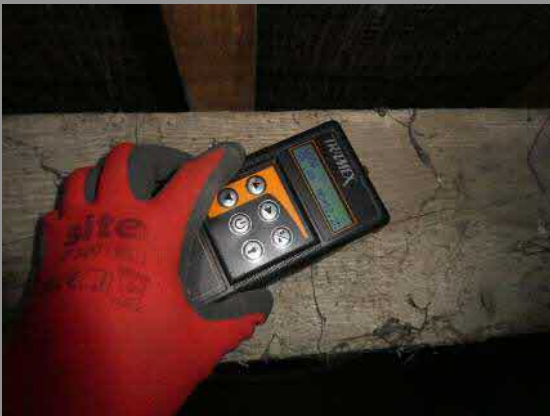
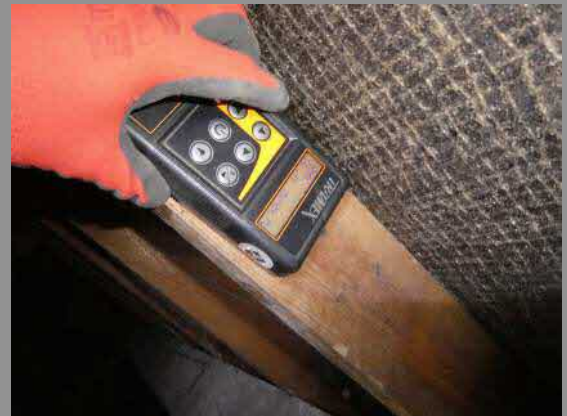
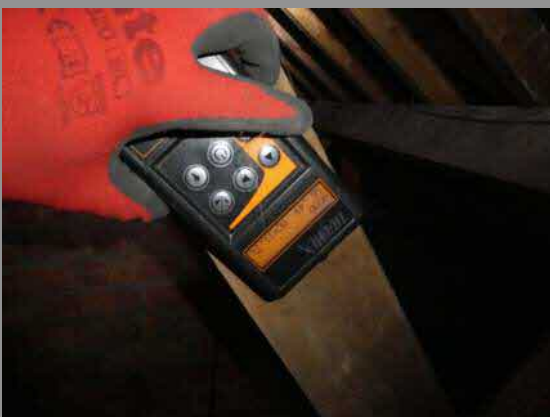
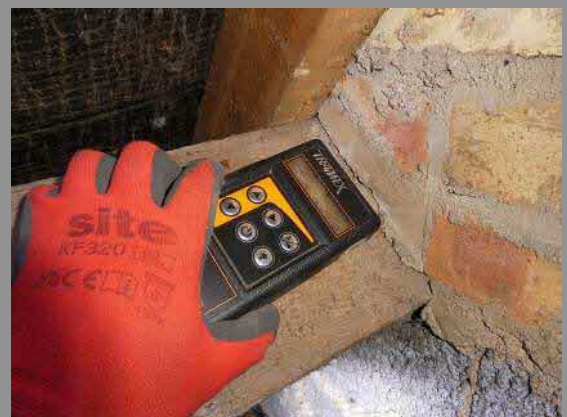
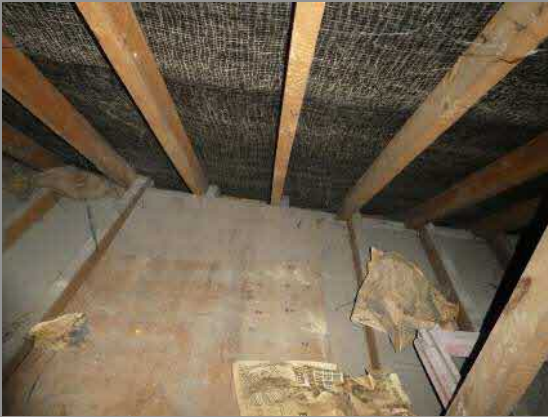
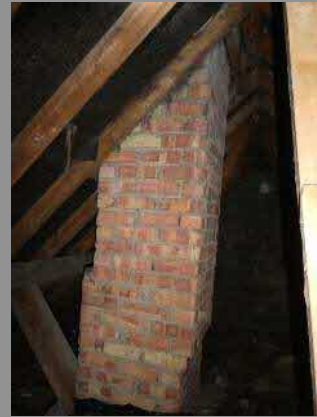
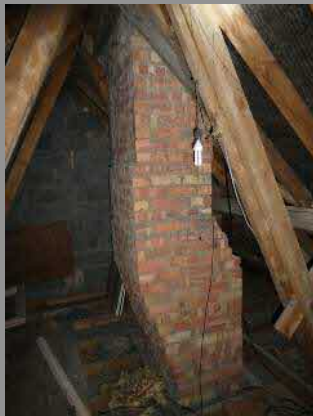
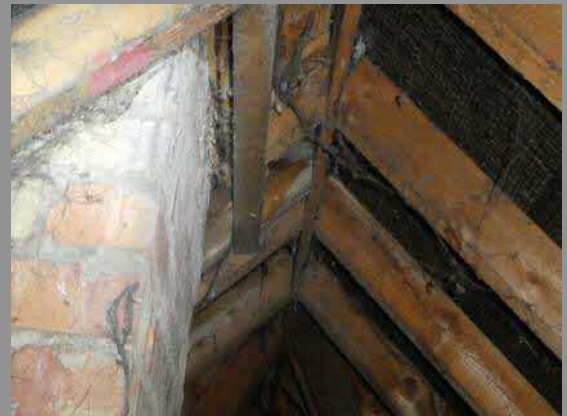
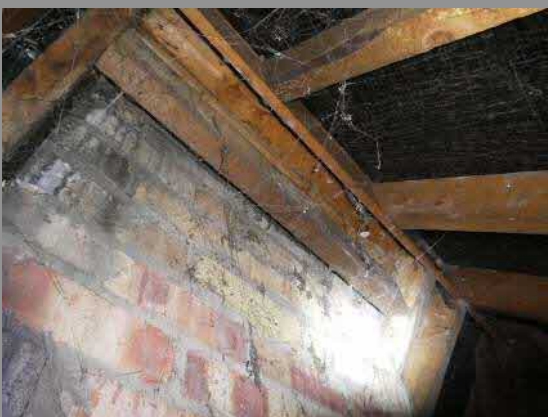
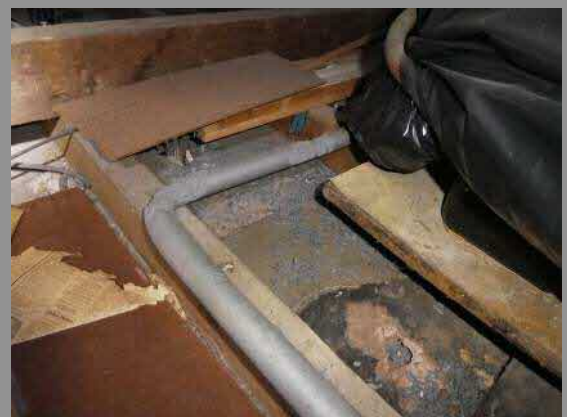
There is a lack of suitable lateral restraint provided between rafters and all the gable walls, resulting in gaps to the tiled roof covering adjoining the edges of all the gables (see D2 Roof Coverings). Condition rating 2. This should be repaired soon.

The roofing felt beneath the tiles is a type of bituminous felt, commonly used in this situation, and becomes brittle with age. This material also sometimes contained asbestos fibres (see I3 Risks). It also has a tendency to rot at the eaves if not properly supported, and the rear of the fascia/soffit

boarding will become damp and provide conditions for wet rot to occur (see D2 Roof Coverings). Condition rating 2. This should be repaired/replaced soon.

Some of the exposed roof timbers were tested with an electronic damp meter, and only low moisture content readings were noted to the timbers, but there is a lack of ventilation to the roof space and evidence of wood-boring insect infestation. Condition rating 2. A lack of ventilation in the roof space can cause mould growth, woodworm and wood rot, additional ventilation should be provided soon in the form of vents to the soffit boards, air bricks to the gables and/or tile vents to the roof slopes fitted with fly screens.

Our inspection of visible timbers revealed scattered evidence of wood-boring beetle infestation. There is a possibility that the infestation noted may be active and as a result may require specialist treatment. You should instruct a specialist contractor, ideally Property Care Association registered, to carry out a full inspection of the property and to implement all necessary remedial treatment against wood-boring beetle infestation, rot and other timber defects (Please see Section J - Risks).

There are no mild steel straps to tie the roof structure to the gable walls. We would recommend one metal strap per slope to the rafters is bolted to the gable walls and secured back across at least three rafters with timber noggins in between to provide lateral restraint between the front gable wall and roof structure.

You should instruct a competent roofing contractor to provide an estimate for these works and any necessary associated repairs prior to exchange of contracts.
