# Your survey report

80 Granbrook Lane, Mickleton,  
Gloucestershire, GL55 6TF

11th August 2023

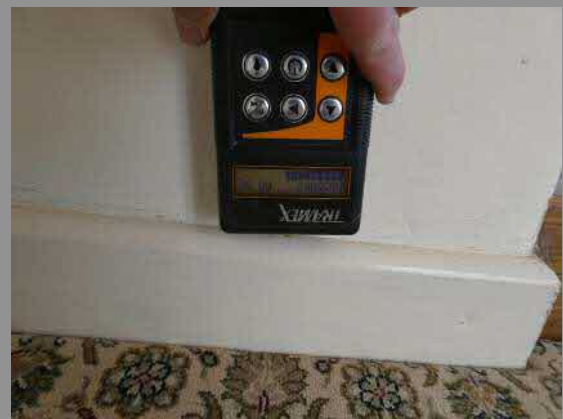
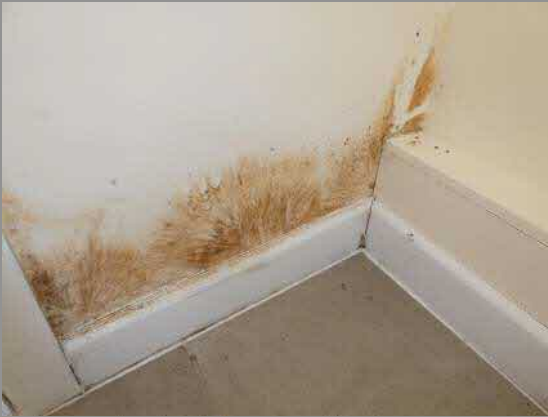
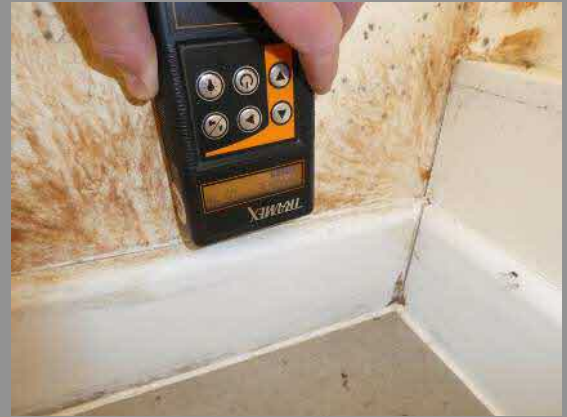
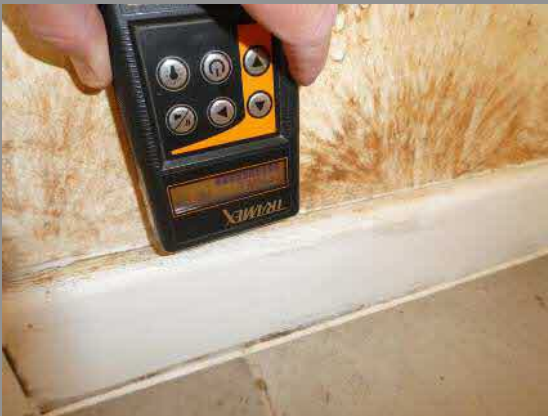
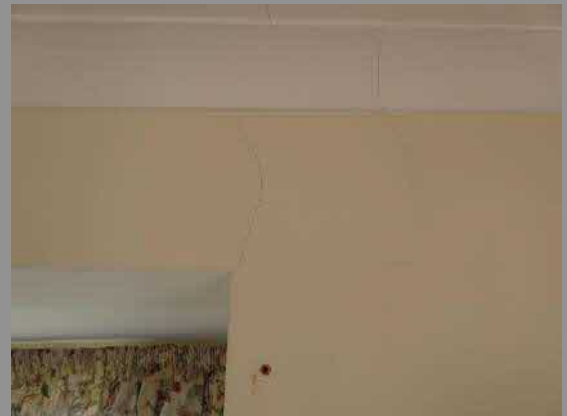
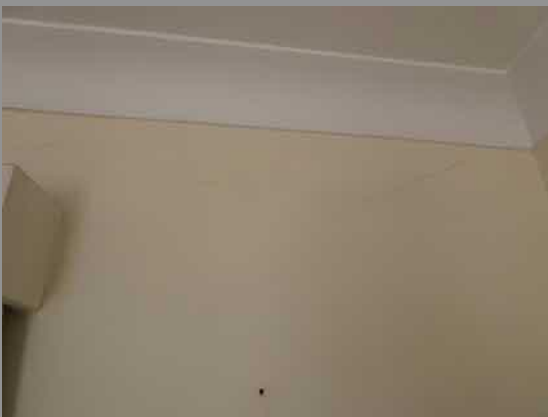
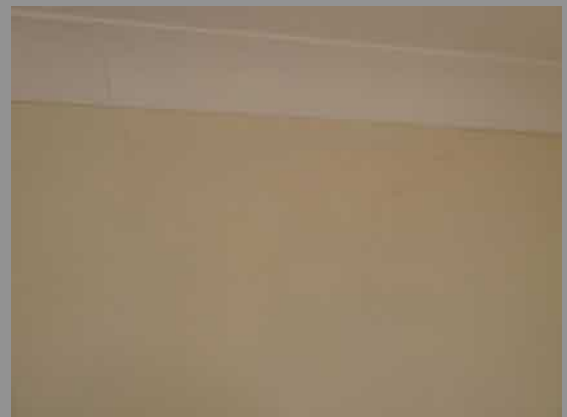
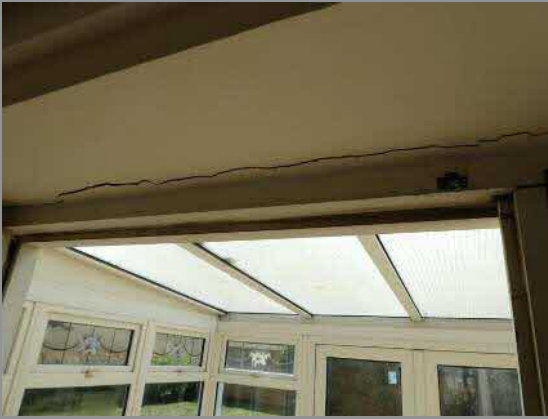
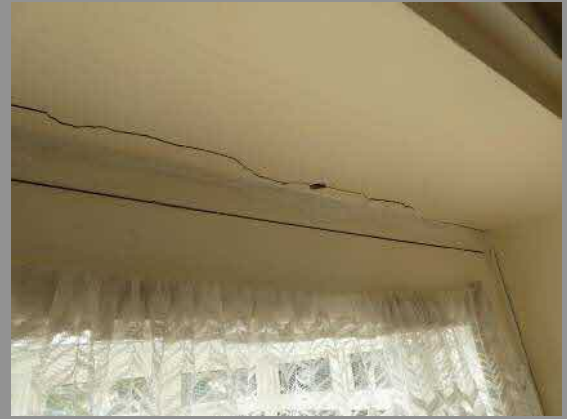
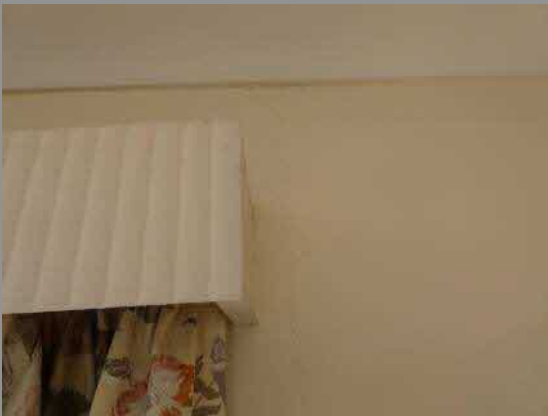
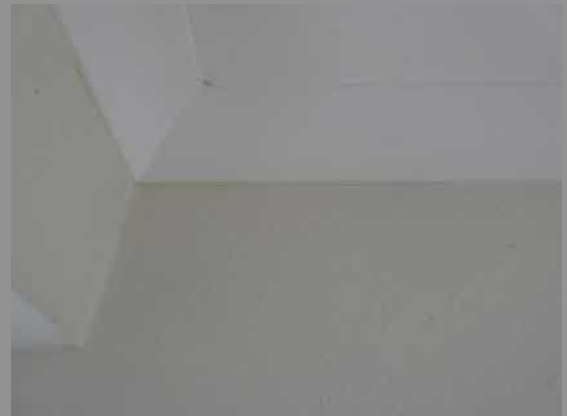
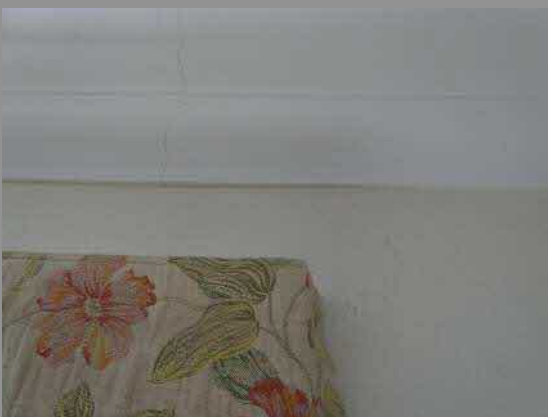
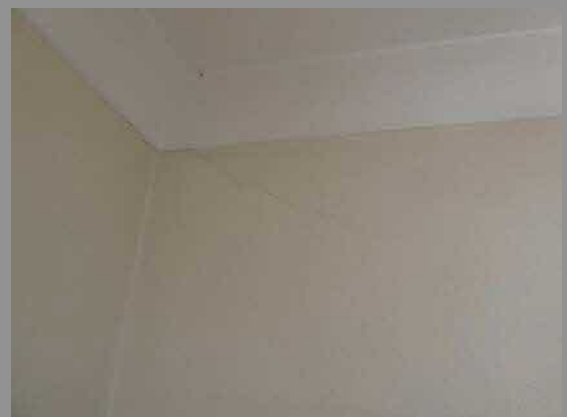
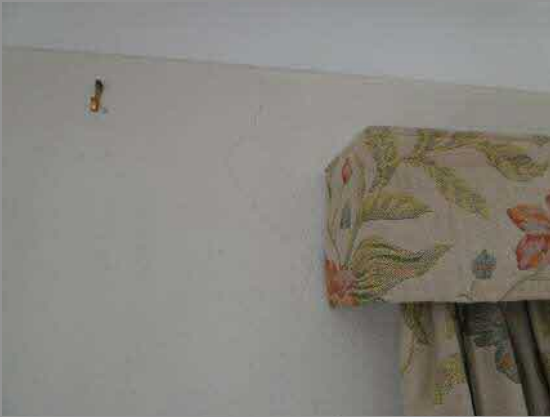
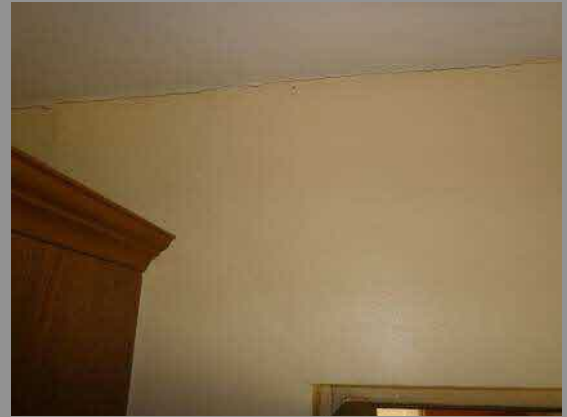
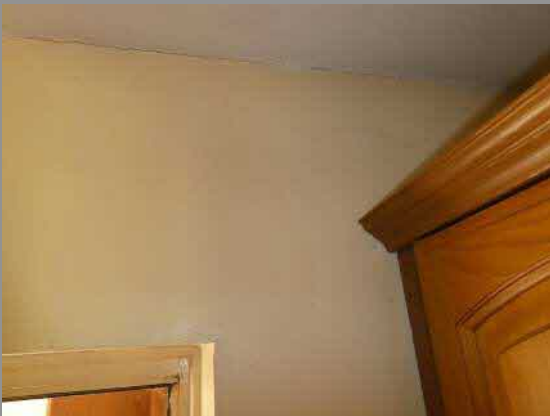
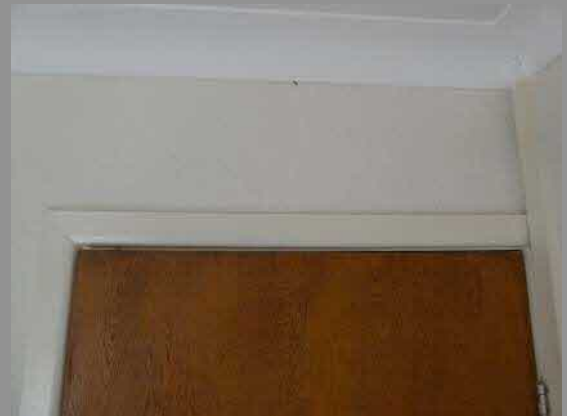
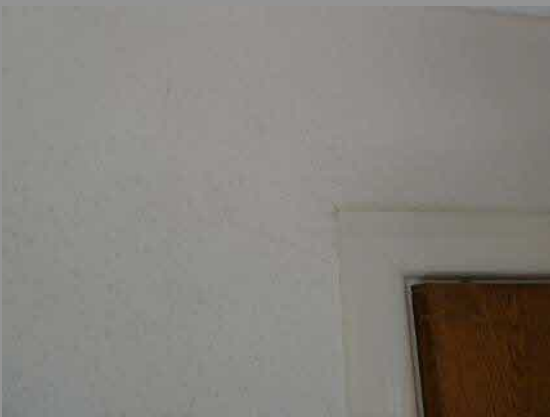
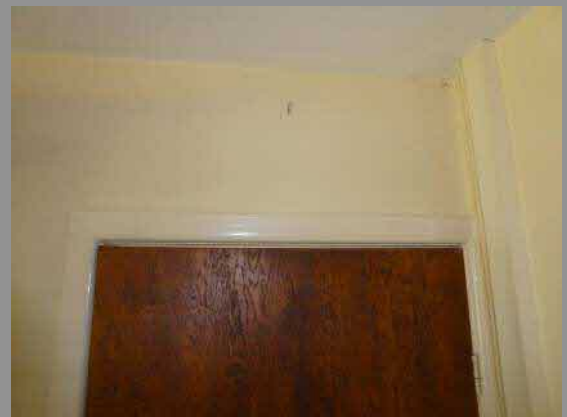
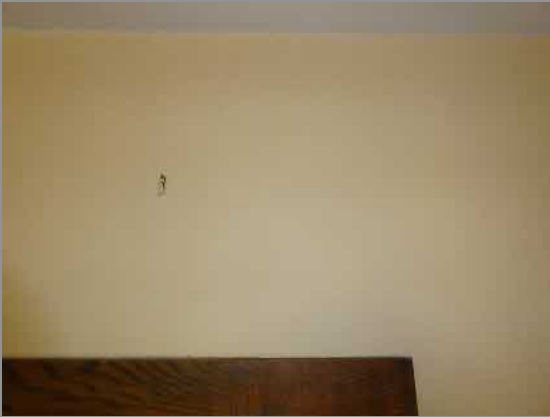
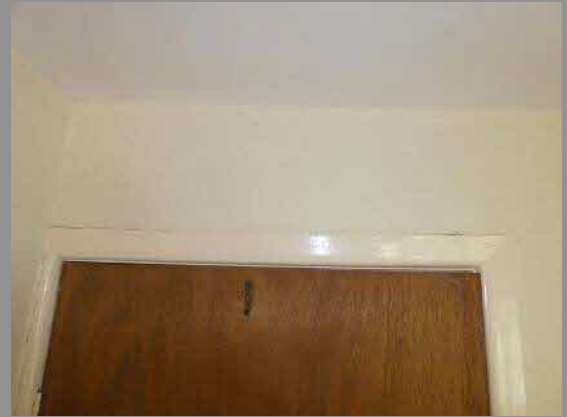
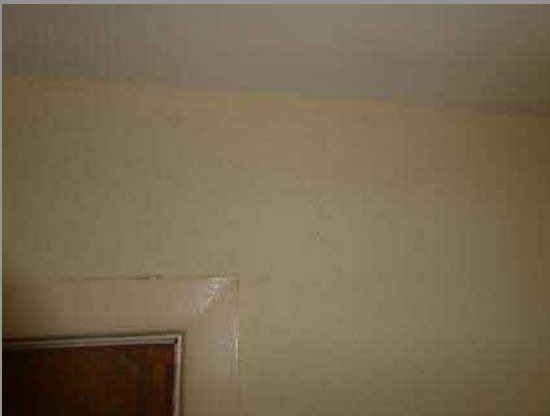
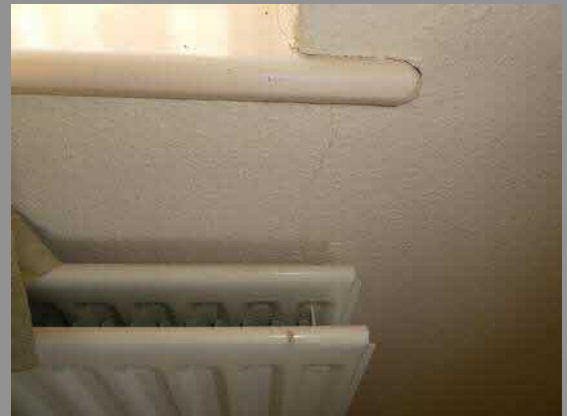
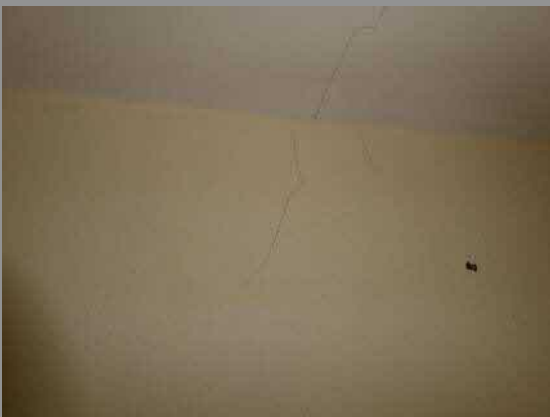
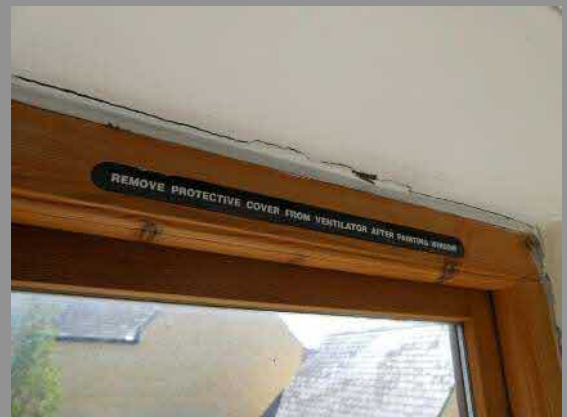
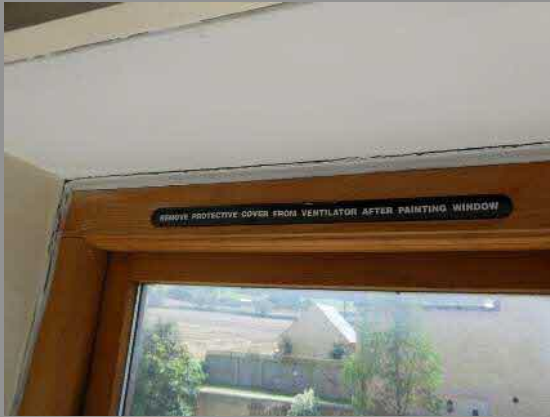
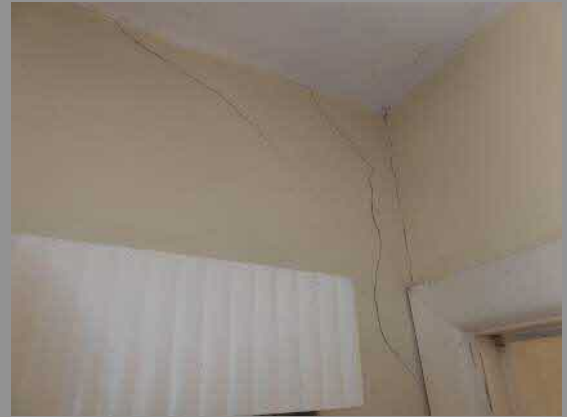
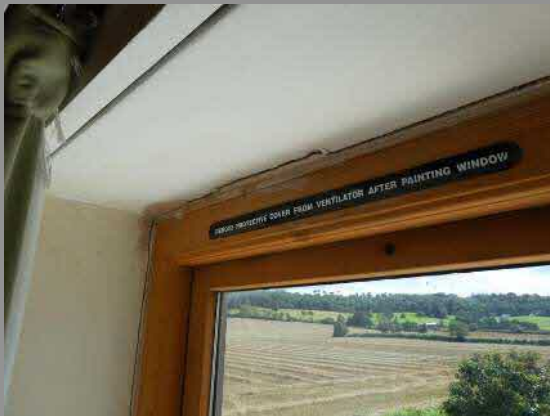
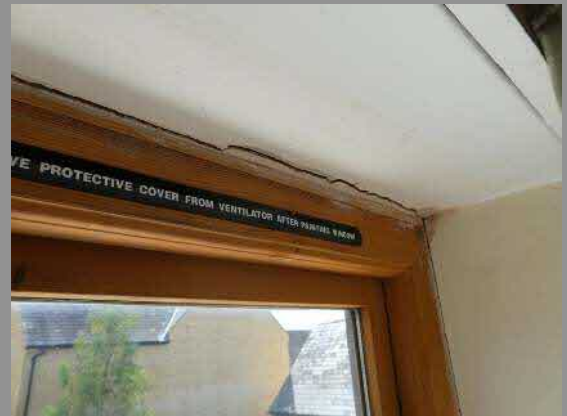
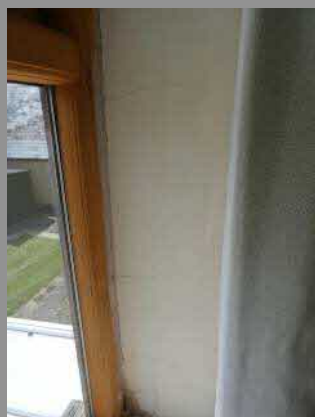
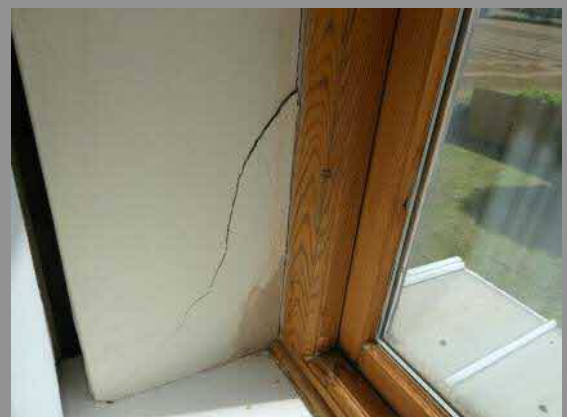
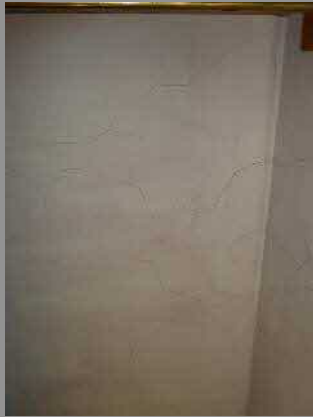
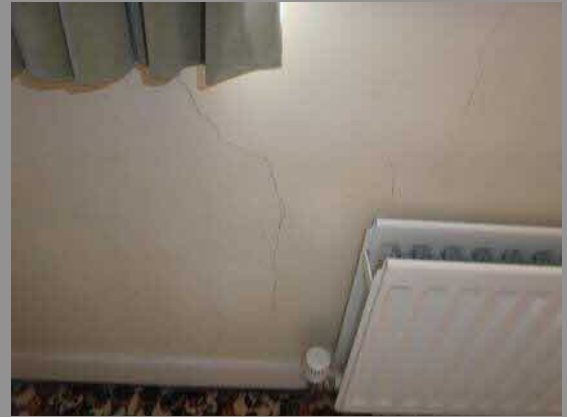
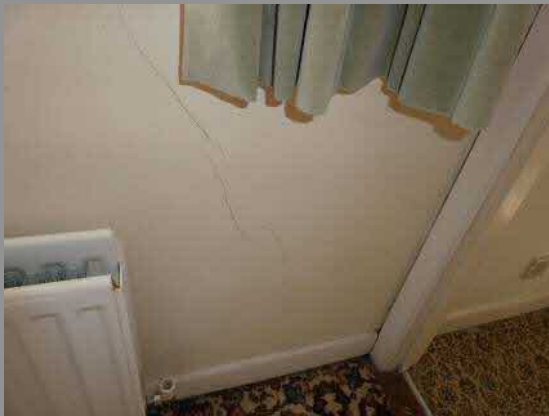
Tests were taken with an electronic moisture meter at regular intervals in a structured, methodical manner to internal wall surfaces. Moderate moisture content readings were noted to the left-hand side of the chimney breast in the sitting room and the internal wall between the hall/kitchen in the cupboard. Low to moderate moisture content readings were noted to the internal wall between the cloakroom/utility, with fungus noted growing on the wall. No evidence of any significant dampness was detected to any of the other internal walls, although you should be aware that kitchen units, wall tiles, furniture and floor coverings restricted our ability to test all areas. Condition rating 3. Further investigation.

Cracking to the plaster was noted to the inner face of the outside walls in the sitting room, dining room and kitchen, corresponding to the cracking noted externally to the brickwork (see E4 Main Walls and I1 Risks). Condition rating 2. Once the cause of the cracking noted externally has been diagnosed and repaired, a degree of replastering will be required to these areas of internal cracking.

Cracking was noted to the plaster at the junction of the side wall in the sitting room and single storey extension (see I1 Risks). Condition rating 2. This should be repaired soon. A range of factors common to properties of this type and age can cause the outside walls of a property to move by small amounts. This cracking is probably due to some differential movement between the different structures. This can be concealed on redecoration, but is likely to re-crack over time.

Movement was noted to the internal walls between the hall/dining room and hall/kitchen, resulting in distortion to the door frames, cracking to the plaster over the door openings and binding of the doors in the frames (see I1 Risks). Condition rating 3. Further investigation. A range of factors common to properties of this type and age can cause the inside walls of a property to move by small amounts. This movement is probably due to some slight settlement in the internal walls over time. This probably happened some time ago, and any further significant movement is probably unlikely. However, given the movement/cracking noted to the outside walls, you are advised to instruct a structural engineer to make an inspection and provide a report together with any repairs recommended.

Movement was evident in the first floor partitions, which has caused some distortion to the door frames to the bedrooms, cracking to the plaster over the door openings and binding of the doors in the frames. Cracking was also noted to the internal walls to bedrooms 1 and 2 (see I1 Risks). Condition rating 3. Further investigation. The internal solid walls between bedroom 1/shower room, bedroom 1/bedroom 2 and landing/shower room are built off the corresponding ground floor partitions below. However, the internal wall between the shower room/bedroom 3 appears to be simply built off the first floor joists, which was common practice at the time of construction. Overtime, the weight of the partition above can cause some deflection to the floor joists, resulting in movement to the partition. You are advised to instruct a structural engineer to make an inspection and provide a report together with any repairs recommended. If this movement/cracking were to get any worse, then it may be necessary to provide additional support in the form of a steel beam inserted below the first floor partition between the shower room and bedroom 3.

Cracking to the plaster was noted to the inner face of all the external walls to all the bedrooms and landing except the shower room, corresponding to the cracking noted externally to the brickwork (see D4 Main Walls and I1 Risks). Condition rating 2. This should be repaired soon. Once the cause of the cracking noted externally has been diagnosed and repaired, complete replastering will be required to all the inner faces of the walls in these areas.

We could not discover the cause of the dampness. You should ask an appropriately qualified person to inspect the problem and provide you with a report. To do this properly, parts of the property will have to be disturbed, and you should discuss this with the current owner. Once you have repaired the dampness, you may have to carry out other additional work that could typically include replacing damp plaster, repairing rotten timber, etc.

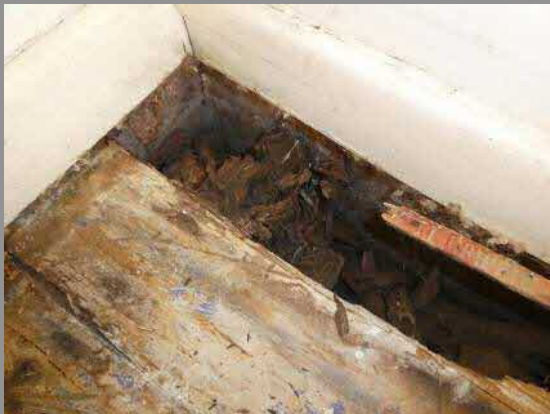
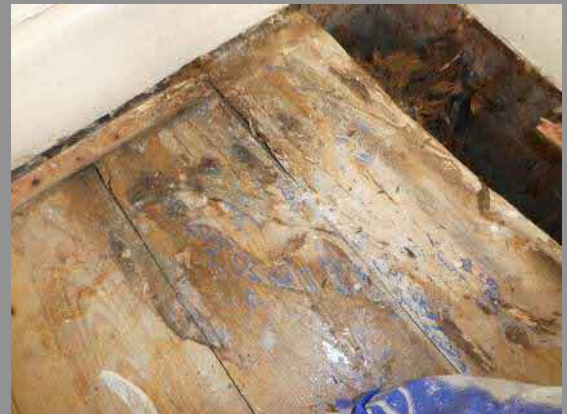
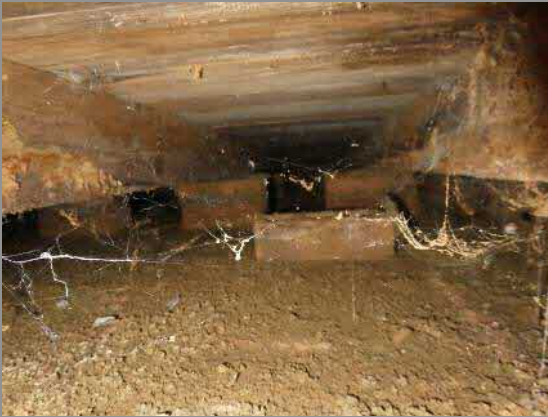
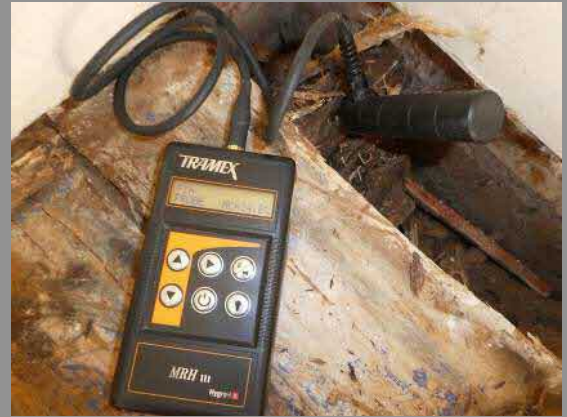
The ground floors in the sitting room and most of the dining room are built of timber joists and probably supported midspan on honeycomb sleeper walls covered with floorboards except the side extension which is covered with boarding and all the floors are finished with carpet. There is extensive decay to both the floor joists and floorboards to the front/rear walls in the sitting room and rear wall in the dining room (see I1 Risks). Fungus is also growing on the floor boards and joists in the dining room (see I1 Risks). The floors also slope towards the outside walls as a result of the decay. When tested with a damp meter, high moisture content was noted to all the timbers (see I1 Risks). High moisture content readings were also noted to the boarded floor in the side extension to the sitting room (see I1 Risks). This is due to the damp walls and lack of subfloor ventilation (see D4 Main Walls). Condition rating 3. This should be repaired now. The rest of the floor structure will need to be inspected to determine the extent of the decay, but it is likely that both the timber floors in the sitting room and dining room will be beyond economical repair and will require replacement.

There is only one air brick visible to the east gable wall to ventilate the timber floor in the sitting room. This has a wasp's nest inside, which is likely to be blocking the vent. The side extension may also have blocked the original vents to this gable wall, and there are no vents in this wall either. There are only two air bricks visible to the west gable wall to ventilate the timber floor in the dining room. The level of ventilation to the timber floors is therefore inadequate. Condition rating 3.

The remaining ground floors in the hall, kitchen, utility, cloakroom and section of floor under the stairs in the dining room are built of solid concrete and other materials that are supported by the ground, with carpet or tile finish. When tested with a damp meter, low to moderate moisture content readings were noted to the solid floors, particularly the floor in the cupboard in the hall and dining room (see I1 Risks). This is probably due to lack of damp proof membrane, damp outside walls and lack of proper seal where the floors butt up against the outside walls. Condition rating 3. Further investigation. Although we could not see the full extent of the dampness problem, we suspect more serious defects exist in hidden areas. You should ask an appropriately qualified person to inspect the floor and identify the full extent of the problems.

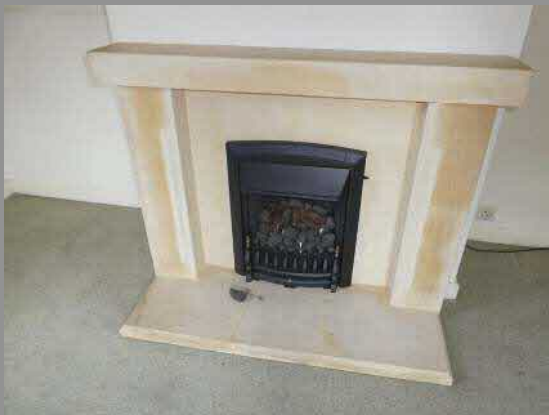
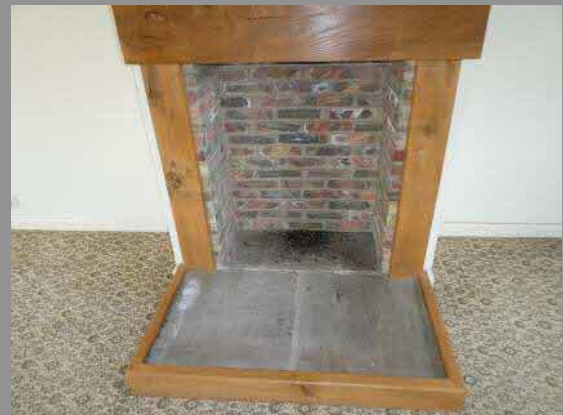
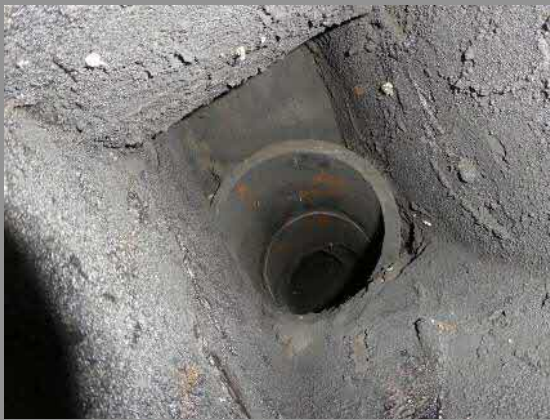
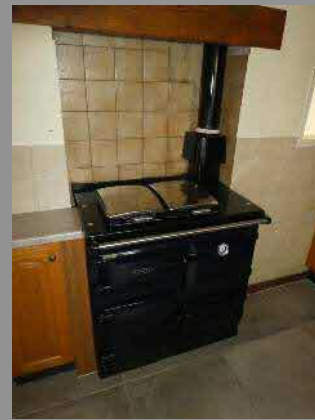
The stone fireplace is fitted with a coal effect gas fire venting into the chimney stack. No significant dampness was noted to the chimney breast at the time of our inspection. There is no carbon monoxide detector in this room. This is a safety hazard (see I3 Risks). There is no evidence that this appliance has been serviced in the last 12 months. This is a safety hazard. Condition rating 3. All heating installations should be installed and serviced regularly (usually every year) by an appropriately qualified person (see section F4). Without specialist tests, we cannot comment on the condition of the flue. You should have it checked prior to use. It is recommended you arrange for the appliance to be tested by a qualified engineer/HETAS registered installer.

The open fireplace has a brick surround and concrete hearth connected to the chimney stack externally. No significant dampness was noted to the chimney breast at the time of our inspection. There is no carbon monoxide detector in the room. This is a safety hazard (see I3 Risks). There is soot debris in the fireplace and a build up of soot to the lower part of the flue. Condition rating 2. This should be swept soon.

There is a two plate gas fired Rayburn with metal flue into the chimney stack, which also provides the central heating. There is a carbon monoxide detector in this room. There is no evidence that this appliance has been serviced in the last 12 months. This is a safety hazard. Condition rating 3. All heating installations should be installed and serviced regularly (usually every year) by an appropriately qualified person (see section F4). Without specialist tests, we cannot comment on the condition of the flue. You should have it checked prior to use. It is recommended you arrange for the appliance to be tested by a qualified engineer/HETAS registered installer. We understand the Rayburn is to be removed by vendor on the sale of the property.

There are chimney breasts in these bedrooms for the fireplaces in the sitting room, dining room and kitchen below. No significant dampness was noted to the chimney breasts at the time of our inspection. Condition rating 1. No repair is currently needed. The property must be maintained in the normal way.

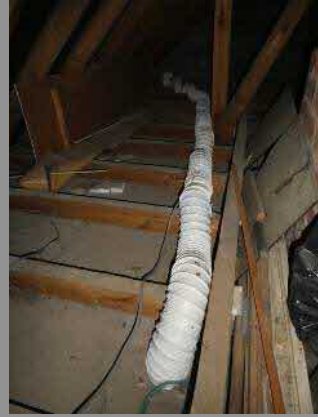
The fittings and appliances in the shower room comprise a fully tiled glazed shower cubicle with curved glass doors having an electric Mira shower, wash hand basin in vanity unit and low flush WC with concealed cistern. The fittings are modern but only of an average quality. There has been or is a leak to the fittings or pipework that has resulted in the damp staining to the ceilings below in the hall and sitting room (see E2 Ceilings). Condition rating 3. Further investigation. We could not establish the cause of the leak. You should instruct a suitably qualified contractor to make an inspection to determine the cause of the leak and the repairs required prior to exchange of contracts.

There is an externally venting extractor fan fitted, which worked when turned on, but the ducting in the roof space is kinked, not insulated and the distance to the vent in the gable wall is too long. Condition rating 2. This should be replaced soon.

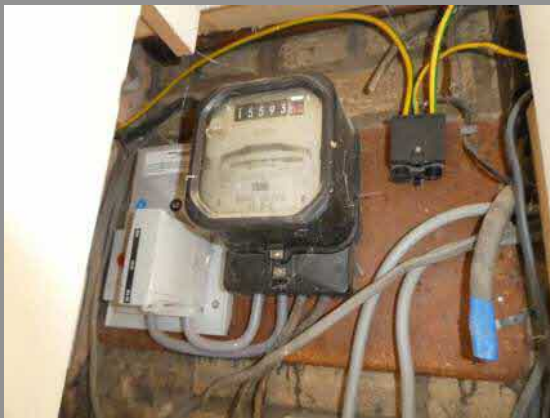
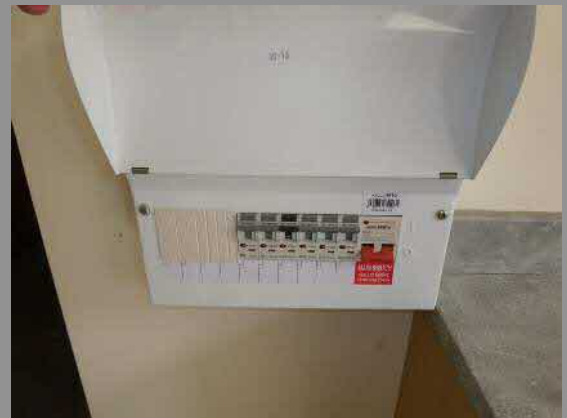
Any alterations that have been undertaken to the electrical installation within a property since 1st January 2005 must now follow certain Building Regulation principals (BS 7671), such work being undertaken and/or certified by a suitably accredited electrician. Whilst the visible wiring appears satisfactory, if there is no record of an electrical test having been recently undertaken, it is recommended that the installation be tested by a competent electrician ('NICEIC/ECA' registered) prior to purchase so that you are aware of any likely future costs and all recommendations implemented. Thereafter, the installation should be retested every ten years. However, we would strongly recommend an inspection of the electrical system on change of ownership (See I3 Risks).

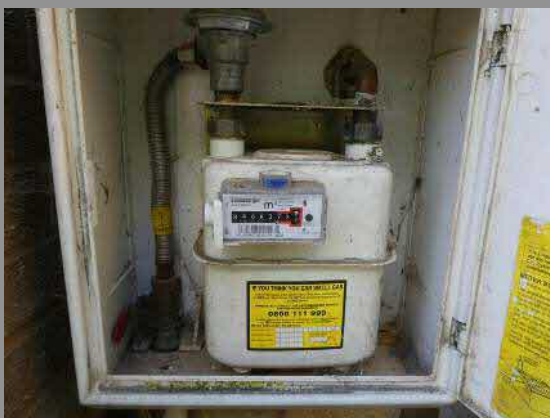
Without specialist examinations of the system we are unable to comment on the quality or safety of the system and as a precautionary measure we would recommend further investigations be undertaken prior to purchase. If a recent test certificate, dated within the last 12 months, is not available for the gas supply and appliance(s) then we recommend they are tested (See I2 Risks). Thereafter, the installation should be serviced annually.

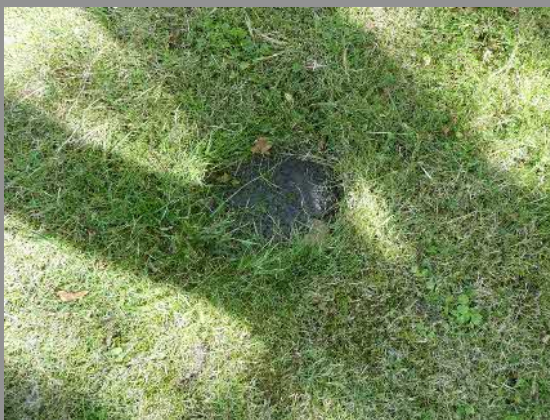
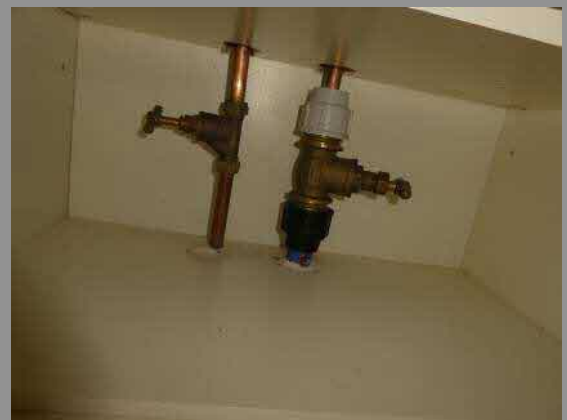
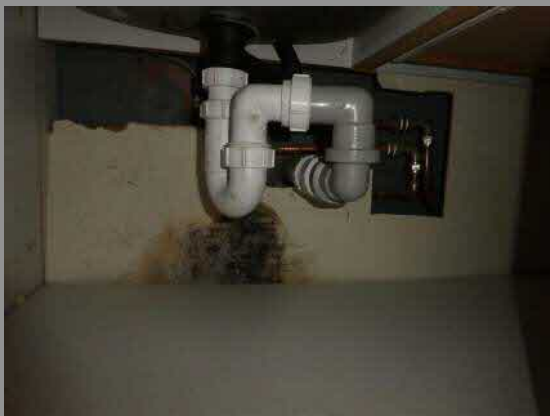
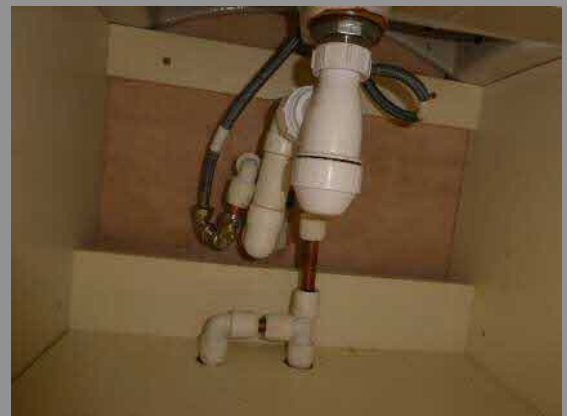
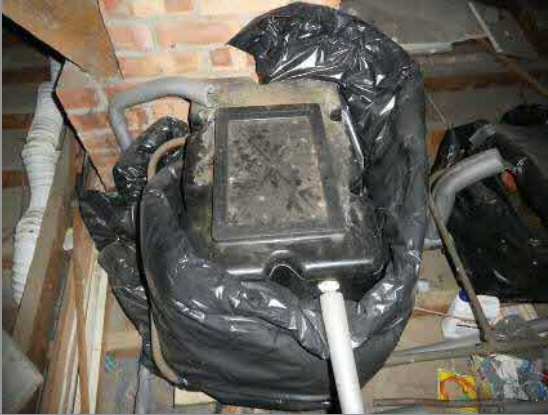
There is an independent mains water supply to the property. The external stop valve is located in the grass verge in front of the property. The stop valve within the property is located in the vanity unit in the cloakroom. The water was turned off at the time of our inspection. The supply pipe is made of blue plastic. It should be appreciated that leaks can occur for some time before signs are apparent on the surface. The internal pipework is made of copper and plastic. There is a partly lagged cold water tank located in the roof space having a close-fitting lid, but where the overflow pipe discharges to could not be determined. The internal pipework is made of copper and plastic. As noted under F8 Bathroom Fittings, there is or has been a leak that may be from pipework that is concealed in the floor void below the shower room. Condition rating 3. Further investigation. You should instruct a suitably qualified contractor to make an inspection to determine the cause of the leak and the repairs required prior to exchange of contracts.

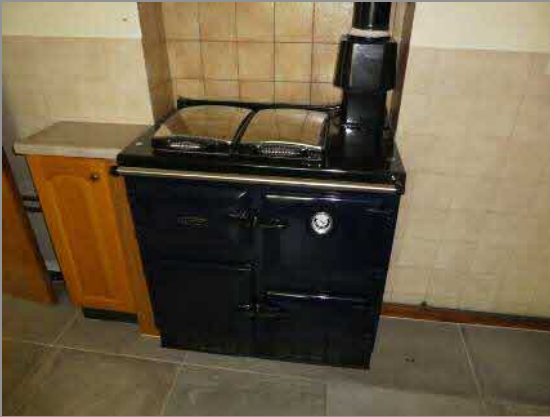
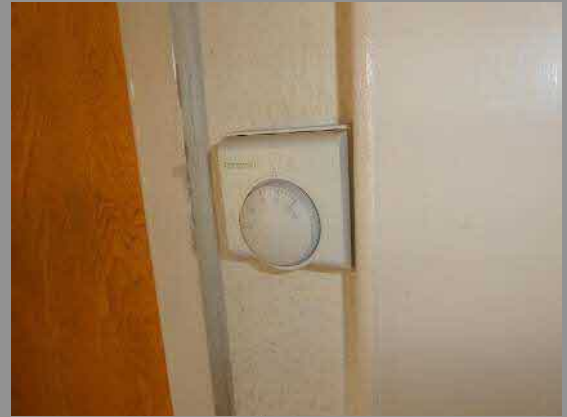
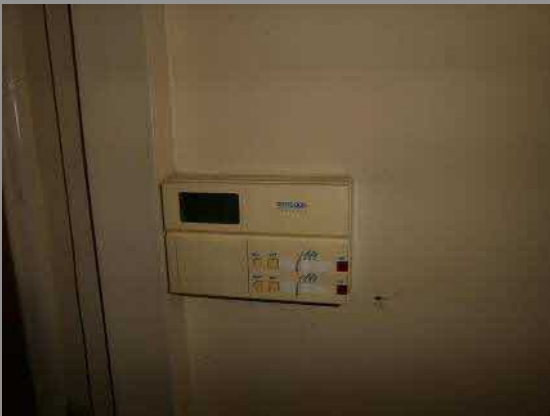
We understand the Rayburn is to be removed by the vendor on sale of the property, so the house will have no means of heating until a new gas fired boiler is installed.

You should be aware that boilers and systems of this type require regular maintenance, and any servicing or replacing of components must be carried out only by approved installers. You should ensure that you are familiar with the instruction manual for the system, and we always recommend that the system is checked to ensure that it complies with all current regulations, particularly so far as protection device and safety is concerned. We recommend a service contract is entered into with an appropriately qualified local company, such as a 'Gas Safe' registered heating engineer. We recommend the service record of the boiler is obtained and if this is not available, or if there is any doubt as to when the boiler was last serviced, then a check by a 'Gas Safe' registered heating engineer, before exchange of contracts, is strongly recommended.

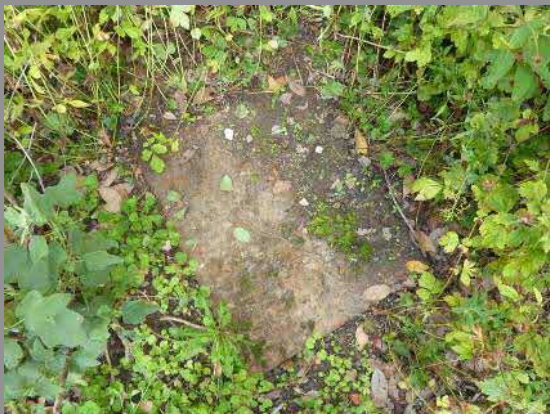
Photo - 254

cloakroom and utility fittings. The second chamber is located in the front garden. The cement benching is badly perished and missing to the base of the brick chamber. The mortar around the frame is also badly cracked/loose. It also has no proper inspection cover. It appears to have connections from the first chamber, kitchen and shower room fittings. The third chamber is located in the block paved driveway. The deep blue brick chamber appeared to be free flowing with connections from the second chamber and also the adjoining property No. 1 Hidecote View. From here, the drains presumably connect to the mains in the road. The fourth chamber is located by the east side driveway entrance for storm drains and runs across the front of the grass verge. It has no proper cover. Condition rating 3. Further investigation. You are advised to obtain a CCTV inspection of the drains as a precaution to confirm there are no issues and/or undertake any repairs as identified. Repairs are also required to the inspection chambers.

The shower room fittings connect to the underground drains via a series of plastic pipes called a soil stack located in the floor then down in boxing in the hall below, with an external vent pipe through the front roof slope not fitted with a guard. A plastic guard should be fitted to the open end of the stack to prevent the entry of birds and vermin. The cloakroom WC connects to the underground drains direct into the floor. The cloakroom wash hand basin connects to the underground drains via an external plastic waste pipe through the front wall into the ground. The washing machine waste pipe in the utility connects to the underground drains into boxing in the cloakroom. The kitchen fittings connect to the underground drains via an external plastic waste pipe to the gully on the front wall. The gully has no slate backing to prevent damp penetration internally. Condition rating 2. This should be repaired soon.

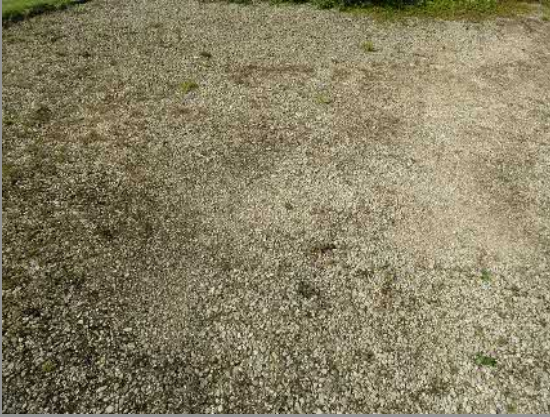
*Photo - 267*

The house is approached over a gravelled driveway on the east side, with parking for several vehicles. The gravel drive is worn and weedy. There is also a second vehicular entrance on the west side comprising block paving, which is sunk in places due to the tree roots of the Ash tree on the front boundary. The remainder of the front garden is lawned with shrub borders and an area of concrete paving in front of the house. Condition rating 2

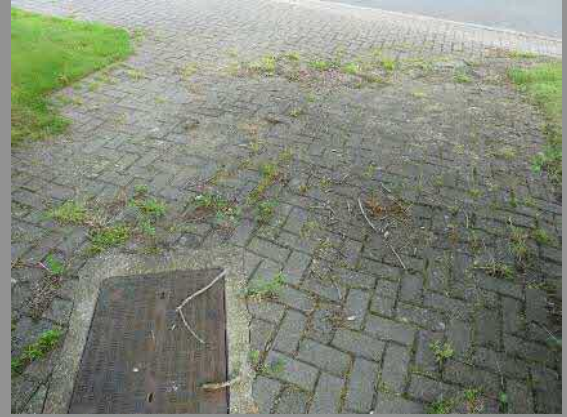
*Photo - 268*

There is an area of lawn at the side of the house with a concrete paved area and shrub borders. The paving continues around the conservatory and forms a paved patio area adjoining the rear of the house, and also continues along the west boundary to the rear. The concrete paving is sunk and uneven in places. The remainder of the garden is lawned with shrub borders. Condition rating 2
