4D TREE SURVEY

Pre-development tree survey to BS5837 May Cottage
Elston.

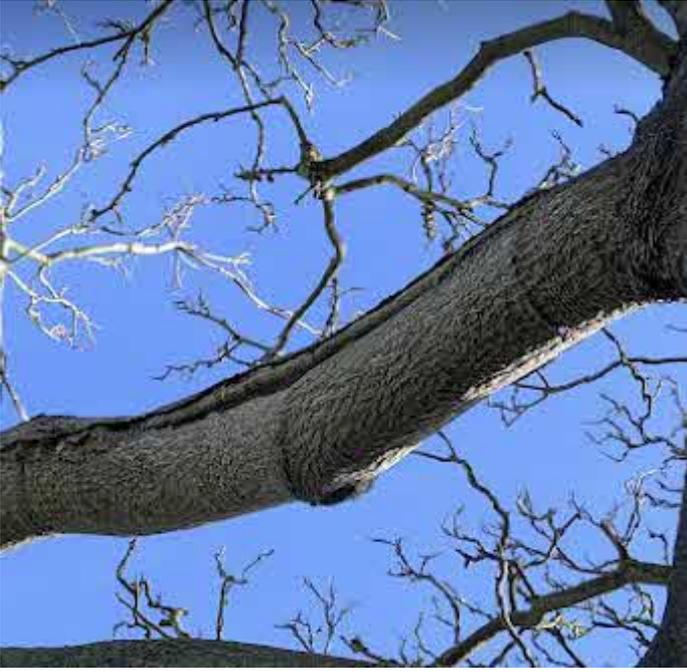
I have also recommended that TU02 is examined by the neighbouring properties appointed tree care professional to ensure that their public liability is maintained. In my opinion the tree is classified as U due to the findings of my visit.
