ARBORICULTURAL REPORT
at
41 Knox Green
Binfield
Bracknell
Berkshire
RG42 4NZ

- 1.1.1 This arboricultural report is required by our client as part of an investigation into soil shrinkage subsidence damage at:

41 Knox Green, Binfield, Bracknell, Berkshire, RG42 4NZ.

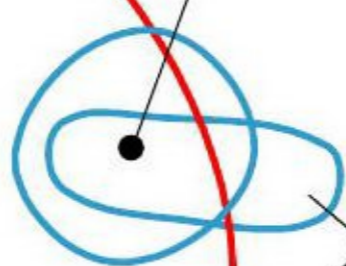
T4

G 3	Mature Mixed Shrubs	4	<10	See Plan	Policy Holder Species include Berberis, Honeysuckle and Lilac. Situated in the garden of the subject property.	FAIR	2.7	NO DATA	10+	Yes	No	No	Maintain at current size over the forthcoming years.
T 4	Mature Snowy Mespilus <i>Amelanchier lamarckii</i>	3.5	20	3	Policy Holder Situated in the garden of the subject property.	FAIR	4.4	NO DATA	10+	Yes	No	No	Maintain at current size over the forthcoming years.
T 5	Mature Common Ash <i>Fraxinus excelsior</i>	19	70	16	Policy Holder Situated in the garden of the subject property. Considered to be older than the property.	FAIR	12.5	MOD	20+	Yes	Yes	Likely	Remove to ground level and treat the stump to prevent regrowth.
G 6	Mature Mixed Shrubs	2	<10	See Plan	Policy Holder Situated in the garden of the subject property.	FAIR	4.5	NO DATA	10+	Yes	No	No	Maintain at current size over the forthcoming years.
G 7	Mature Mixed Trees	To 13	Avg. 35	See Plan	Policy Holder Four trees situated in the rear garden of the subject property. Species include Horse Chestnut, Yew, Apple and Rowan. Not inspected in detail due to proximity to damaged area.	FAIR	7.5+	MOD	20+	Yes	No	No	Maintain at current size over the forthcoming years.

- 6.5 We consider the vegetation identified as **G3**, **T4** and **G7** to be of possible future concern to the subject property, if left unmanaged. We have therefore recommended that these items of vegetation be maintained at their current size over the forthcoming years. These works are only recommended as a precaution and are not considered a priority to resolve the damage observed at the subject property.
