**CCTV REPORT FOR: 41 KNOX GREEN
BINFIELD
BRACKNELL
RG42 4NZ**

Insured: Mrs Alison Sinclair
Reference: DLG-SN-22-004171 Ins Ref: 083212738

Site Visit: 04-Jul-22
Report Date: 09-Aug-22

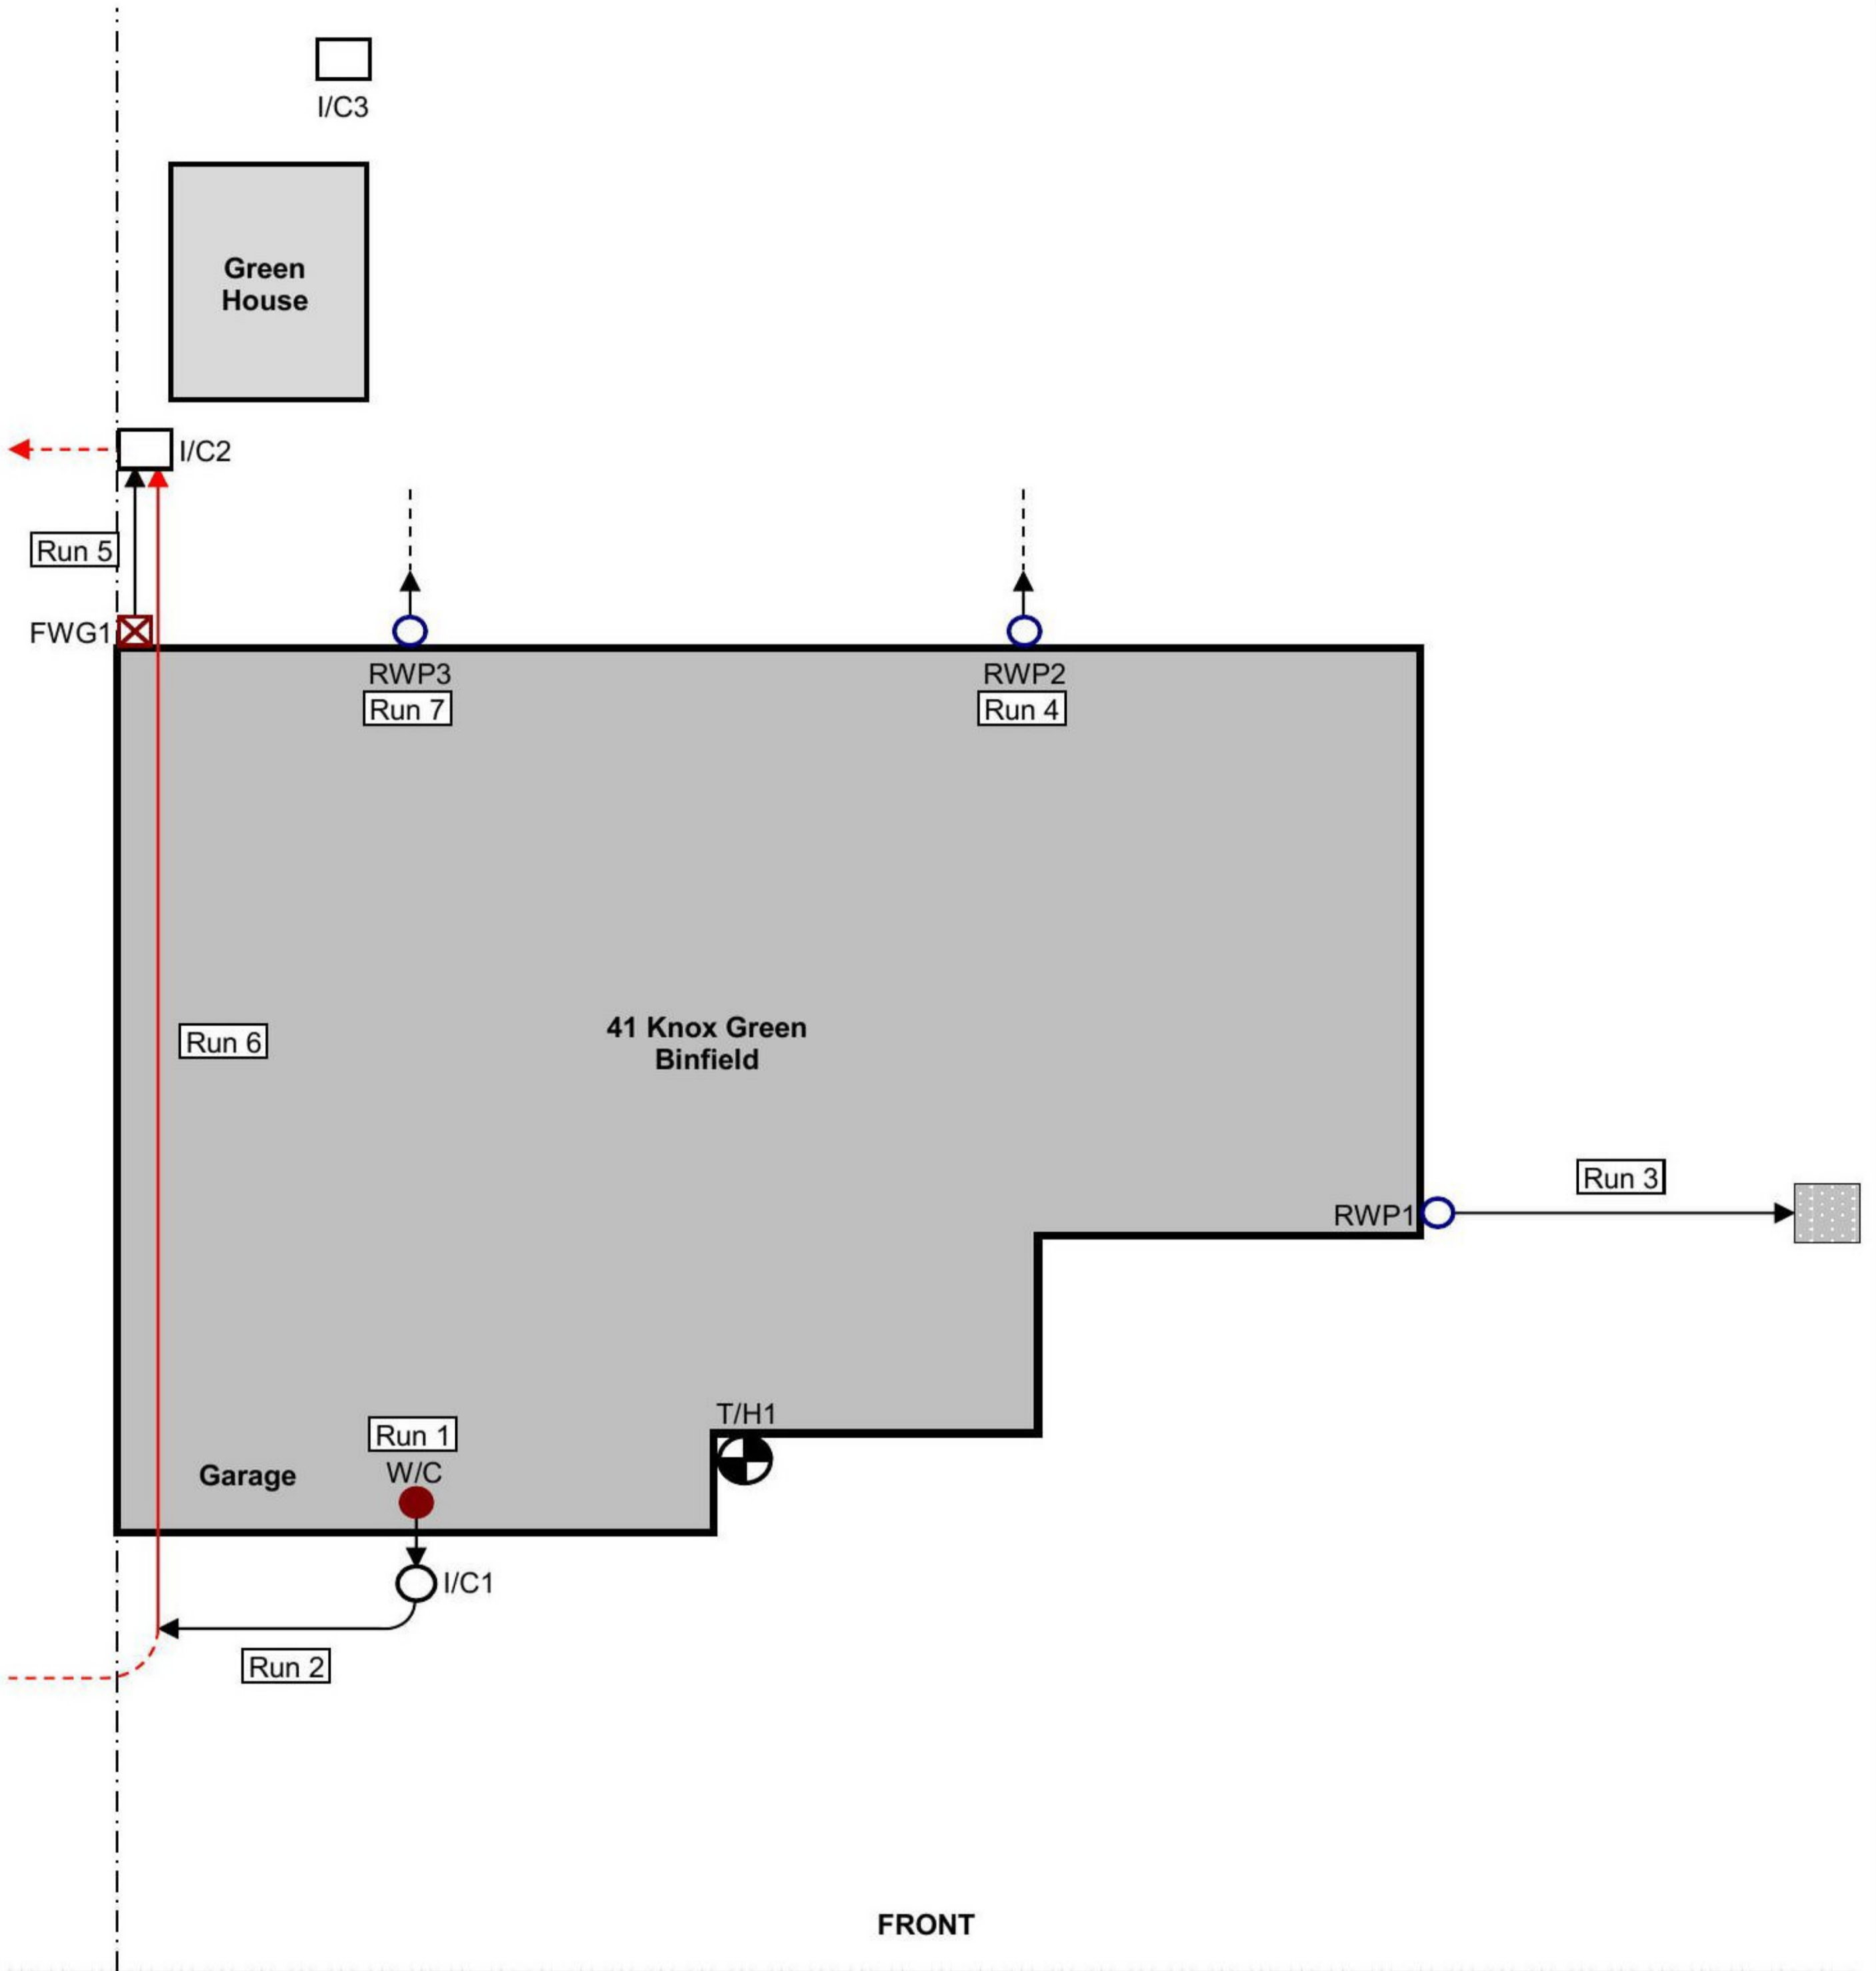
(This plan is not to be scaled and is provided to illustrate general layout only)

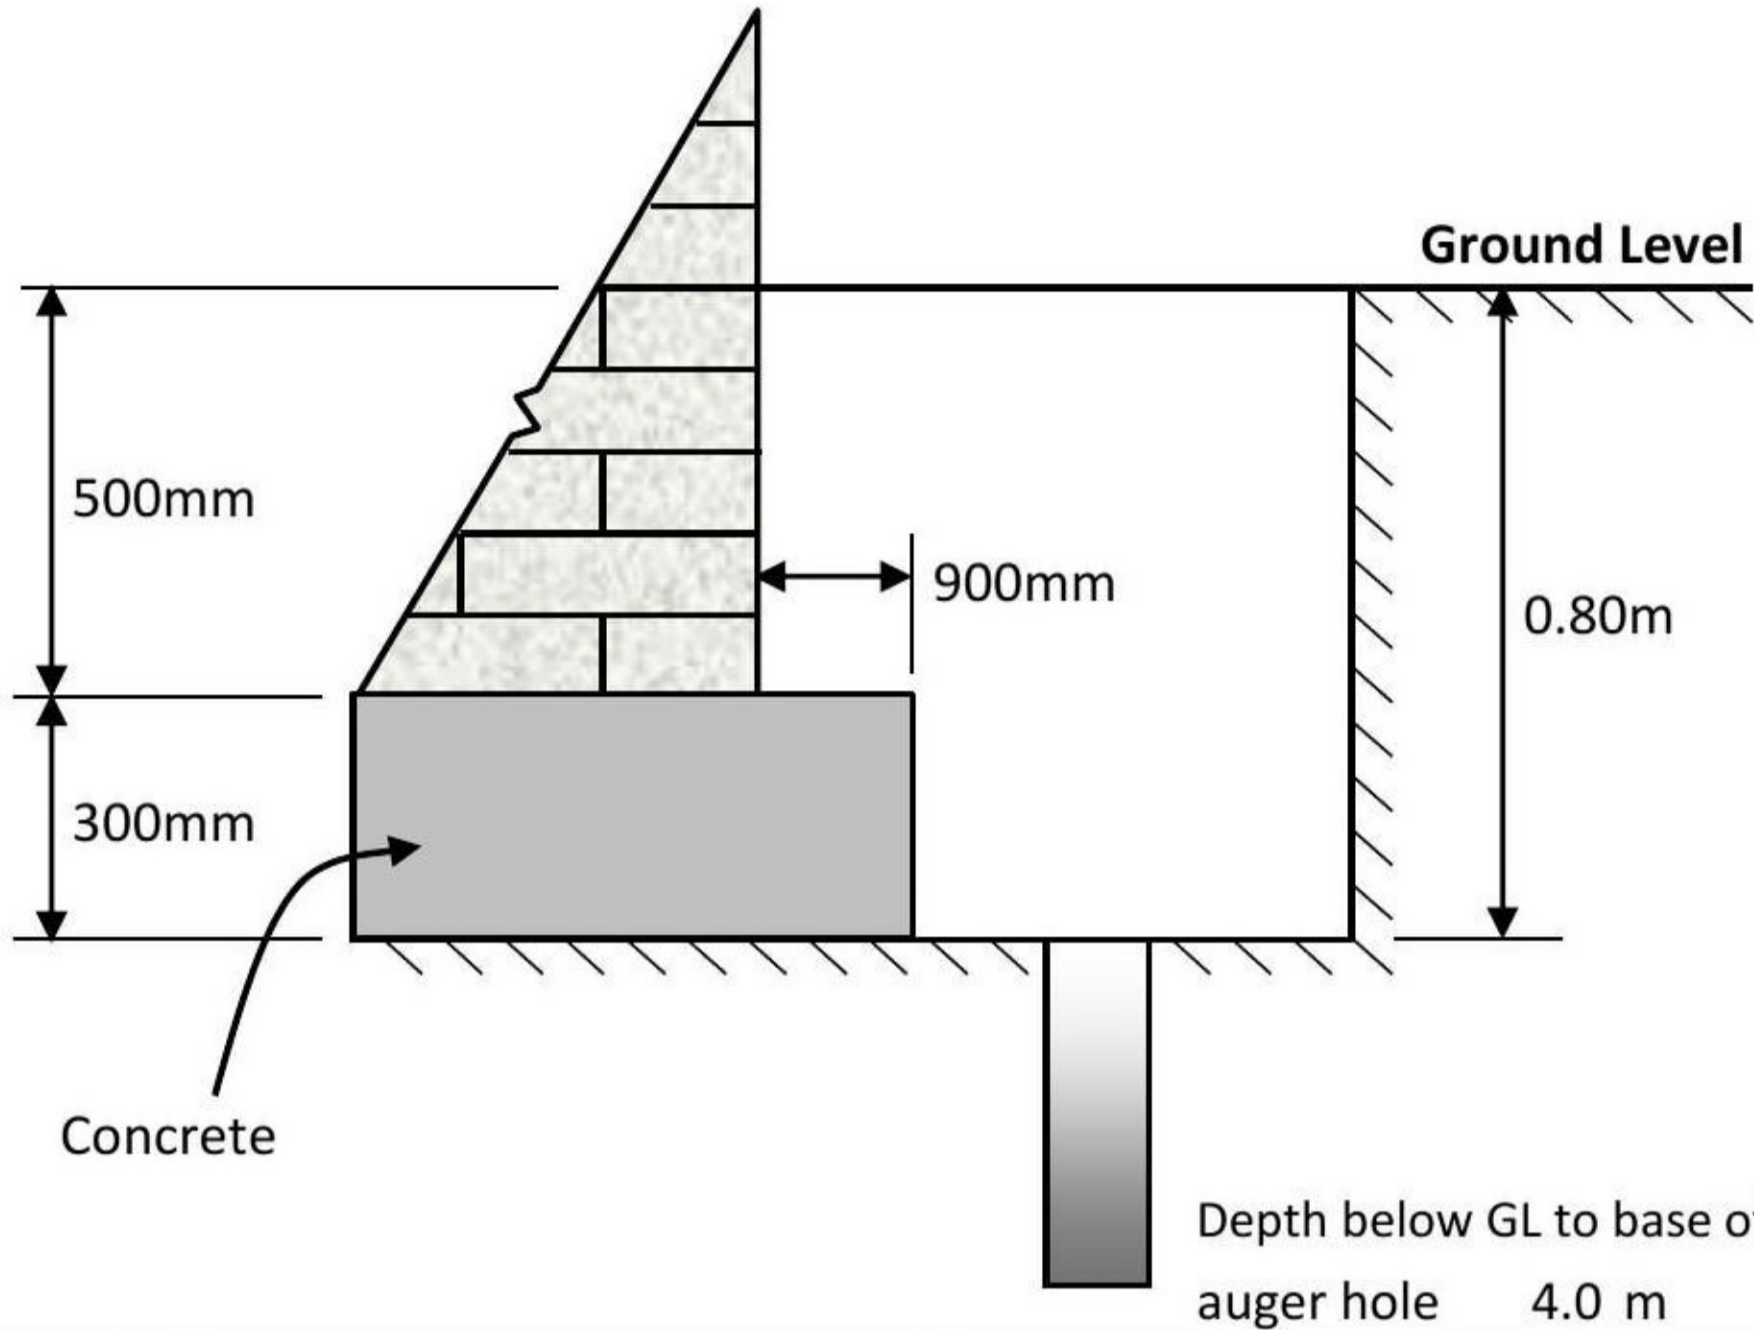
Location: **Junction of House & Porch** T/H No. **1a**
 Ground Surface: **Dry** Weather: **Dry** Date: **04-Jul-22**

House Foundation Cross Section (Not to Scale)

Roots Depth & Diameter:
 From 0.8m
 Down to 2.0m
 up to 2mm diameter

Water Depth Hit & Rise:
 None observed on site

Reason for Termination :
 Hole at instructed depth

General Comments :
 House appears to be built off a concrete raft with a 0.9m spread.

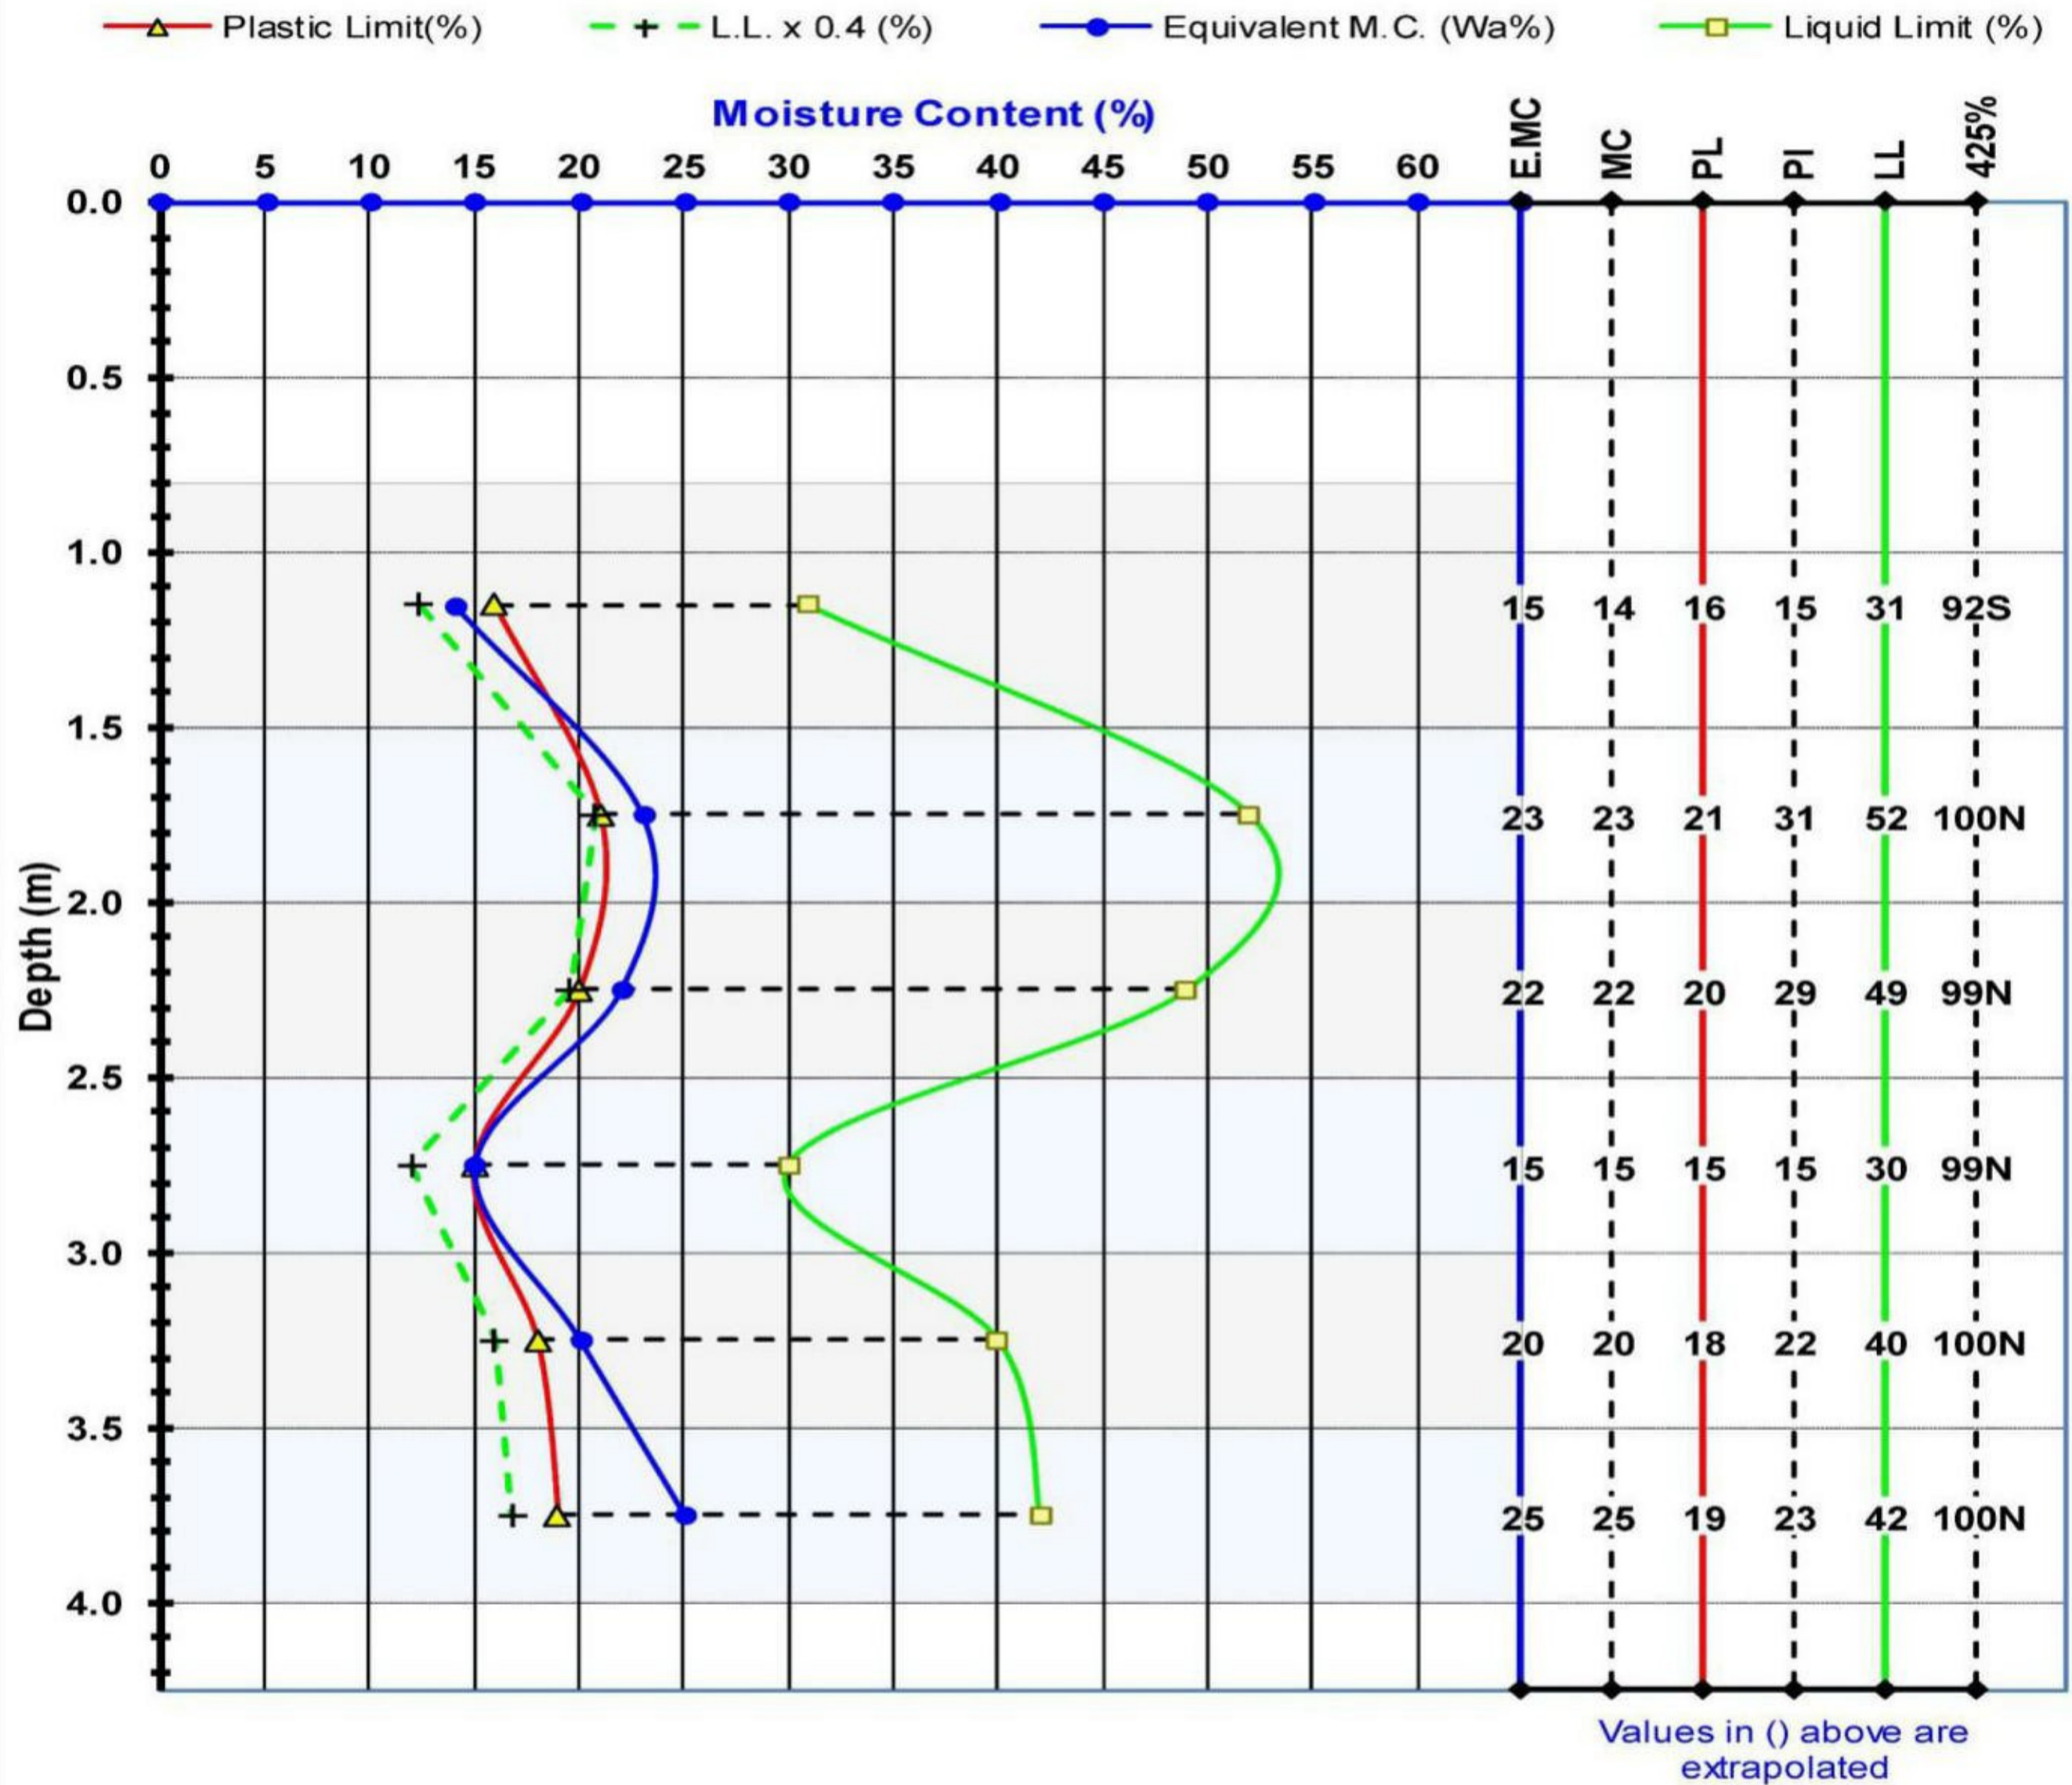
LABORATORY TESTING RESULTS

Depth T (m)	Depth B (m)	1 - Junction of house & porch	Plasticity (BS 5930)	Volume Change (BRE 240)	
		Brief Soil Description		M.PI	(BRE 240)
0.8	1.5	Brown sandy CLAY with rare medium gravel	Low ML	14%	Low
1.5	2	Stiff brown/grey slightly sandy CLAY with rare root fibre	High CH	31%	Medium
2	2.5	Stiff brown/grey sandy CLAY with rare medium gravel & root fibre	Intmd. CI	29%	Medium
2.5	3	Firm orange/grey sandy CLAY with rare medium gravel & root fibre	Low ML	15%	Low
3	3.5	Firm orange/grey sandy CLAY with rare medium gravel	Intmd. CI	22%	Medium
3.5	4	Firm orange/grey sandy CLAY with rare root fibre	Intmd. CI	23%	Medium
