Tree Survey Report

By: Alicia Morton-Thurtle
AMT Tree Surgeons
October 2023

Site: Drinnick Road, Nanpean, PL26 7YN Cornwall
Client: Garden Buildings Cornwall

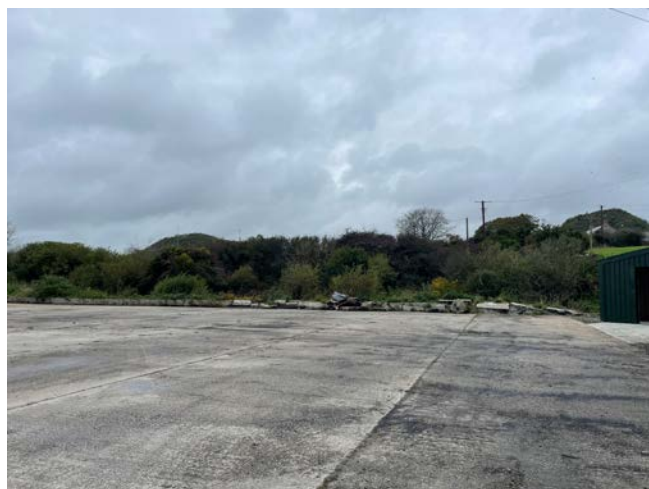
(From left to right, T009, T008, T007 and T006)

T-6 This tree adds visual-perceptual and bio-physical benefits to the plot. The tree is considered to be in good health and in Appendix 2 Tree Data is marked as B1 for this reason. The proposed development falls within the RPA of this tree where it is situated on a bank alongside the river Fal, and without proper ground protection/use of specialised foundations there is a chance that construction activities or the use of heavy machinery in this area may cause a detrimental impact to this tree. A tree protection fence must be placed as shown in the Tree Protection Plan to mitigate potential branch, soil and root disruption during work.
