ARBORICULTURAL IMPACT ASSESSMENT REPORT
BS 5837:2012 'Trees in relation to design, demolition and construction. Recommendations'

26 Beech Hill, Hadley Wood EN4 0JP

DATE: December 2023
OUR REF: SHA 1699 AIA

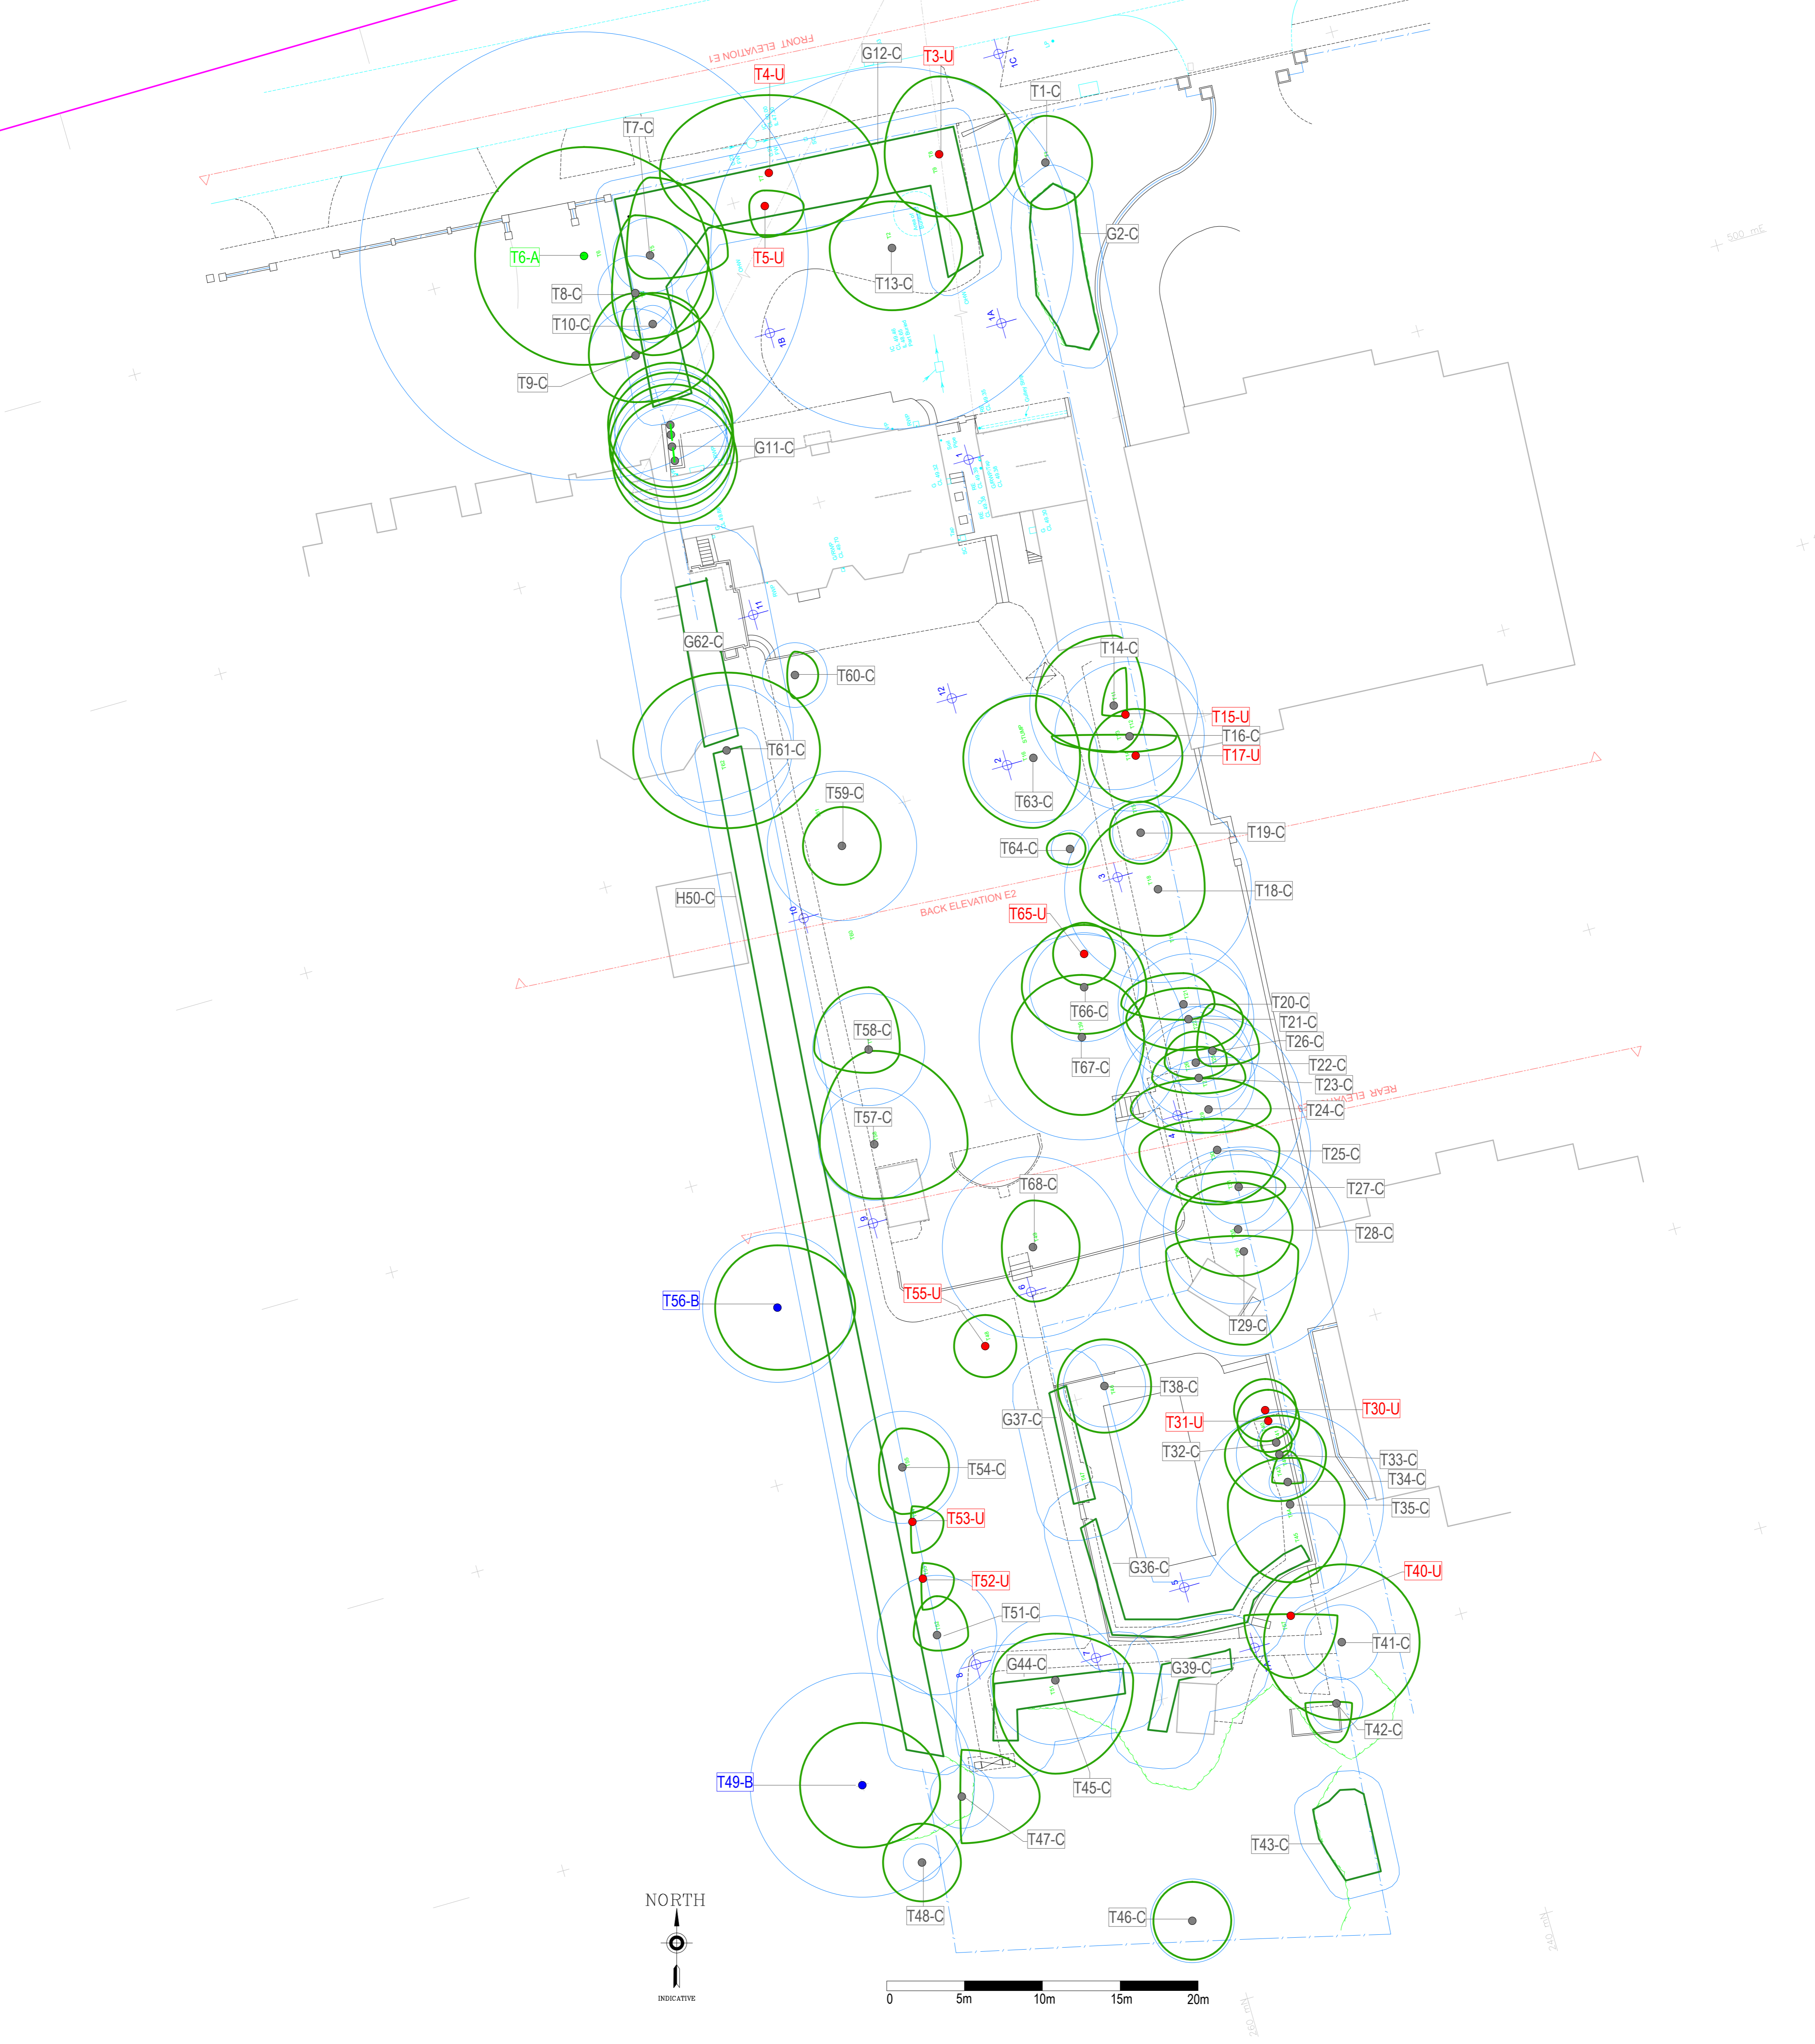
Tree survey plan SHA 1699 TSP

4.1. *Generally:* There are 58 individual trees, 9 groups and 1 hedge which form the subject of this survey. Full details are found in the survey sheets at appendix 1 and their location on the tree survey plan *SHA 1699 TSP* at appendix 2.

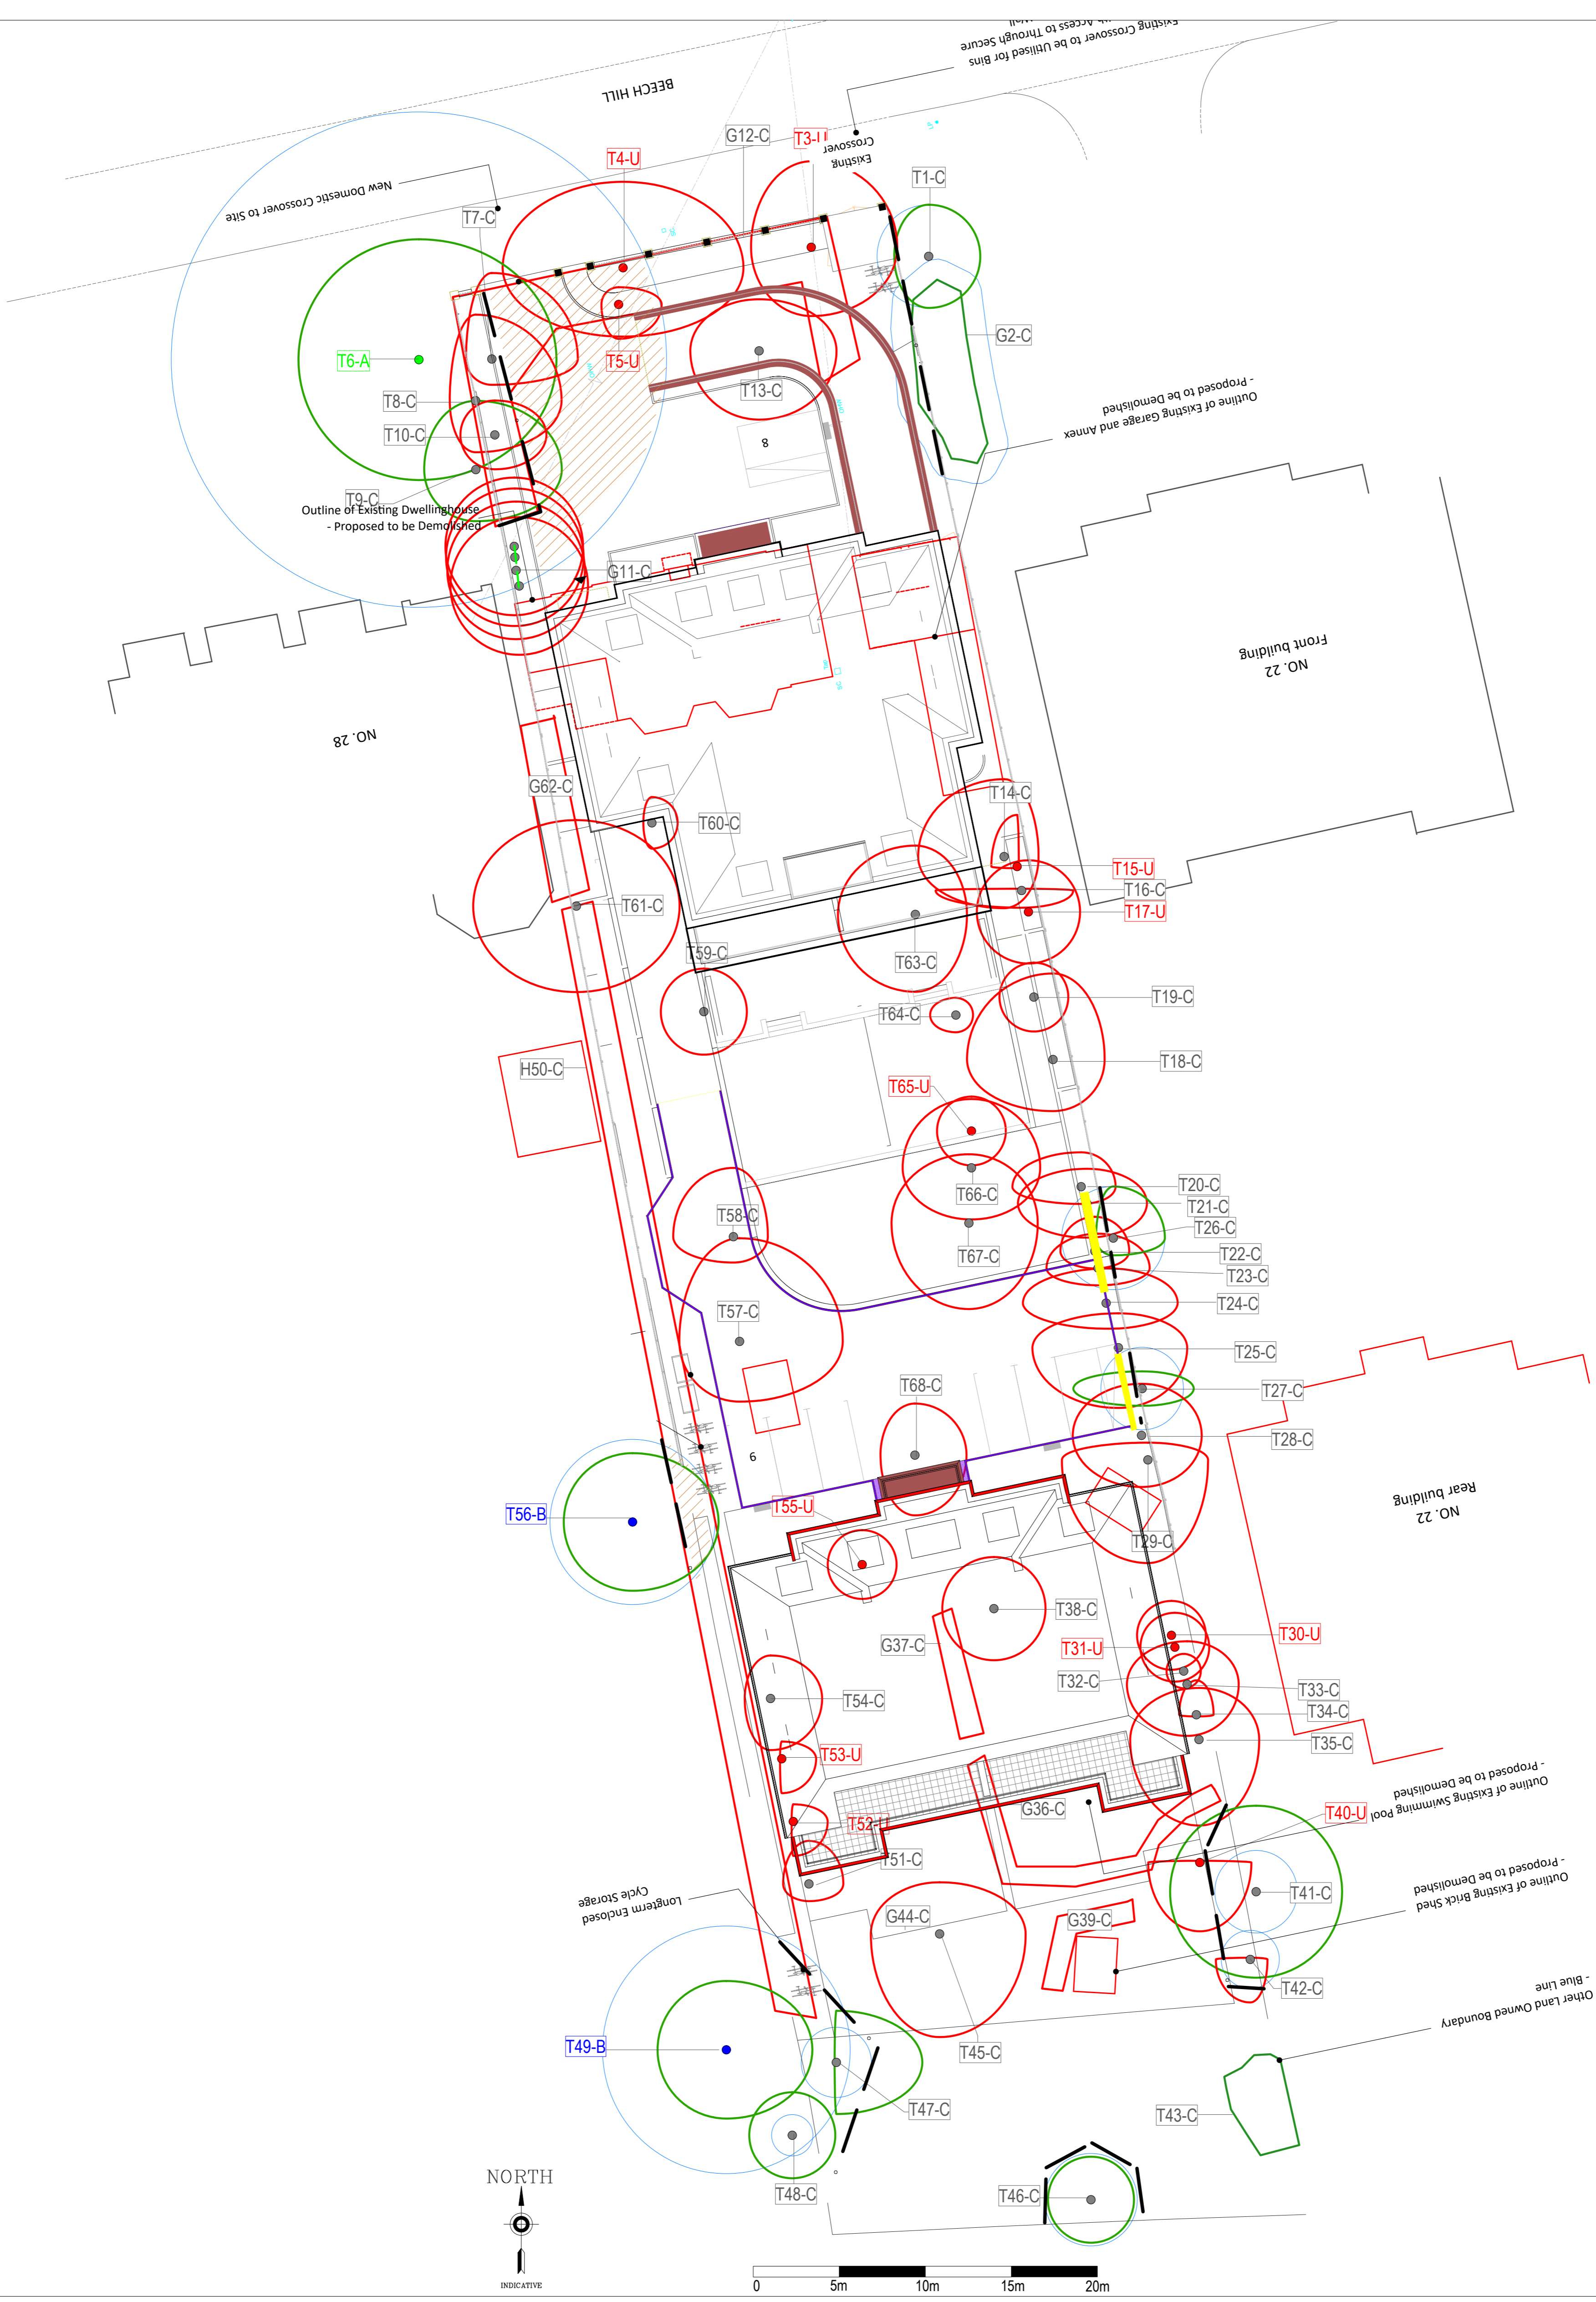
Tree protection plan SHA 1699 TPP

6.6 *Impact on the roots* –The root protection area of T6 is within the site and the proposed drive. During the demolition and construction phase the ground will be protected by robust ground mats/cellular confinement system to take heavy loads. Suitable products are found at appendix 5. There can be no excavation in this area, therefore any drainage and services must be outside the root protection area. The new hard surfacing in this area will be a minimal dig and porous construction and be carried out in accordance with an Arboricultural Method Statement (AMS) to be further refined post planning. A draft is found at appendix 6.

Ground protection during demolition and construction comprising ground mats - see report for details. No excavation in this area. New hard surfacing to be minimal dig and porous construction.

- 8.2. That the arboricultural method statements are developed further in respect of drainage and hard surfacing near the offsite oak T6 and are observed by all site personnel and supervised at key stages by the project arboricultural consultant. Short supervision reports are to be written after each inspection as a record of compliance and audit trail to the Local Authority.
