Arboricultural Consultancy for Lloyds Bank

| Insured | Mr Roger Wood | Address | 9 Strathbrook Road, London, SW16 3AT | | |
| Client | Subsidence Management Services | Contact | Nigel Buxton | Claim No. | IFS-LBG-SUB-22-0102319 |

Scope of Report: To survey the property and determine significant vegetation contributing to subsidence damage, make recommendation for remedial action and assess initial mitigation and recovery prospects. The survey does not make an assessment for decay or hazard evaluation.

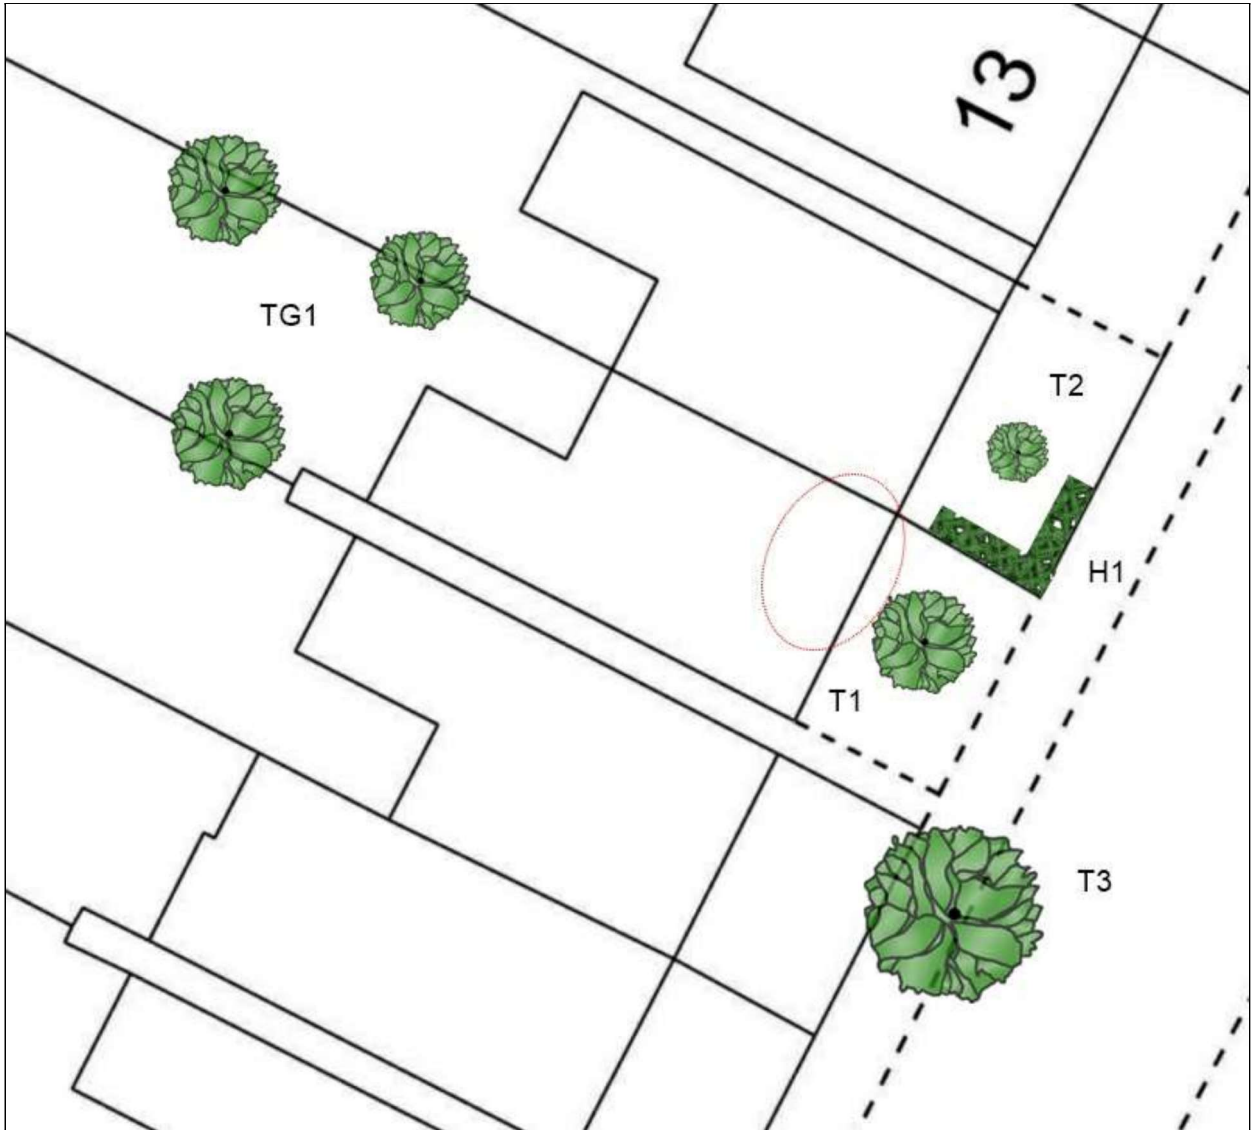
7. Site Plan

Please note that the footing of the insured property fall within the anticipated rooting distance of additional vegetation which we believe presents a foreseeable risk of future damage and accordingly we have made recommendations in respect of this.
