**TECHNICAL REPORT ON A SUBSIDENCE CLAIM**

**Crawford Reference: SU2002228**

**The Old Church  
Merley Park Road  
Ashington  
Wimborne  
BH21 3DF**

**SUBSIDENCE CLAIM**

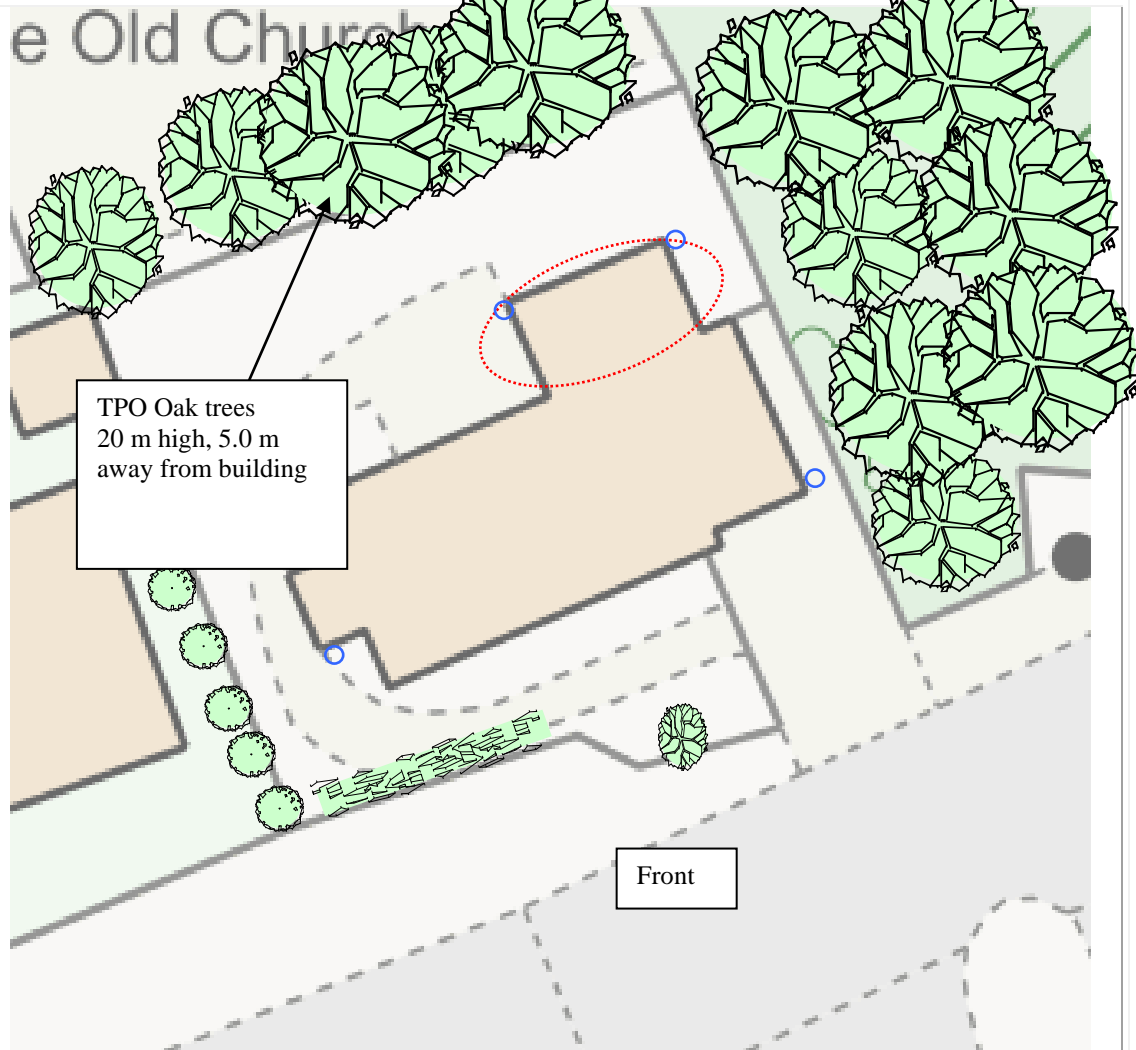
**Site Plan**

There are several trees beyond the rear boundary and to the right, some with roots that may extend beneath the house foundations. The following are of particular interest:-
