project: **watertower ormskirk**
dwg no: **008**
dwg: **structural survey**
scale: **1:100 @ A1**

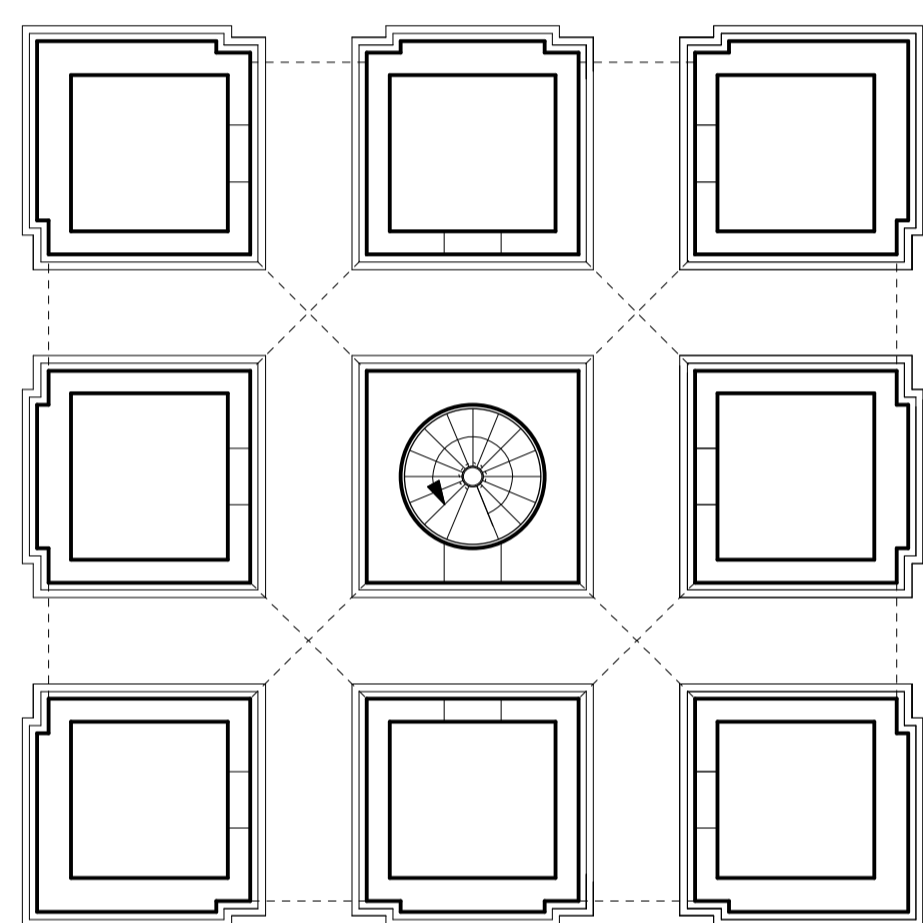
ground

intermediate supports missing

limited movement in front corner

rusting of bottom ring beam forcing wall out [around entire perimeter]

iron beams damaged in places and suffering from stress fractures throughout [through either age or damage occurring when water tank was taken down in the 1980's]

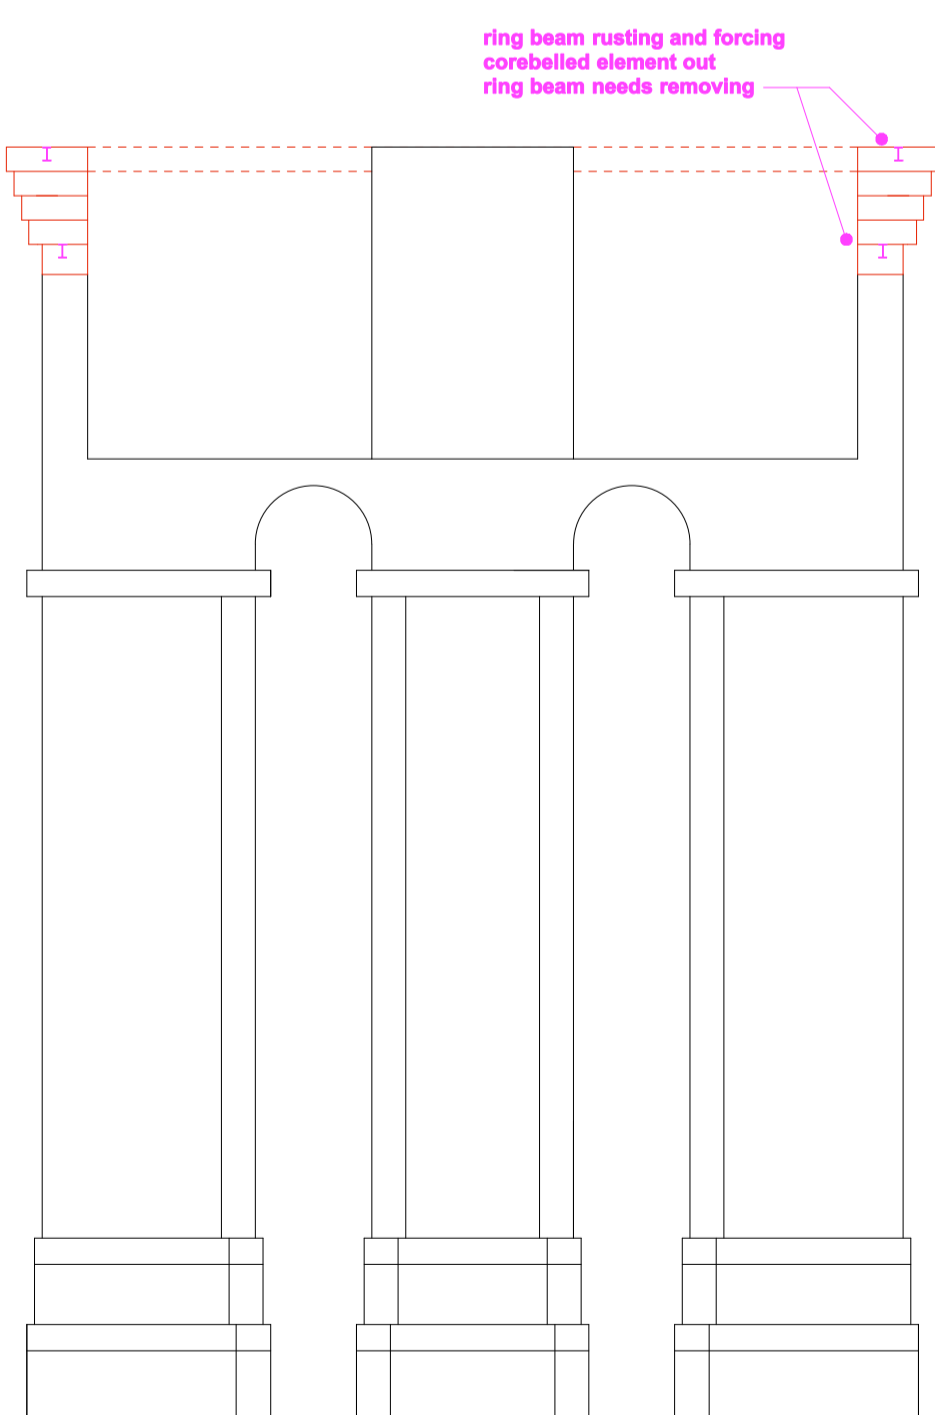
section aa

severe movement in one corner

rusting of bottom ring beam forcing wall out [around entire perimeter]

corners strapped somewhat haphazardly - from internet photographs strapping visible from before 2000 [presumably put up when tank was taken down]

movement of outside walls pulling iron frame which in turn is pulling brick staircase

all corners strapped cracking up stone from outward movement of perimeter
