Arboricultural Consultancy for Lloyds Bank

Insured	Mr Richard Hammond	Address	55 Gellatly Road, New Cross, SE14 5TU		
Client	Subsidence Management Services	Contact	Ian Domigan	Claim No.	IFS-LBG-SUB-22-0102990
ES Ref	SA-250953	Consultant	Kirk Thompson		
Report Date	18/11/2022

55 Gellatly Road, New Cross, SE14 5TU

TP/BH1 Foundation Detail and Borehole Log

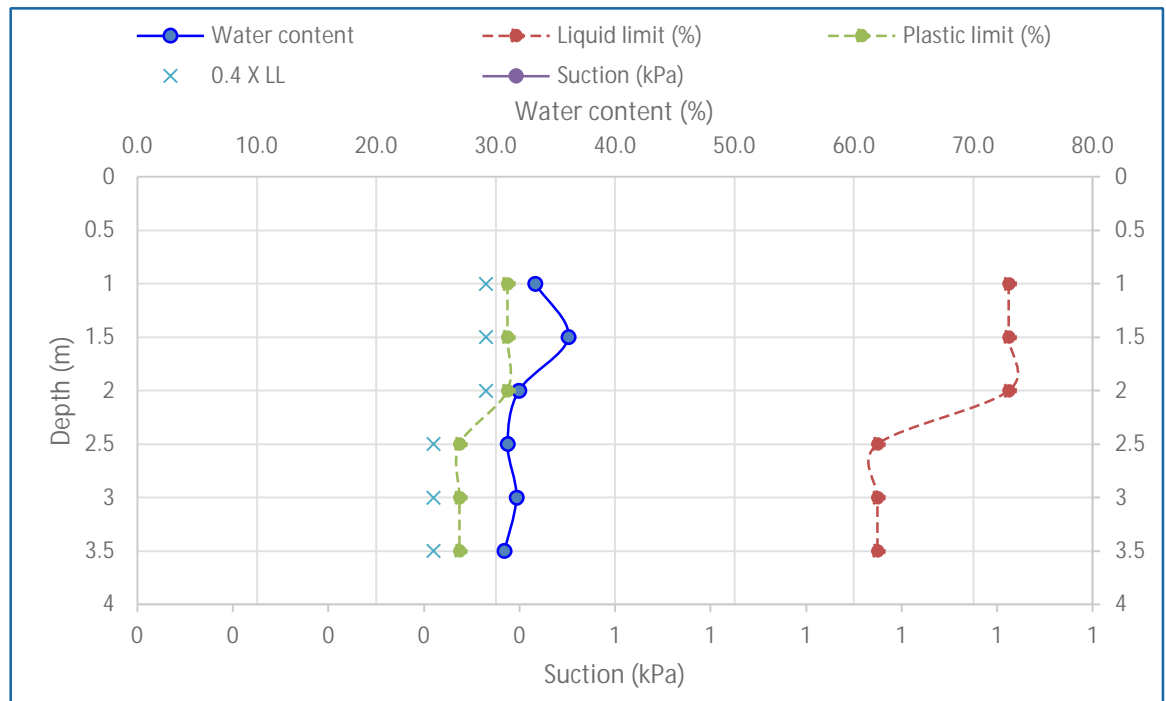
Plasticity Chart for Casagrande Classification

Lab Ref	Depth (m)	WC (%)	LL (%)	PL (%)	PI (%)	.425 mm (%)	mod. PI (%)	Av. Suc. (kPa)	Description
1	1	33.3	73	31	42	99	42		Firm brown/light brown/grey silty CLAY
2	1.5	36.1	73	31	42	99	42		Firm brown/light brown/grey silty CLAY with rare sand
3	2	32.0	73	31	42	99	42		Firm brown/light brown/grey silty CLAY with rare sand
4	2.5	31.0	62	27	35	99	35		Firm brown/light brown/grey slightly sandy silty CLAY
5	3	31.8	62	27	35	99	35		Firm brown/light brown/grey slightly sandy silty CLAY
6	3.5	30.7	62	27	35	99	35		Firm brown/light brown/grey slightly sandy silty CLAY
