The Sizewell C Project

Application for Listed Building Consent
Upper Abbey Farm, Hay Barn and Cart Lodge
Farm Buildings at Upper Abbey Farm. Leiston, Suffolk:
Heritage Asset Assessment

Farm Buildings at Upper Abbey Farm, Leiston, Suffolk

Heritage Asset Assessment

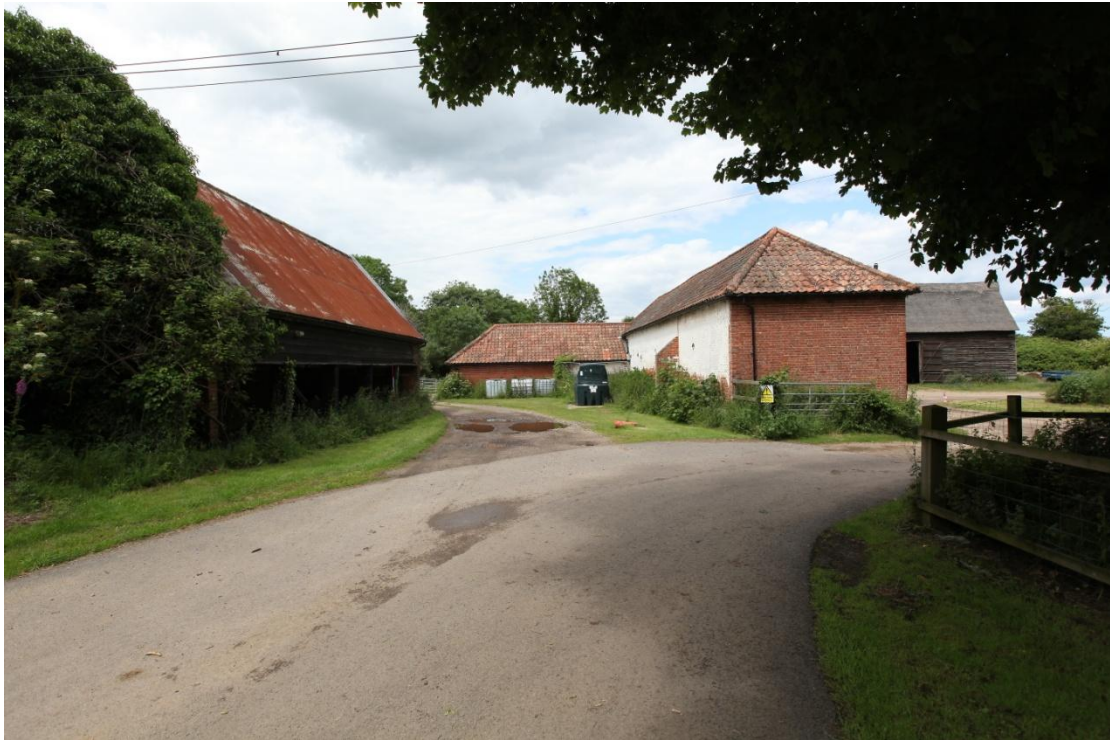
Illus. 1. A general view of the farm buildings from the site entrance to the south showing the brick stable (2) in the centre with the cart lodge and granary (3) to the left and the barn (1) in the rear to the right.

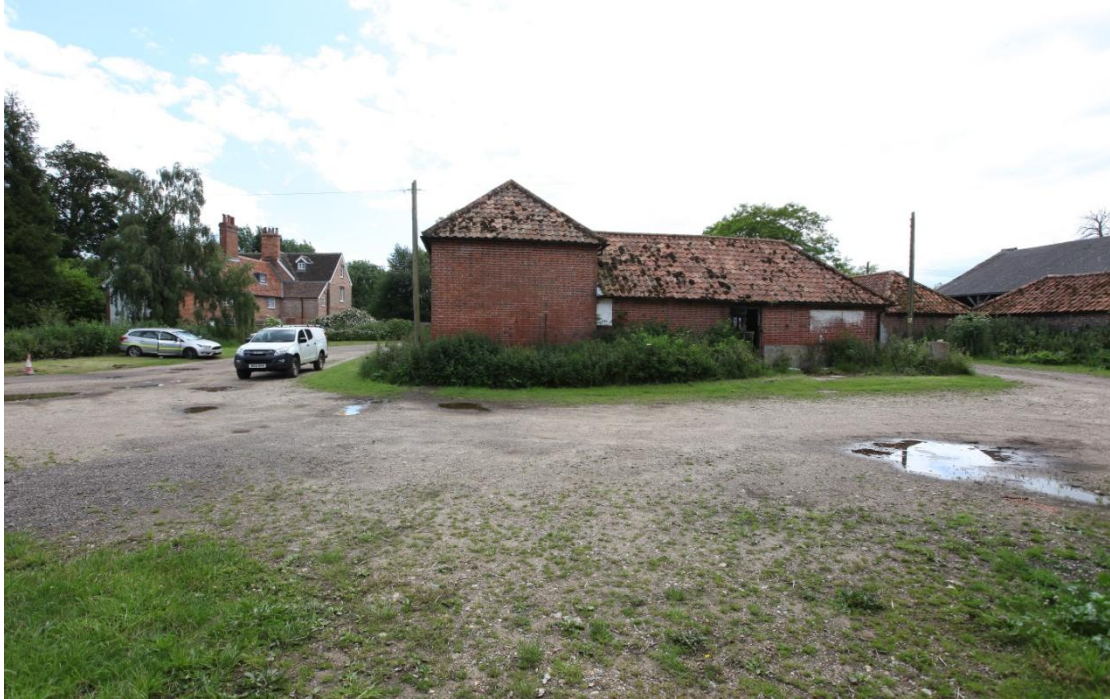
Illus. 3. A general view of the site from the barn (1) to the north showing the L-shaped brick stable flanked on the left by the house (8) and on the right by the uniformly pantiled small brick cart-shed (4) and the open-sided flint-rubble shelter-shed (5). The large building in the rear to the right is a late-20th century covered cattle yard.

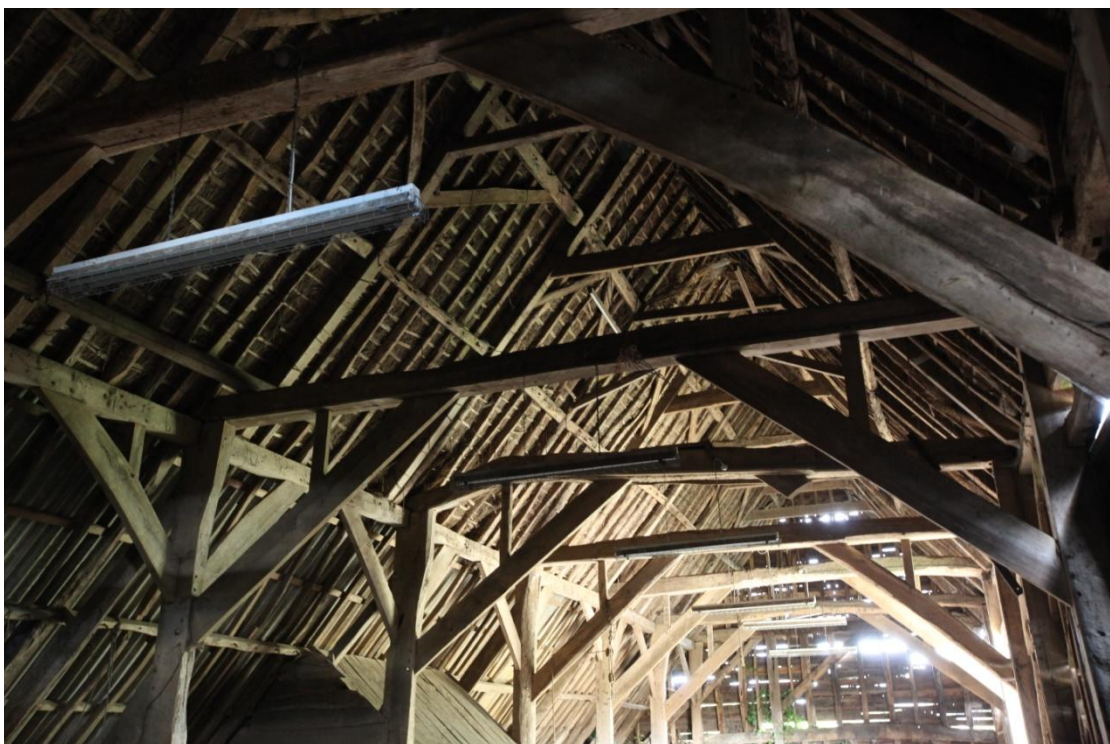
Illus. 6. A general view of the barn's impressive roof (1) from the west showing its complete array of tie-beam and arcade-plate braces with a full complement of wind-braces in the two-tier roof of linear butt-purlins.

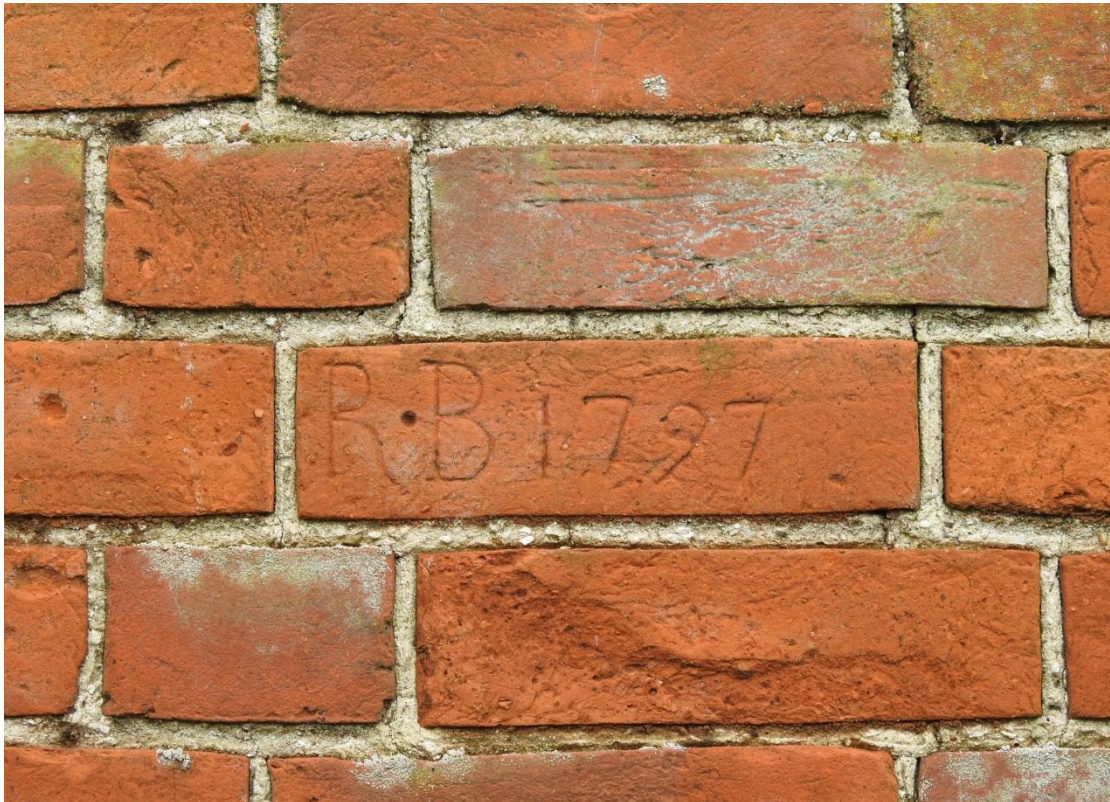
Illus. 20. A detail of the third of the three sets of initials neatly incised into the brickwork of the cart lodge's northern external gable (3), all dated 1797: From top to bottom 'Z K', 'M B' and 'R B' (the latter shown here). A fourth set, 'S P' is followed by what appears to be the number '3'. The style of lettering is convincing and the structure probably dates from this year. 'M B' and 'R B' may be Daniel Barker's antecedents.
